Asbestos Inspection & Register

**123-125 Donnison Street
Gosford NSW 2250**

Report Number: R20465

Report Date: 24 March 2020

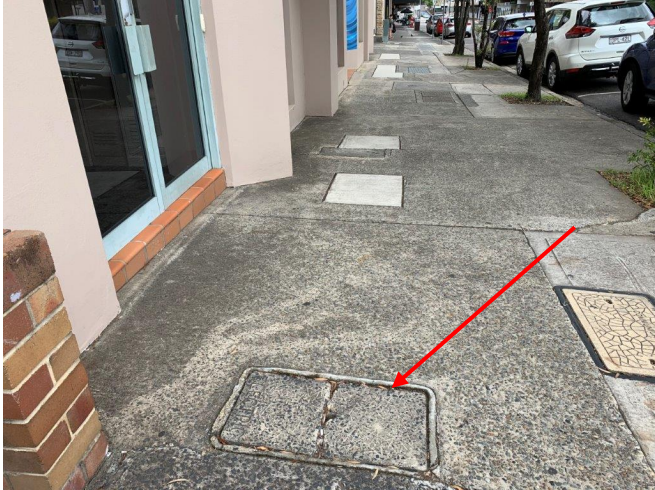
Photograph: 3898	Photograph: 3876
Description: Asbestos cement telecom pit at front entry	Description: Presumed asbestos thermal insulation internal to hot water system
Locations Found: External	Locations Found: G.2 Laundry
