## **Hazardous Materials Survey**

**IMPERIAL SHOPPING CENTRE**

**171 MANN STREET,  
GOSFORD NSW 2250**

**ESP Job: J38401 – May 2018**

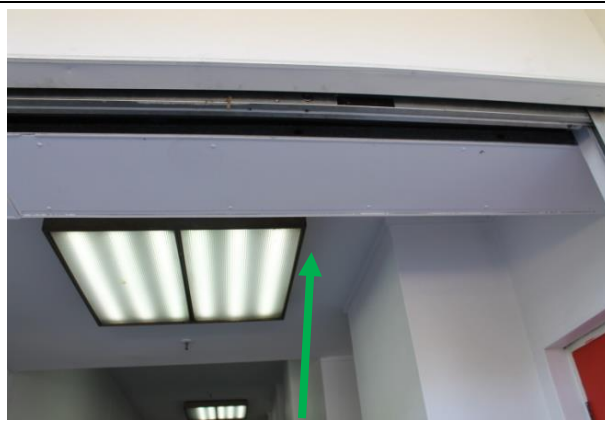
**Photo: 1**

Williams St Ramp Ceiling Panel  
Flat Fibro Cement Sheetting

**No Asbestos Detected – Sample No: E25797**

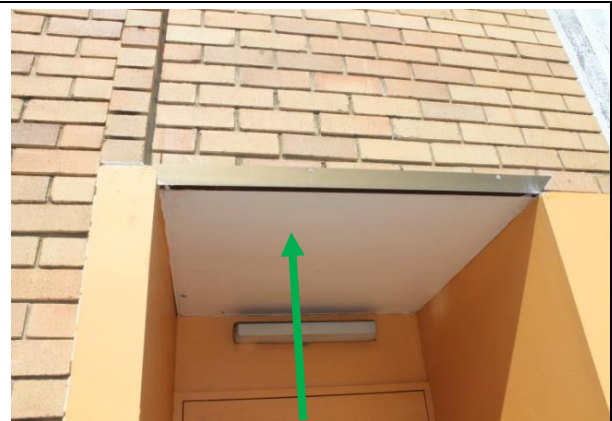
**Photo: 2**

Erina St Entrance Ceiling Above Fire Door  
Flat Fibro Cement Sheetting

**No Asbestos Detected – Sample No: E25798**

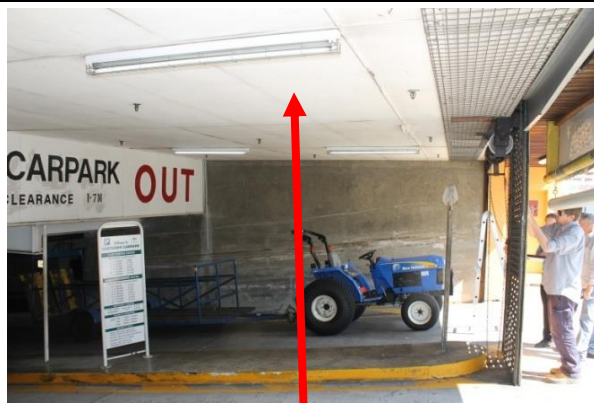
**Photo: 3**

Erina St Carpark Entrance Ceiling  
Flat Fibro Cement Sheetting

**Asbestos Detected – Sample No: E25799**

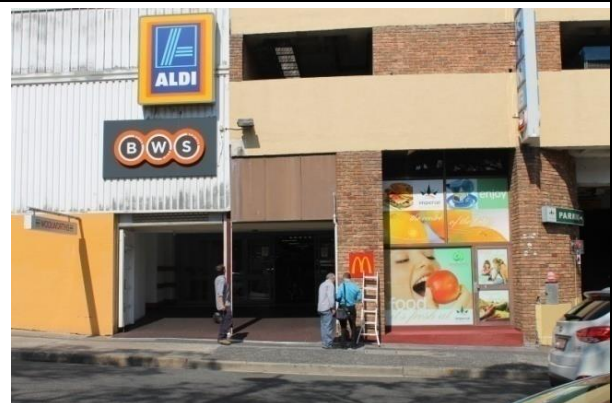
**Photo: 4**

Erina St Pedestrian Entrance Ceiling  
Flat Fibro Cement Sheetting

**No Asbestos Detected**

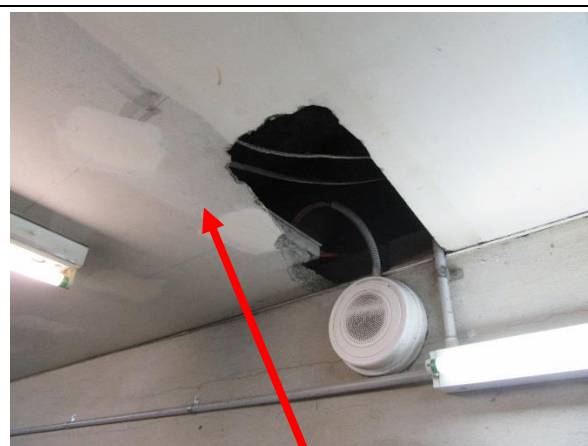
**Photo: 5**

Plant Services Stairwell  
Flat Fibro Cement Sheetting

**Asbestos Detected – Sample No: E25806**

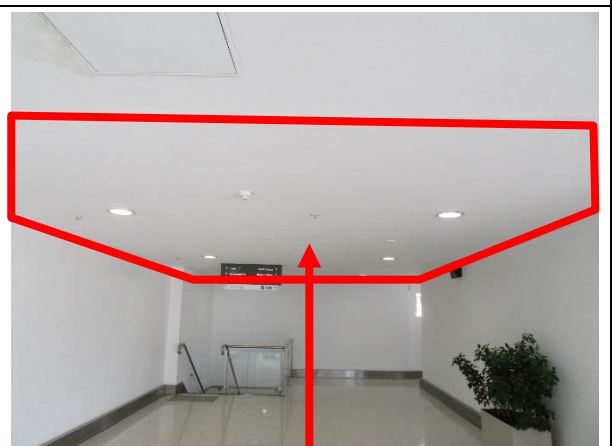
**Photo 6**

L4 Foyer Ceiling  
Flat Fibro Cement Sheetting

**Asbestos Detected – Refer to Sample No: E25806**

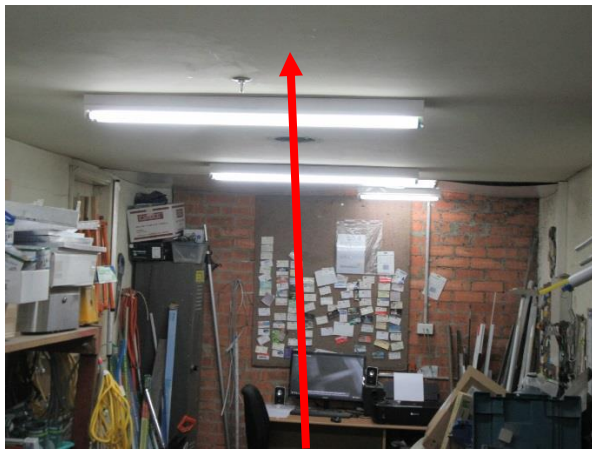
**Photo 7**

Maintenance Room  
Flat Fibro Cement Sheeting

**Asbestos Detected – Sample No: E25810**

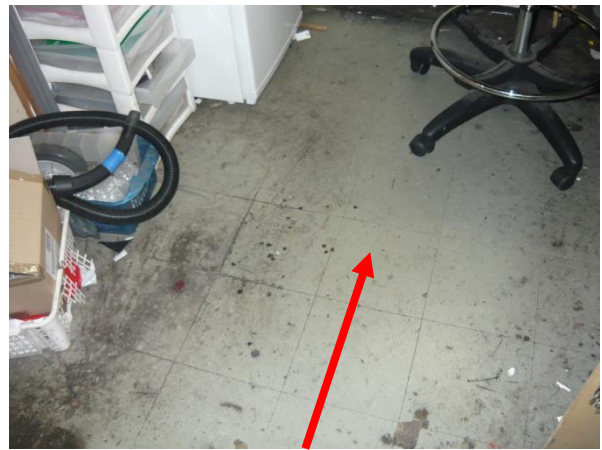
**Photo 8**

| Photo No | Sample No | Location / Room | Surface Description | Material Description | Material Status | Friable/ Non-Friable | Condition | Risk Rating | Recommendations/Comments | Qty (m <sup>2</sup> ) |
|---|---|---|---|---|---|---|---|---|---|---|
| 8 | E25816 | Imperial Shoe Repairs Back Room S162a/163 | Floor | 12x12 Vinyl Floor Tiles | Chrysotile Asbestos Detected | Non-Friable | Good | Low | Remove & replace | |

Imperial Shoe Repairs Back Room  
Vinyl Floor Tiles

**Asbestos Detected – Sample No: E25816**

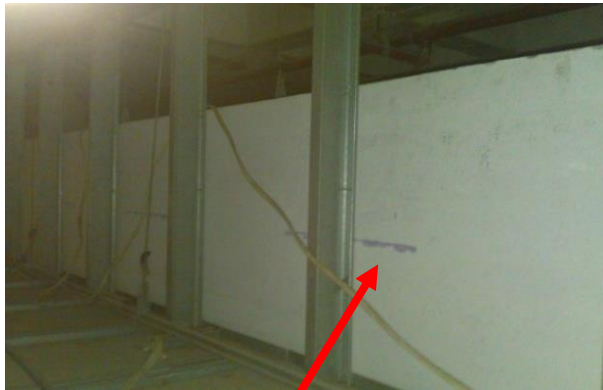
**Photo 9**

Ceiling Space Bulk Head - Adjacent Woolworths  
Flat Fibro Cement Sheeting

**Asbestos Detected – Sample No: E61677**

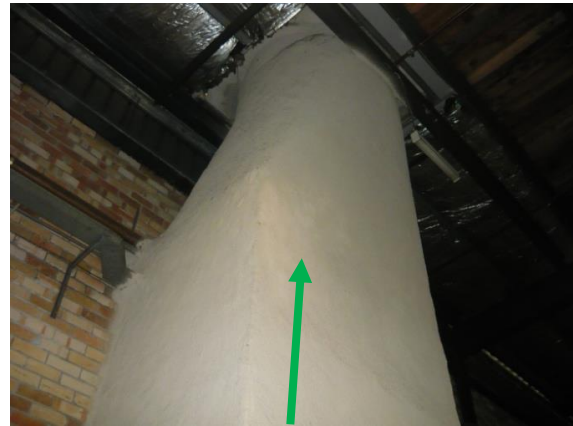
**Photo 10**

Woolworths Vermiculite Coated Tower  
**No Asbestos Detected – Sample No: E25808**

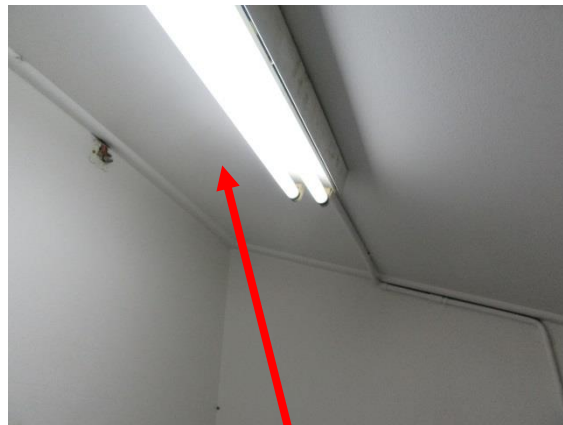
**Photo 11**

Stairwell Ceiling  
Flat Fibro Cement Sheeting
