Health Infrastructure NSW
Hazardous Building Materials Survey

The Lodge
Labyrinth Way, Westmead NSW

28 January 2021

56200/130,973 (Rev 1)

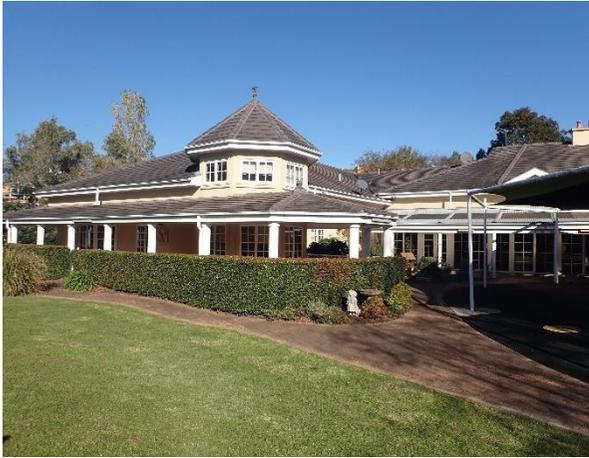
Photo 1: Overview of the Lodge

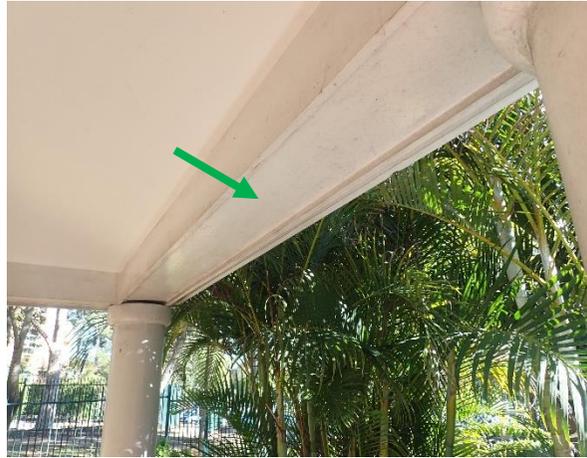
Photo 2: Lodge, non-asbestos containing fibre cement sheeting to eaves

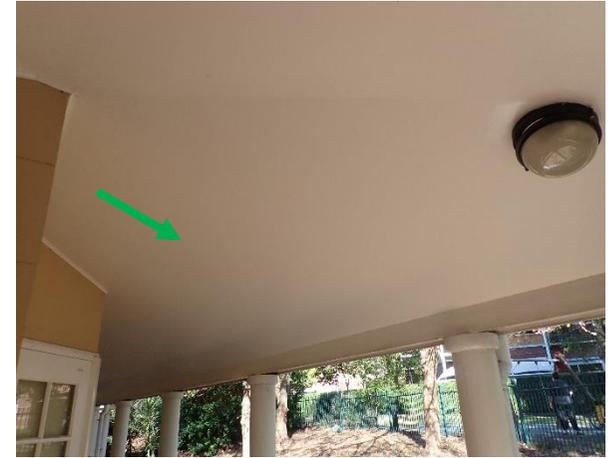
Photo 3: Lodge, non-asbestos containing fibre cement sheeting to veranda soffits

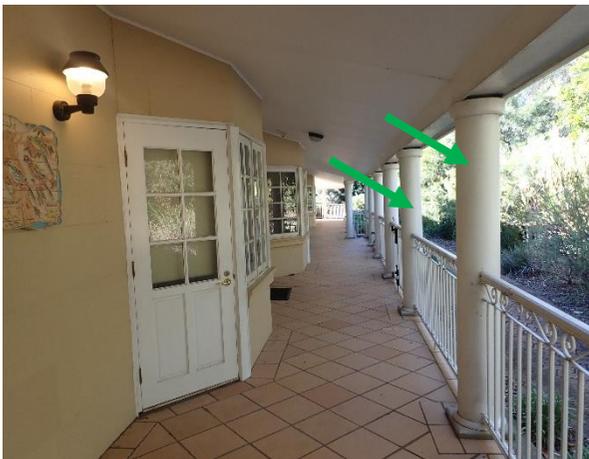
Photo 4: Lodge, non-asbestos containing moulded fibre cement columns to veranda

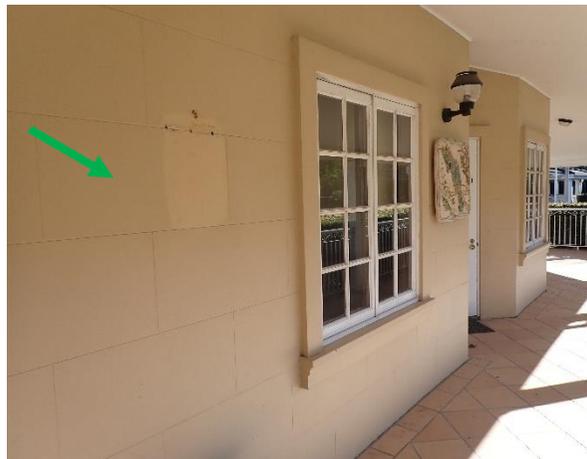
Photo 5: Lodge, non-asbestos containing fibre cement sheeting to external walls

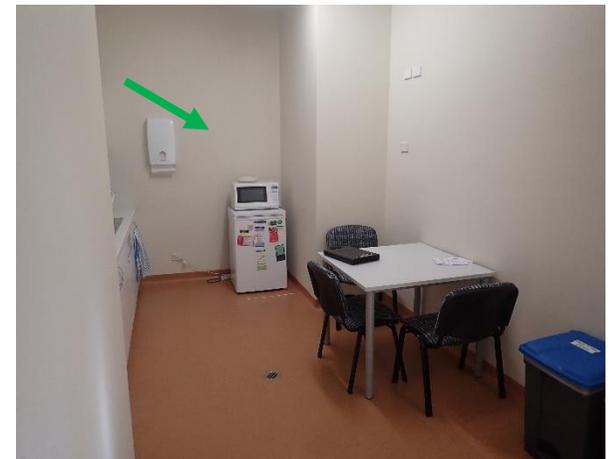
Photo 6: Lodge, non-asbestos containing fibre cement sheeting to east kitchen walls

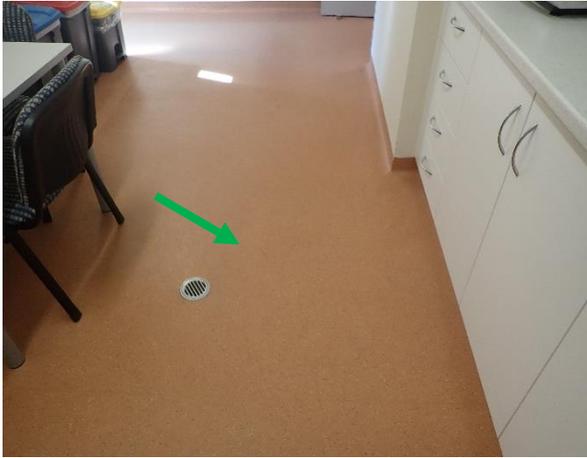
Photo 7: Lodge, non-asbestos containing brown vinyl flooring to east kitchen

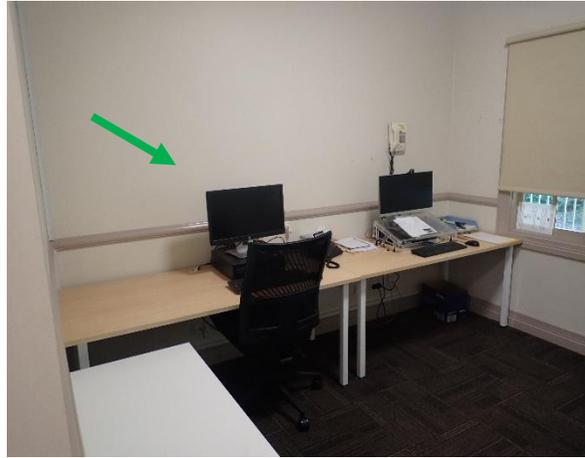
Photo 8: Lodge, non-asbestos containing fibre cement sheeting to internal fire walls (behind plasterboard)

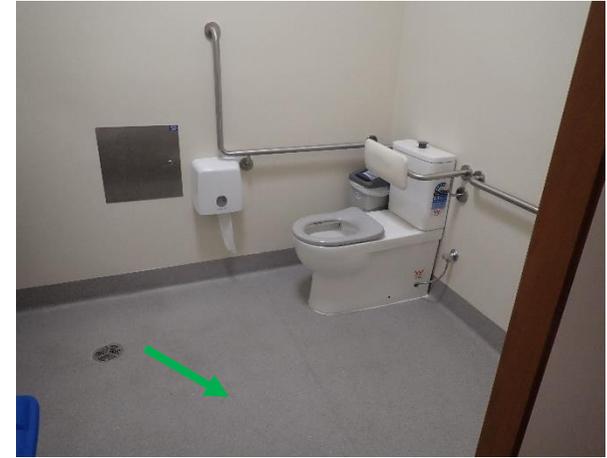
Photo 9: Lodge, non-asbestos containing grey vinyl flooring to east disabled toilet

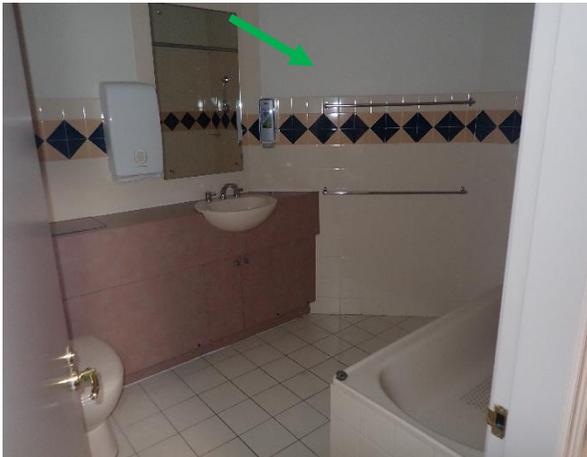
Photo 10: Lodge, non-asbestos containing fibre cement sheeting to bathroom walls throughout

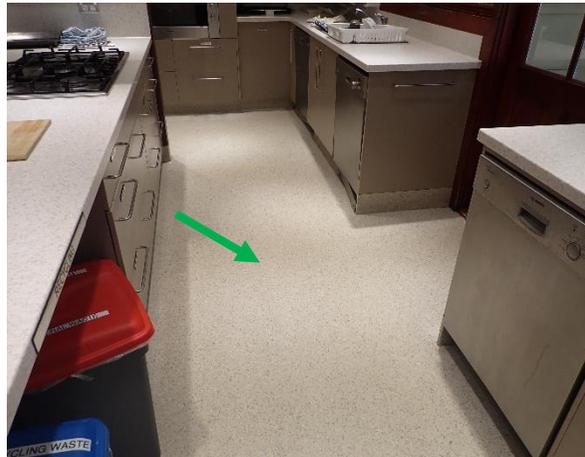
Photo 11: Lodge, non-asbestos containing grey vinyl flooring to central kitchen

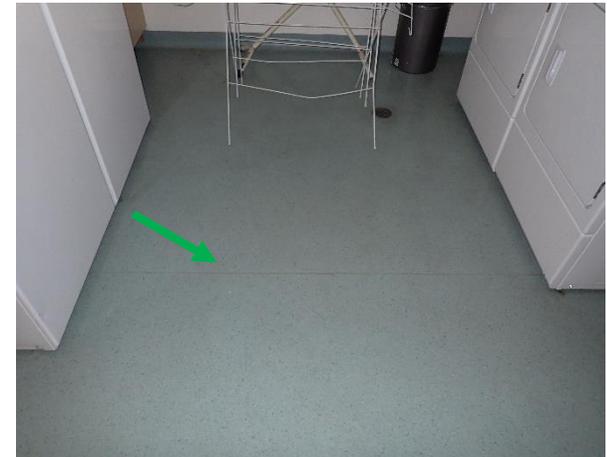
Photo 12: Lodge, non-asbestos containing green vinyl flooring to west laundry

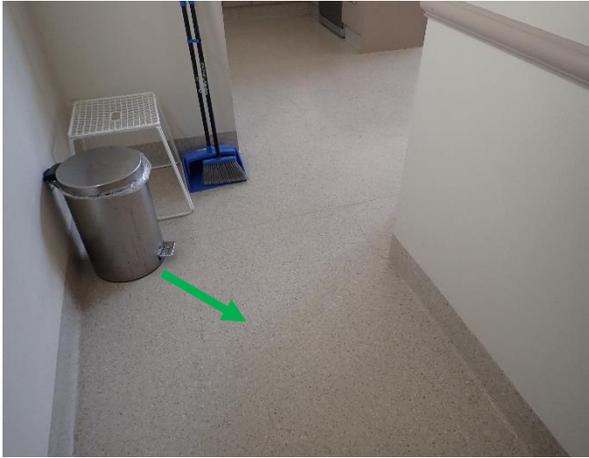
Photo 13: Lodge, non-asbestos containing grey vinyl flooring to E1 kitchen

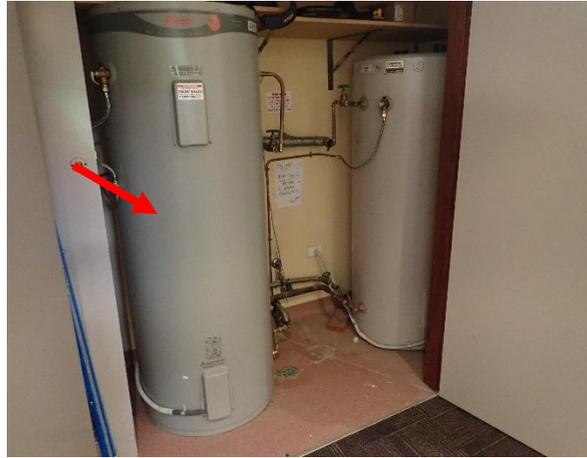
Photo 14: Lodge, assumed internal SMF insulation to hot water systems in east HWS cupboard

The synthetic mineral fibres encountered during this inspection were generally contained and deemed to be low risk. These SMF materials can be removed with the building and demolition waste with care taken not to generate fibres. Appropriate PPE is recommended including the use of P2 respirator as minimum and appropriate removal methodology as outlined in [NOHSC: 1004(1990)] and [NOHSC: 2006(1990)].

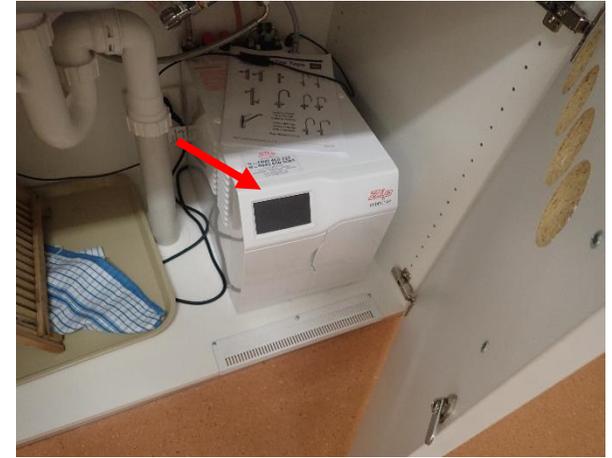
Photo 15: Lodge, assumed internal SMF insulation to instant hot/cold water system in east kitchen

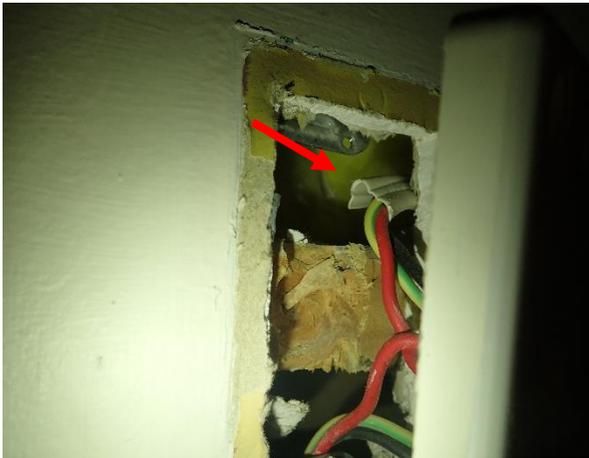
Photo 16: Lodge, assumed SMF insulation batts to internal wall cavities

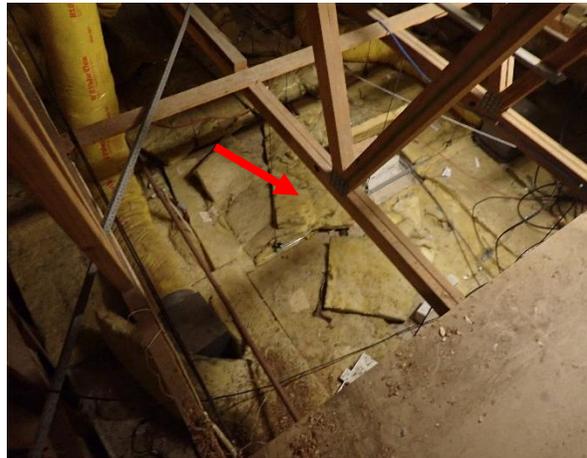
Photo 17: Lodge, assumed SMF insulation batts throughout the ceiling cavity

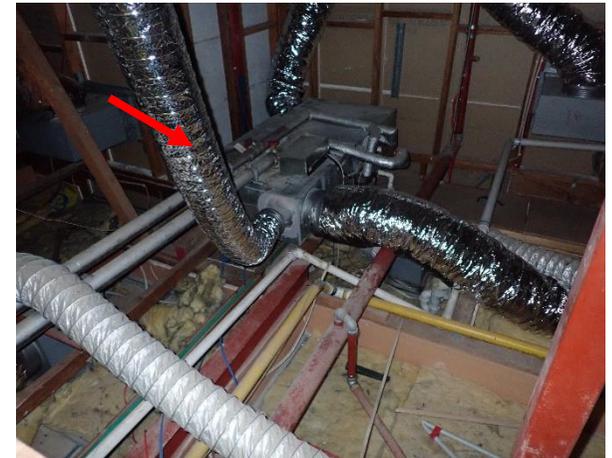
Photo 18: Lodge, assumed SMF insulation to air conditioning ducting throughout ceiling cavity

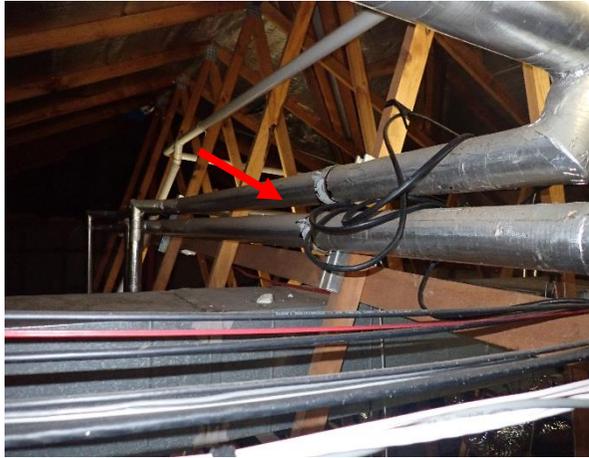
Photo 19: Lodge, assumed SMF insulation to pipework throughout ceiling cavity

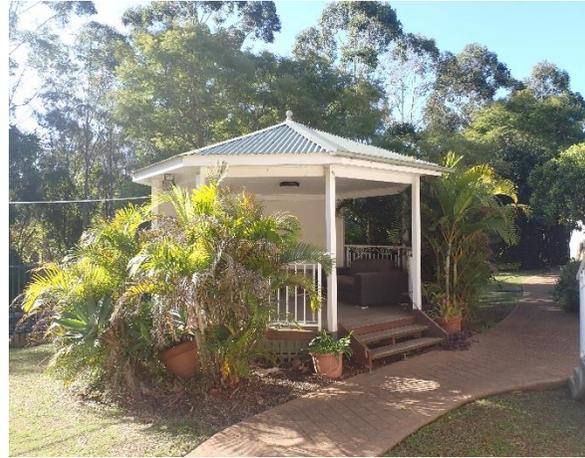
Photo 20: Overview of the Gazebo

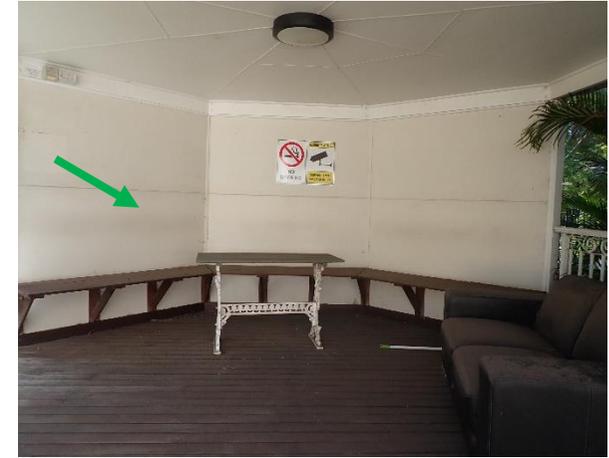
- Non-asbestos containing fibre cement sheeting (A-13) was identified to the north wall. This material was also identified to the ceiling and eaves.
- All accessible paint systems were screened via XRF spectrometer and classified as non-lead based paints (XRF result < 0.1 mg/cm²).
- No other hazardous materials were identified at the time of inspection.

Photo 21: Gazebo, non-asbestos containing fibre cement sheeting to the north wall

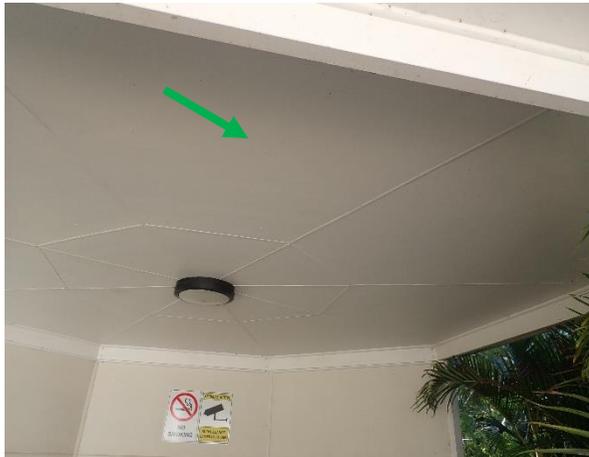
Photo 22: Gazebo, non-asbestos containing fibre cement sheeting to the ceiling

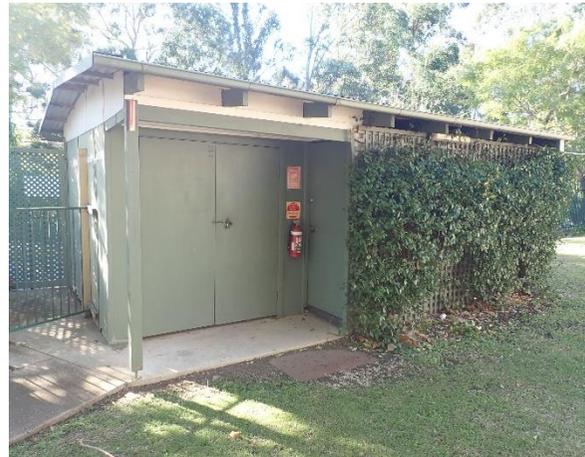
Photo 23: Overview of the Shed

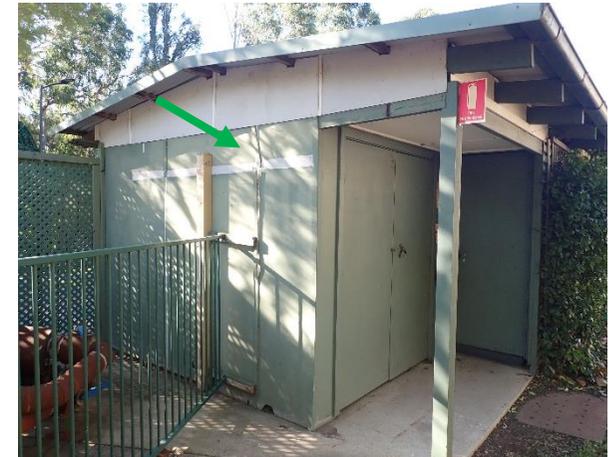
- Non-asbestos containing fibre cement sheeting (A-14) was identified to the external walls. This material was also identified to the internal walls, ceiling and eaves.
- All accessible paint systems were screened via XRF spectrometer and classified as non-lead based paints (XRF result < 0.1 mg/cm²).
- No other hazardous materials were identified at the time of inspection.

Photo 24: Shed, non-asbestos containing fibre cement sheeting to the external walls
