# DILAPIDATION REPORT

## Council Assets/Public Infrastructure

**WATERLOO STATION  
COPE STREET**

**24 January 2023**

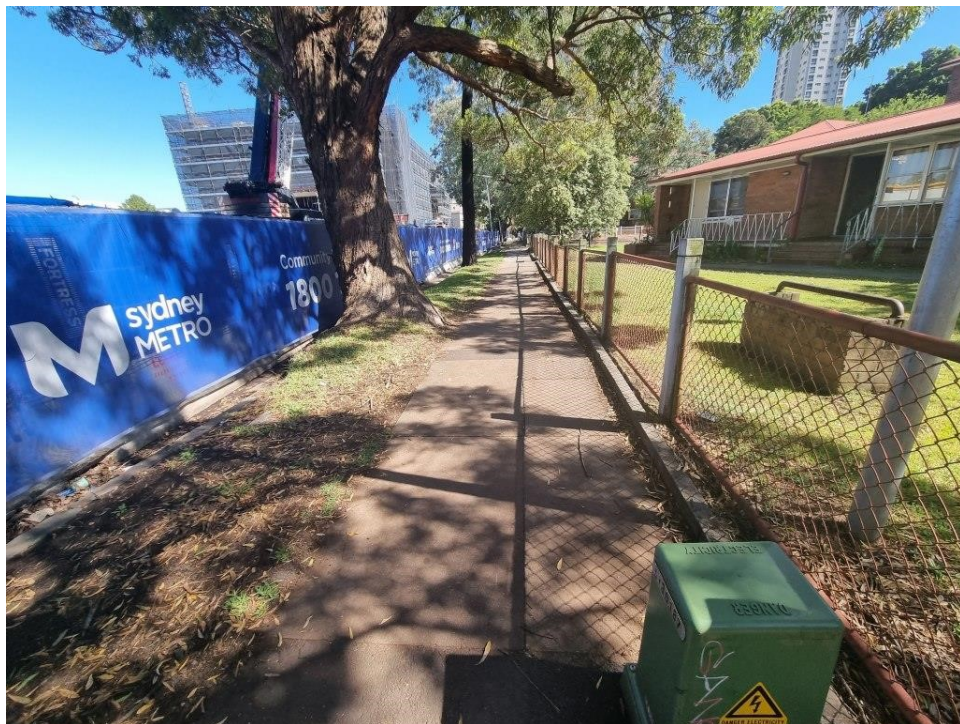
**PHOTO 1**

(Photo showing start point of dilapidation inspection in line of the Waterloo Congregation Church, circled in red, on Cope Street)

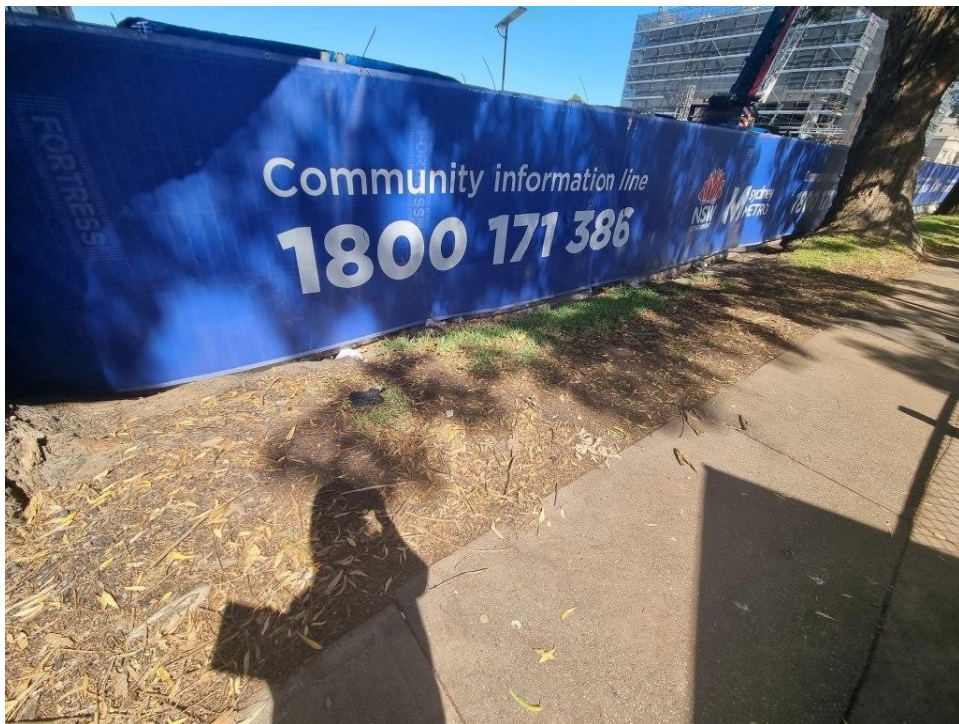
**PHOTO 5**

(Photo showing mesh boundary fence with timber posts on 213-215 Cope Street)

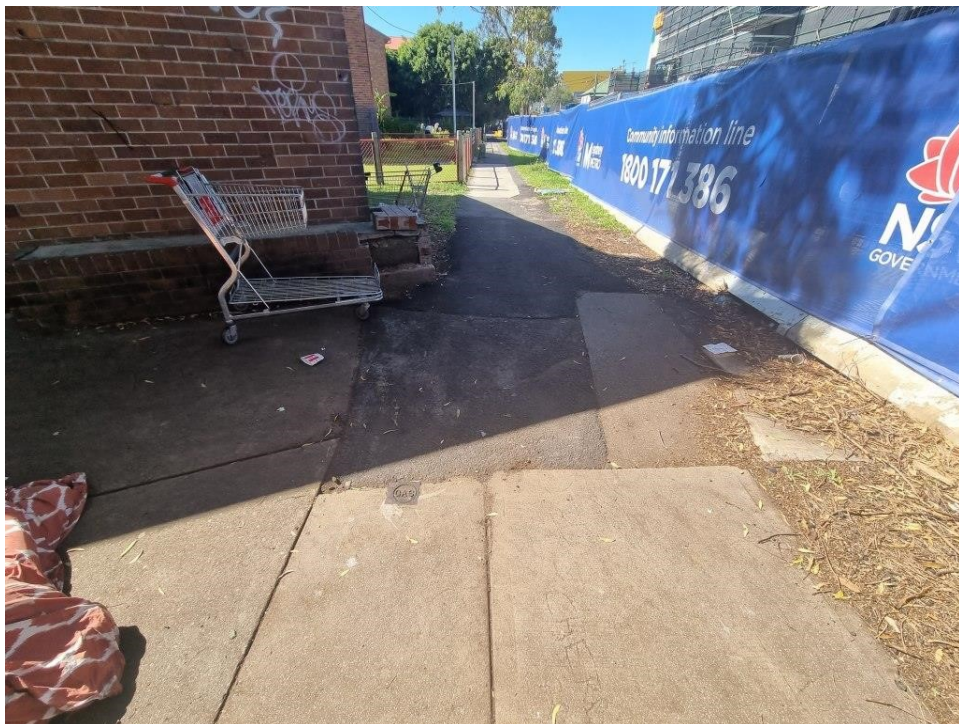
**PHOTO 7**

(Overview of footpath adjacent 213-215 Cope Street)

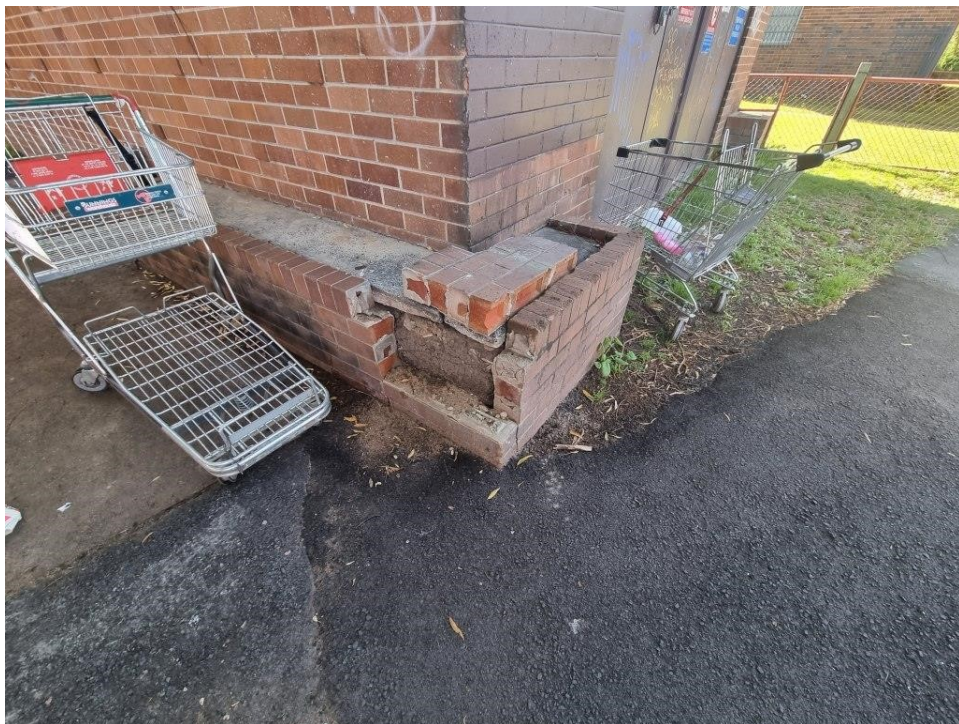
**PHOTO 9**

(Overview of uneven footpath adjacent 215 Cope Street)

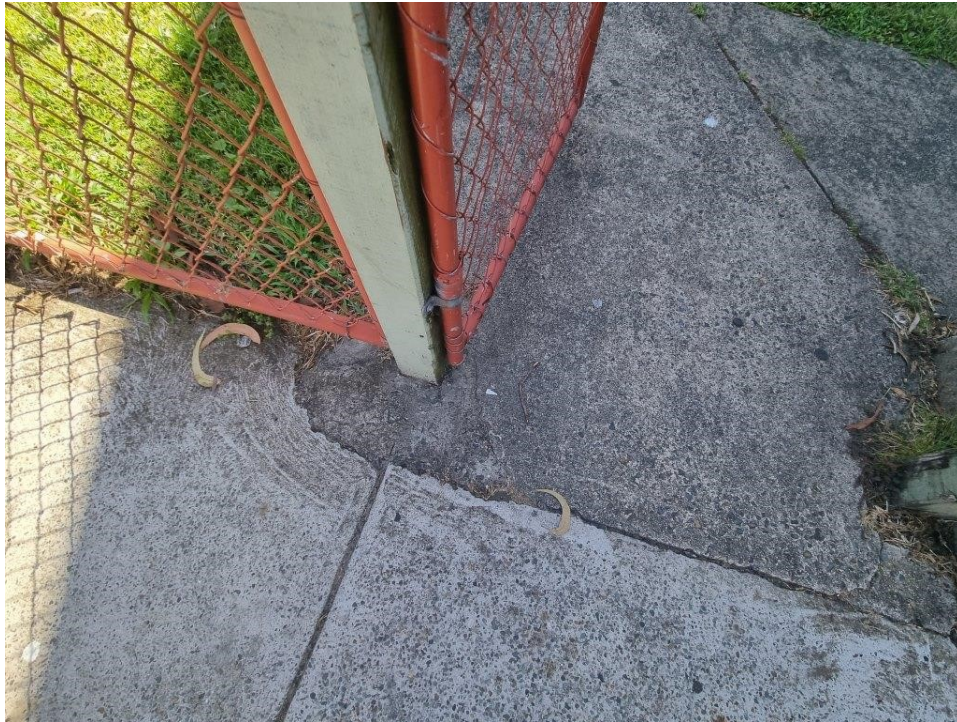
**PHOTO 18**

(Photo showing footpath adjacent to 215 Cope Street)

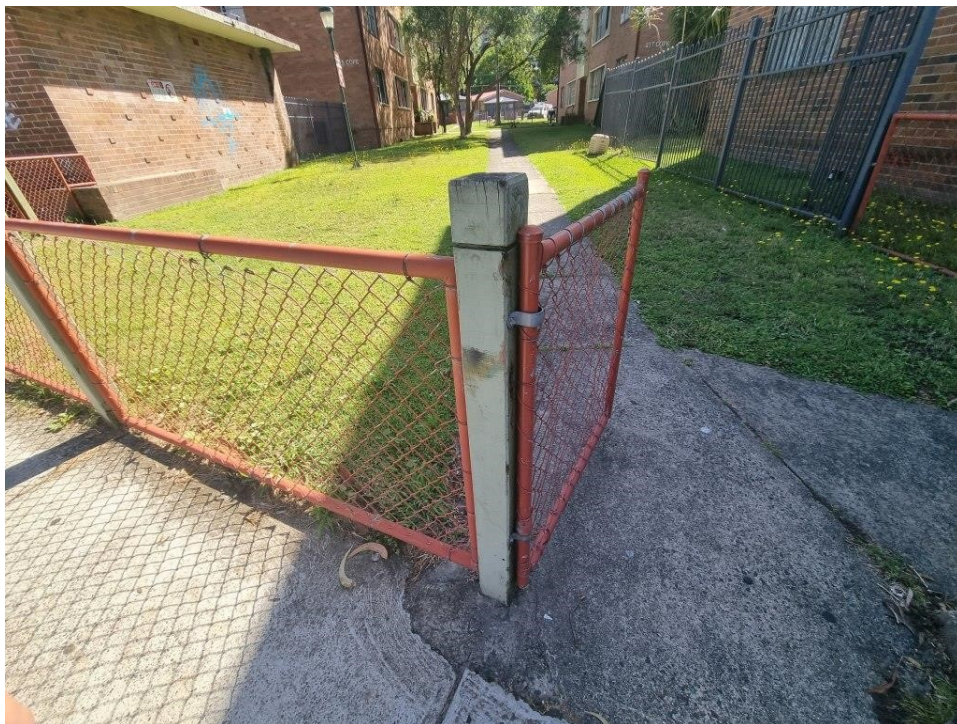
**PHOTO 19**

(Photo showing minor crack on footpath under gate to 215 Cope Street)

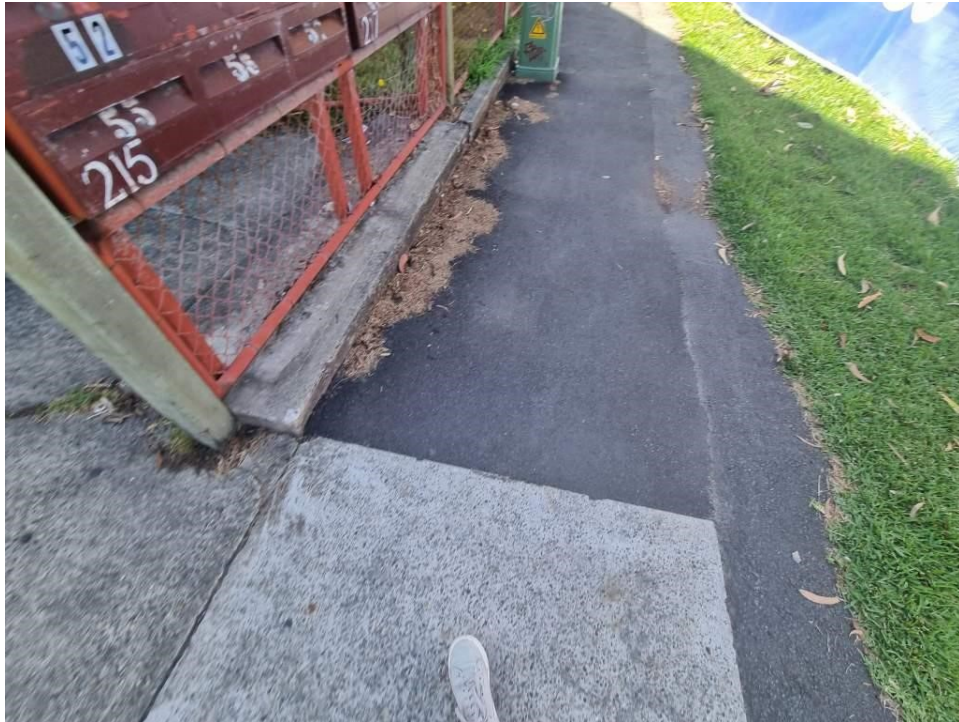
**PHOTO 20**

(Photo showing stained timber post and bent mesh panels adjacent gate of 215 Cope Street)

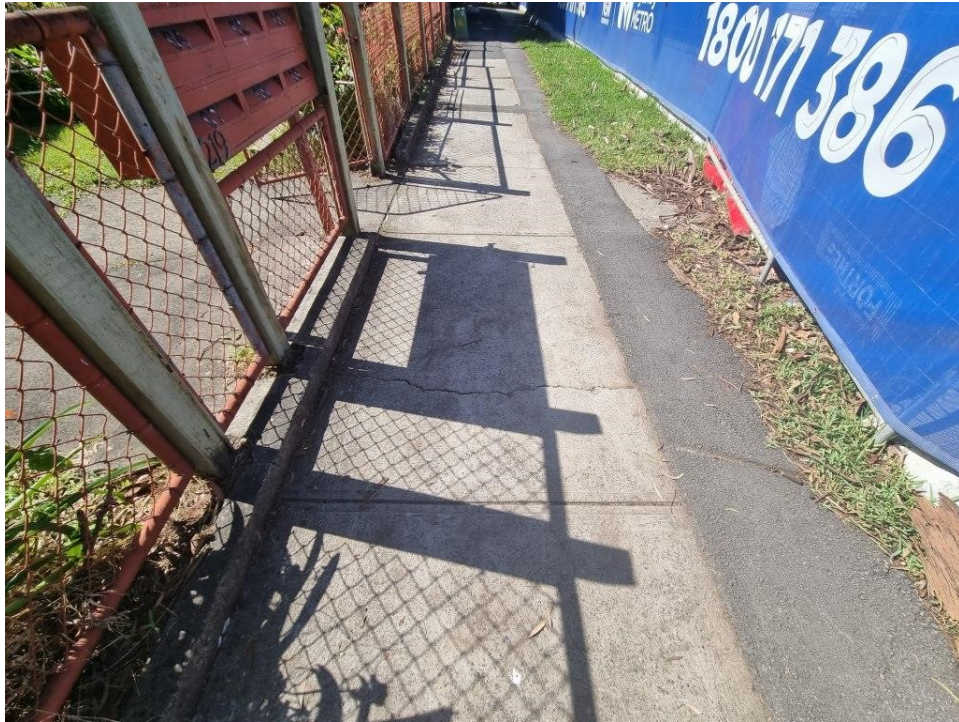
**PHOTO 24**

(Photo showing footpath adjacent to 215 Cope Street and boundary fence)

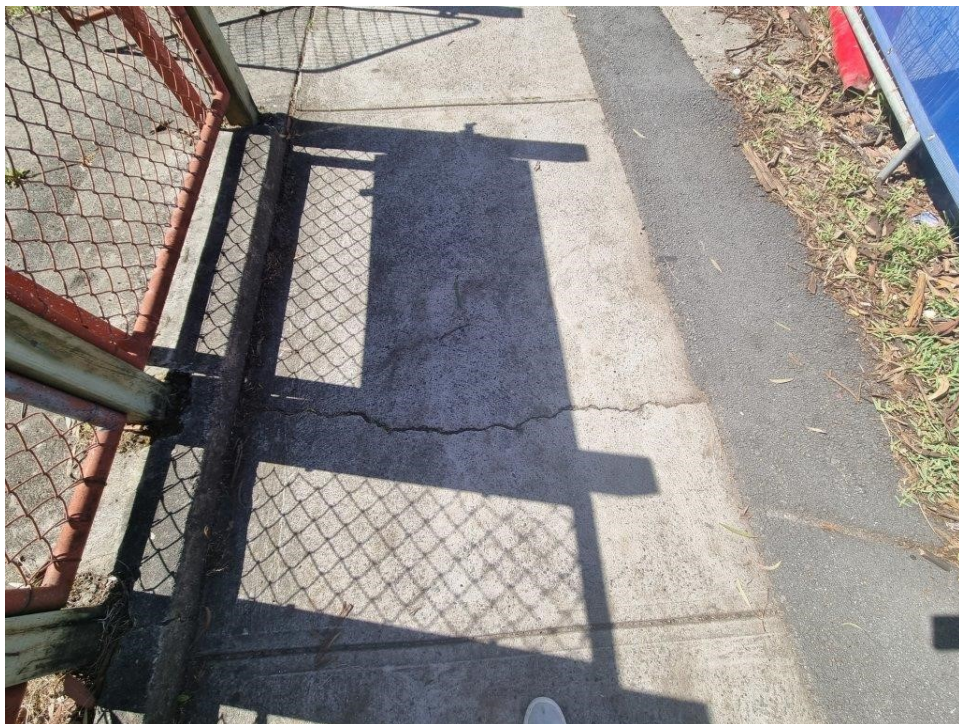
**PHOTO 25**

(Photo showing crack in footpath adjacent 219 Cope Street mailboxes)

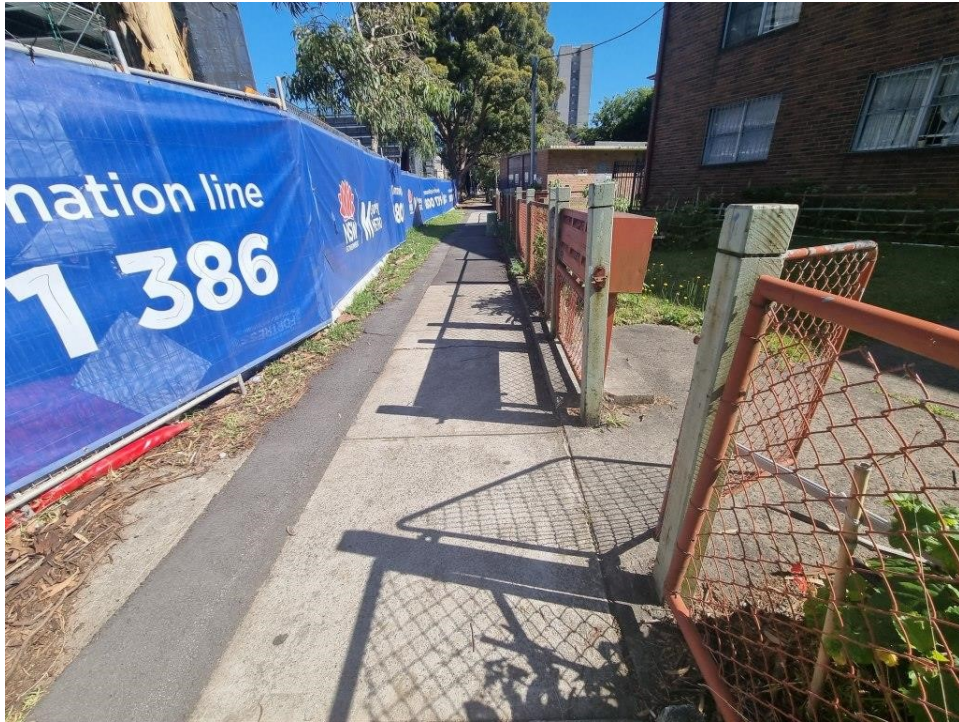
**PHOTO 26**

(Photo showing crack in footpath adjacent 219 Cope Street mailboxes)

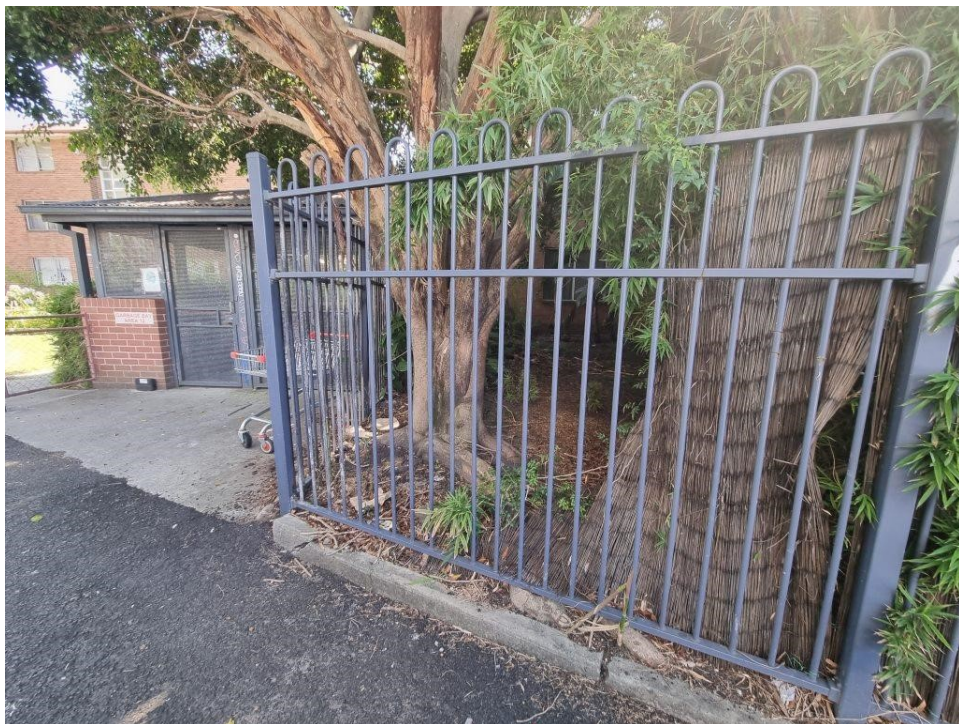
**PHOTO 41**

(Photo showing crack in concrete hob below boundary fence of 113 Wellington Street adjacent 219 Cope Street)

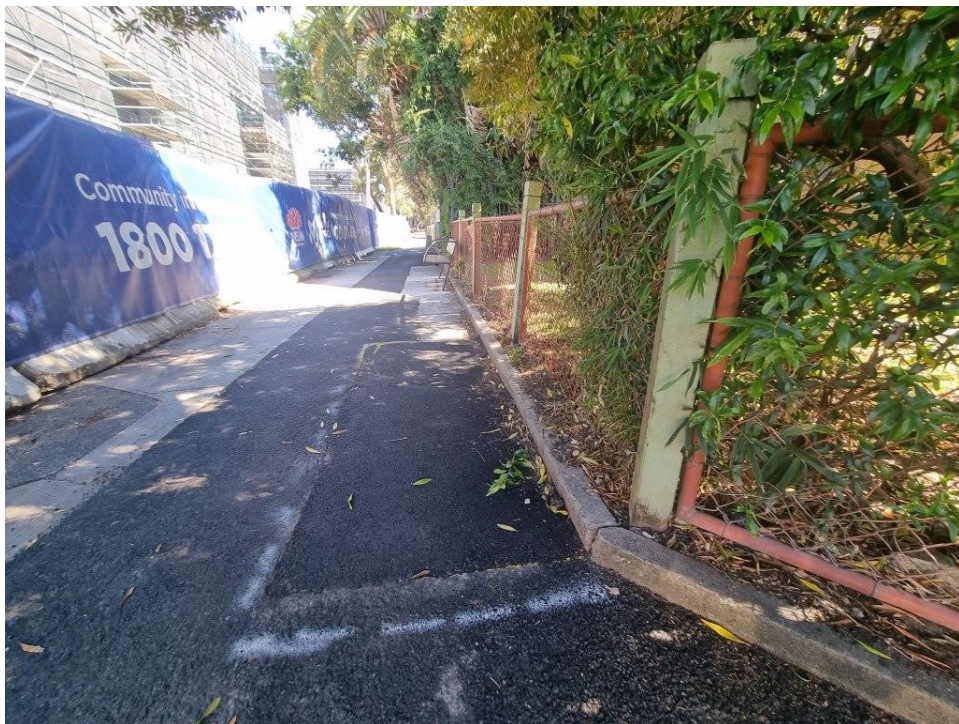
**PHOTO 55**

The Cope Street footpath was mostly concrete pavement with some parts being asphalt. Generally, the footpath was in good conditions with some minor cracking to a few pavers. A few of boundary mesh fences of the properties on Cope Street were bowed or bent. Damage was observed in the form of delaminated bricks on 215 Cope Street.

(Photo showing bowed mesh fence of 113 Wellington Street in corner of Cope Street and Wellington Street)

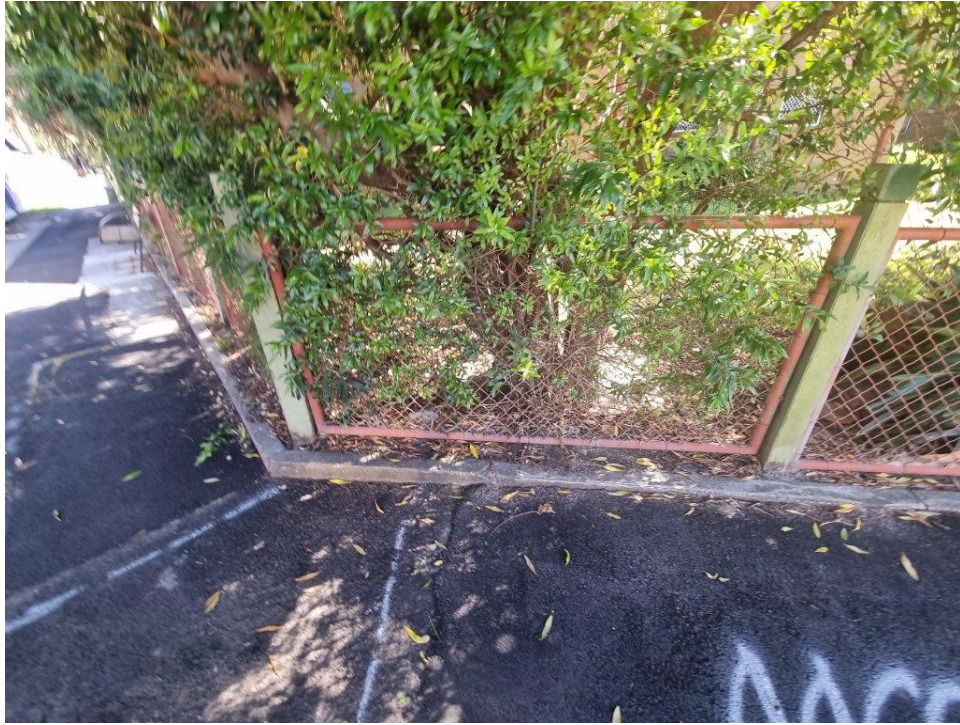
**PHOTO 56**

(Photo showing bowed mesh fence of 113 Wellington Street in corner of Cope Street and Wellington Street)

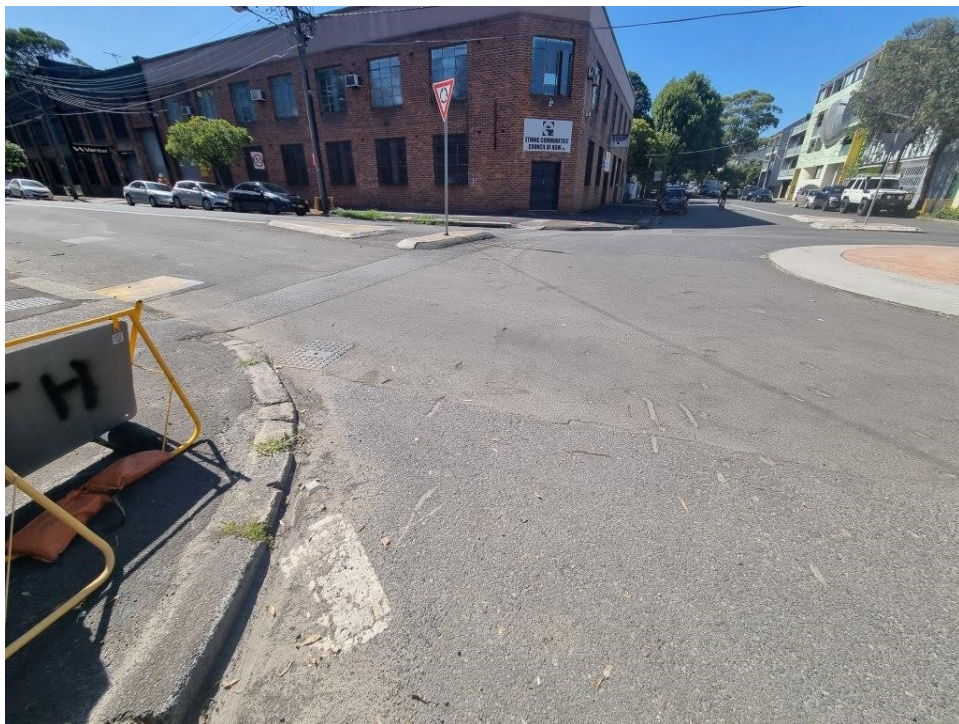
**PHOTO 61**

(Photo showing footpath and cracked kerb in the corner of Cope ad Street and Wellington Street)

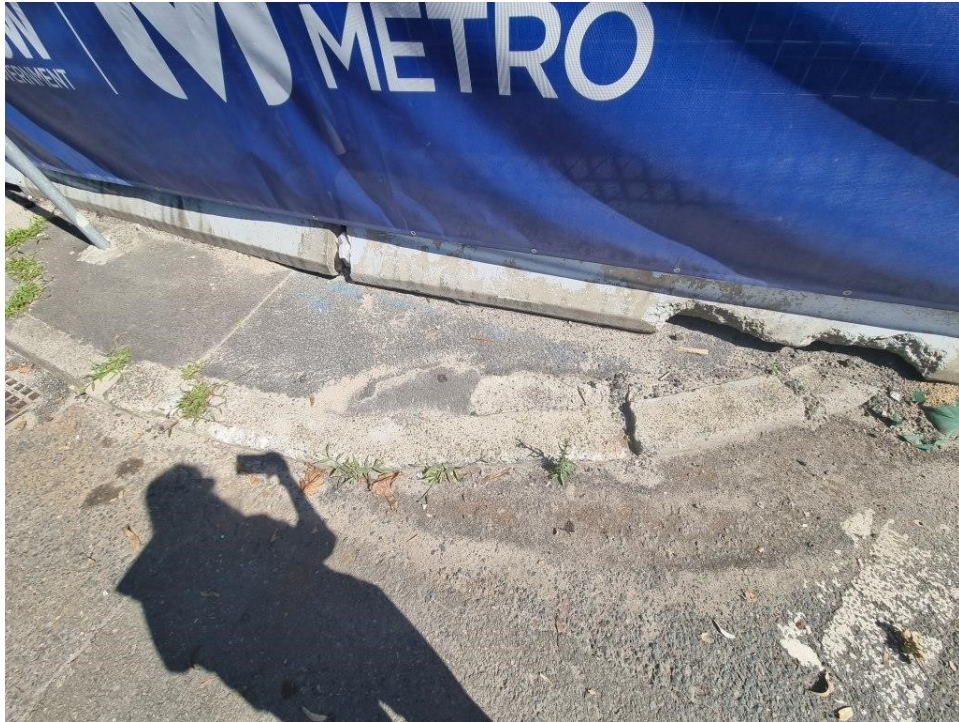
**PHOTO 66**

(Photo showing road along Wellington Street. Footpath has been blocked off)

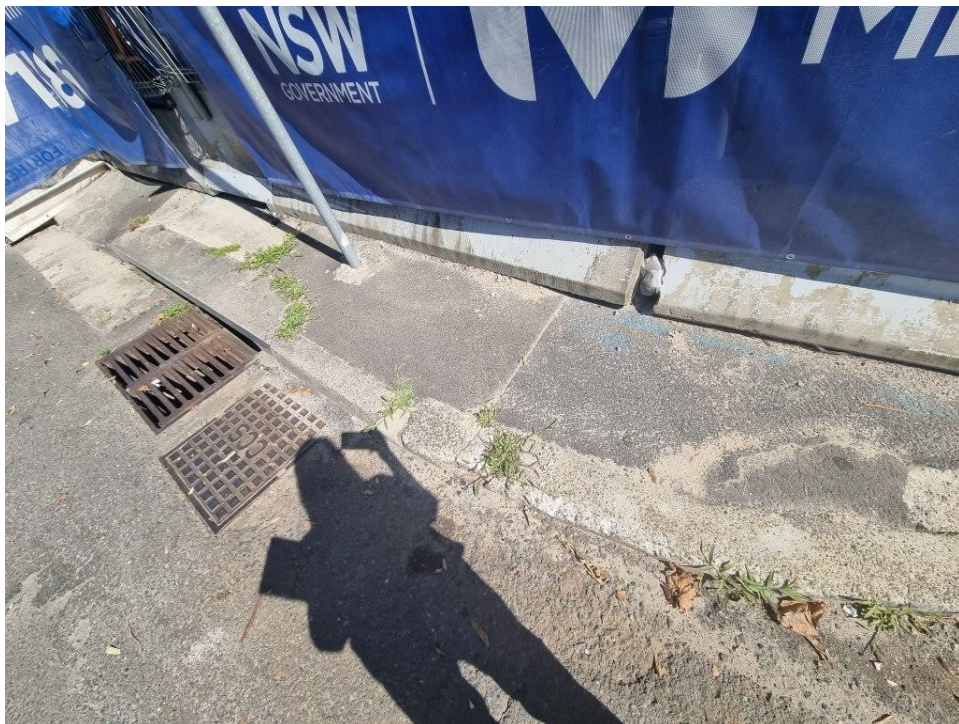
**PHOTO 67**

(Photo showing cracked kerb on corner of Cope Street and Wellington Street)

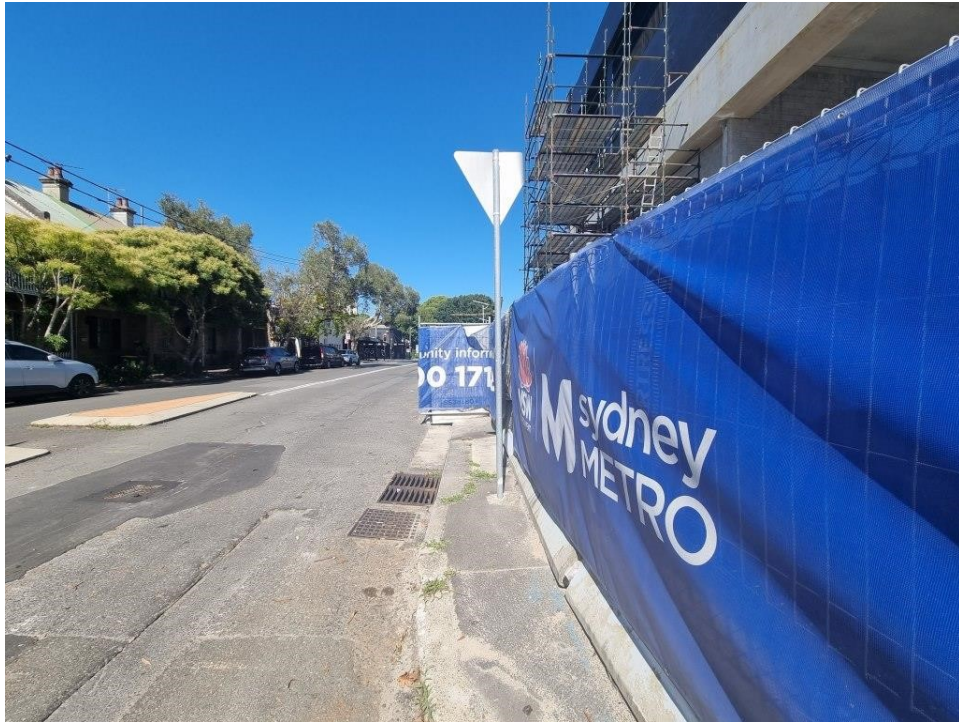
**PHOTO 68**

(Photo showing cracked kerb on corner of Cope Street and Wellington Street)

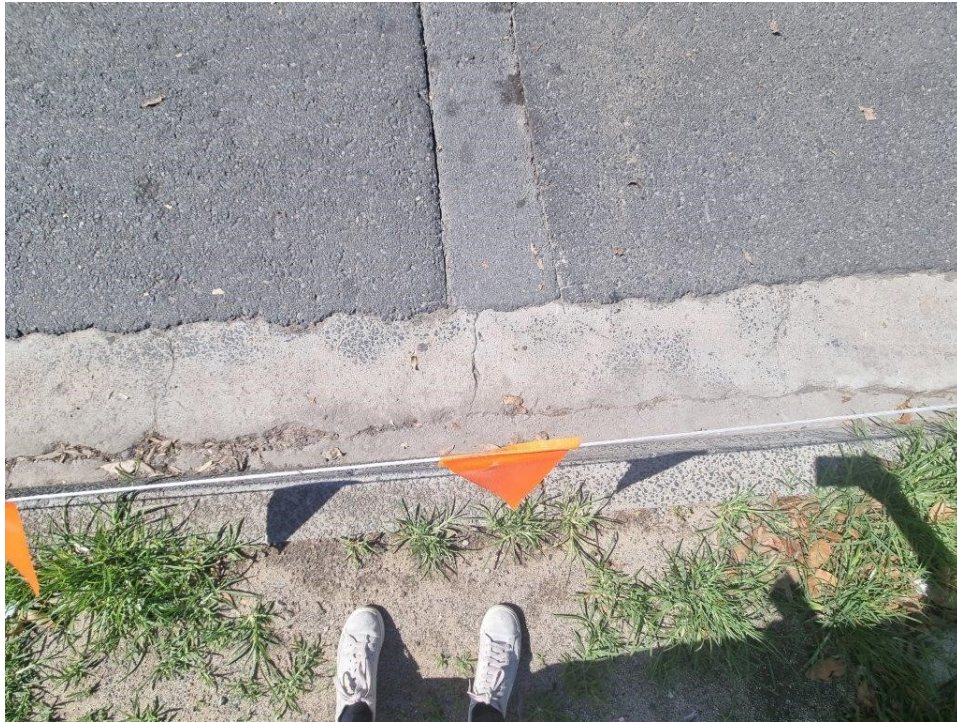
**PHOTO 82**

(Photo showing cracks in kerb and gutter on Wellington Street)

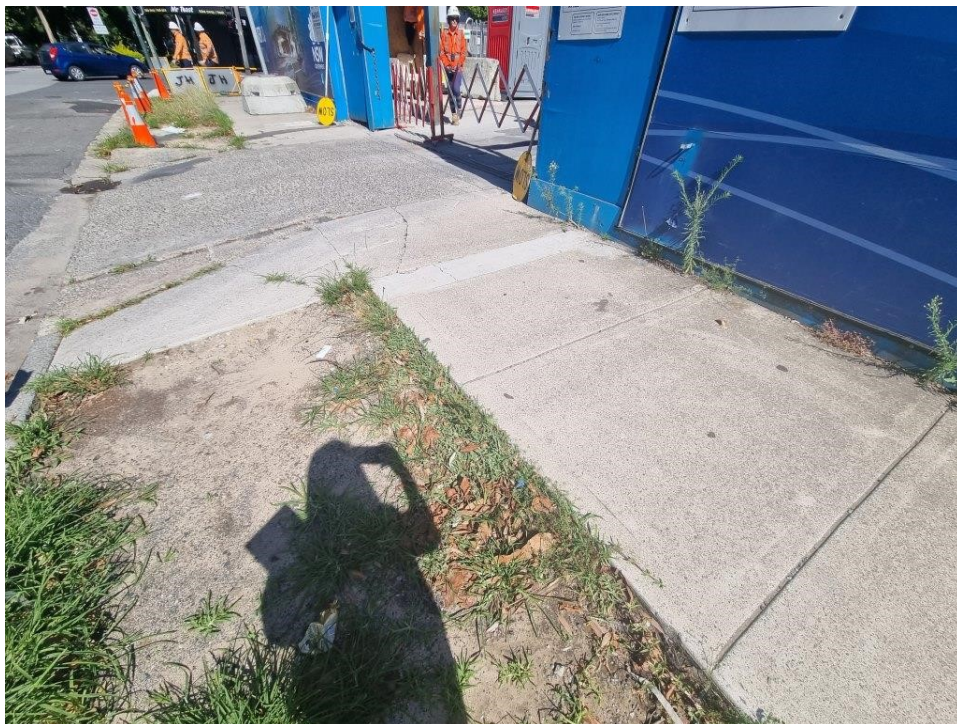
**PHOTO 83**

(Photo showing cracks in kerb and gutter on Wellington Street)

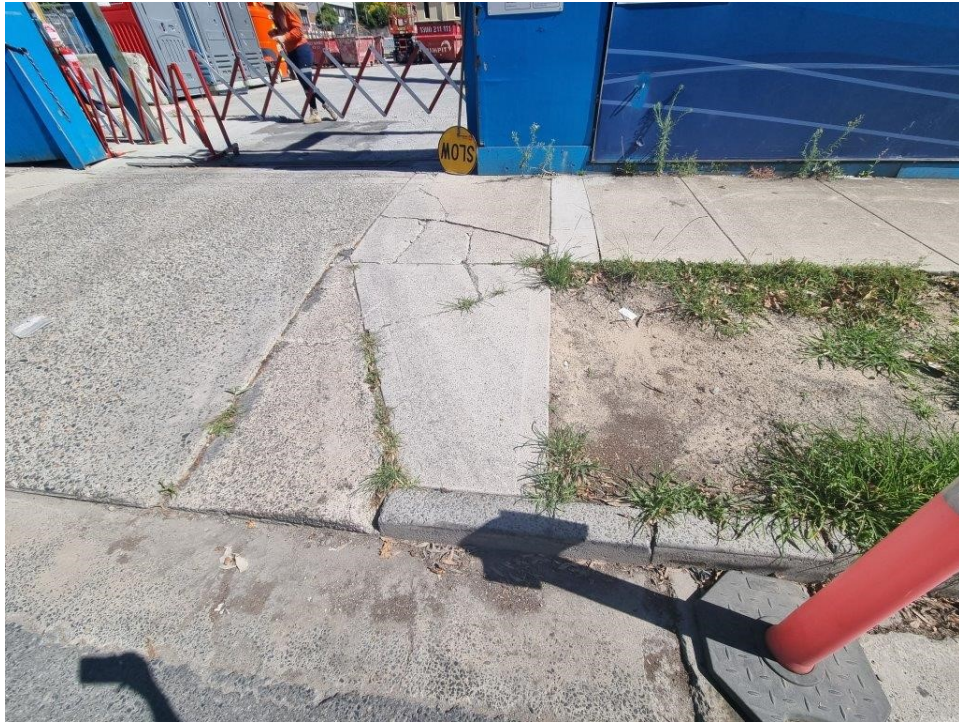
**PHOTO 84**

Wellington Street, between Cope Street and Botany Road, was generally in good condition, except for the driveway, footpath, kerb and road pavement adjacent to the driveway which were severely cracked. There was a depression in the driveway which had been filled. The driveway is the truck entrance to the active construction site for the Waterloo Station project.

(Overview of truck driveway into site on Wellington Street and footpath)

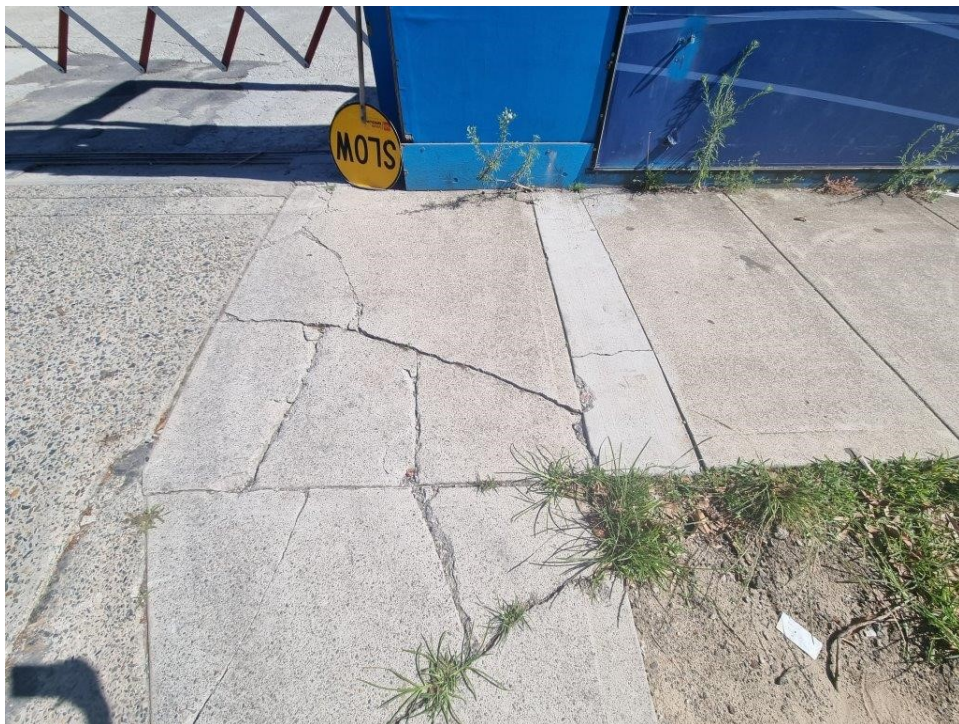
**PHOTO 85**

(Photo showing cracked footpath adjacent truck driveway on Wellington Street)

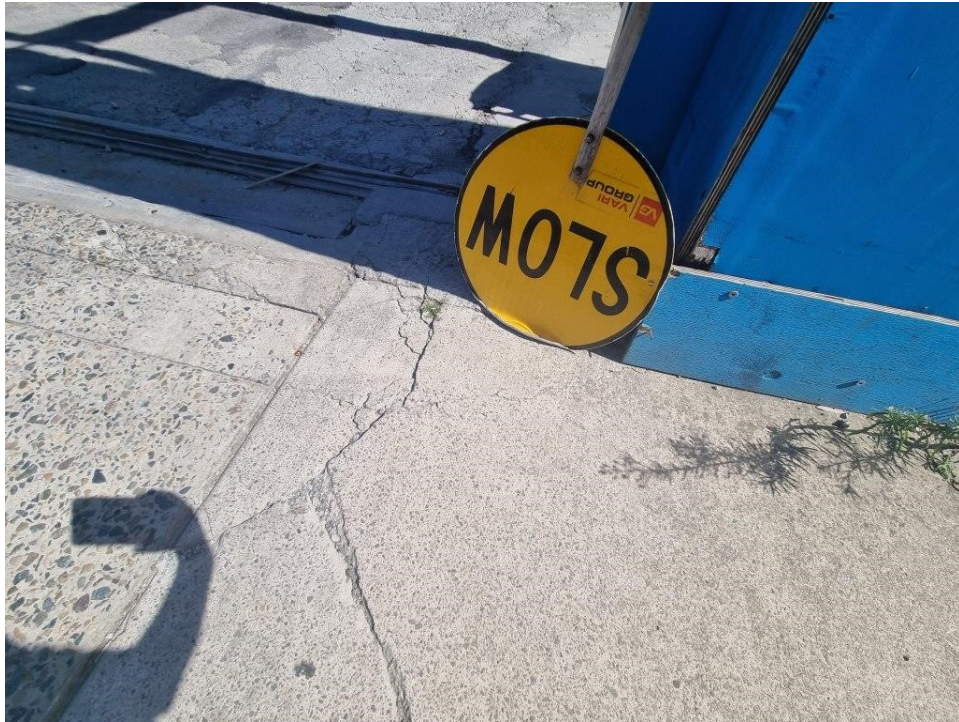
**PHOTO 86**

(Photo showing cracked footpath adjacent truck driveway on Wellington Street)

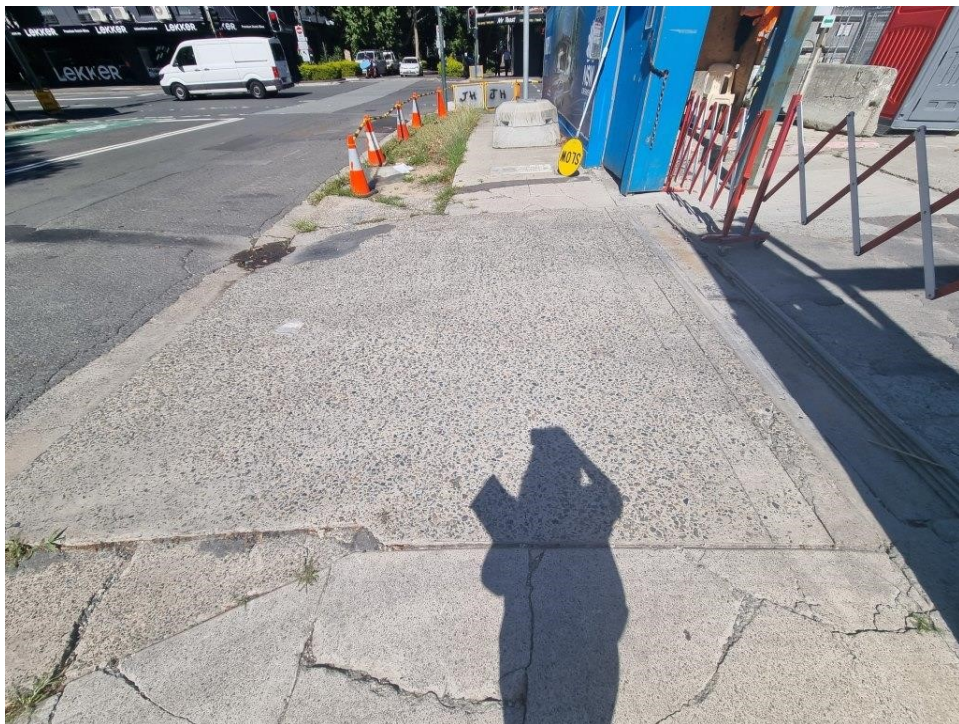
**PHOTO 87**

(Photo showing cracked footpath adjacent truck driveway on Wellington Street)

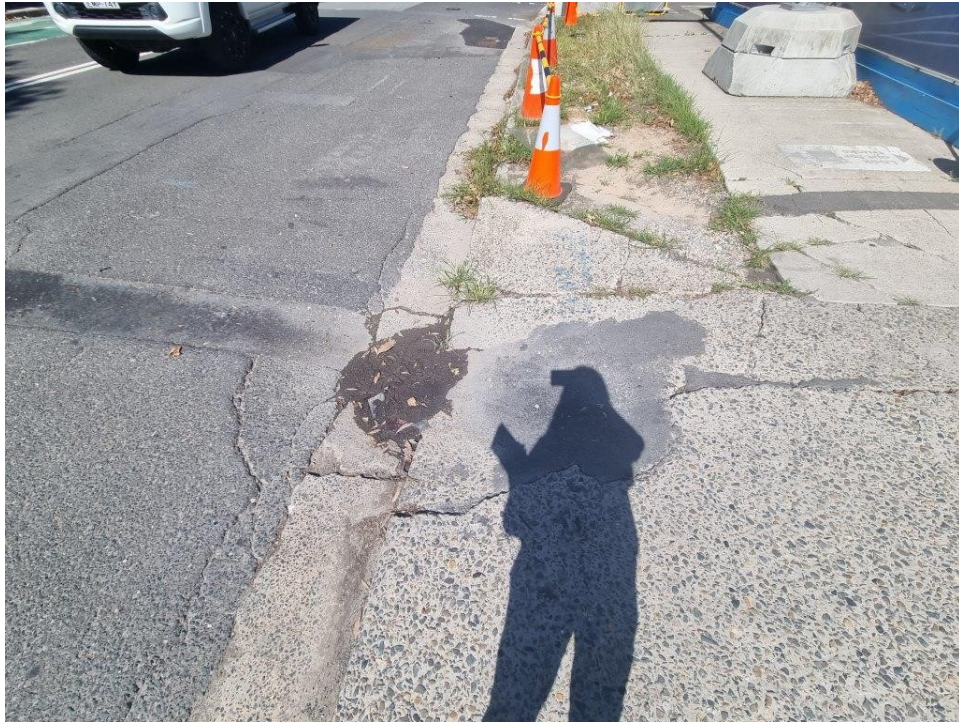
**PHOTO 88**

(Photo showing cracked footpath adjacent truck driveway on Wellington Street)

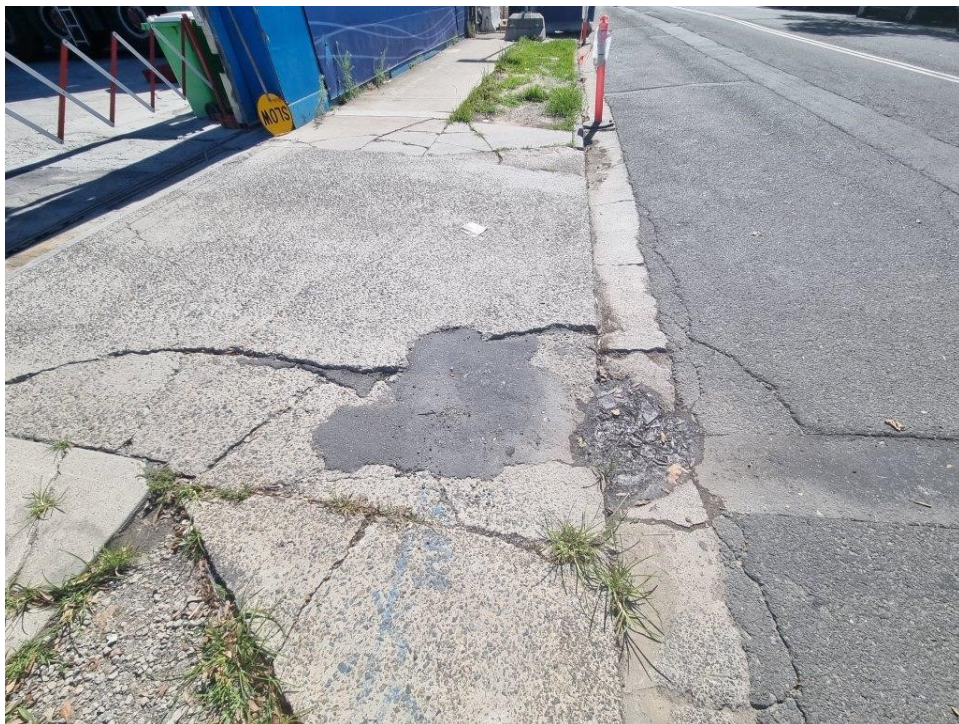
**PHOTO 89**

(Photo showing cracked footpath adjacent truck driveway on Wellington Street)

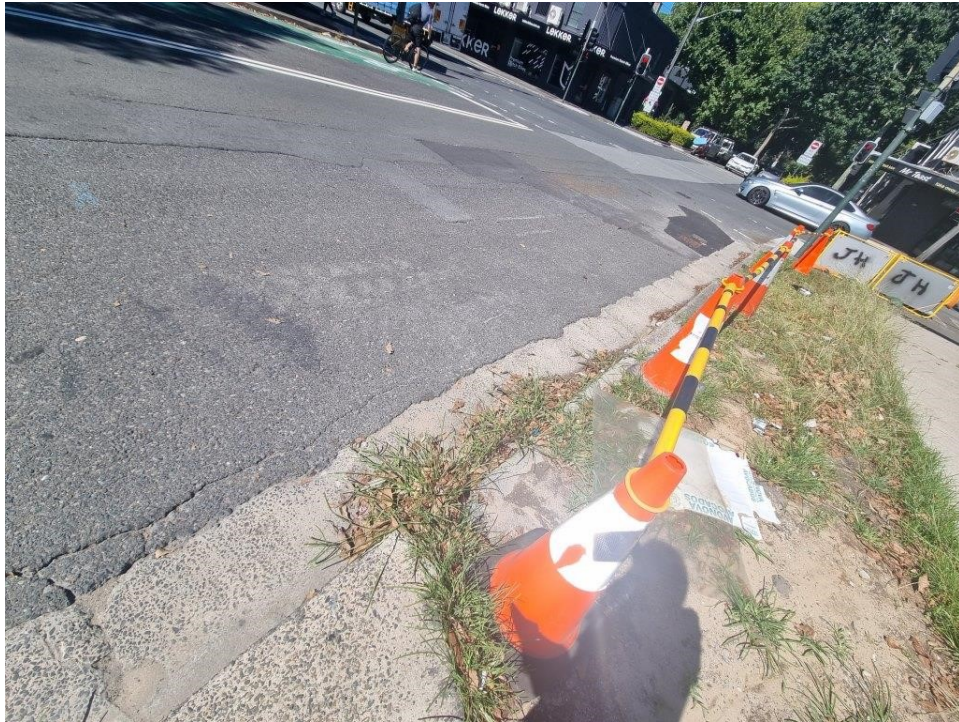
**PHOTO 90**

(Photo showing cracked footpath adjacent truck driveway on Wellington Street)

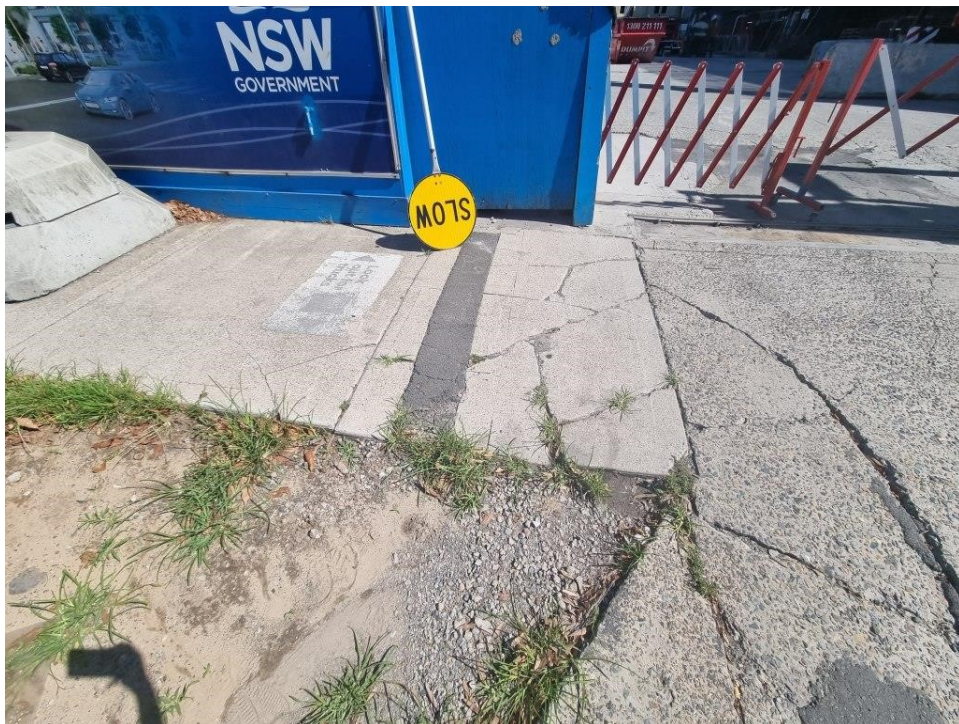
**PHOTO 91**

(Photo showing cracked road pavement adjacent kerb and gutter on Wellington Street adjacent site)

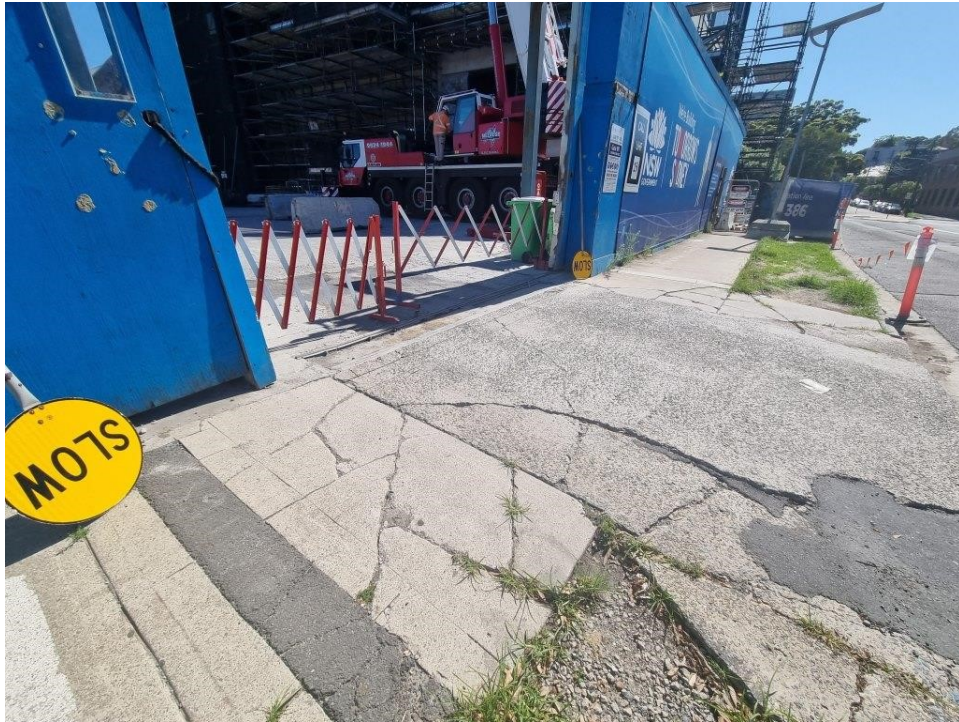
**PHOTO 92**

(Photo showing cracked footpath adjacent truck driveway on Wellington Street)

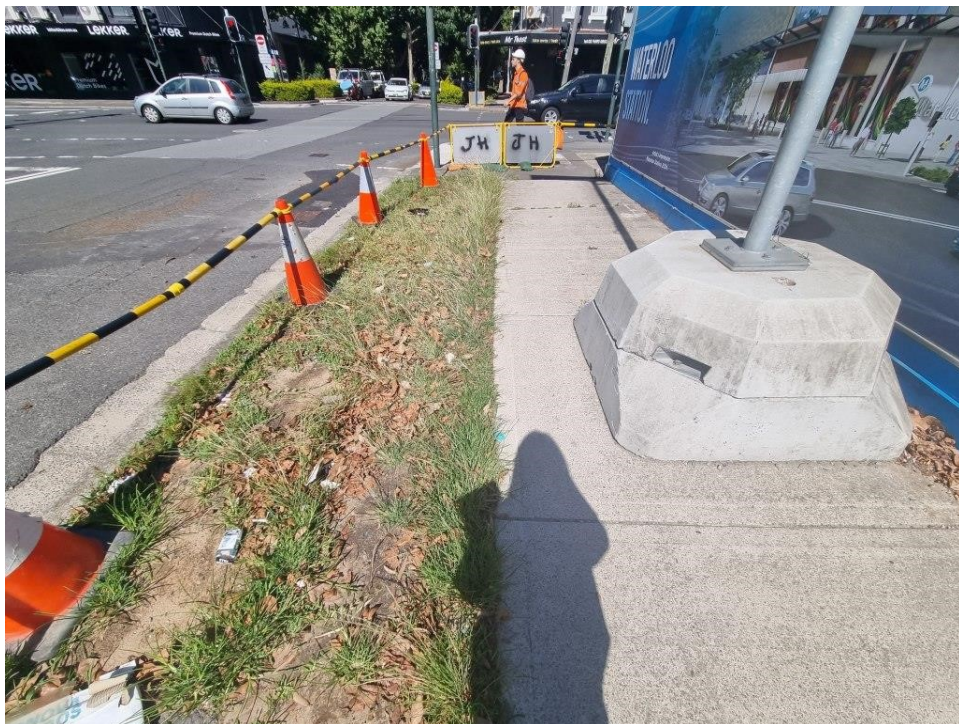
**PHOTO 93**

(Photo showing cracked footpath adjacent truck driveway on Wellington Street)

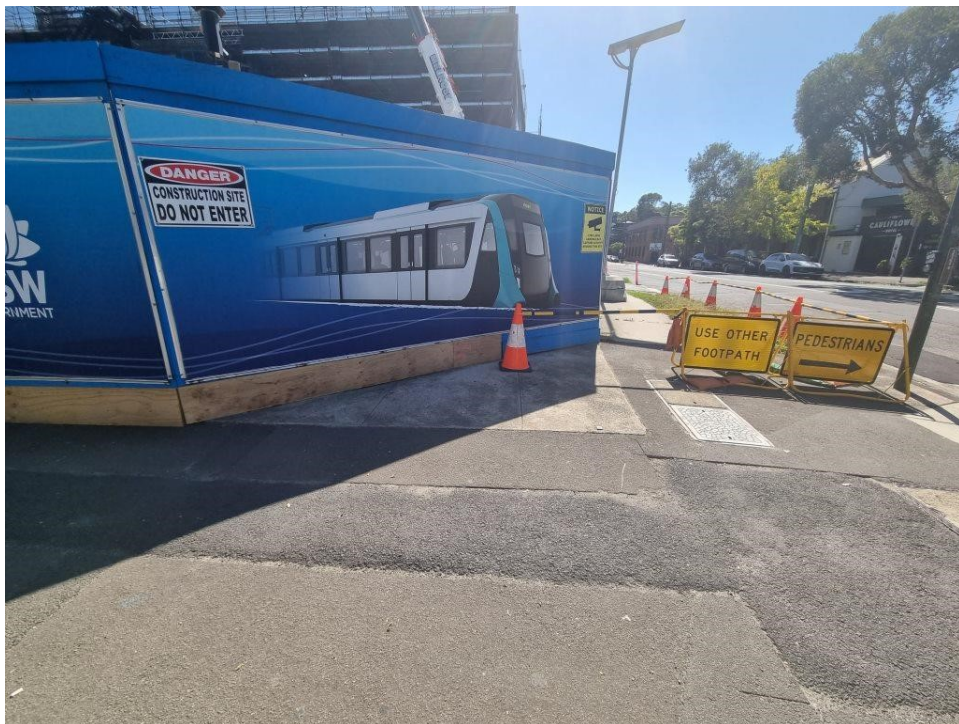
**PHOTO 103**

(Photo showing crack in footpath adjacent valve cover)

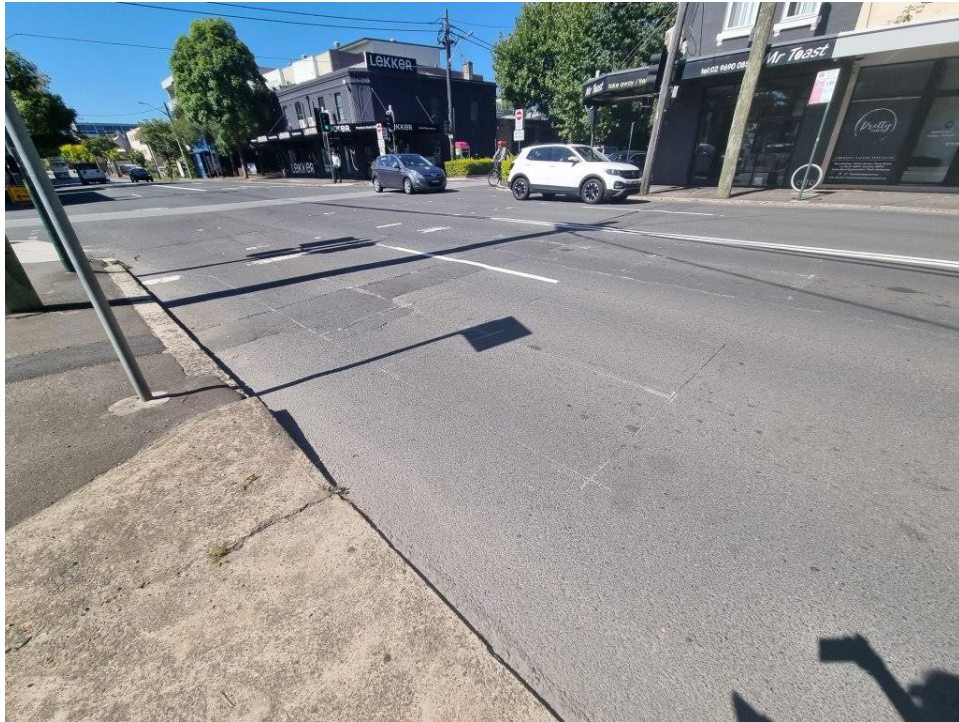
**PHOTO 110**

(Photo showing crack in driveway on Botany Road)

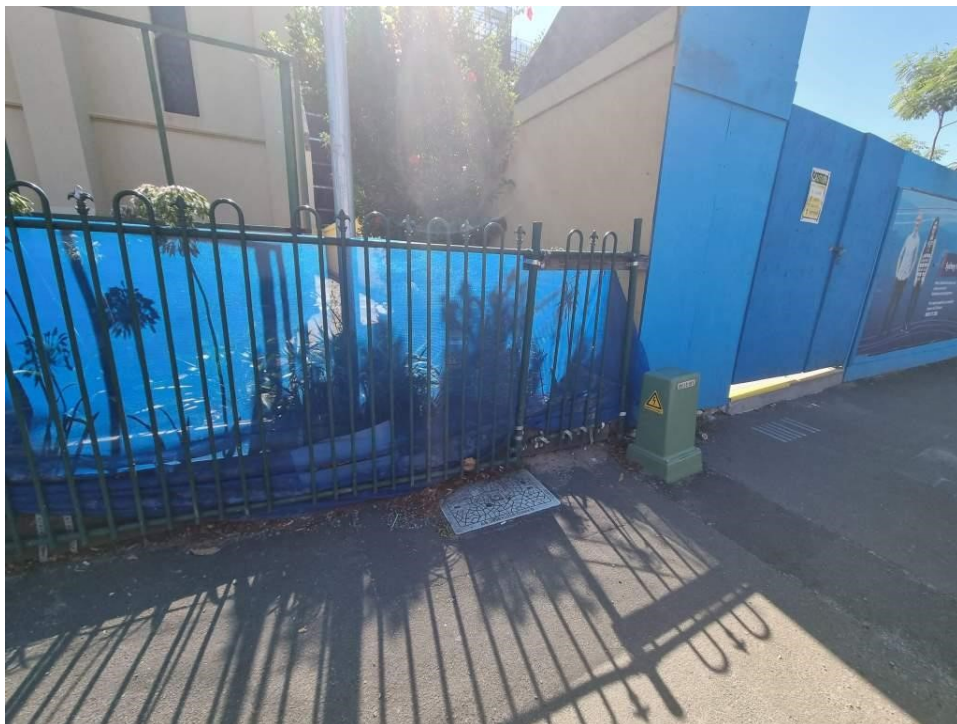
**PHOTO 141**

(Photo showing cracked footpath on Botany Road adjacent Waterloo Congregational Church)
