# DILAPIDATION REPORT

## Council Assets/Public Infrastructure

**WATERLOO STATION  
COPE STREET**

**24 January 2023**

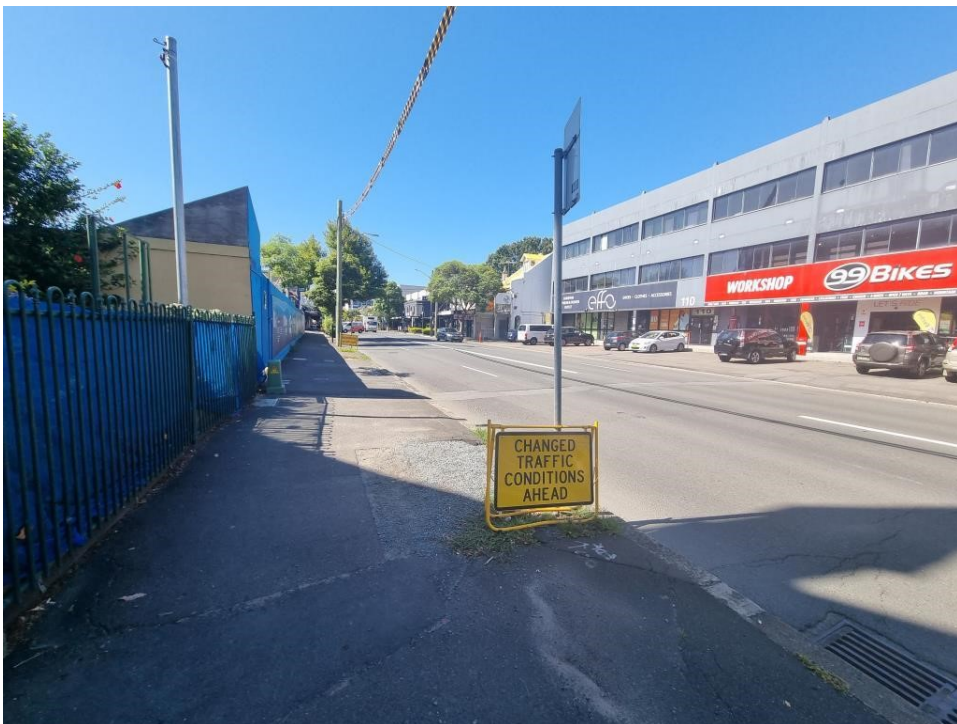
**PHOTO 143**

(Photo showing cracked footpath on Botany Road adjacent Waterloo Congregational Church)

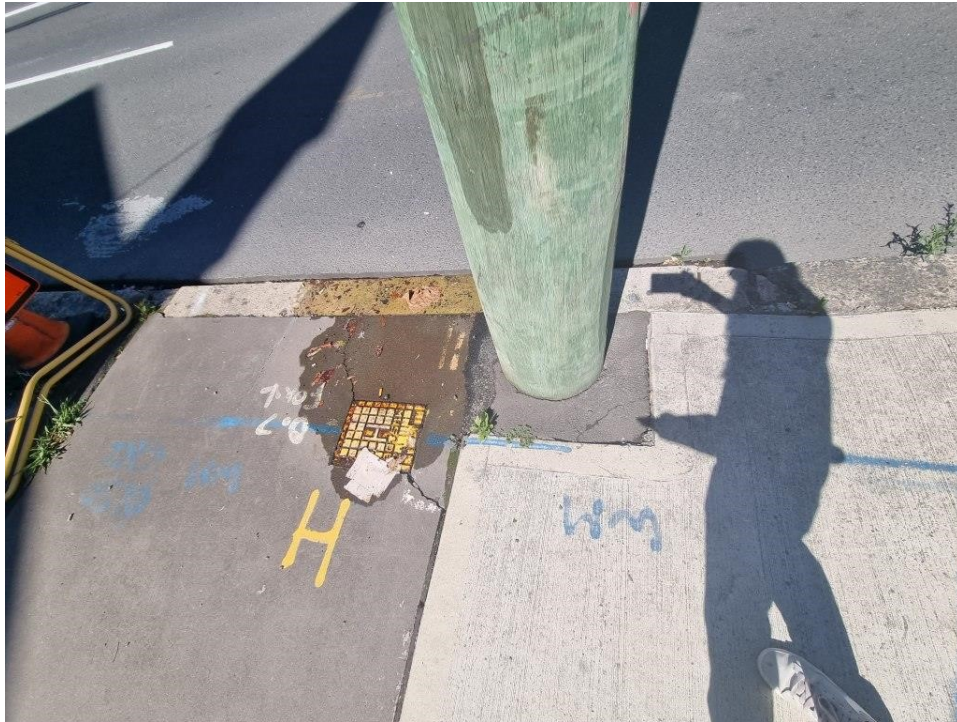
**PHOTO 157**

(Photo showing cable pit and crack on footpath adjacent boundary line of church on Botany Road)
