# DILAPIDATION REPORT

**WATERLOO CONGREGATIONAL CHURCH  
103 BOTANY ROAD  
WATERLOO NSW 2017**

**WATERLOO STATION  
COPE STREET**

**24 January 2023**

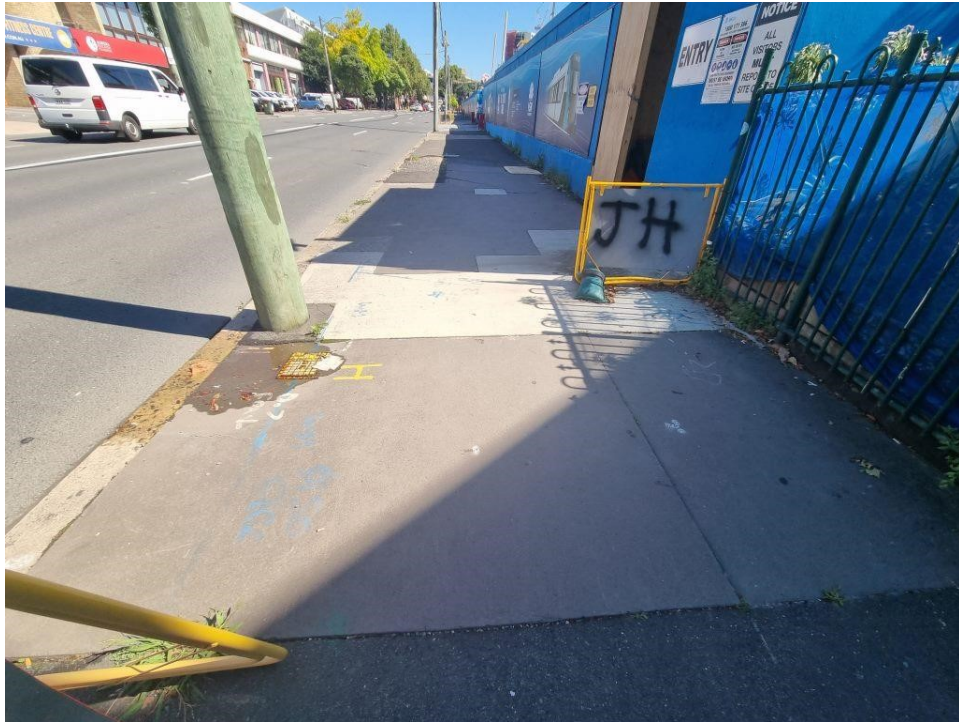
**PHOTO 6**

(Photo showing cracks in the road pavement)

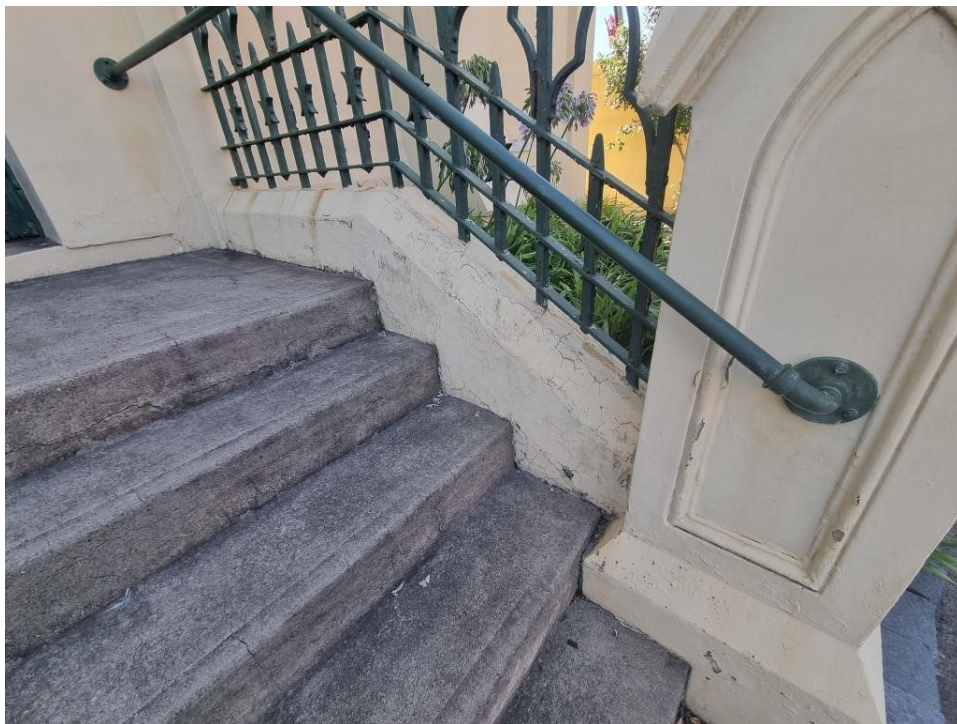
**PHOTO 19**

(Overview of current conditions of the step to the church  
Minor crazed cracking on the steps)

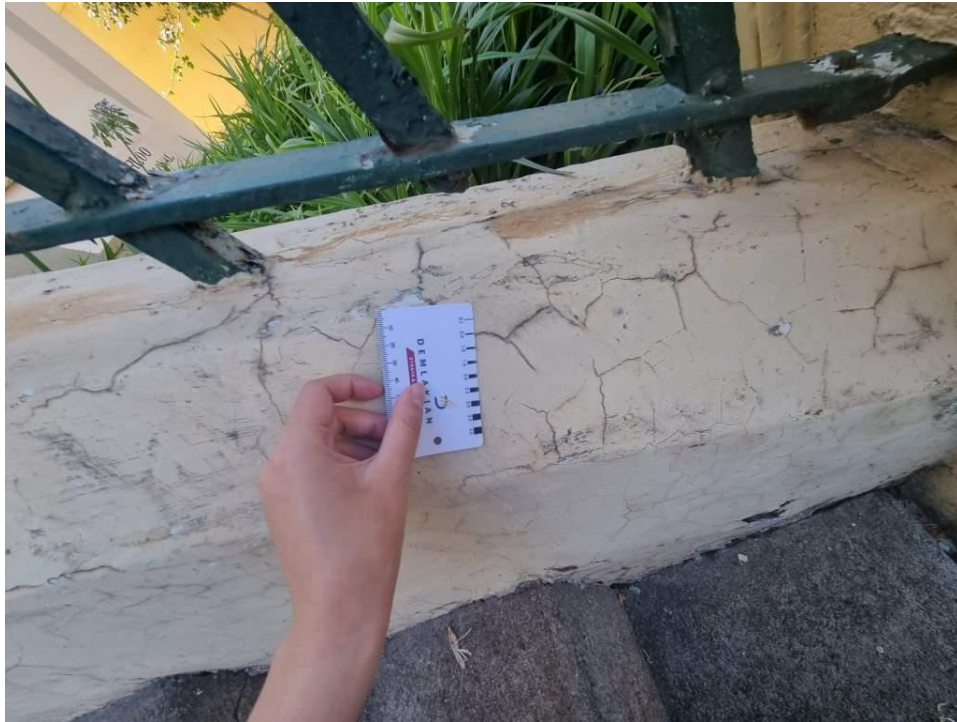
**PHOTO 20**

(Photo showing cracks on the hob below the handrail on the right hand side)

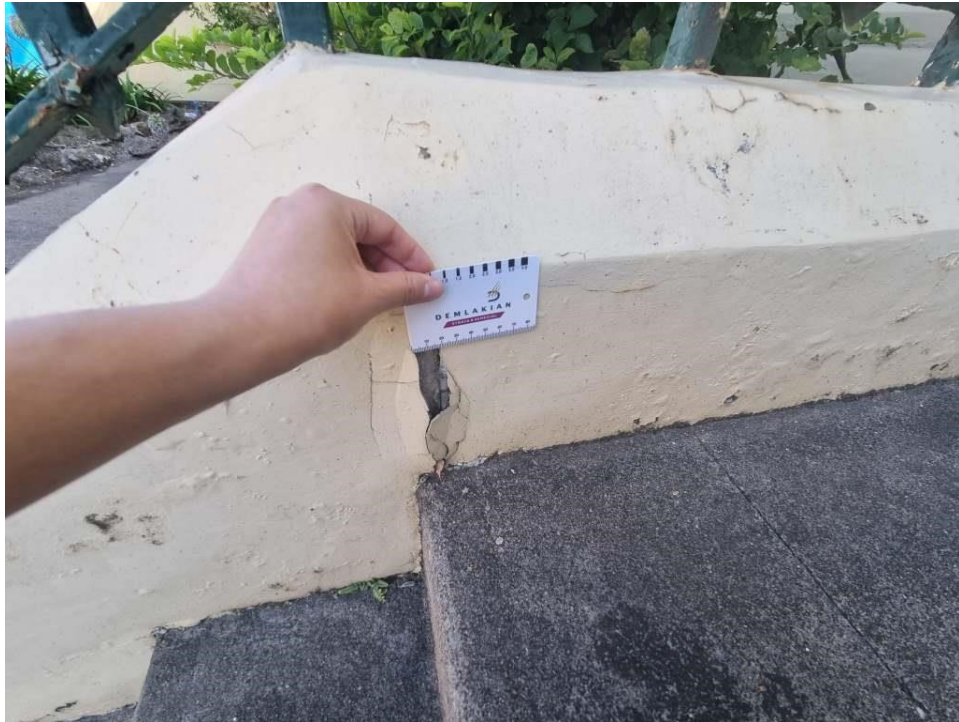
**PHOTO 22**

(Photo showing cracks to the hob below the handrail on the left hand side.  
Delamination of the render is also observed.)

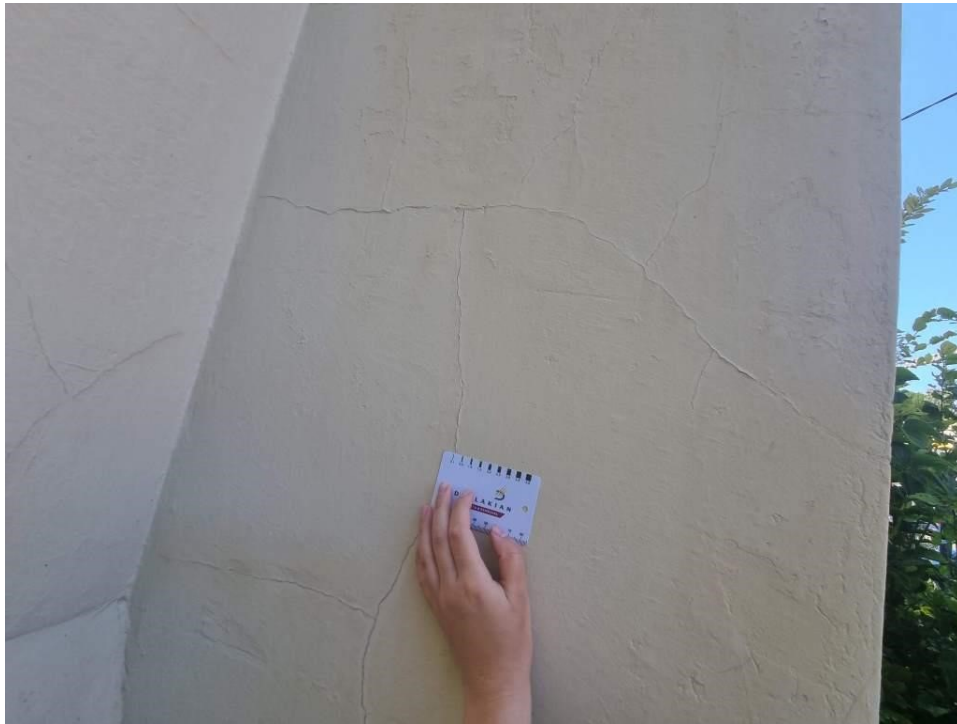
**PHOTO 26**

(Photo showing minor cracking to the external wall)

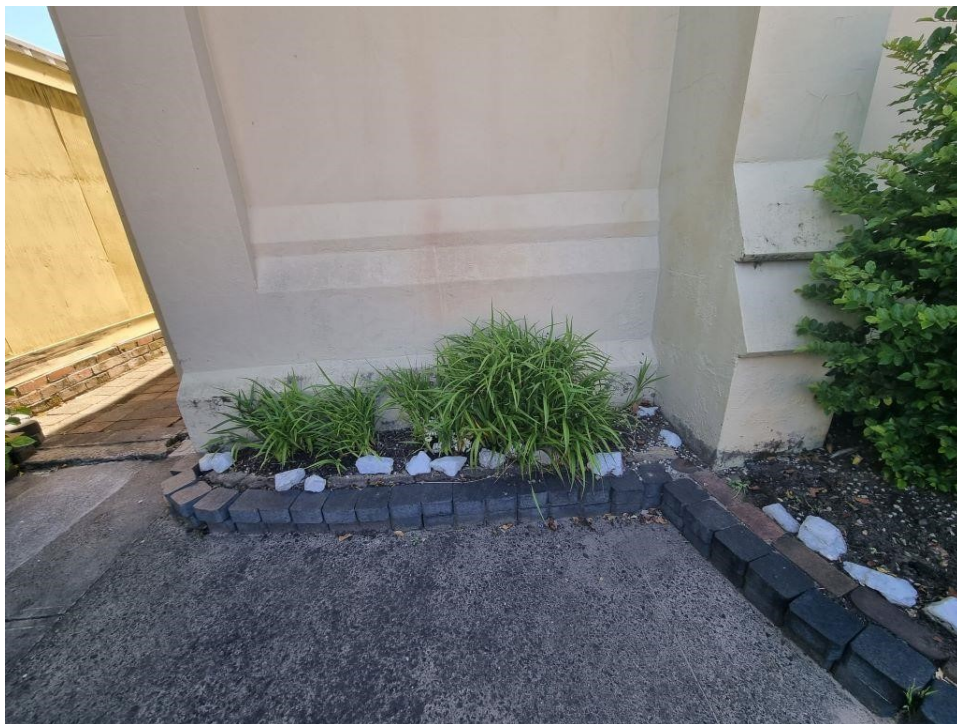
**PHOTO 27**

(Photo showing cracks to external wall with width of 0.1mm)

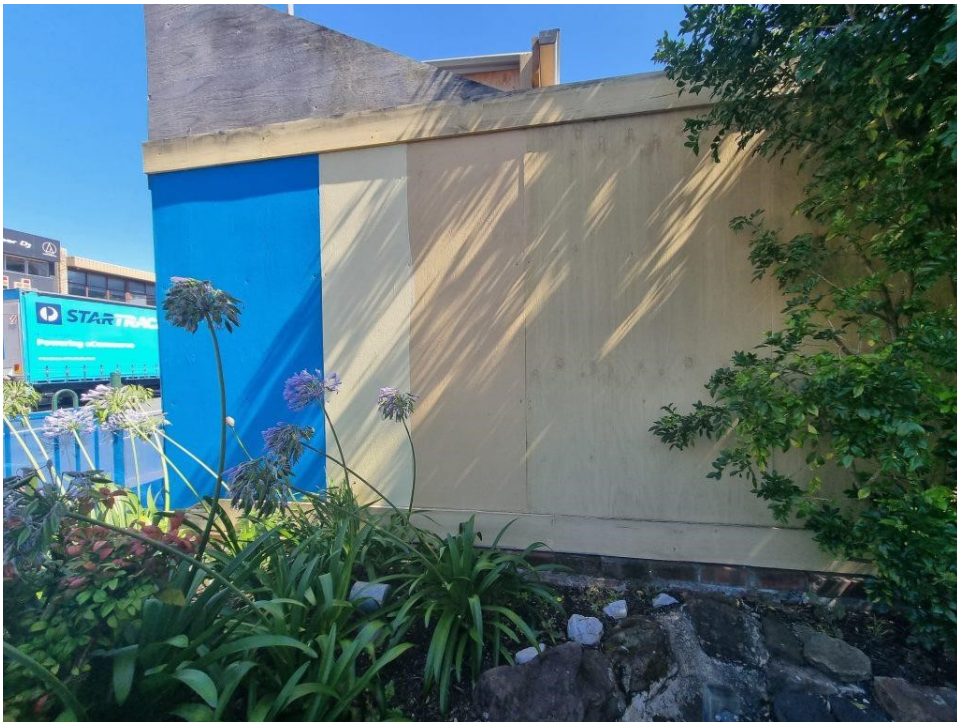
**PHOTO 29**

(Cracking of the bottom section of the external wall behind the vegetation)

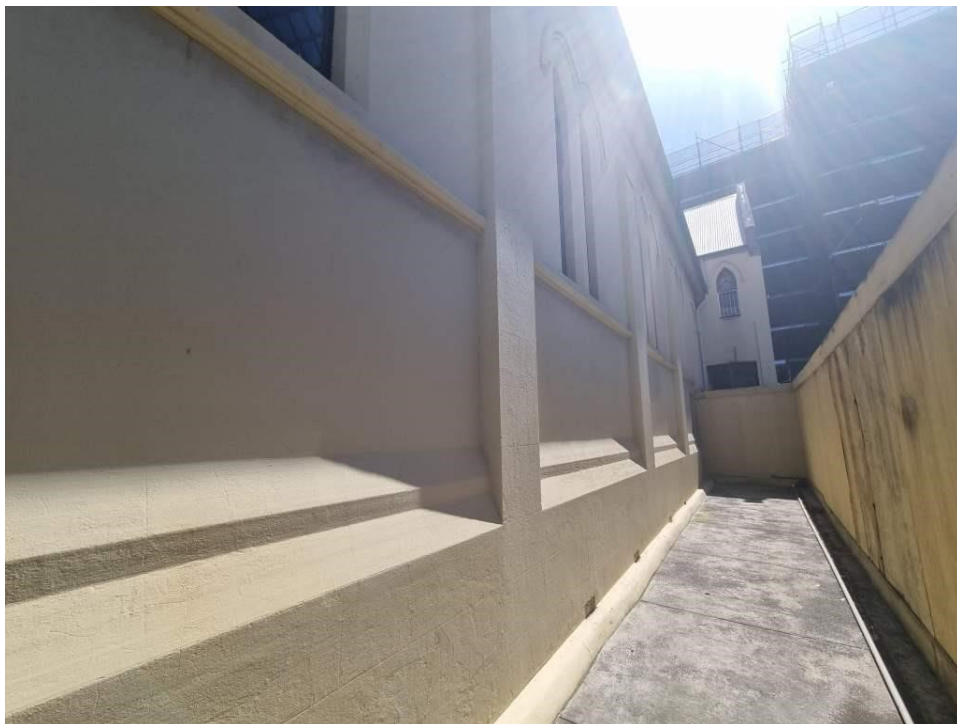
**PHOTO 33**

(Photo showing cracking to the bottom section of the wall on the Southern Façade)

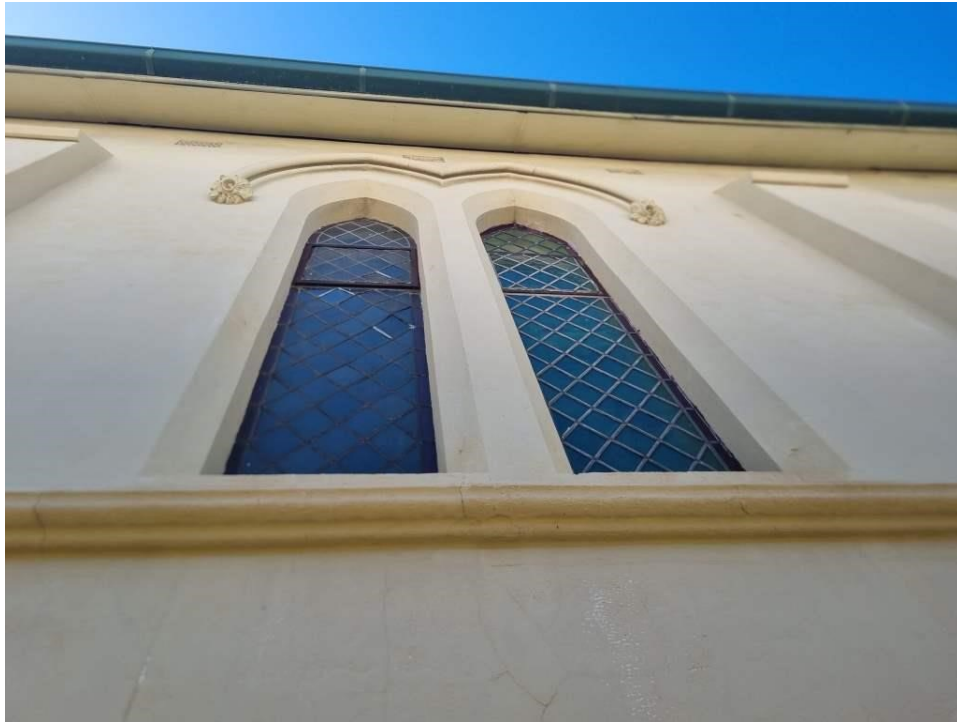
**PHOTO 42**  
(Photo showing cracks with a width of 0.1mm)

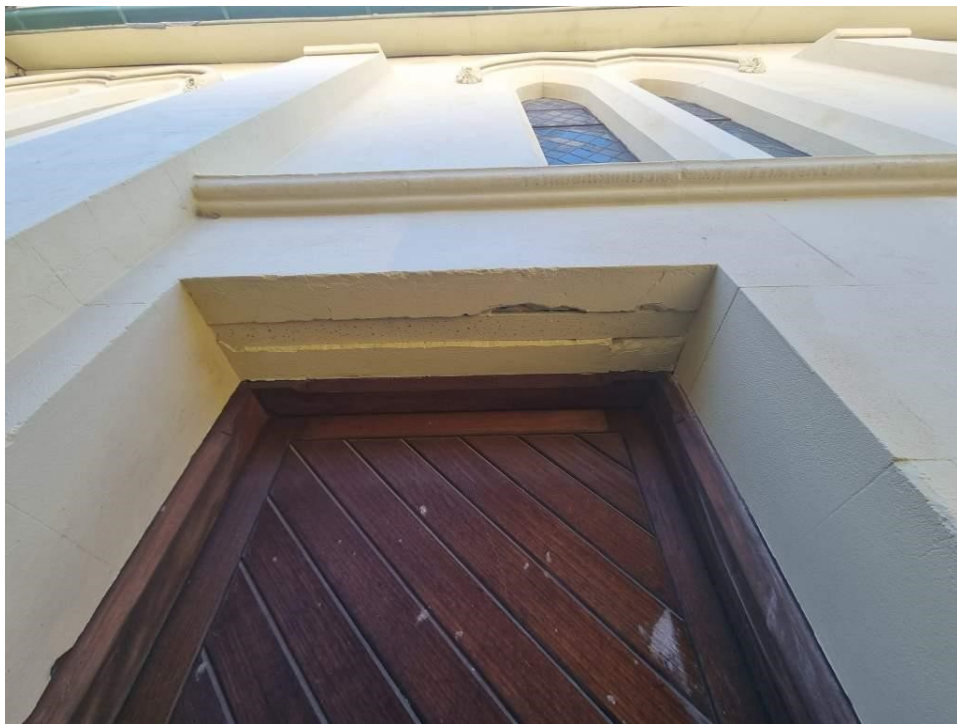
**PHOTO 45**

(Photo showing cracking above the wooden door, unable to measure width of crack)

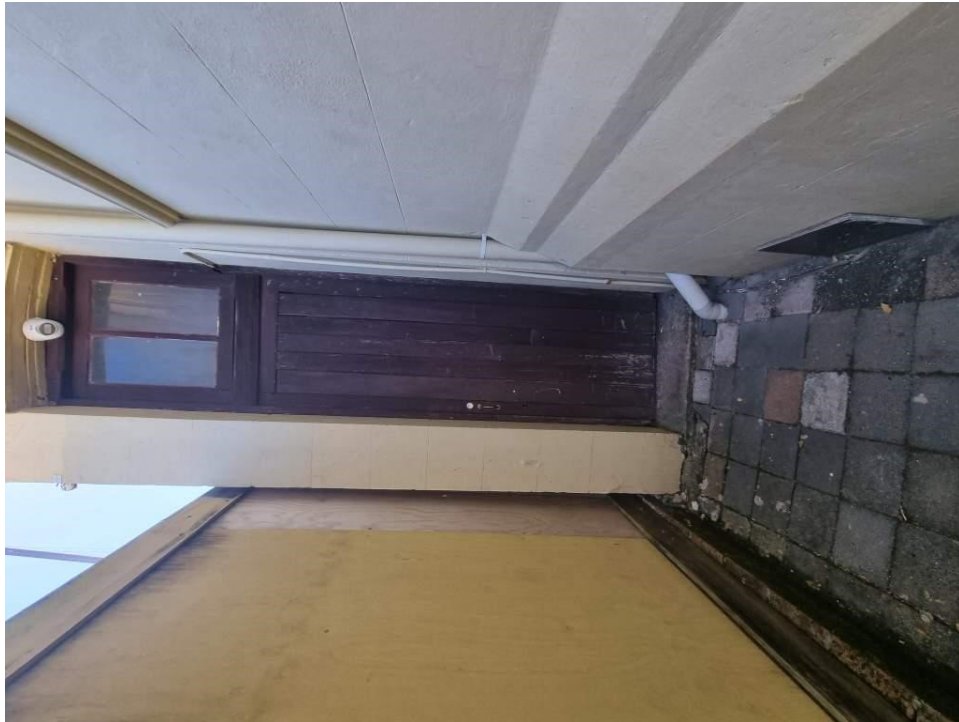
**PHOTO 46**

(Photo showing cracking above the wooden door, unable to measure width of crack)

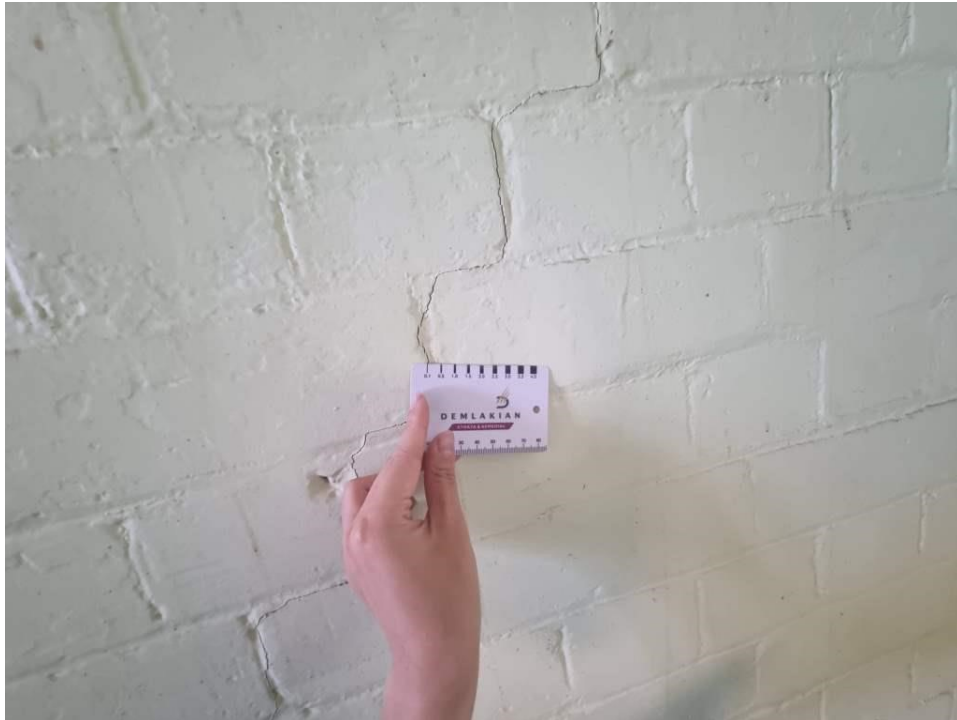
**PHOTO 60**  
(Photo showing cracking below the window adjacent to the stairs on level 2)

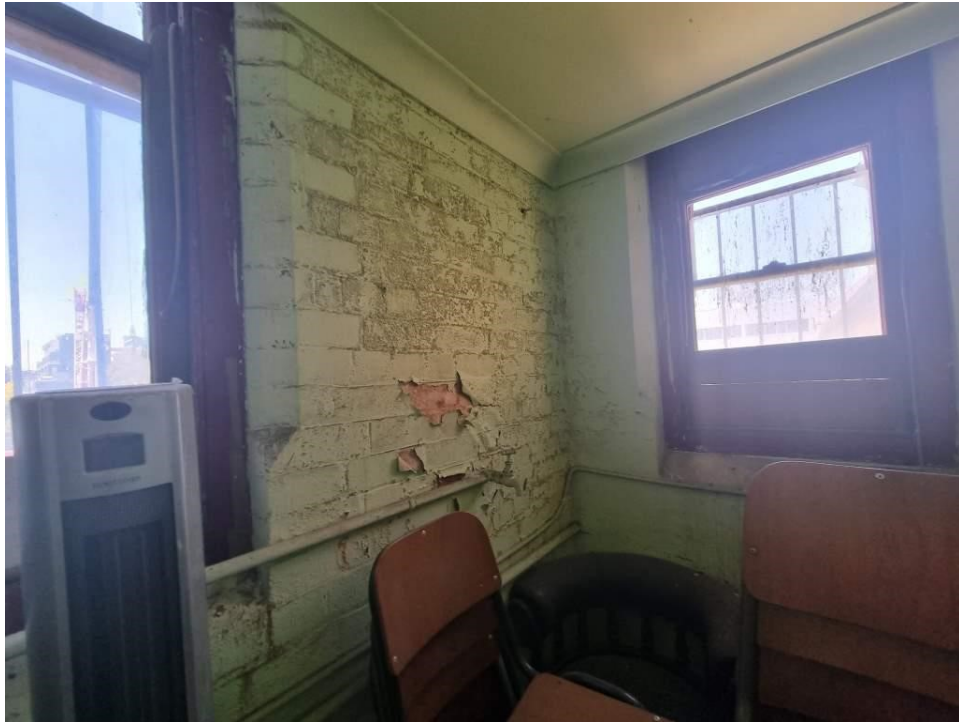
**PHOTO 64**

(Close up of paint peeling mentioned above)

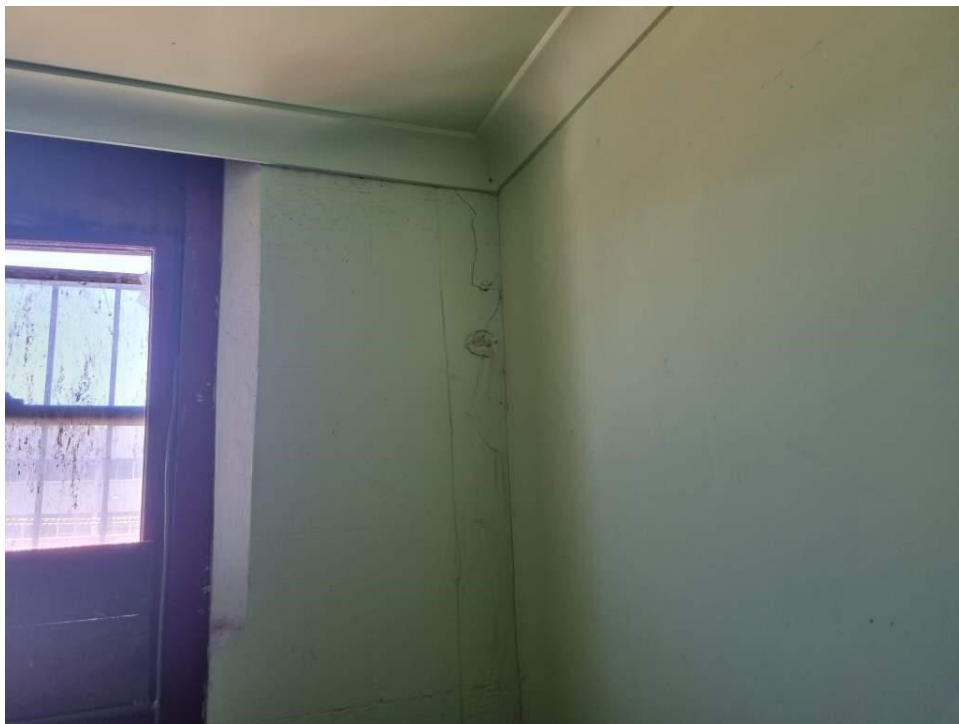
**PHOTO 65**

(Photo showing paint peeling deterioration and stain marks on left brick wall of storeroom)

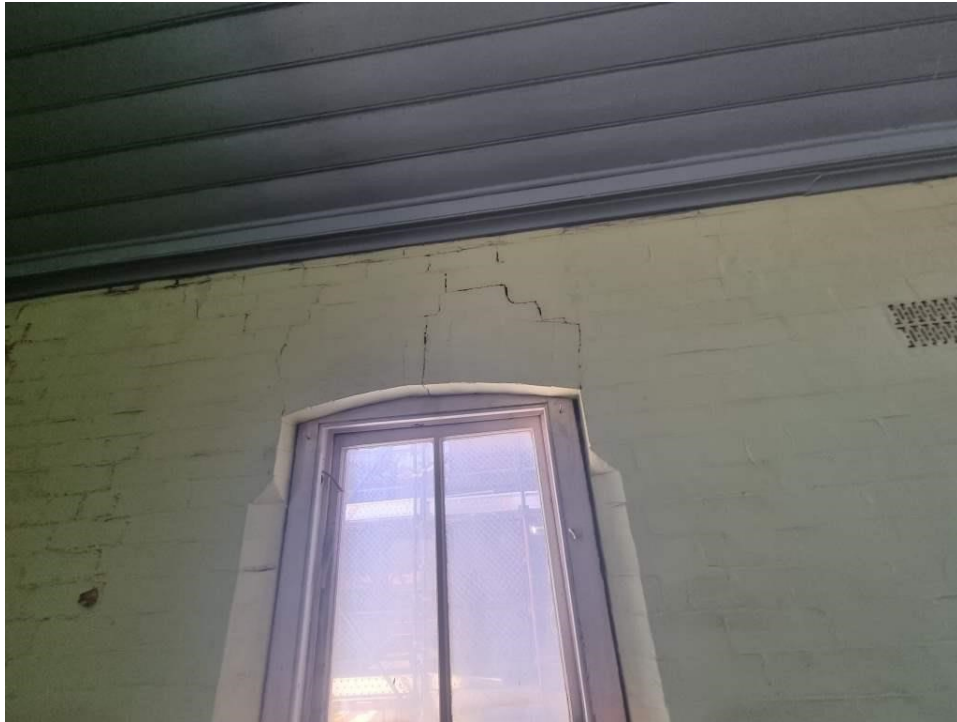
**PHOTO 66**

(Photo showing crack on the wall. Unable to reach to measure width of the crack)

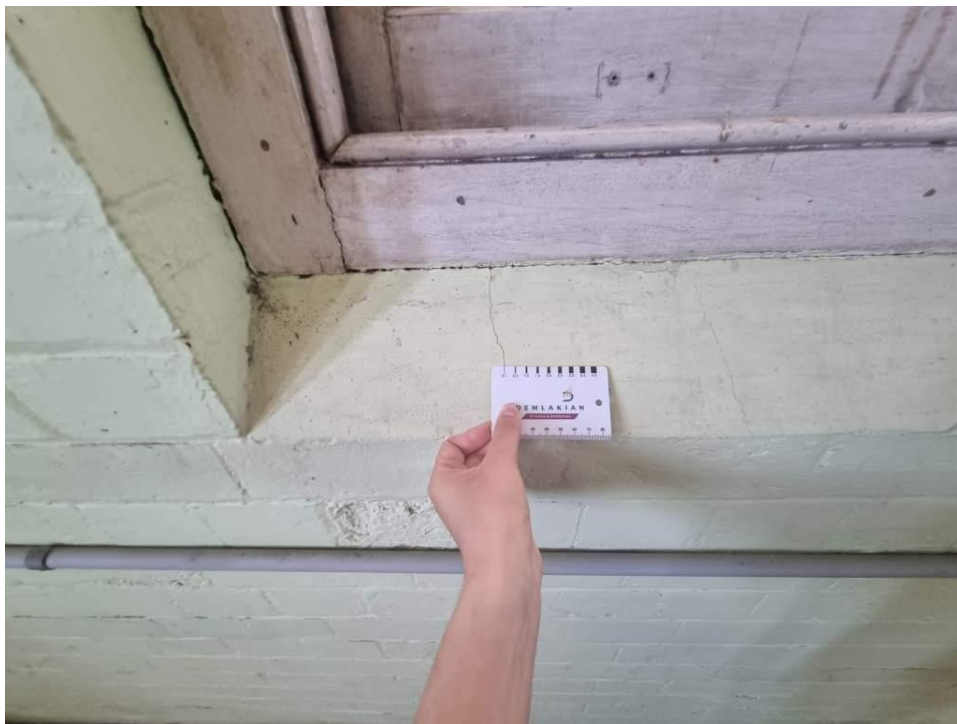
**PHOTO 67**

(Cracking to brickwork above the window.  
Unable to reach and measure width of crack)

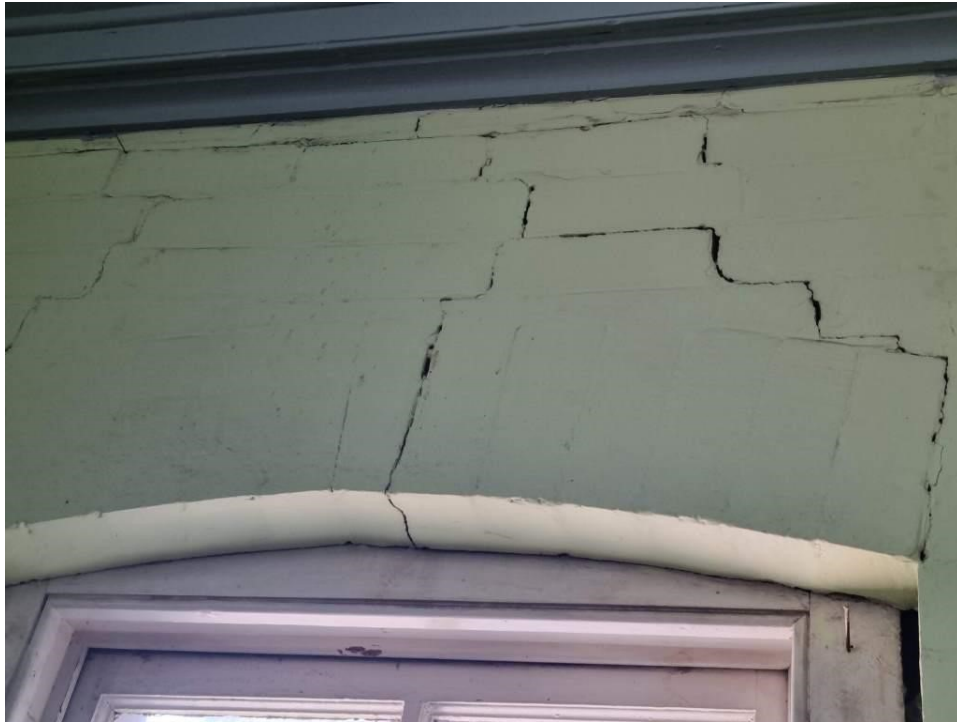
**PHOTO 68**

(Photo showing 0.1mm crack below window)

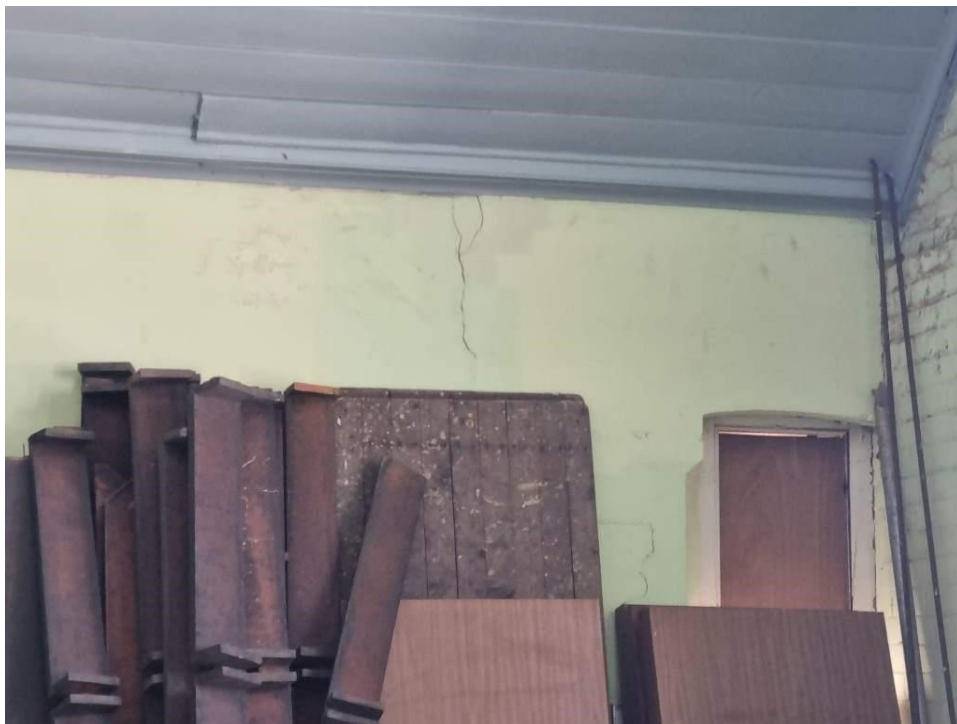
**PHOTO 69**  
(Close up of brickwork crack above window)

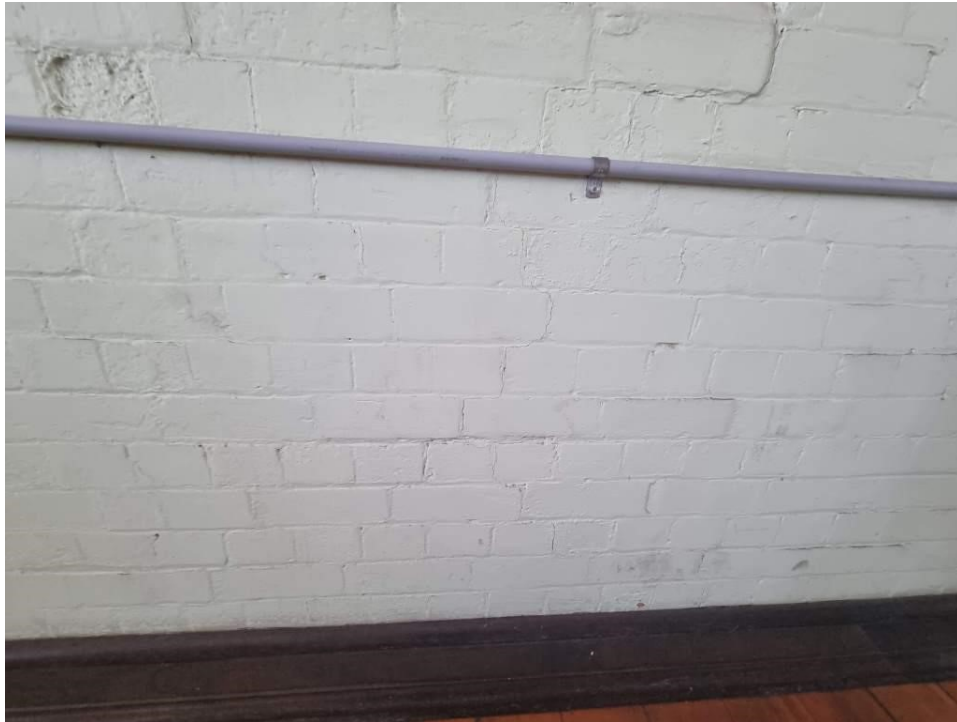
**PHOTO 70**  
(Photo showing brickwork crack to top of wall on Level 2.  
Unable to reach and measure with of cracks)

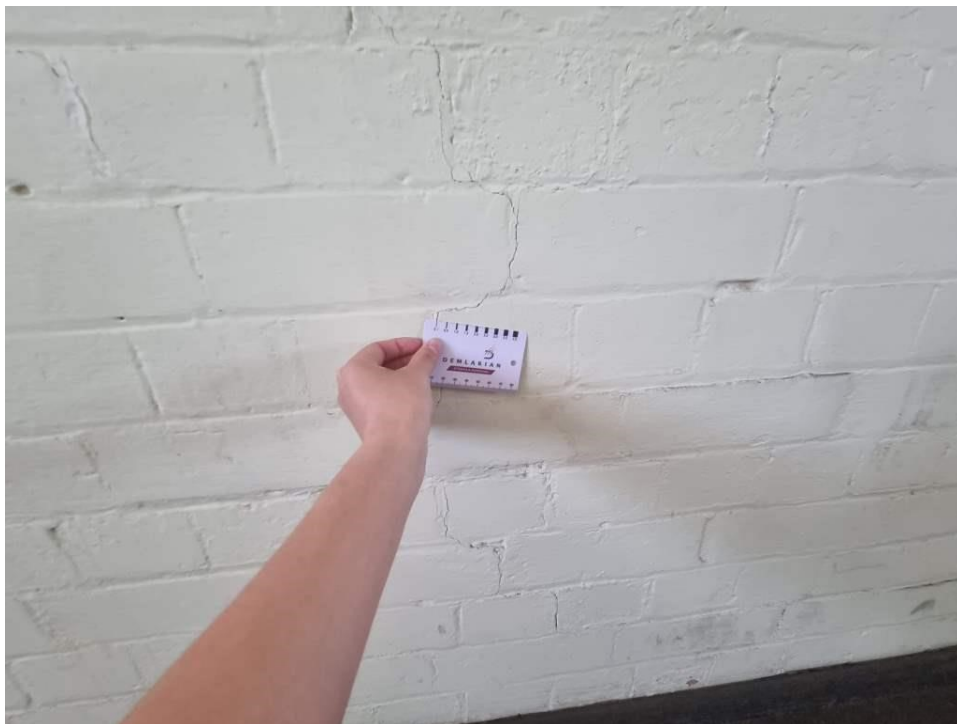
**PHOTO 71**  
(Cracking to brick wall below the windows on level 2)

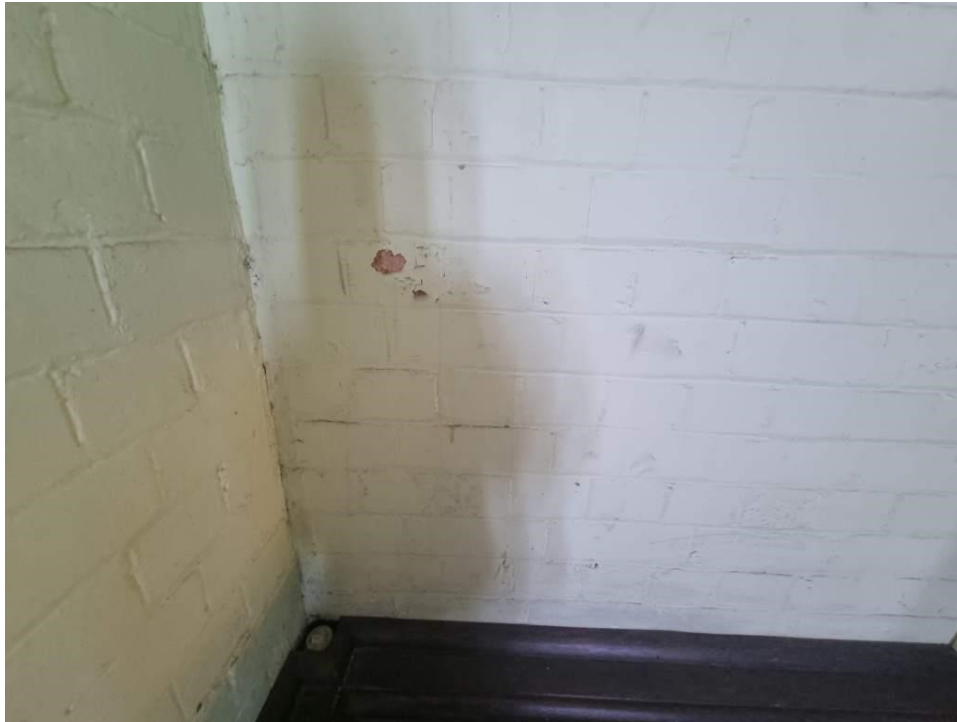
**PHOTO 72**  
(Photo showing cracks are 0.1mm in width)

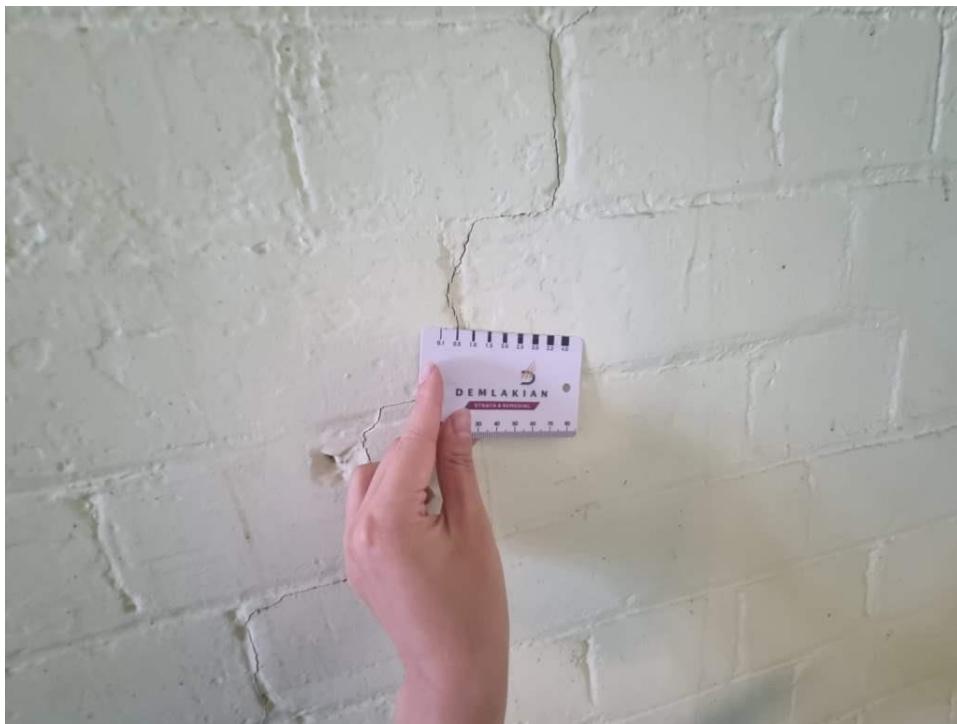
**PHOTO 73**

(Photo showing peeling of paint on wall adjacent to stairs on level 2)

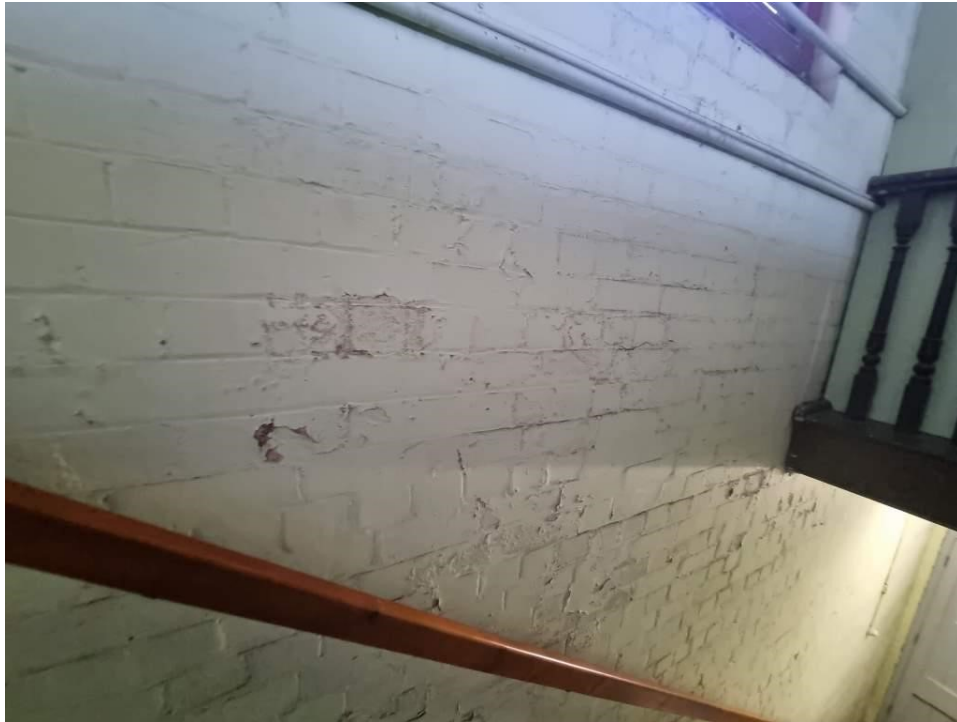
**PHOTO 74**

(Photo showing cracking up to 0.5mm on wall on level 2)

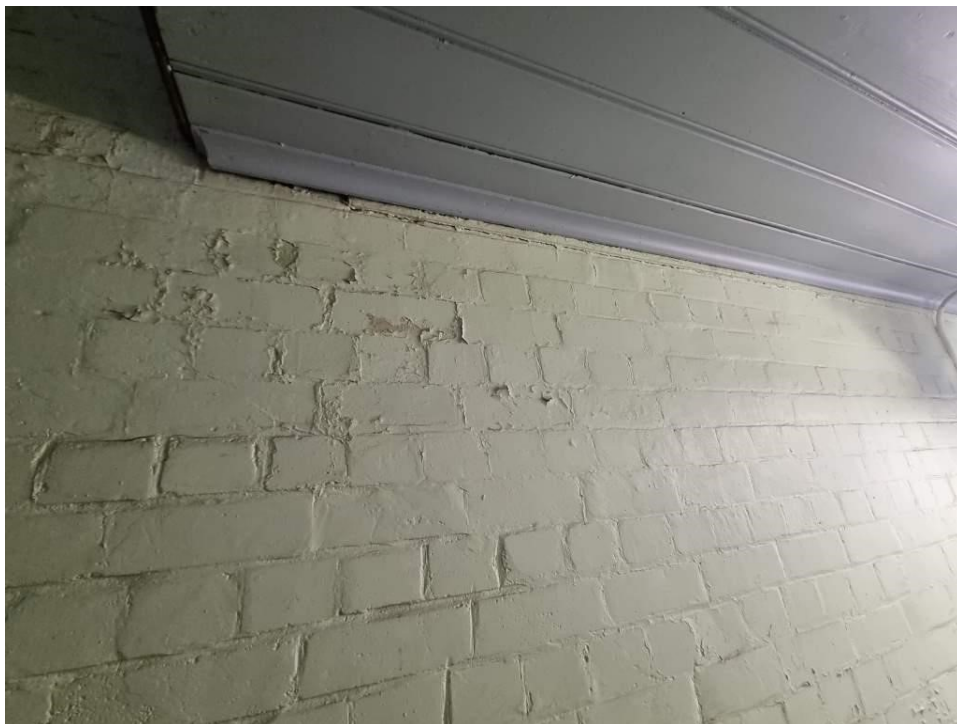
**PHOTO 75**

(Photo showing cracking and peeling paint of brick wall adjacent to stairs at the back of the property)

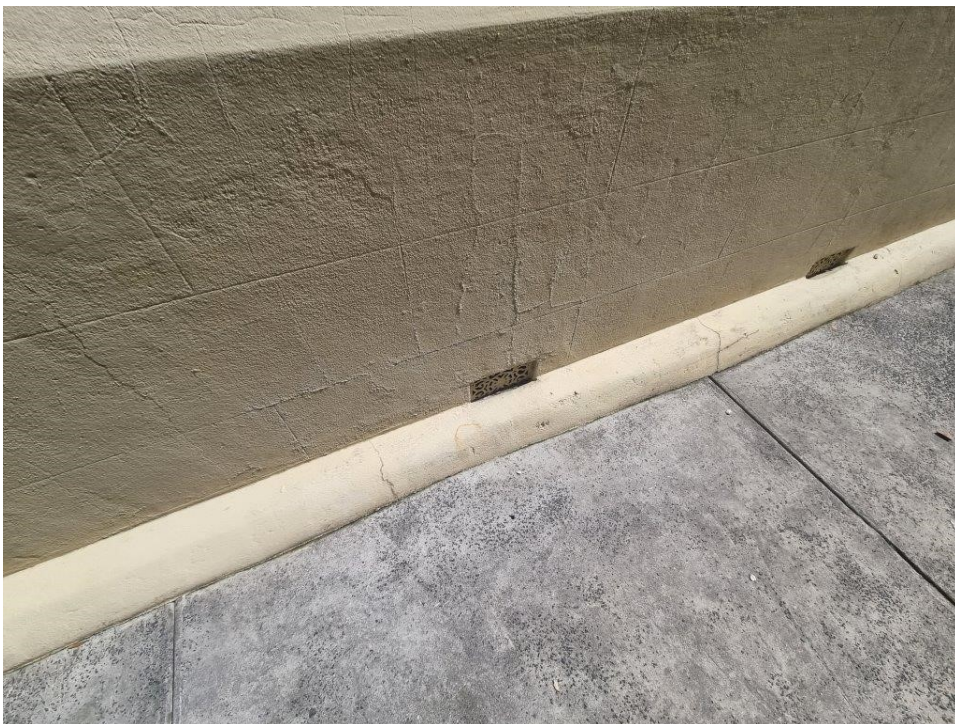
**PHOTO 93**

(Photo showing cracks on bottom section of wall on Southern facade)

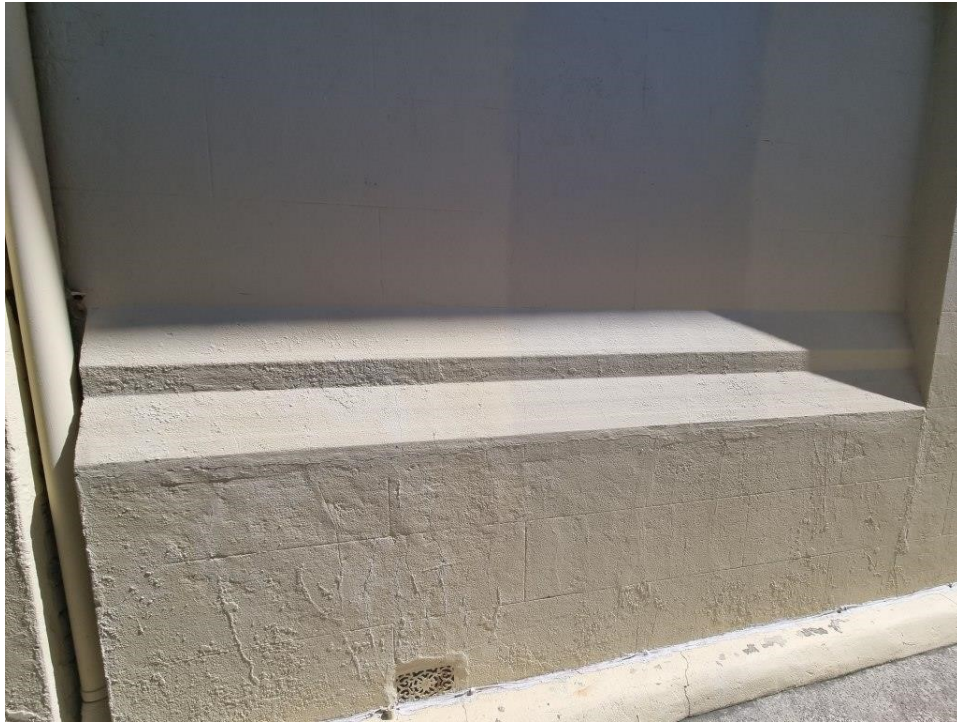
**PHOTO 94**

(Photo showing cracks on bottom section of wall on Southern facade)

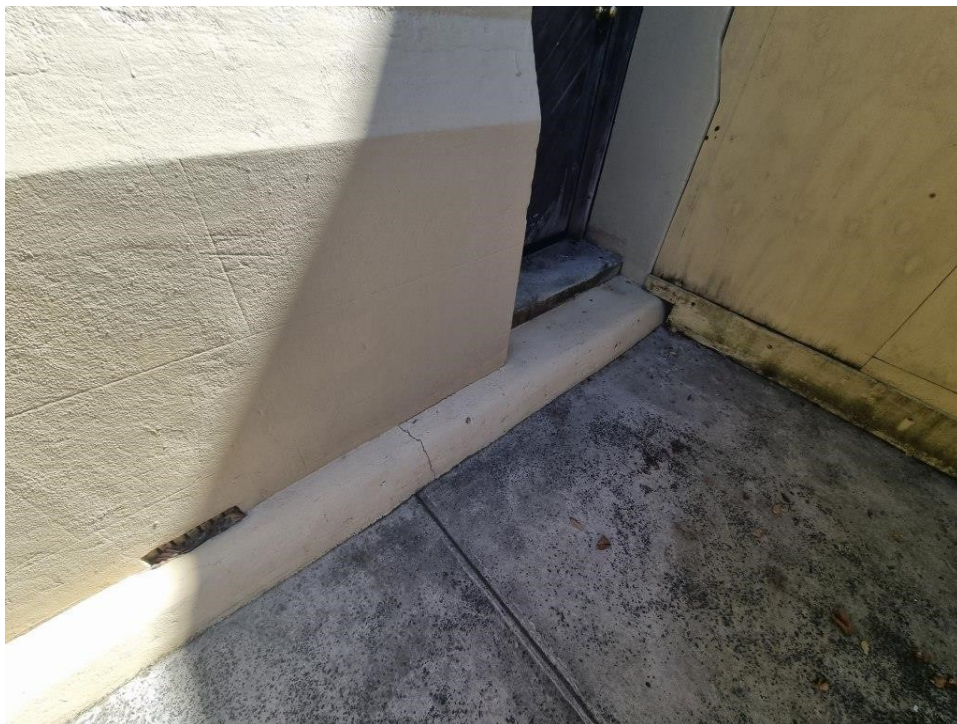
**PHOTO 95**

(Photo showing cracks on bottom section of wall on Southern facade)

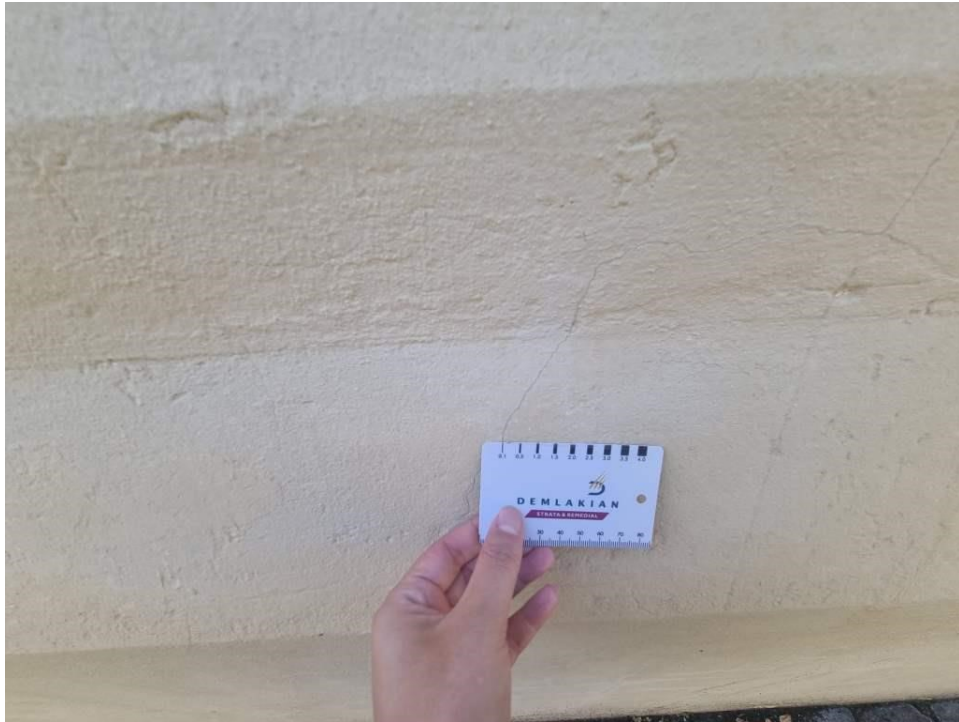
**PHOTO 96**

(Photo showing cracks on bottom section of wall on Southern façade towards southeast corner)

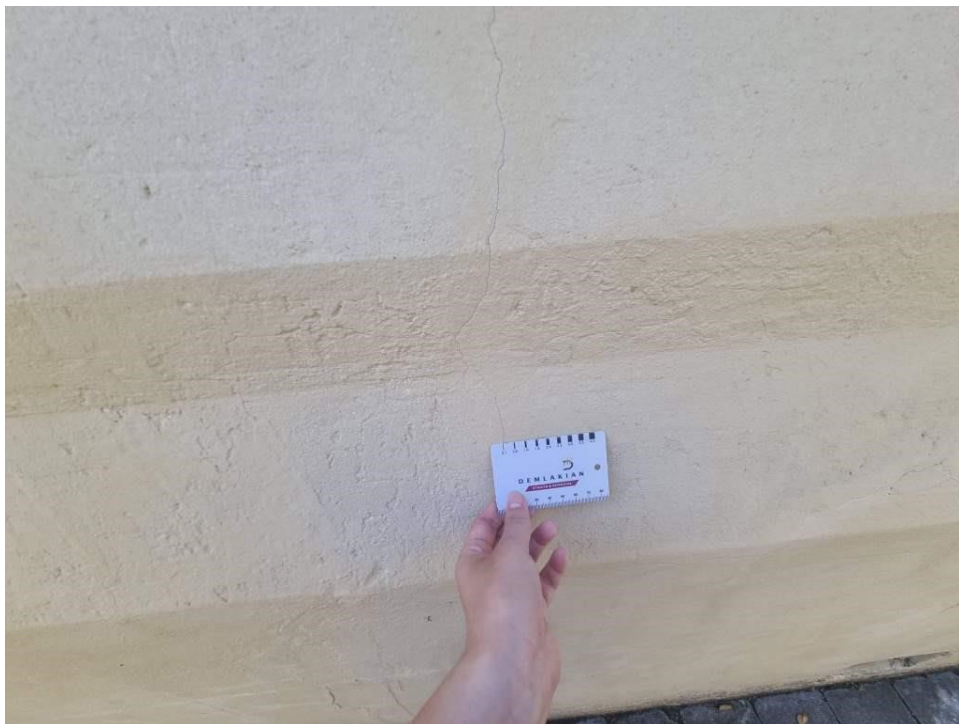
**PHOTO 97**

(Photo showing 0.1mm cracks on southern facade)

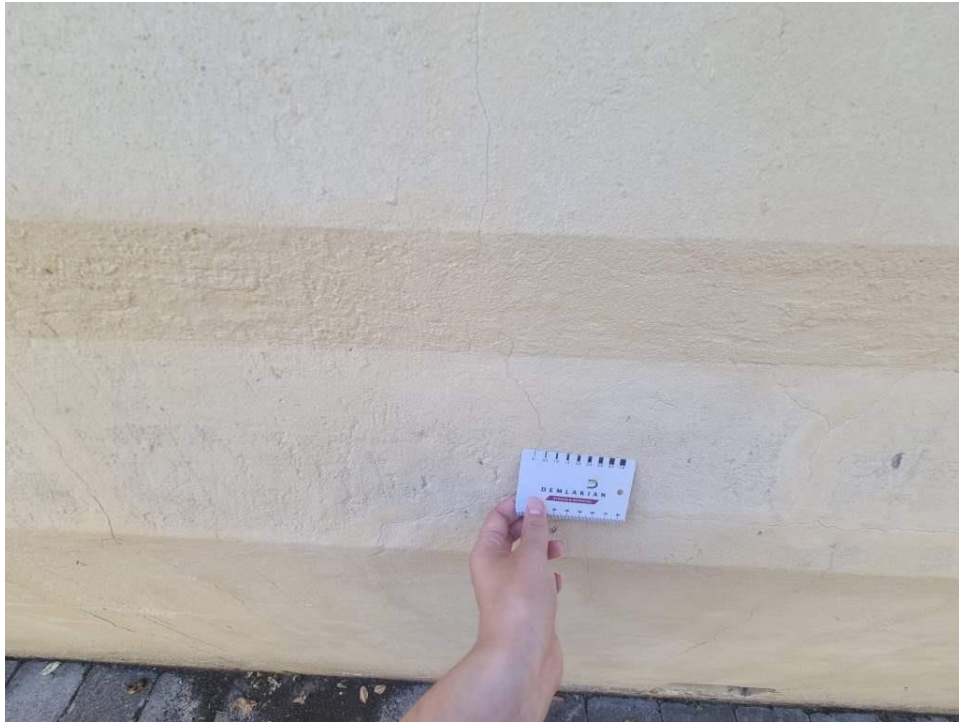
**PHOTO 98**

(Photo showing 0.1mm cracks on southern facade)

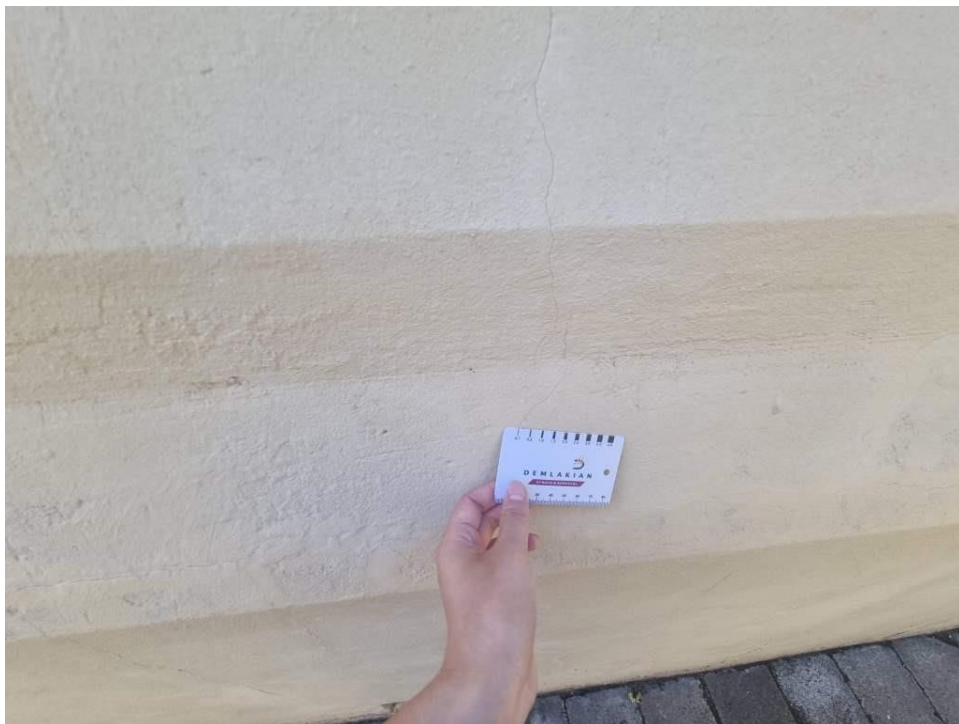
**PHOTO 99**

(Photo showing 0.1mm cracks on southern facade)
