DILAPIDATION REPORT

Council Assets/Public Infrastructure

**WATERLOO STATION
COPE STREET**

DEMLAKIAN CONSULTING ENGINEERS

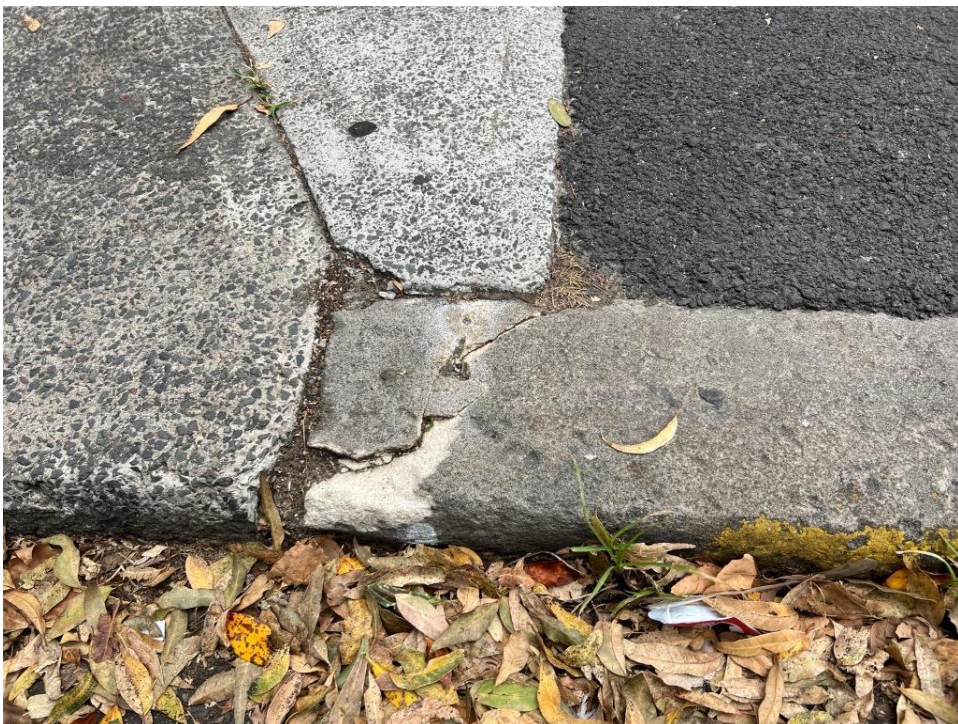
PHOTO 3

(Photo showing cracked and missing concrete in footpath adjacent stormwater pit)

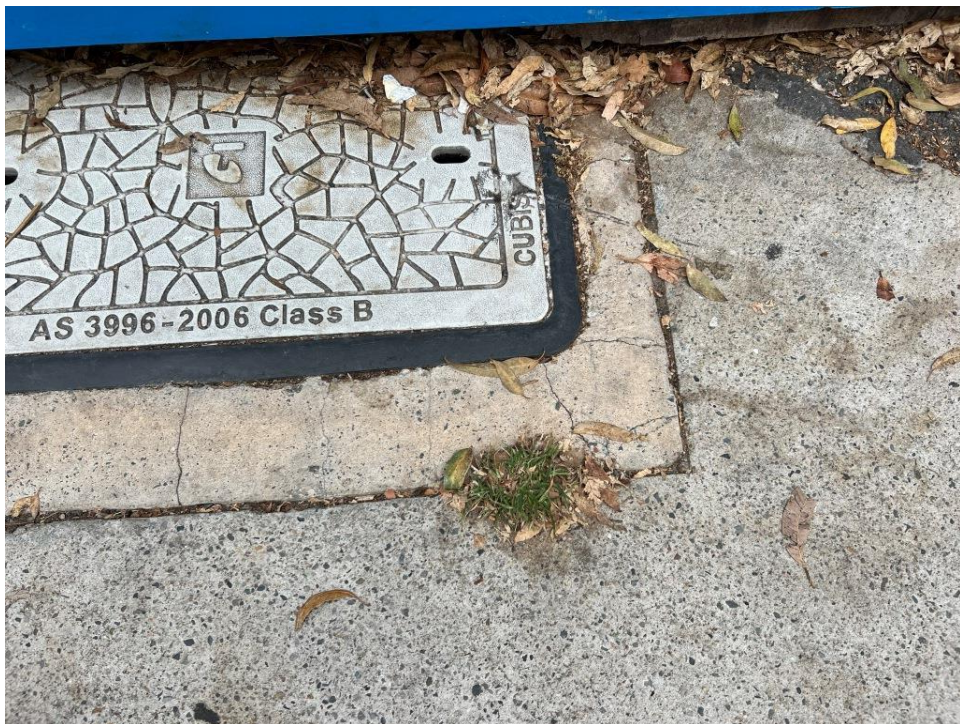
PHOTO 9

(Photo showing cracks in footpath and kerb adjacent cable pits – Raglan Street)

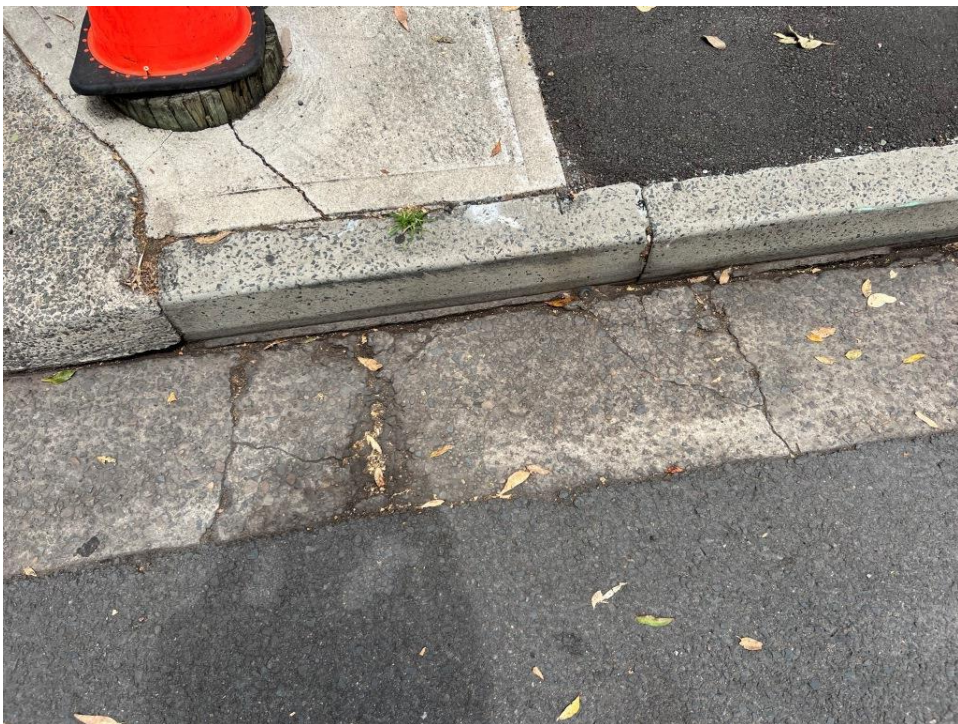
PHOTO 21

(Photo showing cracks in footpath developing from electricity pole's former location – Raglan Street)

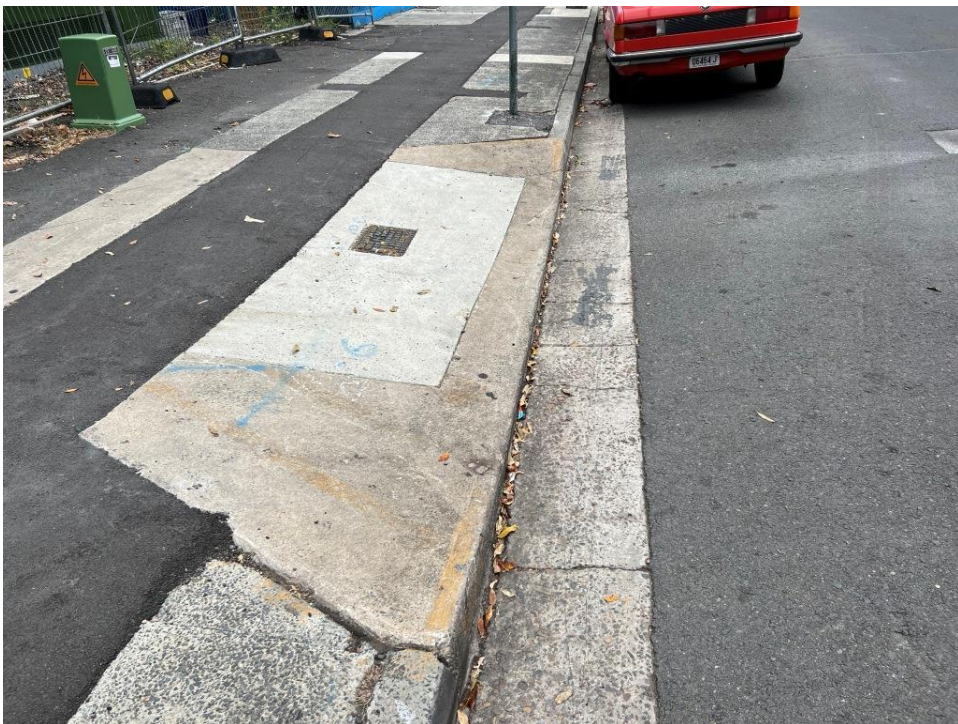
PHOTO 33

(Photo showing crack at end of footpath's saw cut joint – Raglan Street)

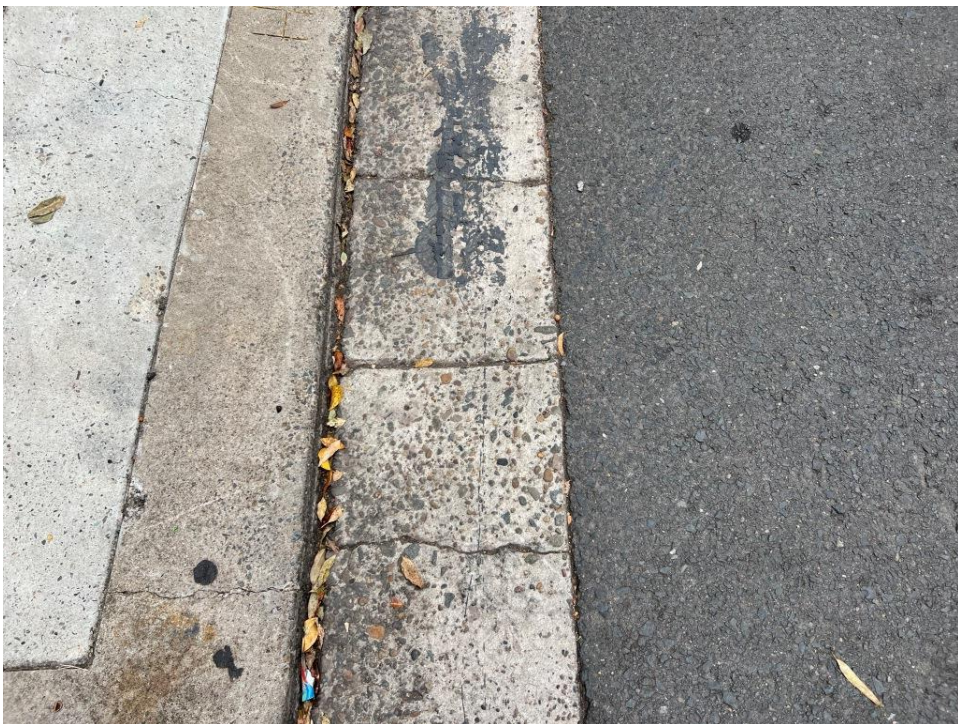
PHOTO 35

(Photo showing crack in gutter – Raglan Street)

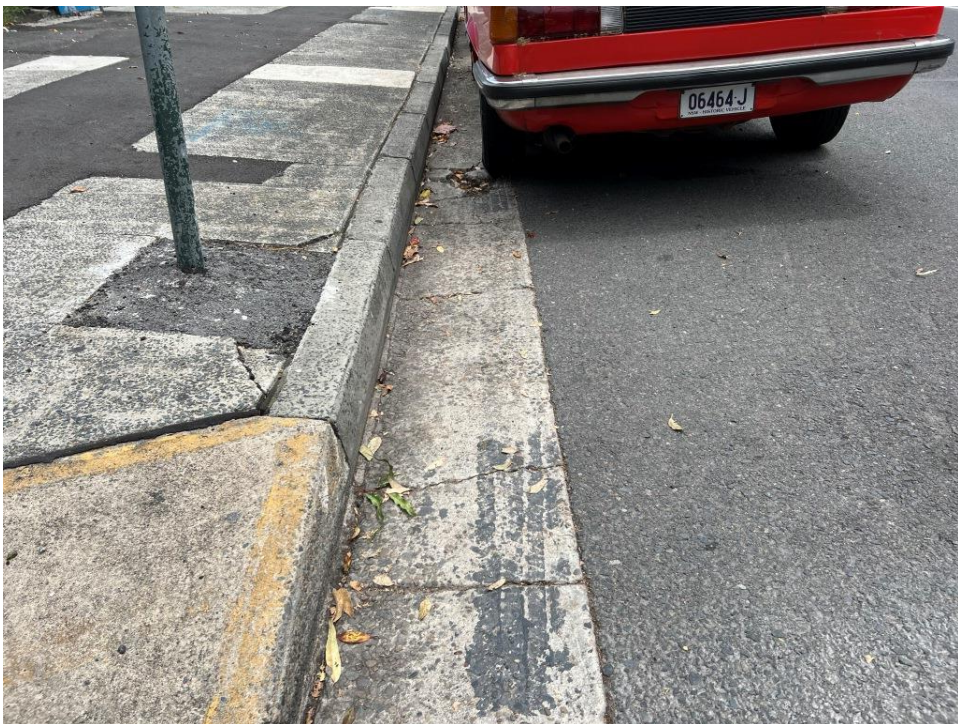
PHOTO 43

(Photo showing crack in footpath/kerb – Raglan Street)

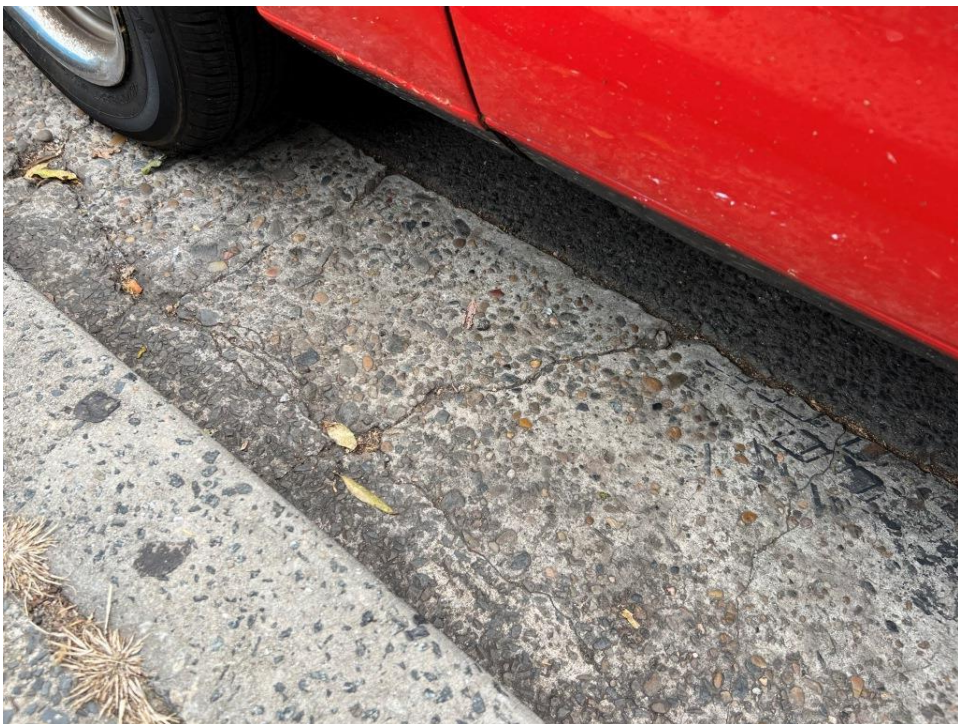
PHOTO 55

(Photo showing cracks in gutter – Raglan Street)

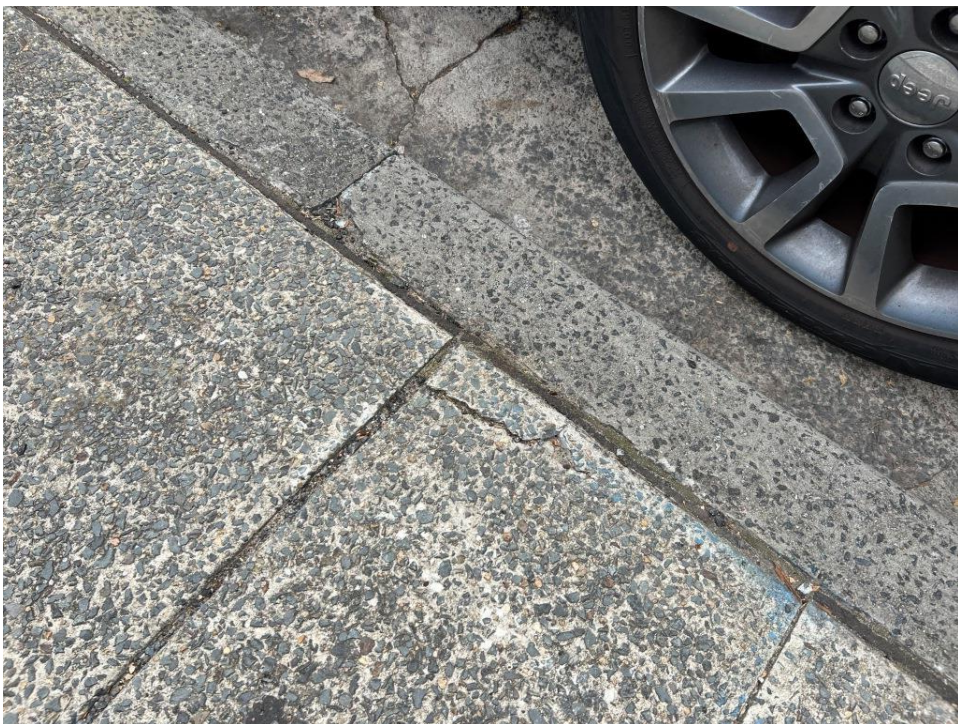
PHOTO 69

(Photo showing cracks/missing concrete in gutter – Raglan Street)

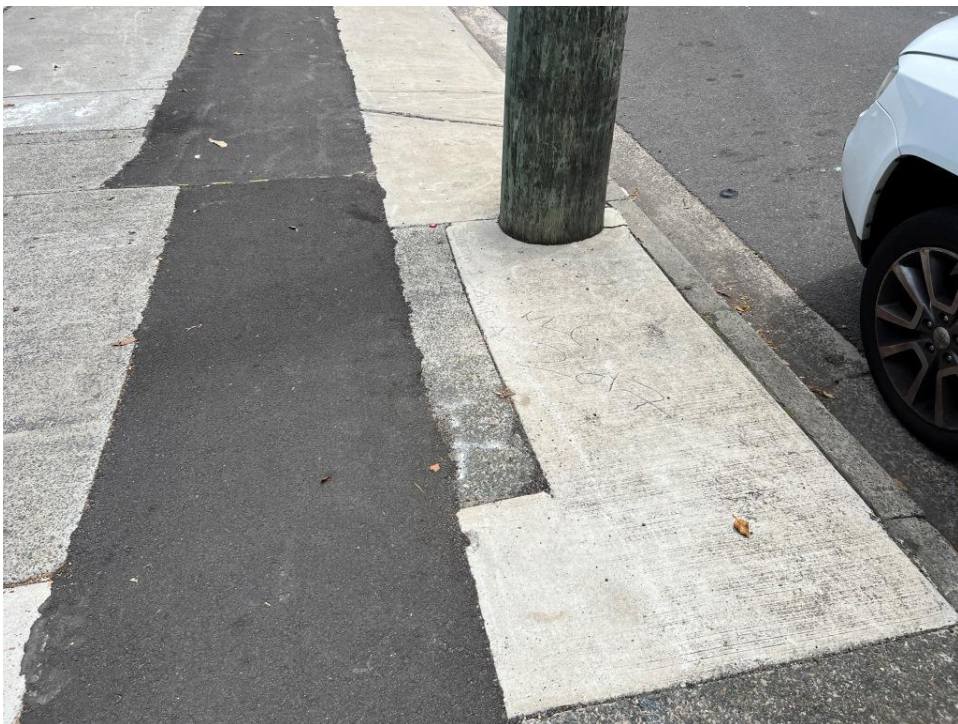
PHOTO 73

(Photo showing crack in footpath – Raglan Street)

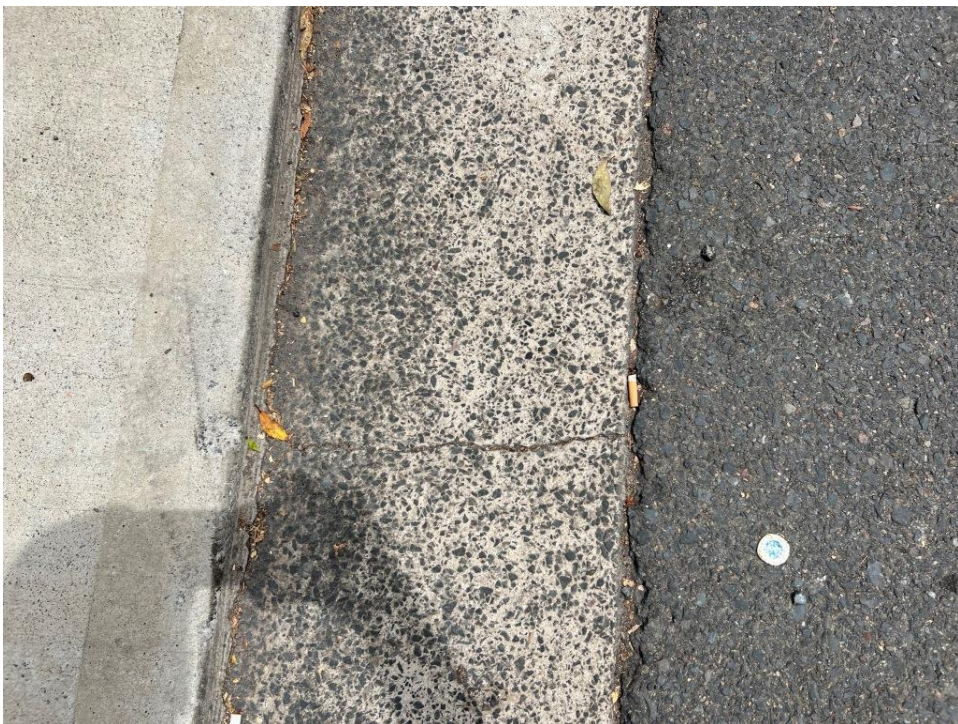
PHOTO 85

(Photo showing cracks in gutter in front of truck driveway – Raglan Street)

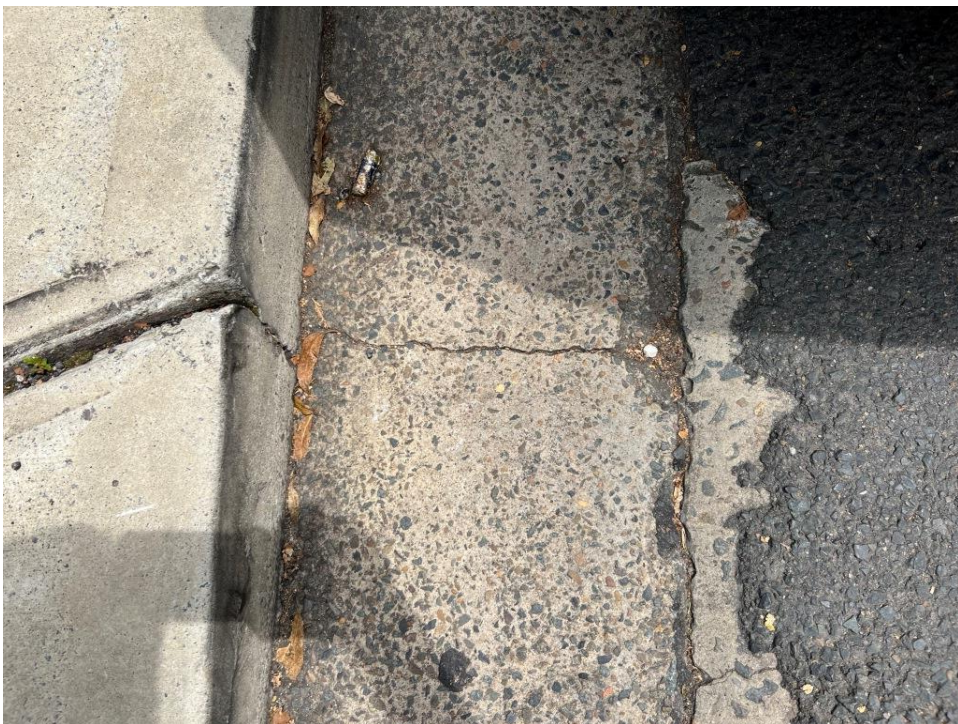
PHOTO 95

(Photo showing cracks in gutter in front of truck driveway – Raglan Street)

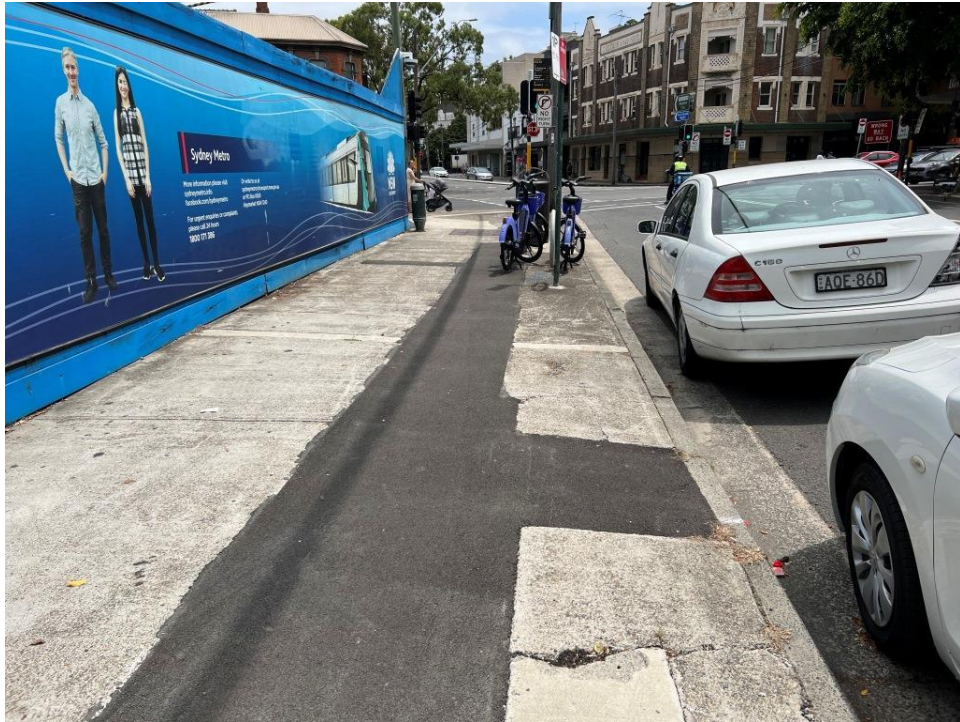
PHOTO 98

(Photo showing crack in footpath – Raglan Street)

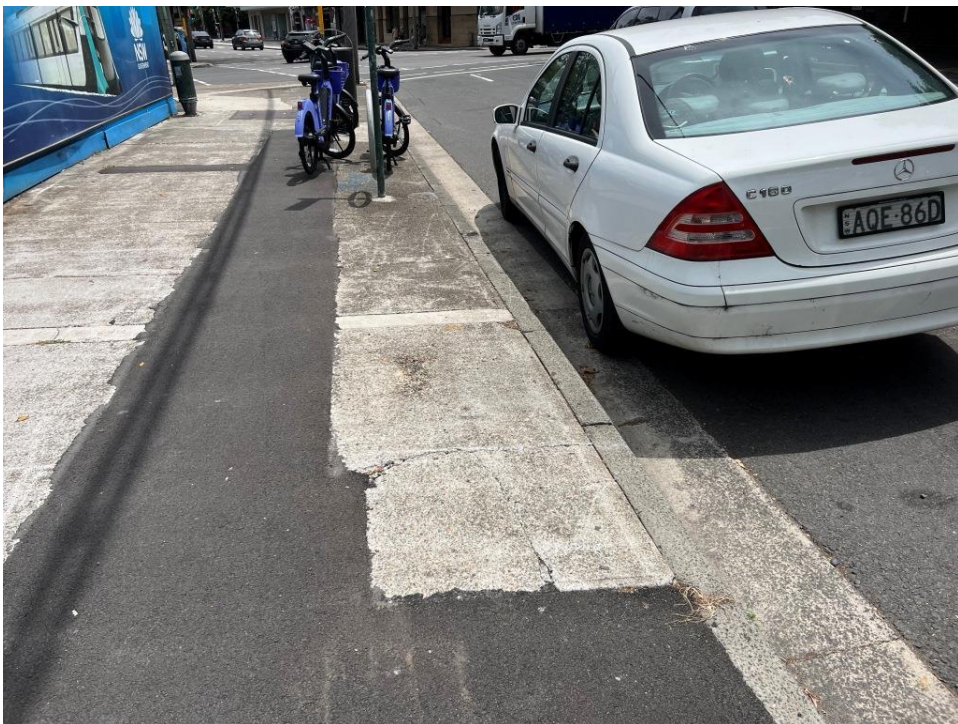
PHOTO 105

(Photo showing crack/missing concrete in footpath – Raglan Street)

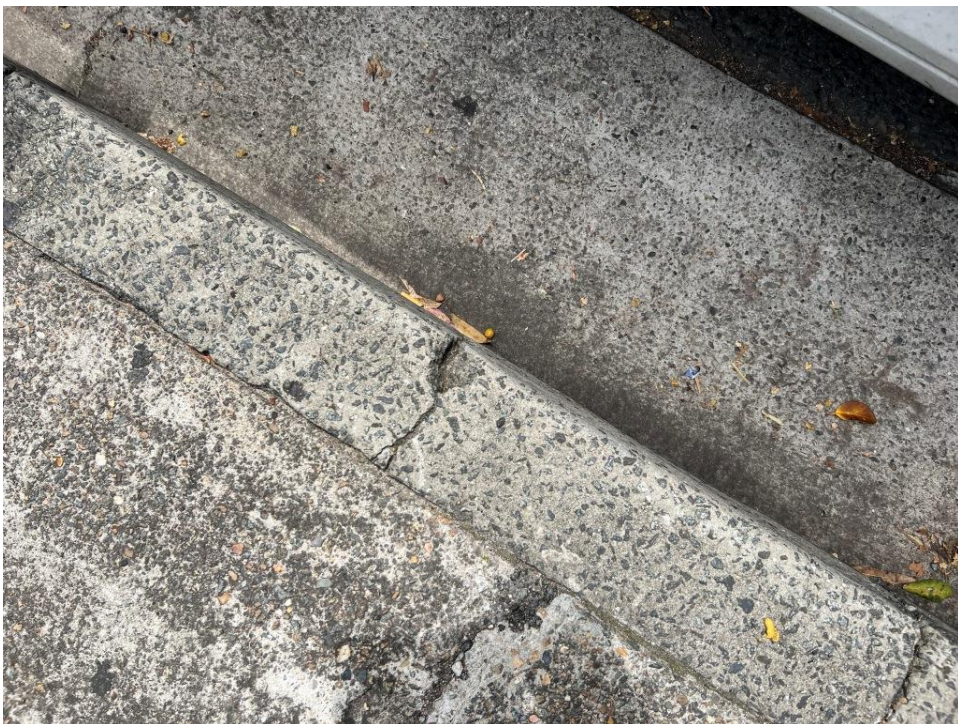
PHOTO 119

(Photo showing crack/missing concrete in footpath and kerb – Raglan Street)

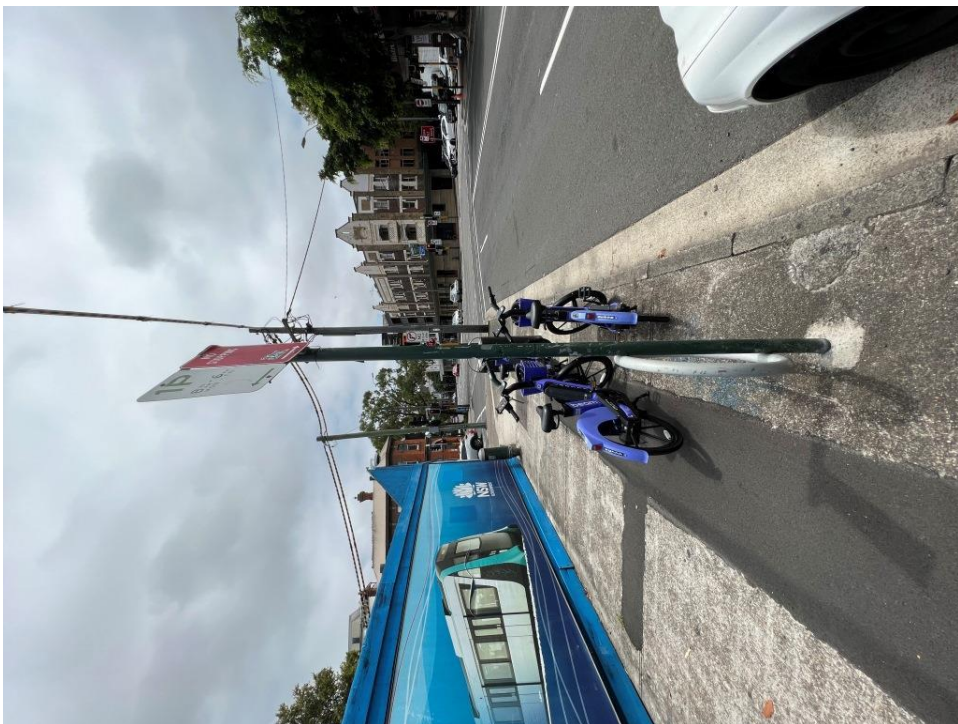
PHOTO 121

(Photo showing crack/missing concrete in kerb and gutter – Raglan Street)

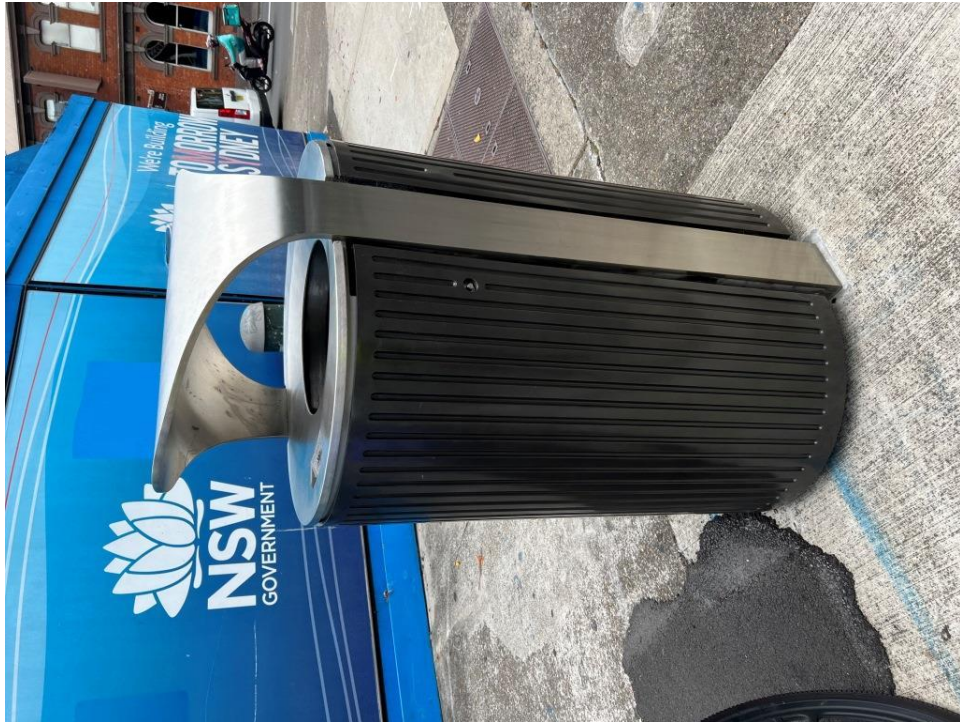
PHOTO 128

(Photo showing crack/missing concrete in kerb and gutter – Raglan Street)

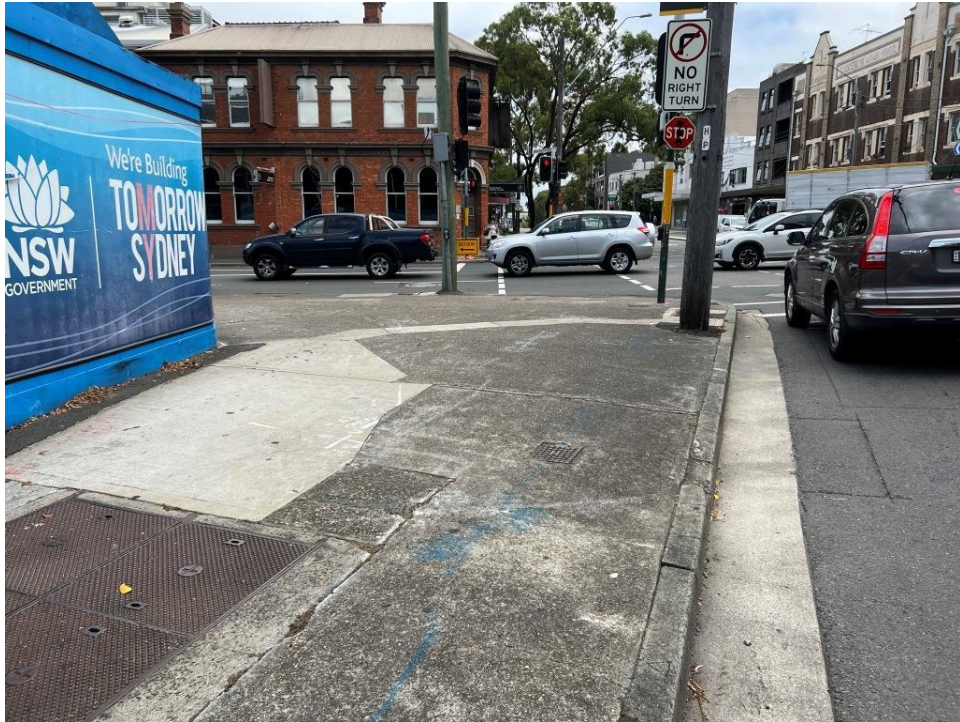
PHOTO 130

(Photo showing crack/missing concrete gutter – Raglan Street)

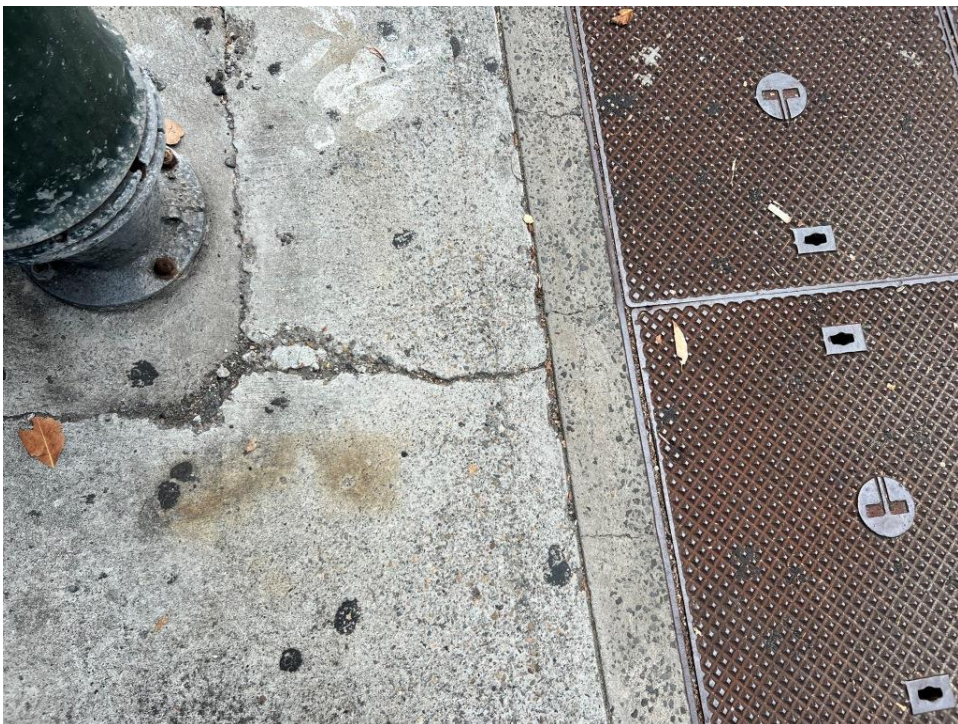
PHOTO 135

(Photo showing crack in footpath – Raglan Street and Botany Road intersection)

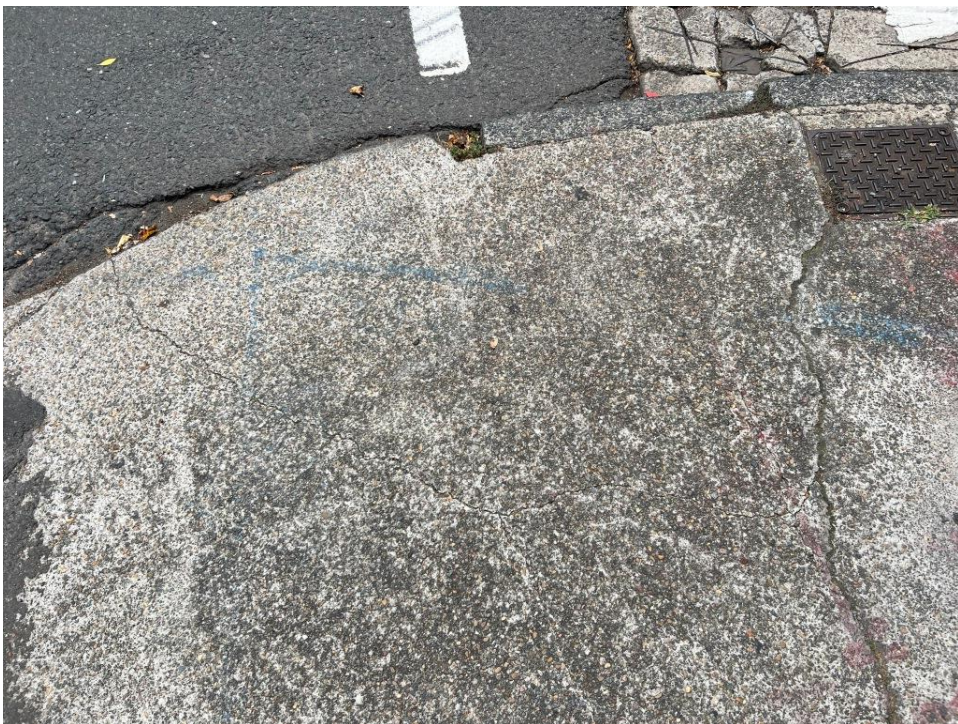
PHOTO 151

(Photo showing crack in footpath – Raglan Street and Botany Road intersection)

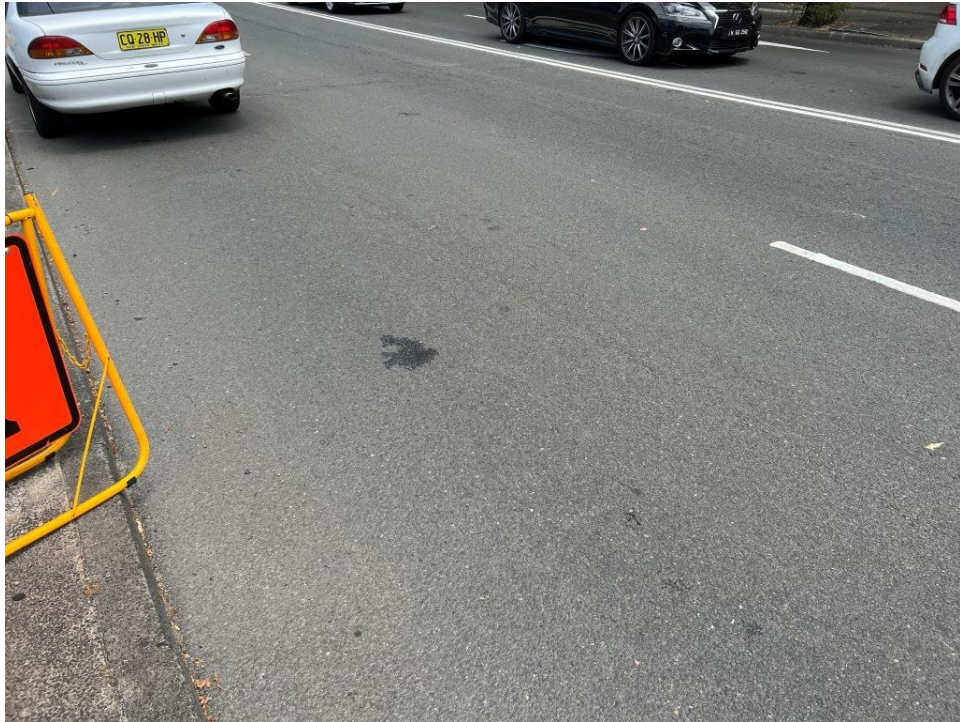
PHOTO 168

(Photo showing crack in footpath – Botany Road)

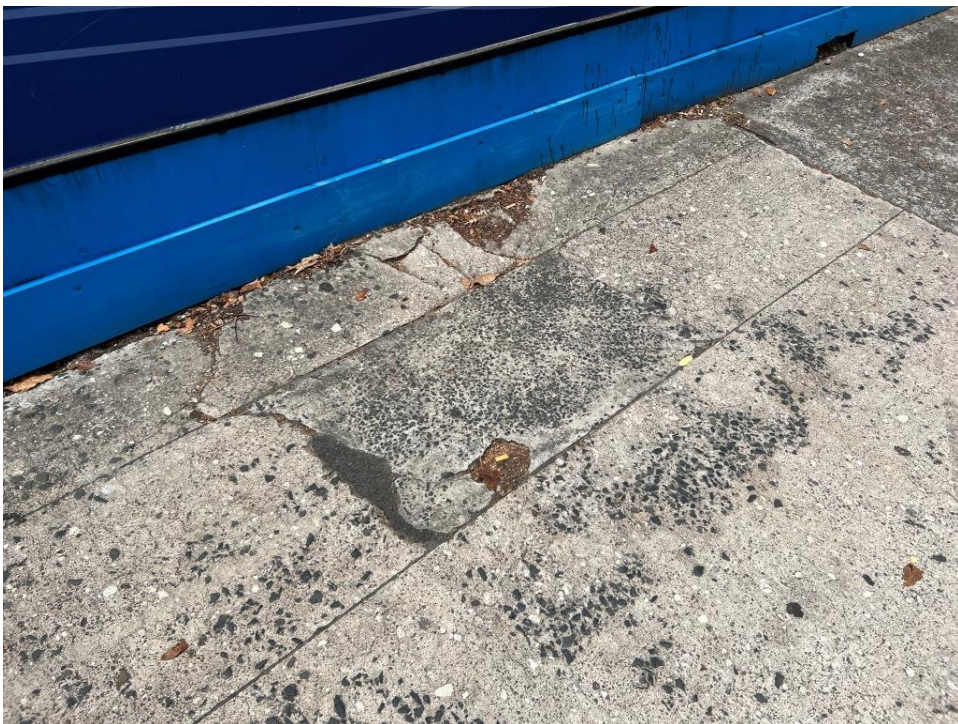
PHOTO 209

(Photo showing crack in kerb adjacent former driveway – Botany Road)

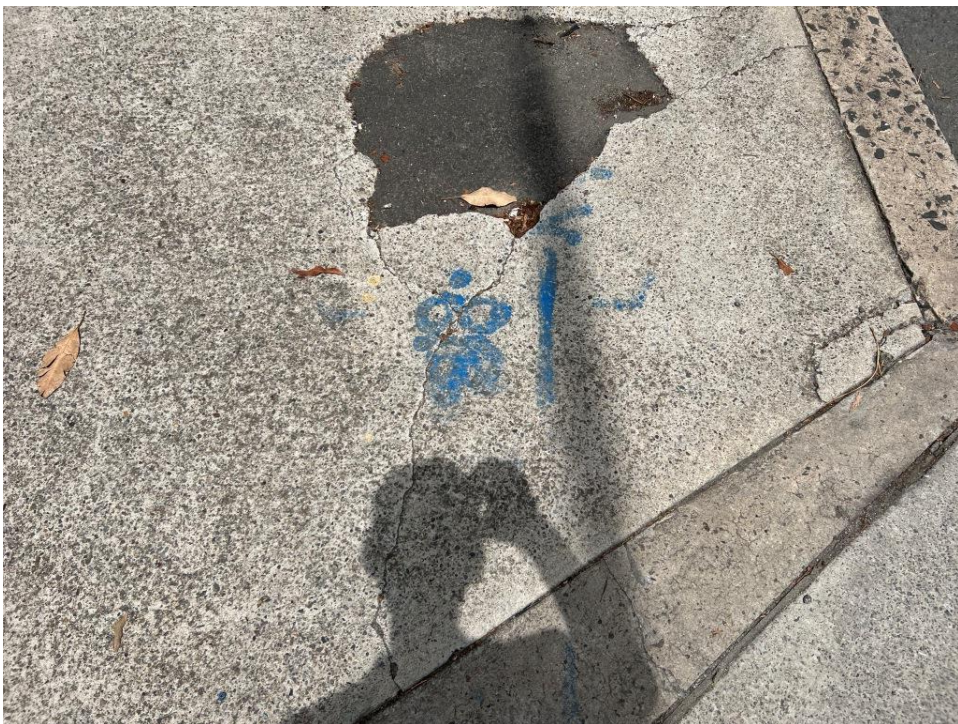
PHOTO 245

(Photo showing cracks adjacent to truck driveway – Botany Road)

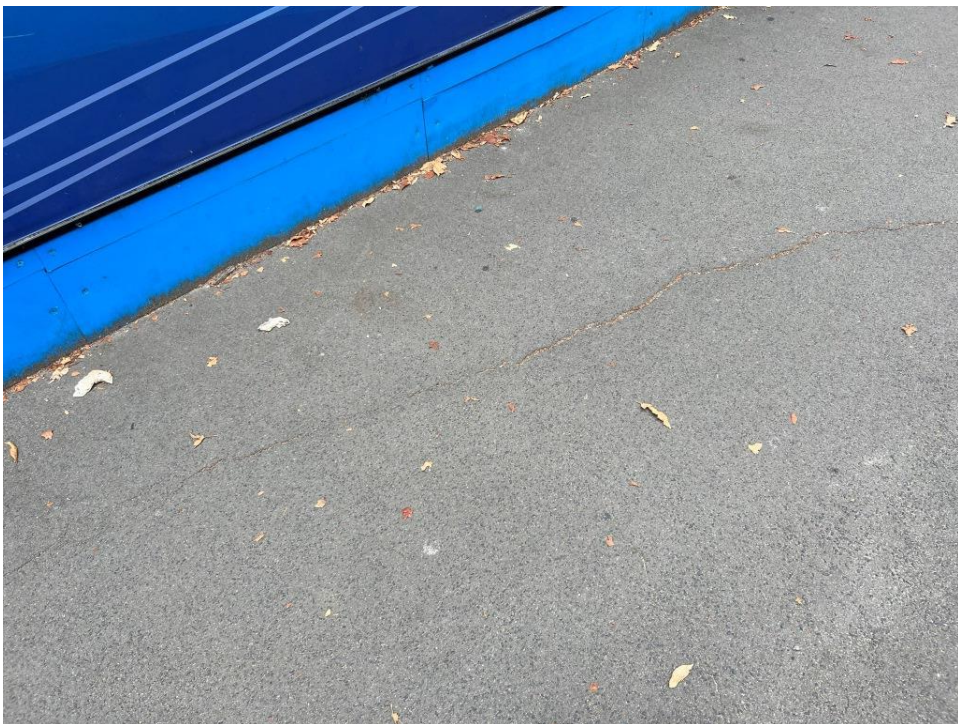
PHOTO 275

(Photo showing cracks in footpath – Botany Road)

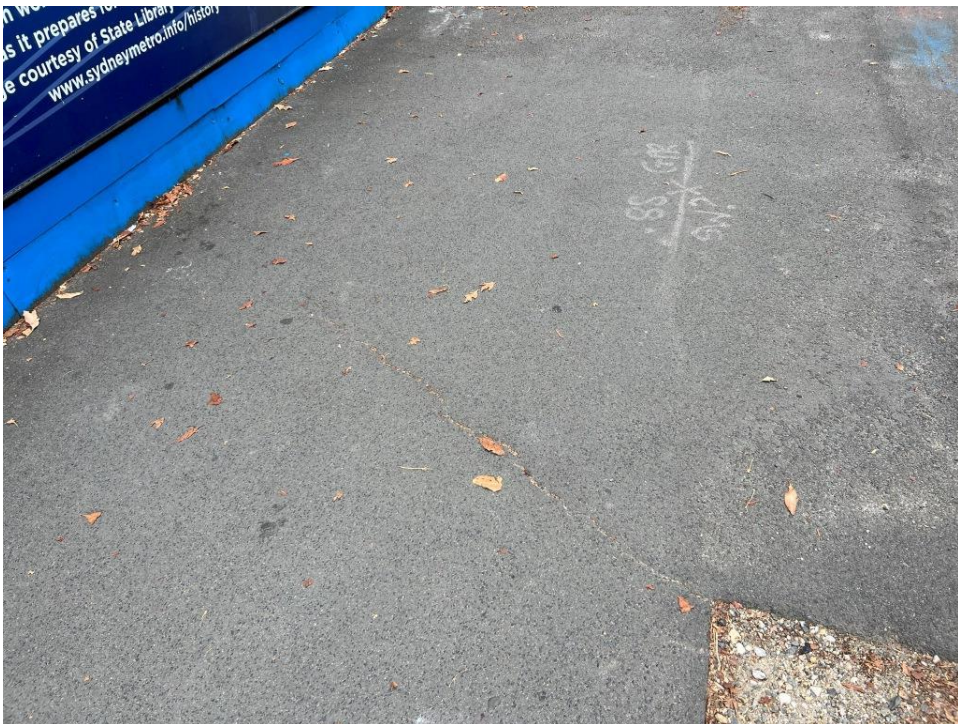
PHOTO 277

(Photo showing cracks in footpath – Botany Road)

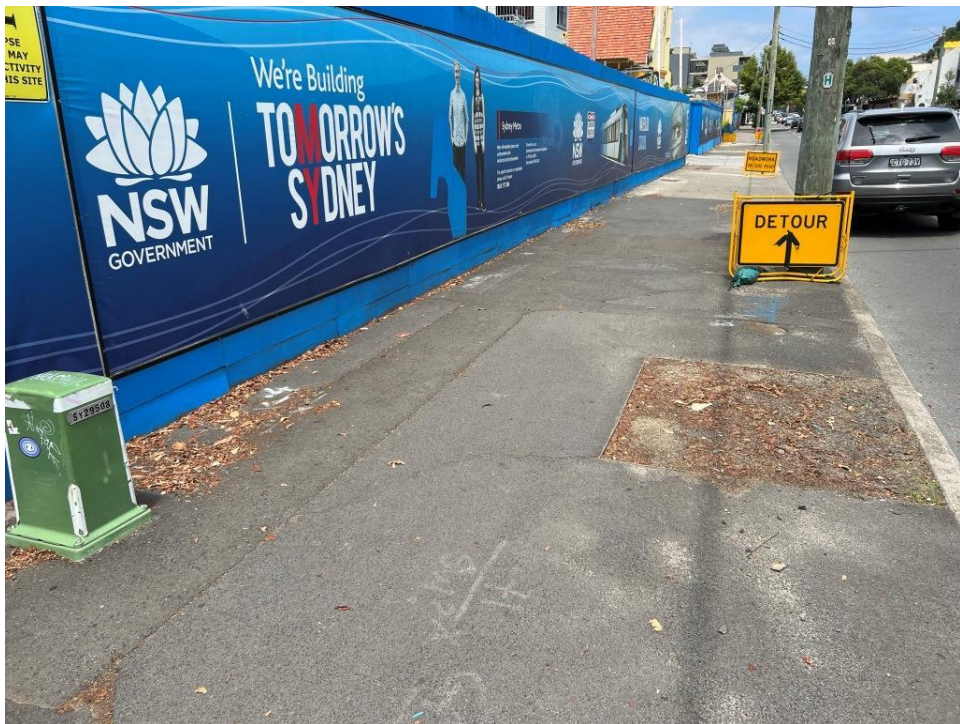
PHOTO 283

(Photo showing cracks in asphalt – Botany Road)

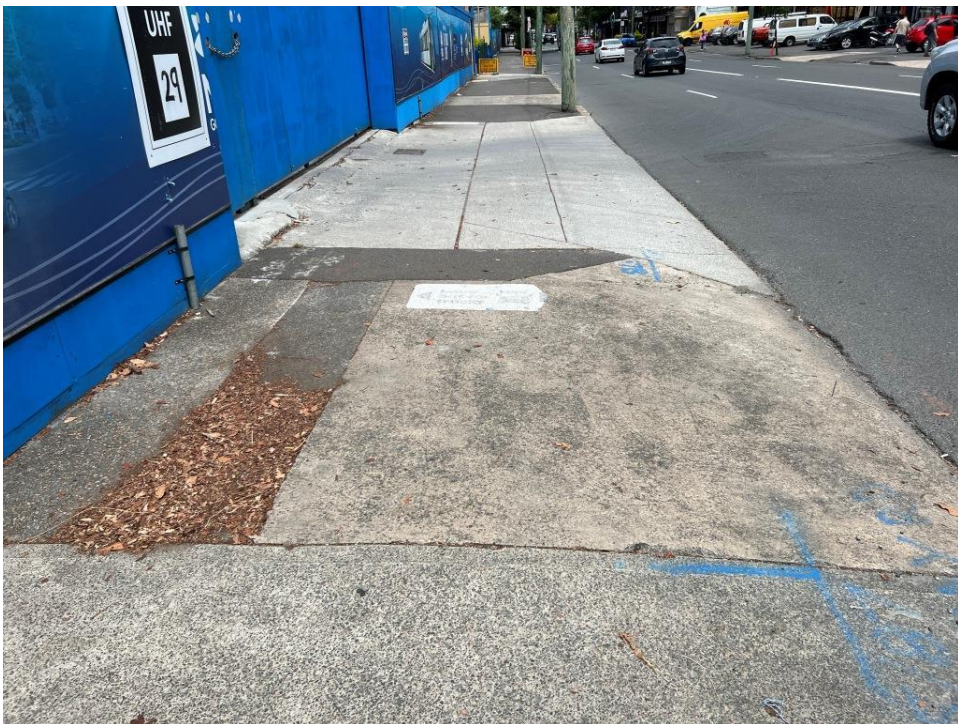
PHOTO 309

(Photo showing cracks in asphalt – Botany Road)

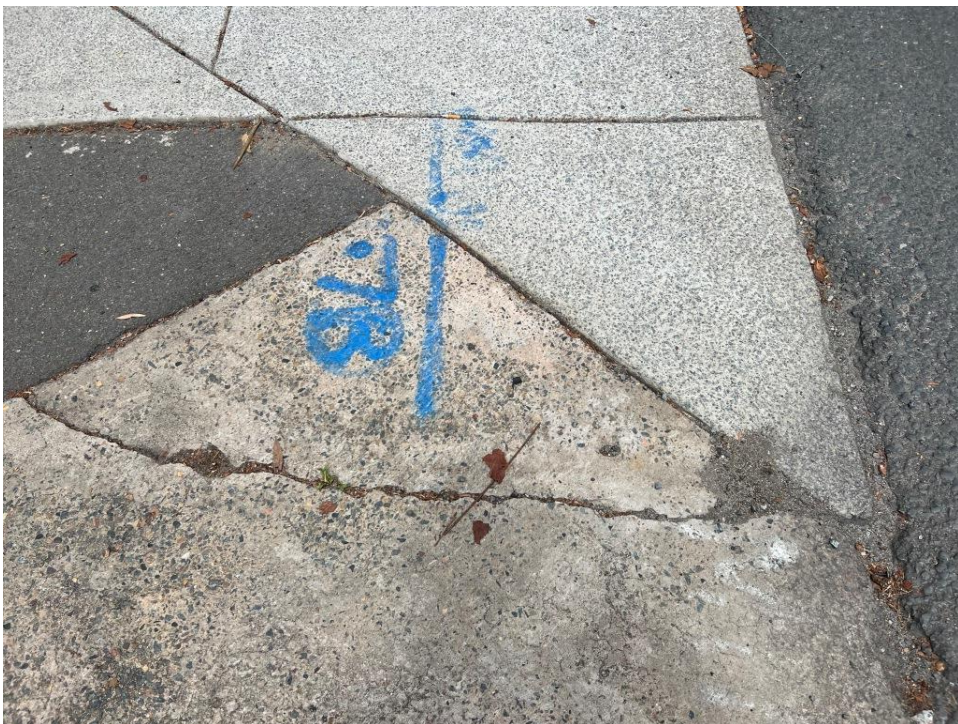
PHOTO 311

(Photo showing cracks in asphalt – Botany Road)

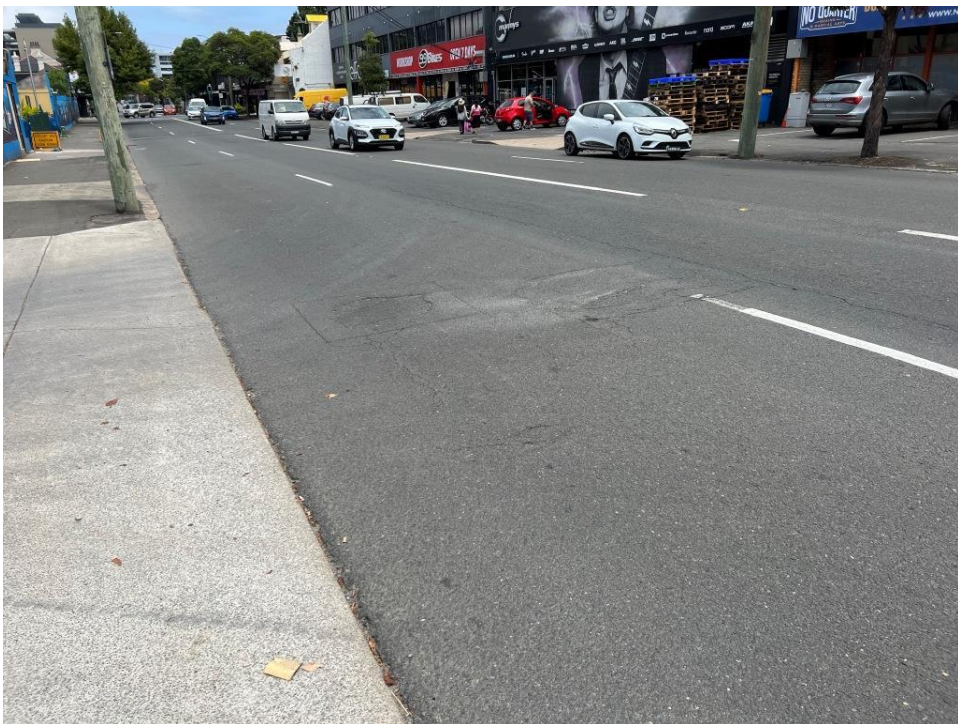
PHOTO 315

(Photo showing cracks in asphalt in front of truck driveway – Botany Road)

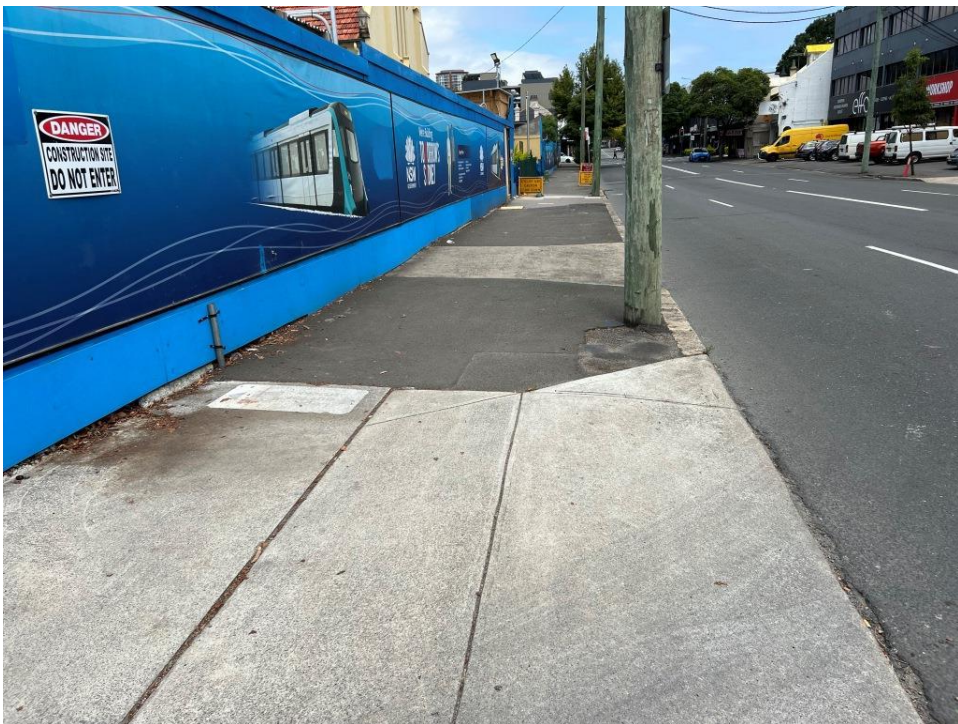
PHOTO 319

(Photo showing cracks in asphalt in front of truck driveway – Botany Road)

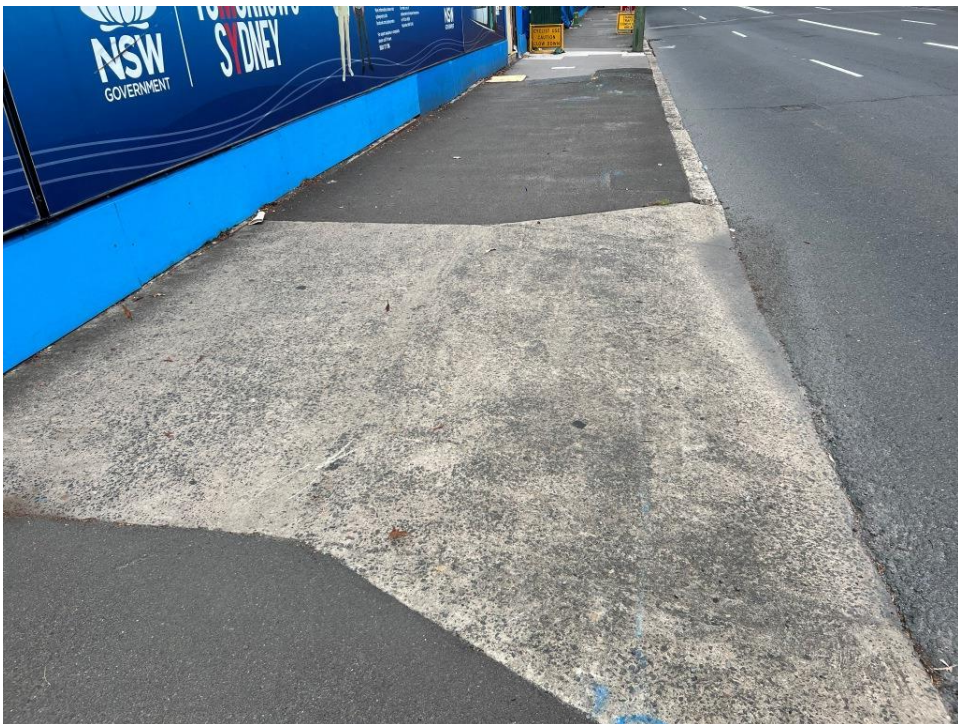
PHOTO 325

(Photo showing cracked kerb at former driveway corner – Botany Road)

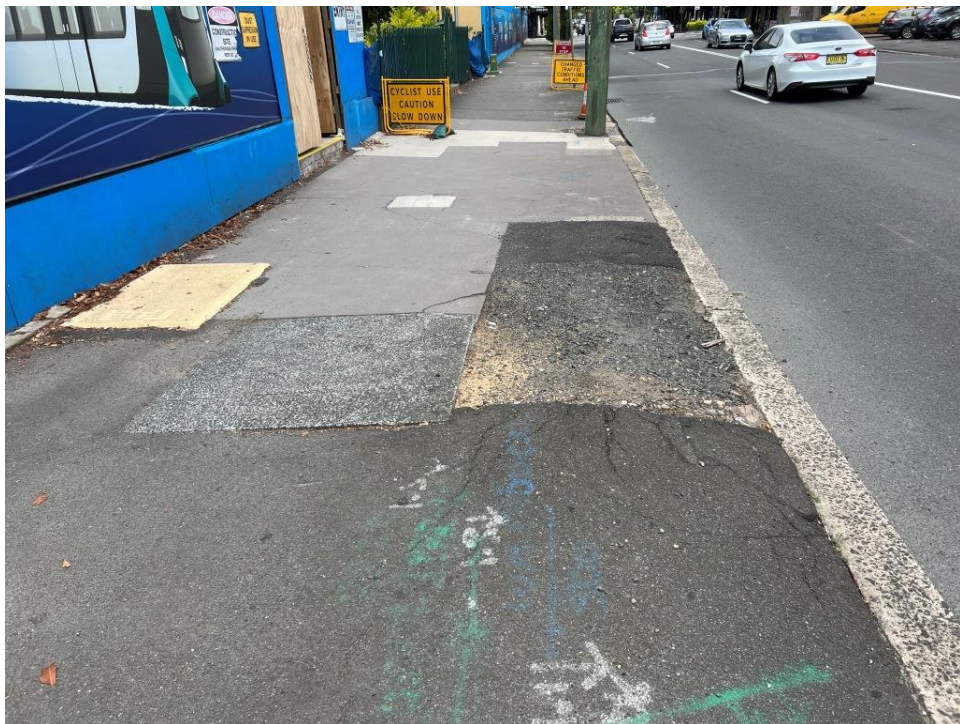
PHOTO 335

(Photo showing cracks in asphalt – Botany Road)

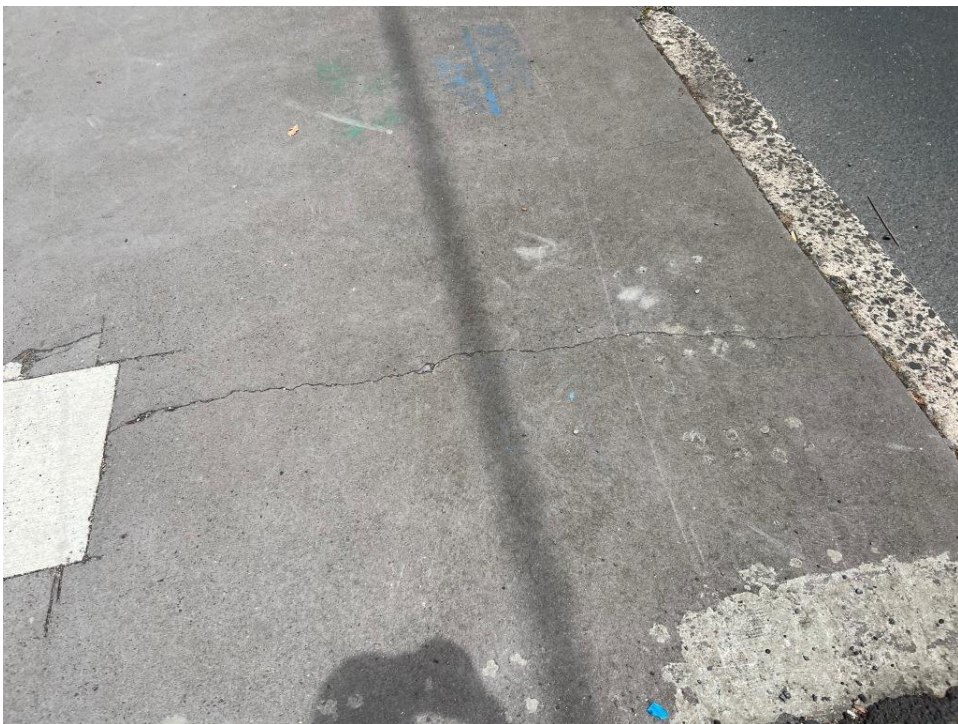
PHOTO 341

(Photo showing cracks in footpath – Botany Road)
