El Australia

Dilapidation Report

E24783 Bluegum Community School

Report Title: E24783 - Dilapidation Report- DR.01 - Council Assets

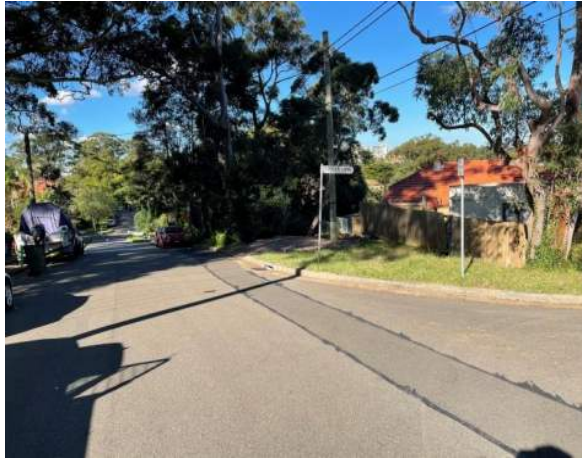
Picture 1

Photo No.	Location	Observational Comment
1	50 William St (Near Lisgar Ln)	Patch repair work conducted along William St.
4	50 William St	Surface cracking along roadway
6	50 William St	Cracks in asphalt outside driveway. Crack in kerb and gutter at entry to driveway
8, 9, 10	55 William St	Patch repair work conducted along William St.
12	55 William St	Minor cracking in asphalt adjacent to stormwater inlet.
17	57 William St	Hairline cracking
22	57 William St	Cracking along roadway
38 -40	59/61 William St	Cracking along roadway (Approx. 1m long)
41 & 42	52 William St	Cracking along roadway (Approx. 1.5m long)
43	52 William St	Cracking in asphalt
52	William St	Minor lipping in pavement slab adjacent to tree. Apparent repair work undertaken.
53, 54	William St	Minor wear and tear to road
55	William St	Repair work undertaken. Minor asphalt deterioration.
57	William St	Minor cracking in asphalt adjacent to kerb and gutter

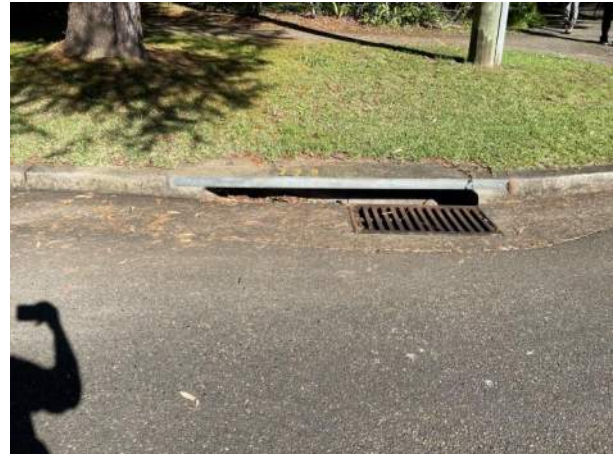
Picture 98

Photo No.	Location	Observational Comment
98	Cnr Rosemead & William St	Minor crack to stormwater inlet
99	Cnr Rosemead & William St	Repair work undertaken.
101, 102	Cnr Rosemead & William St	Visible signs of wear and tear on road.
103	3 Rosemead Rd	Loose rocks above stormwater inlet / gutter
104	3 Rosemead Rd	Hairline cracking (Approx. 1m)
111	3 Rosemead Rd	Hairline cracking in roadway
115	3 Rosemead Rd	Hairline cracking in roadway
124 - 125	4 Rosemead Rd	Moderate crack in driveway slab
128	1A Rosemead Rd	Moderate crack in driveway slab
129 –131, 137 – 140	1A Rosemead Rd	Minor damage to footpath. Lipping evident. Repair work appears to be undertaken
152	Rosemead Rd	Localised repair to road evident.
162	Cnr Rosemead Rd & Dural St	Trench repair work undertaken to road
163, 166, 174	Cnr Rosemead Rd & Dural St	Apparent repair work undertaken to road
176	42 Dural St	Minor concrete spalling on lid
180	42 Dural St	Minor along roadway

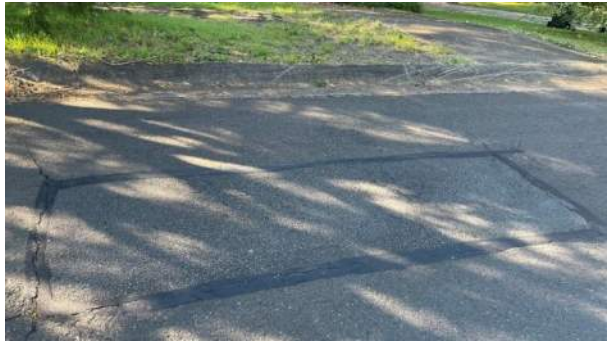
Picture 221

Photo No.	Location	Observational Comment
193 & 194	41 Dural St	Damage to stormwater drain along roadway
202, 205	39 Dural St	Damage in concrete pathway. Lipping of slabs around pit lid
202, 205, 206, 207, 208, 209 & 210	39 Dural St	Damage in brick retaining wall
212 & 213	36 Dural St	Cracking along gutter/driveway
214 & 216, 221	38 Dural St	Cracking along roadway adjacent to repair works
