SITE AUDIT REPORT

REMEDIAL ACTION

PLAN, ASPECT

INDUSTRIAL ESTATE,

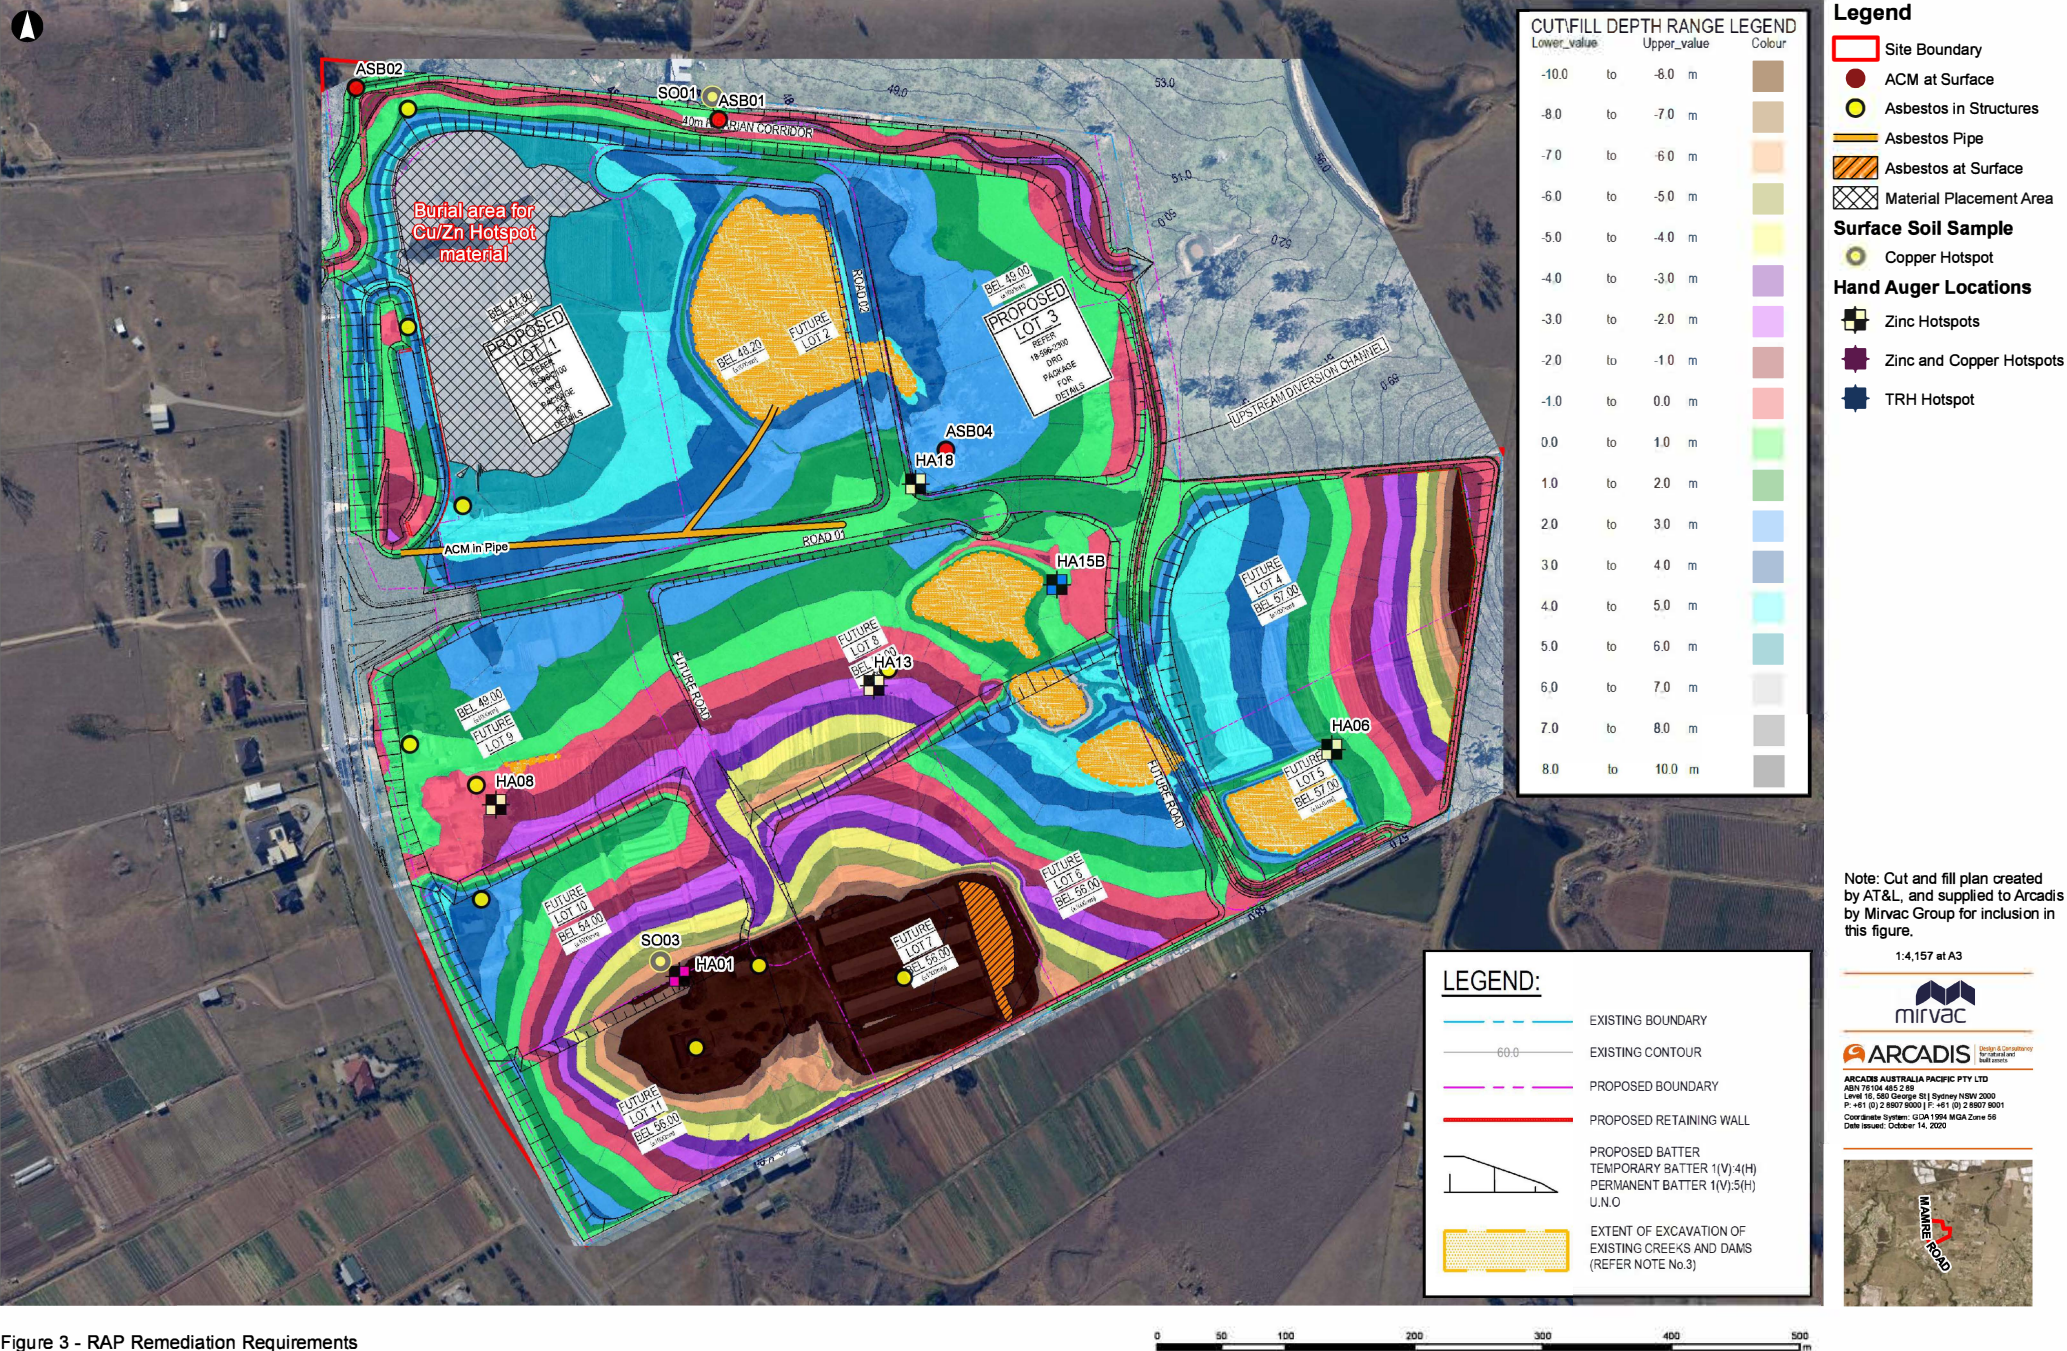
Figure 3 - RAP Remediation Requirements

- Remediation required
 - Localised heavy end petroleum hydrocarbon impact beneath a leaking fuel drum (HA15)
 - Slightly elevated metals (zinc) exceeding ecological criteria at various locations
 - Localised black staining and elevated TRH, copper and zinc concentrations beneath transformer (HA01)
 - Fragments of asbestos containing materials on site surface
 - Asbestos building materials
 - Buried asbestos pipe
- Further Assessment Required
 - Building footprints
 - Dam sediments
- Potential for Unexpected Finds
 - Associated with storage of various materials (such as fuel drums)
 - Associated with the fill across lot 57 – potential aesthetic risk, potential for unidentified ACM
 - Possible waste disposal/burials.

Contaminant	Location	Preferred remediation option
Cu	HA01	Excavate material, blend with stripped topsoil and re-use on site as first fill layer within NW corner of proposed Lot 1, under 8 – 10m of imported fill.
Zn	HA01, HA06, HA08, HA13, HA18, SO01 and SO03	
TRH	HA15	Excavate, collect additional waste classification samples and dispose offsite as hazardous waste or restricted waste.
Asbestos pipe	Lot 56 and 57	Excavate and dispose off site as special waste.
Surface ACM fragments	ASB01, ASB02, ASB04 PACM soil surface around buildings	Environmental Scientist to conduct via Emu bob and licenced asbestos removalist to disposal of ACM offsite.
Hazardous building material –including ACM cladding, lead paint, SMF	Existing buildings/structures – Lots 54-58	Engage HAZMAT specialist to removal HAZMAT from buildings prior to demolition and validate footprints post demolition.
Building footprints – non-hazardous material	Existing buildings/structures – Lots 54-58	Validation soil sampling post demolition, pre cut/fill works.

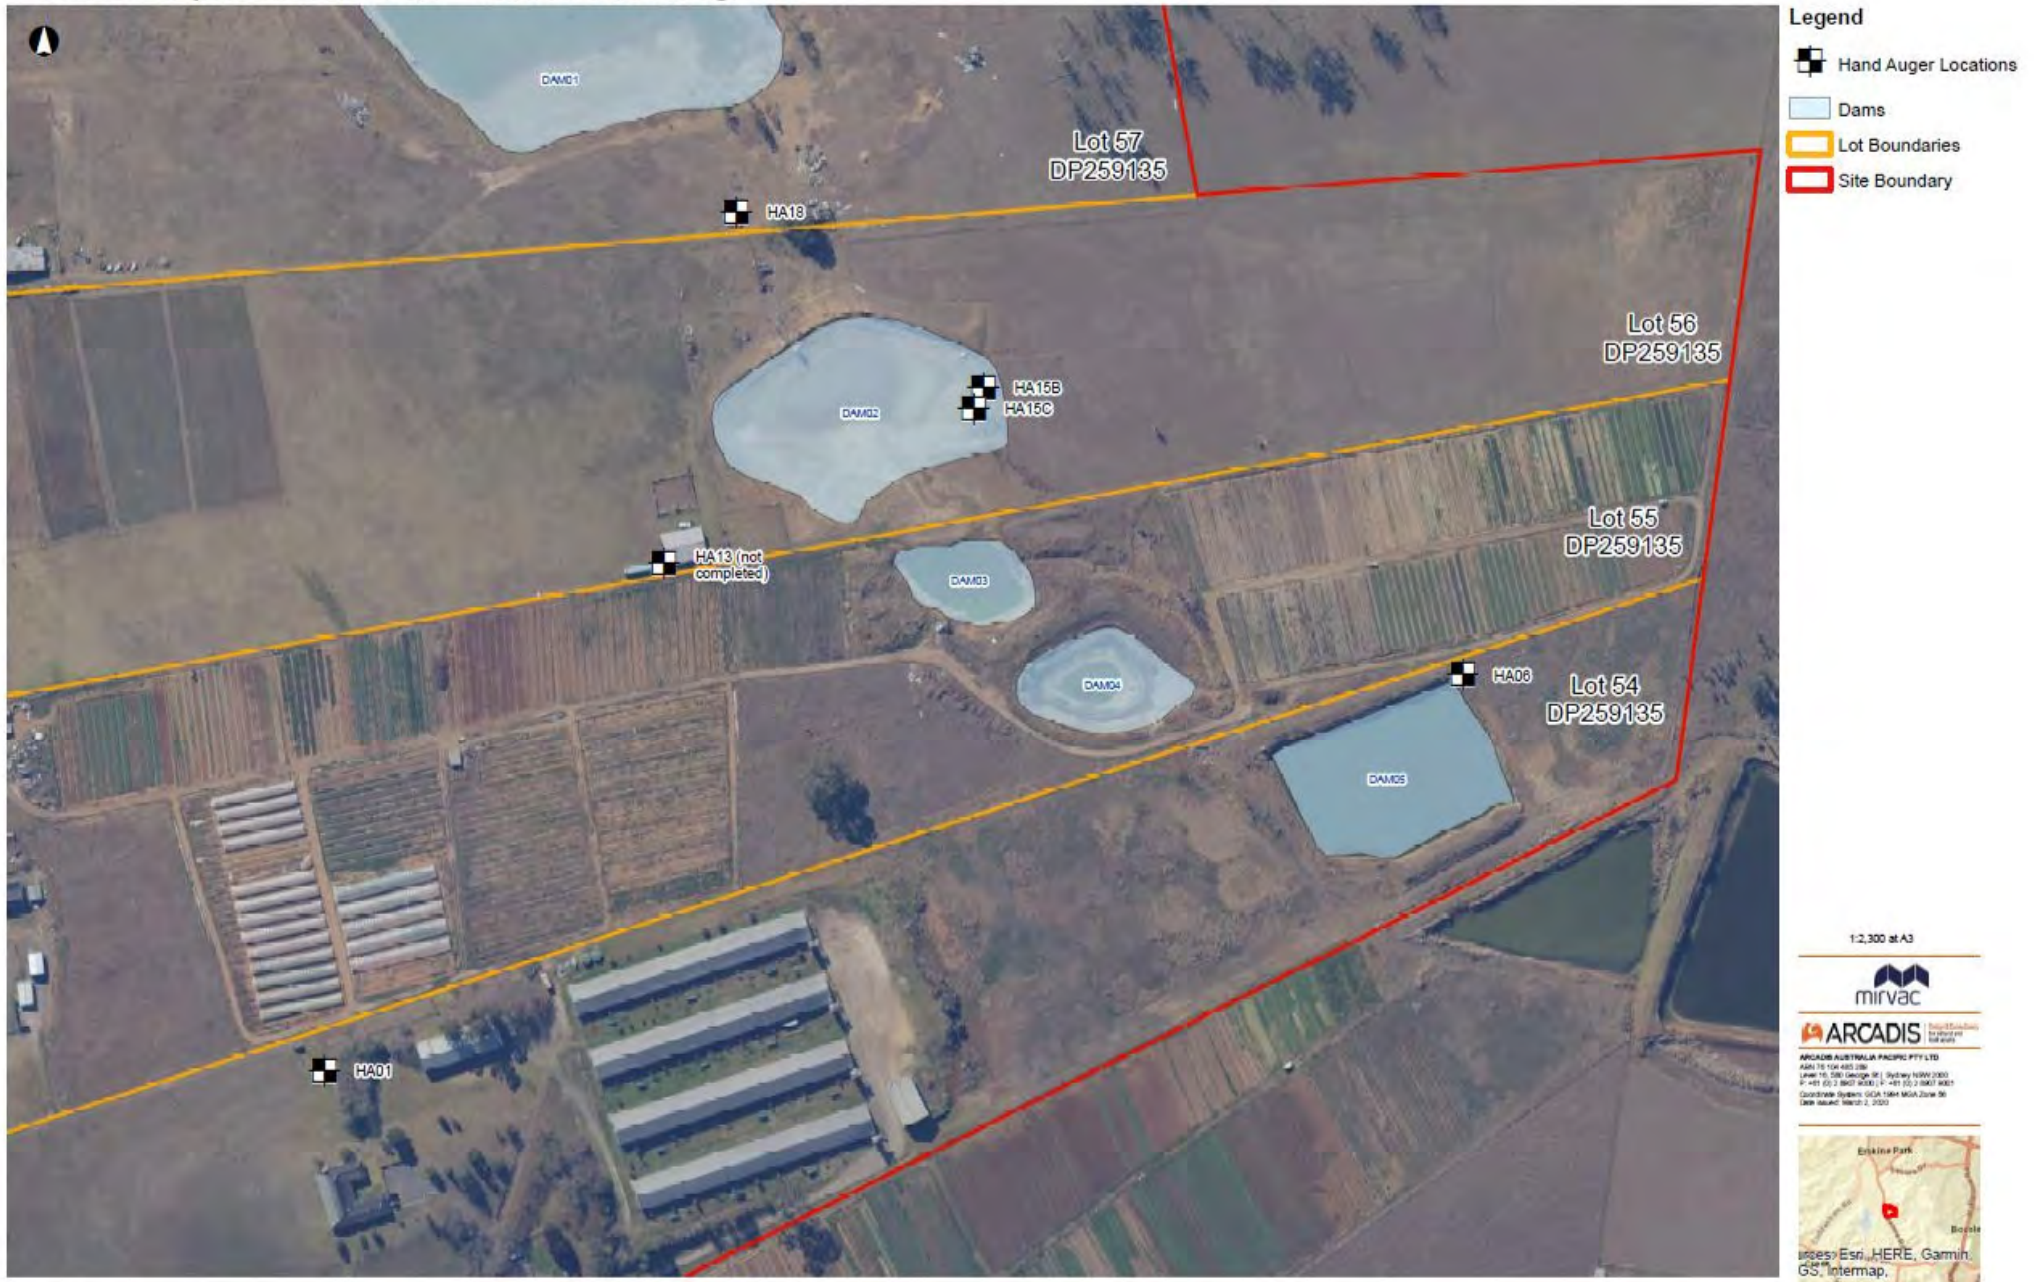
Figure 7 - Hand Auger Locations

Localised odorous and stained soils were observed during site investigations at two locations in the vicinity of a leaking petroleum drum (HA15) and an electrical transformer (HA01). An elevated concentration of TRH F2 of 19,000 mg/kg was reported in soil sample HA15 0-0.1m, which was collected from surface soils underlying the drum. This concentration exceeded the adopted ESL and management limit. The impact is considered to be highly localised to the area of the drum. Slightly elevated concentrations of copper, lead, and zinc (above EILs) and low concentrations of heavy TRH close to the LOR were reported in the sample from the staining near the transformer.

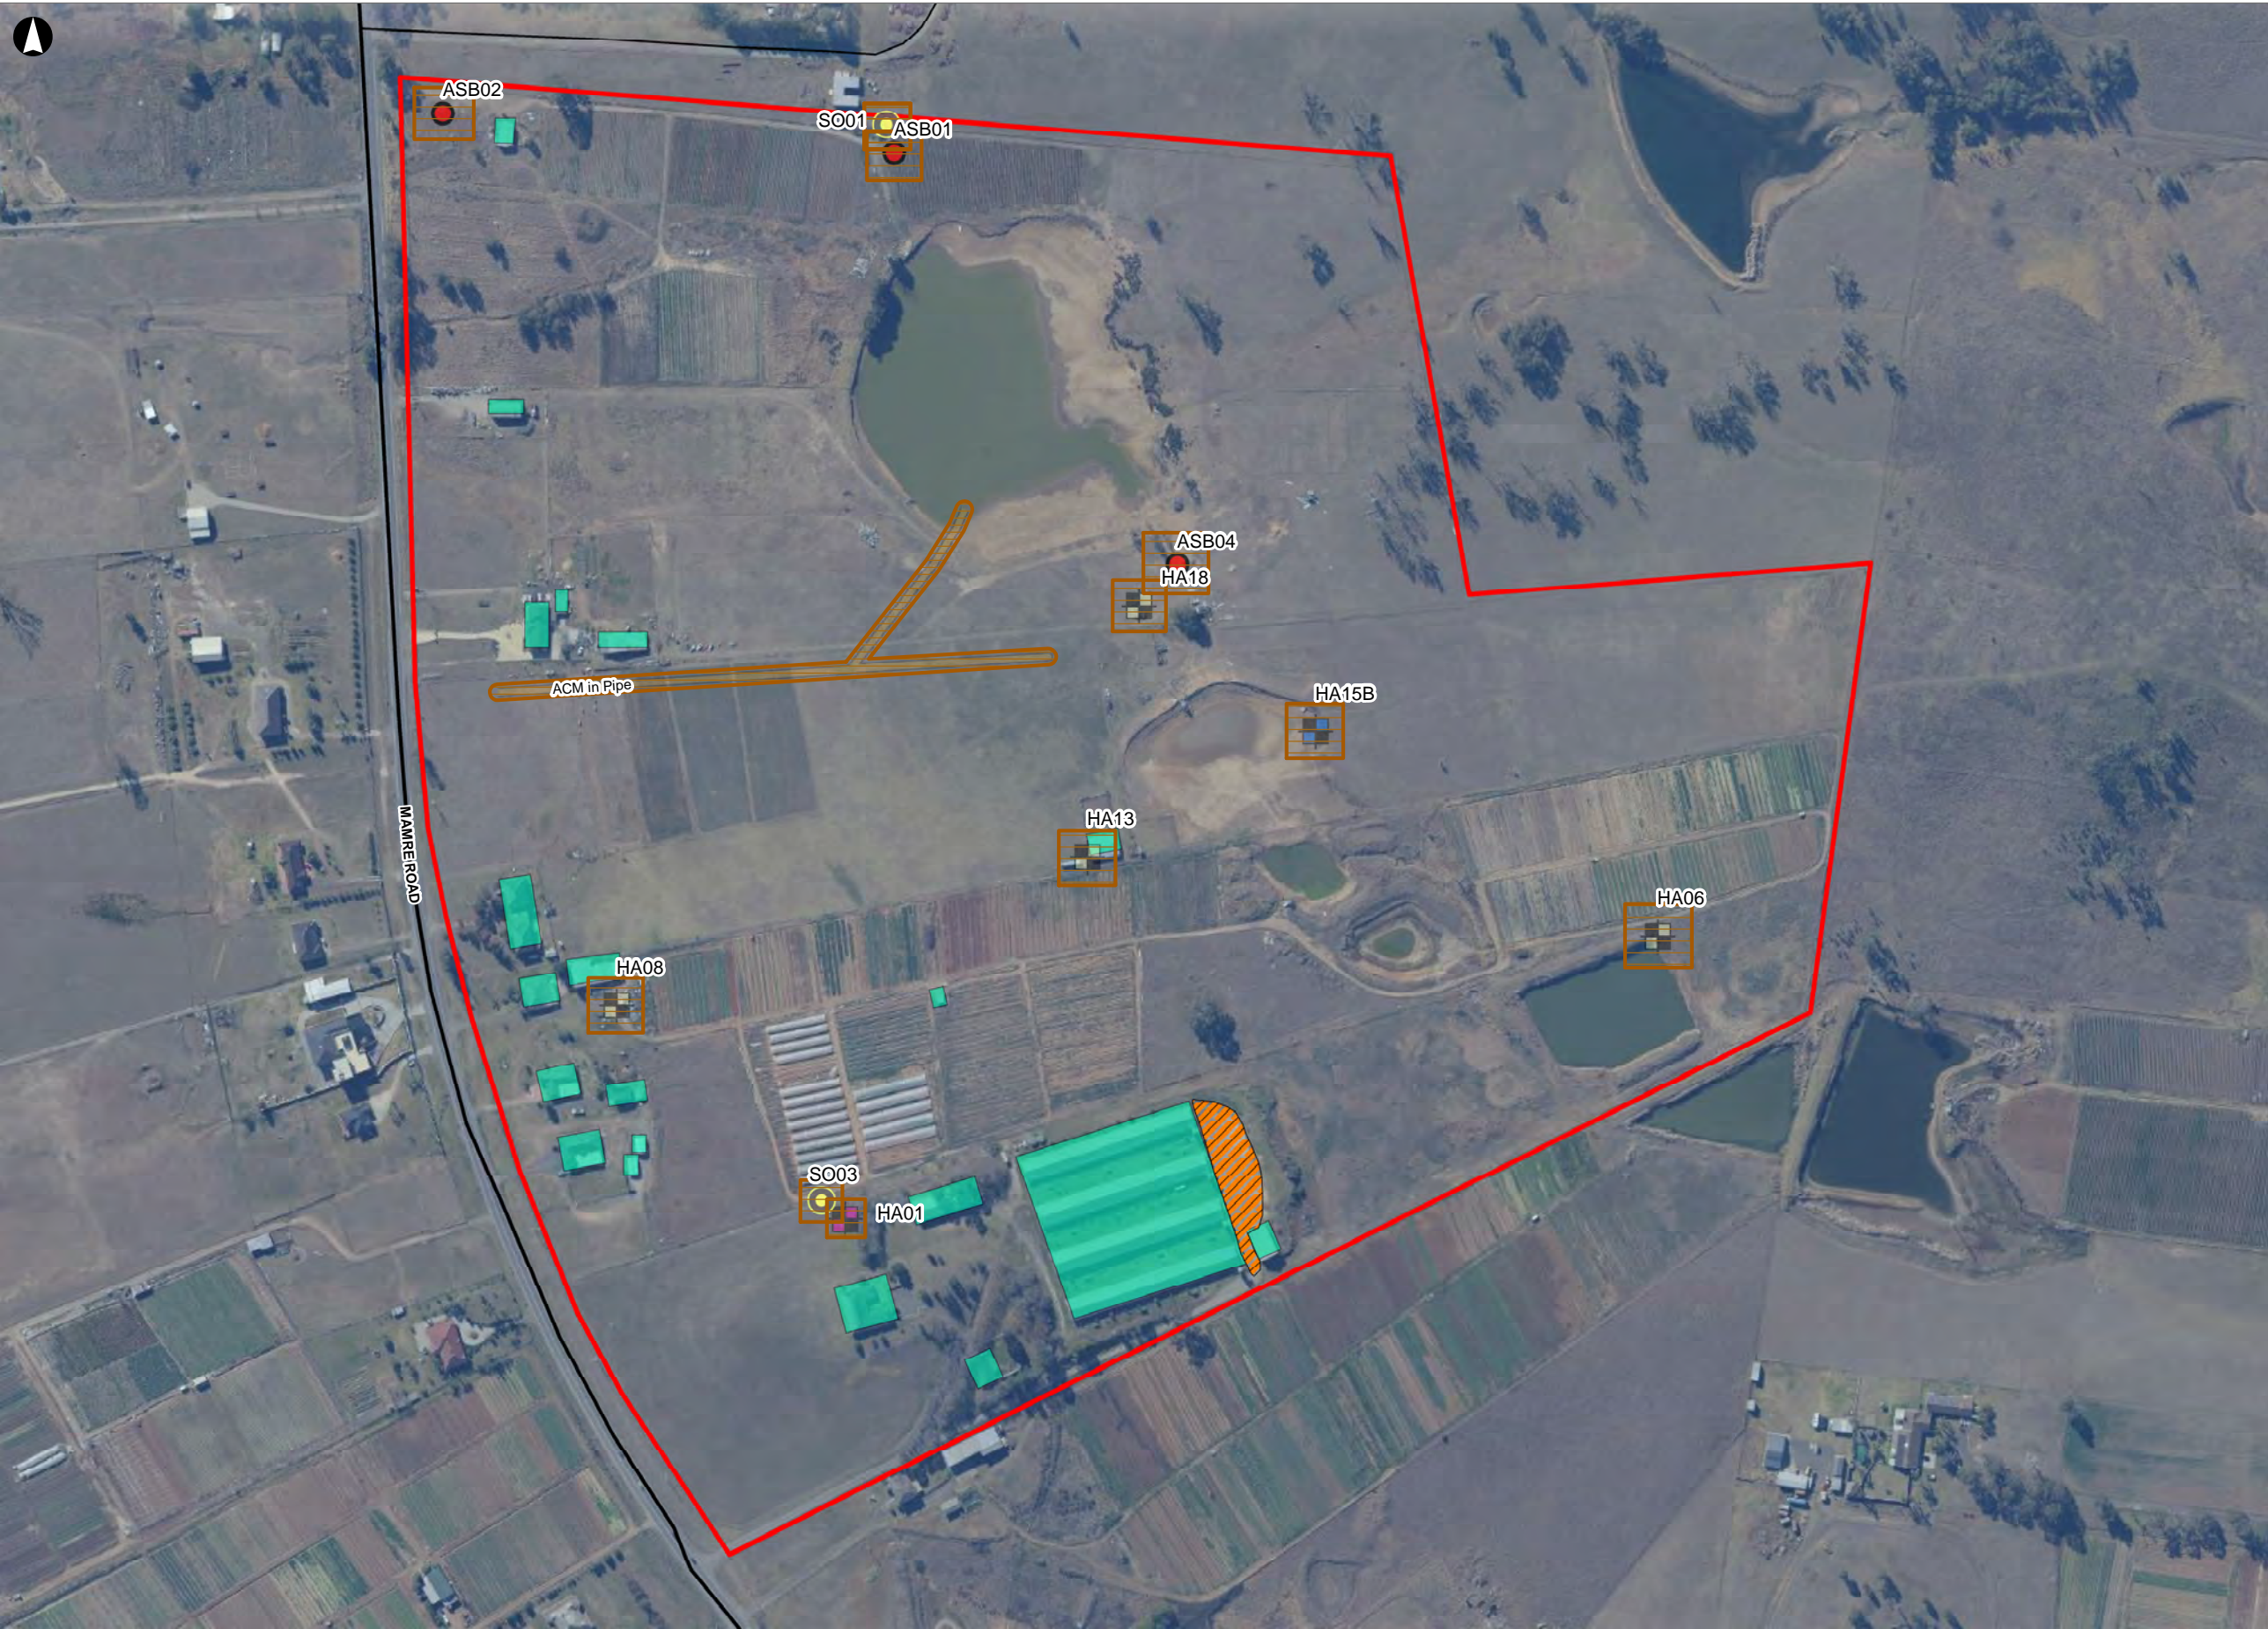
Attachment 10: Proposed Remediation Excavation Locations

The results are consistent with the site history and field observations. An asbestos pipe and minor areas of impact associated with building materials, uncontrolled fill, a leaking drum and transformer have been identified. Remediation is proposed for these areas. Data gaps associated with the building footprints are to be assessed and any further remediation requirements determined. This is considered a reasonable approach.
