Targeted Destructive Hazardous Materials Assessment Report – 115 - 119 Macquarie Street, Sydney NSW **Built**

Targeted Destructive Hazardous Materials Assessment

15 July 2020

S-00622.HMA.002_115-119 Macquarie Street, Sydney NSW

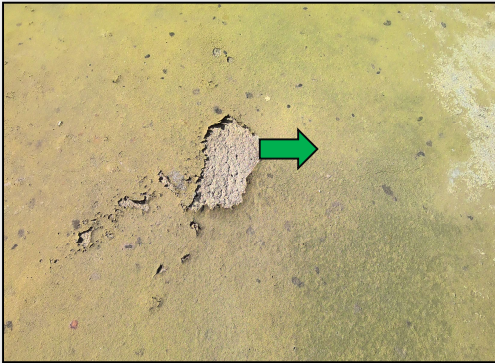
Photo 1: Level 32, internal, upper layer rooftop floor - non-asbestos bituminous membrane.

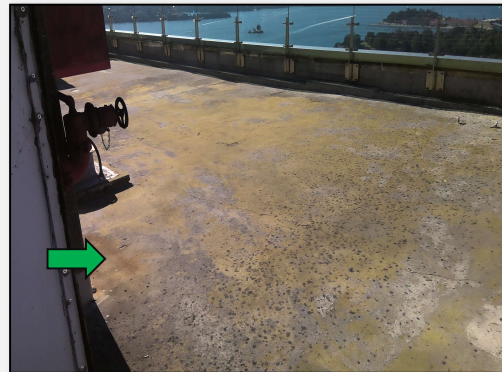
Photo 2: Level 32, internal, lower layer rooftop floor - non-asbestos bituminous membrane.

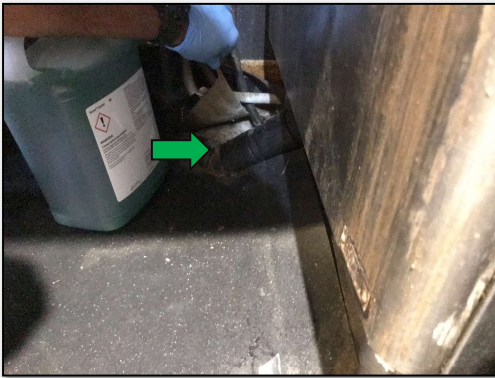
Photo 3: Level 32, internal, back of house flooring under vinyl - non-asbestos compressed cement sheet.

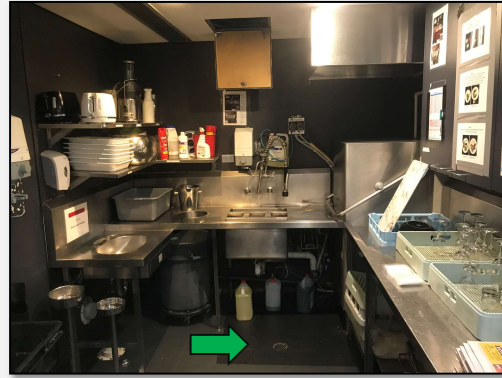
Photo 4: Level 32, internal, back of house flooring - non-asbestos sheet vinyl.

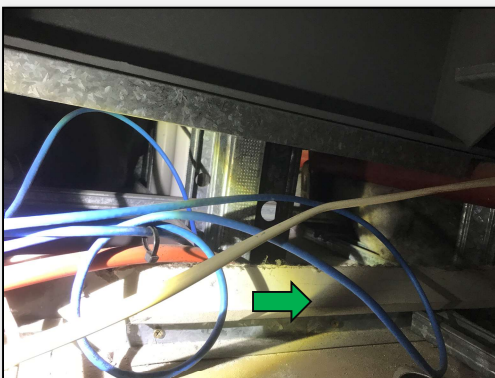
Photo 5: Level 32, internal, ceiling in front of dumb waiter - non-asbestos insulation.

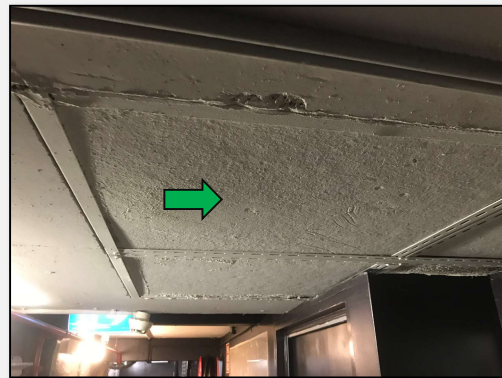
Photo 6: Level 32, internal, bar sitting area under flooring - non-asbestos bituminous membrane.

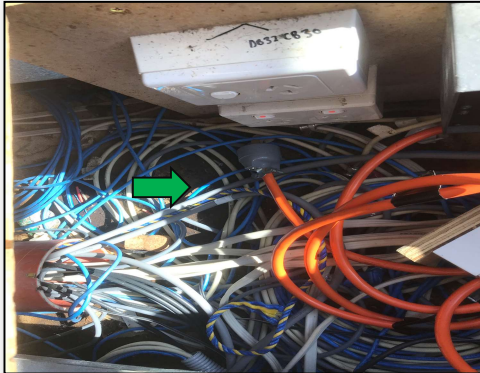
Photo 7: Level 32, internal, bar sitting area under flooring - non-asbestos bituminous membrane.

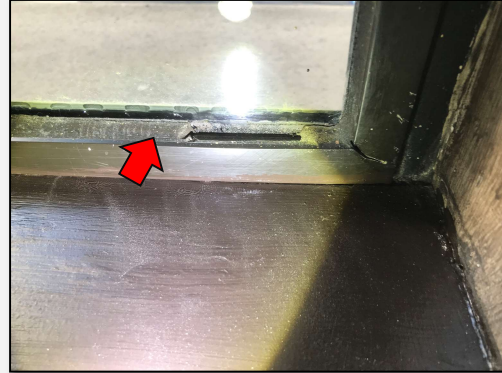
Level 6, internal, around quarter circle windows	mastic sealant	8	Yes	S-00622.002-AS008	Chrysotile	asbestos-containing	Non-Friable	14	m	Good	Unlikely	Low	P3	5 years	Maintain in current condition if to remain in-situ. Remove under controlled non-friable asbestos removal conditions prior to refurbishment or demolition works by a Class A (friable) or Class B (non-friable) licensed asbestos removal contractor.
Level 6, internal, along floor joints between floor tiles, bain marie	mastic sealant	9	Yes	S-00622.002-AS009	No asbestos detected. Organic fibres detected.	non-asbestos	-	-	-	-	-	-	-	-	Nil recommendations.
Level 5, internal, bar flooring	sheet vinyl	10	Yes	S-00622.002-AS010	No asbestos detected. Synthetic Mineral Fibres Detected.	non-asbestos	-	-	-	-	-	-	-	-	Nil recommendations.

Photo 8: Level 6, internal, around quarter circle windows - asbestos-containing mastic sealant.

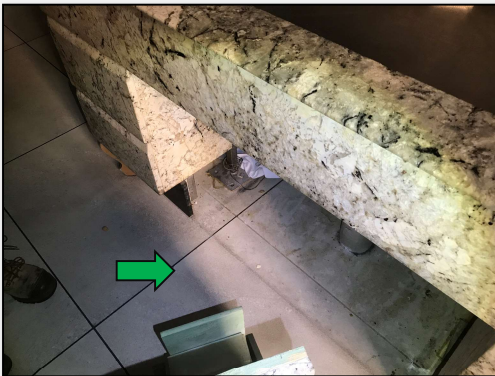
Photo 9: Level 6, internal, along floor joints between floor tiles, Bain Marie - non-asbestos mastic sealant.

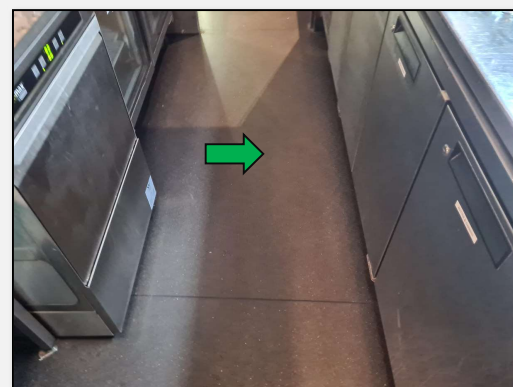
Photo 10: Level 5, internal, bar flooring - non-asbestos sheet vinyl.

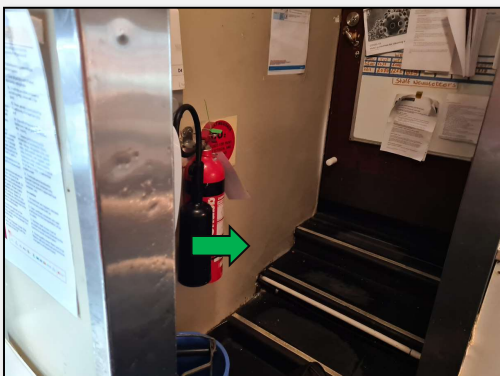
Photo 11: Level 5, internal, kitchenette adjacent bar, wall lining - non-asbestos fibre cement sheet.

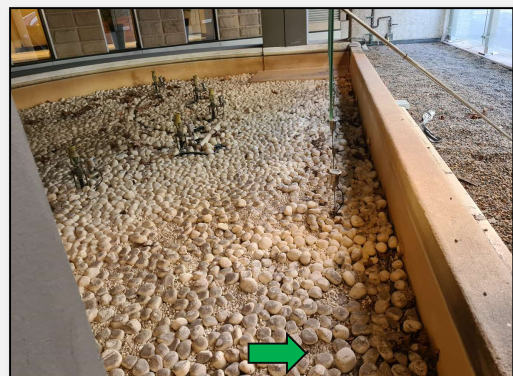
Photo 12: Level 5, external, southern water feature flooring membrane - non-asbestos bituminous membrane.

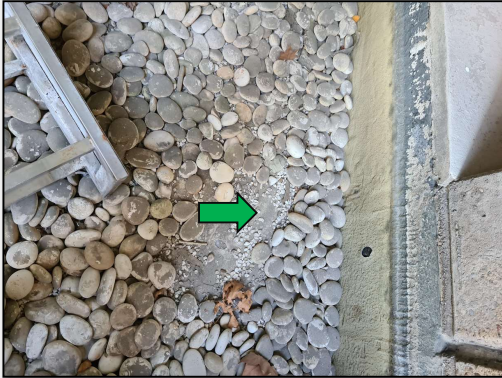
Photo 13: Level 5, external, northern water feature flooring membrane - non-asbestos bituminous membrane.

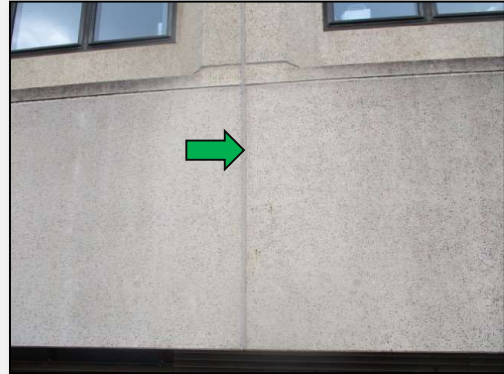
Photo 14: Level 8, external, eastern upper face - non-asbestos mastic sealant.

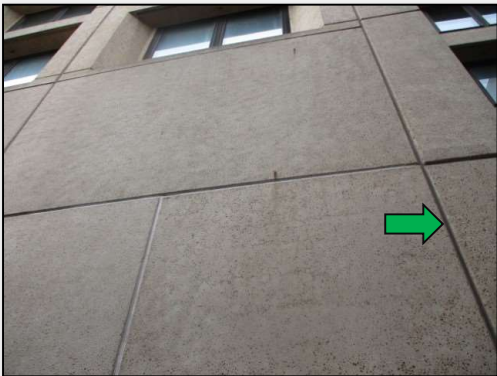
Level 8, external, eastern lower face	mastic sealant	15	Not sampled: previously sampled	S-00622.001-AS002	No asbestos detected	non-asbestos	-	-	-	-	-	-	-	-	Nil recommendations.
Level 8, external, north eastern corner, adjacent plant room	mastic sealant	16	Not sampled: previously sampled	S-00622.001-AS003	No asbestos detected	non-asbestos	-	-	-	-	-	-	-	-	Nil recommendations.
Level 8, external, northern face	mastic sealant	-	Not sampled: previously sampled	S-00622.001-AS004	No asbestos detected	non-asbestos	-	-	-	-	-	-	-	-	Nil recommendations.

Photo 15: Level 8, external, eastern lower face - non-asbestos mastic sealant.

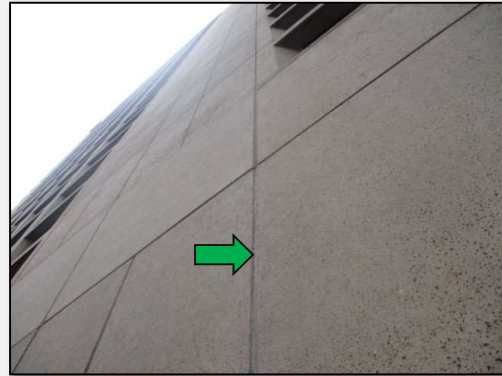
Photo 16: Level 8, external, north eastern corner, adjacent plant room - non-asbestos mastic sealant.

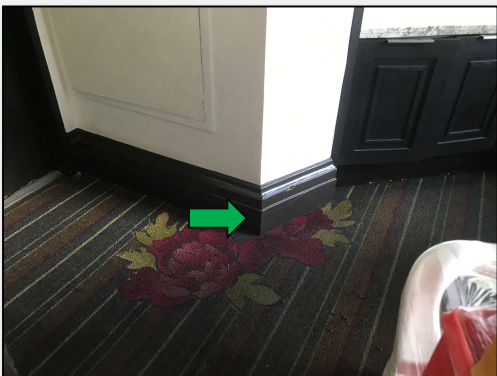
Photo 17: Level 5, internal, throughout dining rooms - Non-lead containing brown coloured paint system.

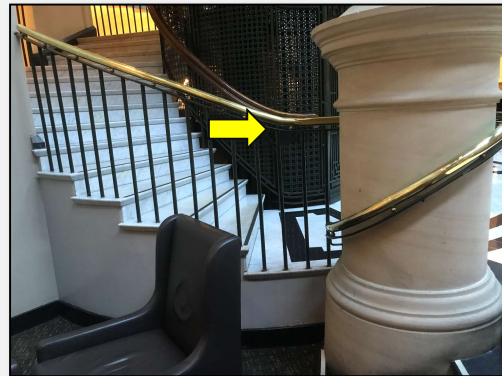
Photo 18: Level 5, internal, balustrade and railings in lobby area - Lead-containing dark green coloured paint system.

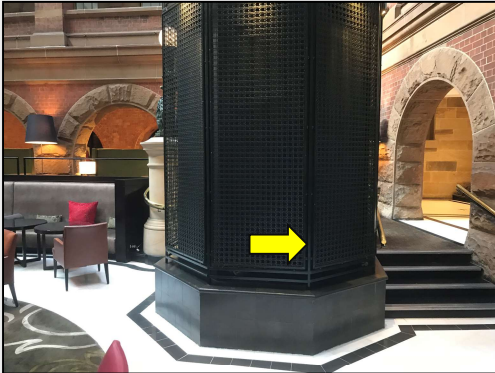
Level 5, internal, metal enclosure in lobby area, green coloured paint system	19	Yes	Paint	S-00622.002-LS003	0.13%	% w/w	Lead-containing	6	m sq	Good	Unlikely	Low	P3	Maintain in current condition, over paint with a lead-free paint as part of ongoing maintenance. If removal works are required then remove under controlled conditions in accordance with AS/NZS 4361.2:2017 Guide to hazardous paint management, Part 2: Lead paint in residential, public and commercial buildings prior to renovation or demolition works.
Level 5, internal, Pillars - throughout in lobby area, beige coloured paint system	20	Yes	Paint	S-00622.002-LS004	<0.005	% w/w	Non-lead containing	-	-	-	-	-	-	Not lead-containing paint ($\leq 0.1\%$ w/w) as described in AS/NZS 4361.2:2017 Guide to hazardous paint management, Part 2: Lead paint in residential, public and commercial buildings.
Level 5, internal, office walls, cream coloured paint system	21	Yes	Paint	S-00622.002-LS005	<0.005	% w/w	Non-lead containing	-	-	-	-	-	-	Not lead-containing paint ($\leq 0.1\%$ w/w) as described in AS/NZS 4361.2:2017 Guide to hazardous paint management, Part 2: Lead paint in residential, public and commercial buildings.

Photo 19: Level 5, internal, metal enclosure in lobby area - Lead-containing dark green coloured paint system.

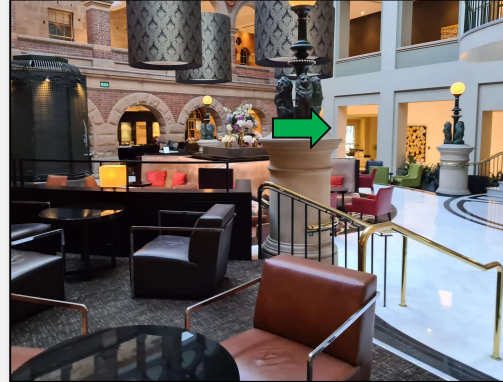
Photo 20: Level 5, internal, Pillars - throughout in lobby area - Non-lead containing beige coloured paint system.

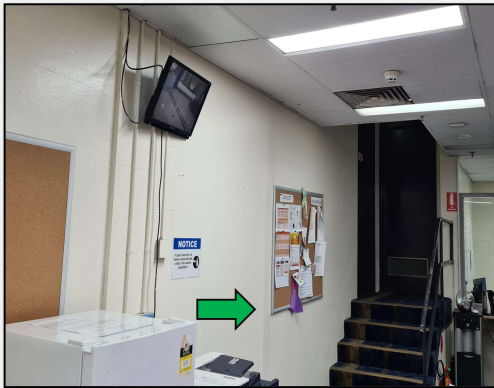
Photo 21: Level 5, internal, office walls - Non-lead containing cream coloured paint system.

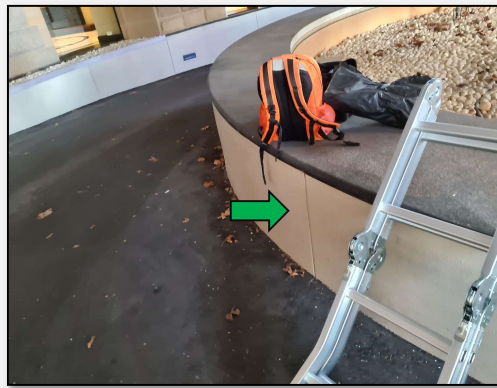
Level 5, external, outer wall of water feature, beige coloured paint system	22	Yes	Paint	S-00622.002-LS006	<0.005	% w/w	Non-lead containing	-	-	-	-	-	-	Not lead-containing paint ($\leq 0.1\%$ w/w) as described in AS/NZS 4361.2:2017 Guide to hazardous paint management, Part 2: Lead paint in residential, public and commercial buildings.

Photo 22: Level 5, external, outer wall of water feature - Non-lead containing beige coloured paint system.
