SCHEDULE OF CONSERVATION AND RESTORATION WORKS

Former Treasury Buildings

MULHPA HOTEL (SYDNEY) PTY LIMITED

25 August 2020

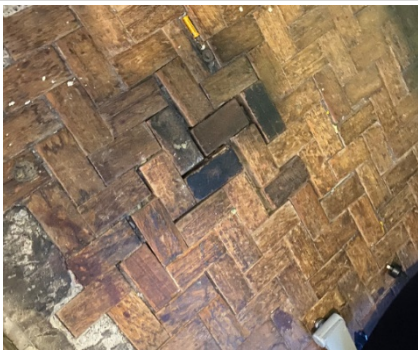
conservation notes below (7.1.2 and 7.1.3) if required.	
Specific Conservation Elements/Actions		
CE2.	<p>Original parquetry in S2.21 and the remnant sections in space S2.19 and S3.17 is to be retained exposed and conserved in accordance with the conservation notes below.</p> <p>Incorporation of the parquetry with any future interior design fitout is to be undertaken in accordance with the guidelines set out at Section 9.</p> <p>Existing parquetry elements in S2.21 are loose. Some pieces have been lost and require replacement in accordance with the below. Loose remnants are required to be refixed as a priority to ensure no further loss of the element.</p>

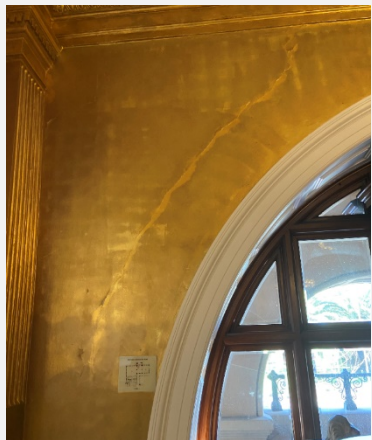
Conservation Element/Action Number	Description	Thumbnail Image
CE5.	All walls to be assessed to identify redundant surface mounted services or ducted skirtings. Redundant elements to be removed and remnant penetrations to be patched in accordance with conservation notes below.	N/A
CE6.	Structural engineer to check over walls (also in accordance with routine maintenance and inspection) to determine structural adequacy. Crack over western door in S2.17 is noted and should be investigated.

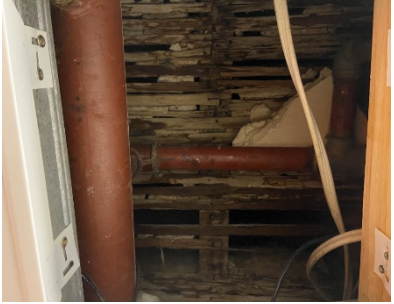
CE8.	<p>Original remnant lath and plaster ceiling in S1.2 is almost entirely obscured by later dropped ceiling. Based on a limited visual inspection it is clear almost all plaster has come away including keys. There is to be no further unnecessary removal of original fabric including no new penetrations. If the later dropped ceiling is at any stage removed or refreshed this is to be treated as an opportunity to assess the condition of the lath and plaster and determine if any stabilisation works are required.</p> <p>All other instances where lath and plaster is remnant above later dropped ceilings are to be treated as above.</p>

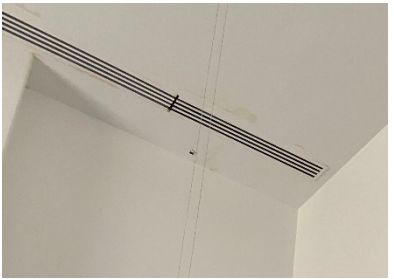
CE9.	<p>Inspect source of water stain to south west corner of S3.1. Engineer to investigate source of water stain. Report source to HC and rectify in accordance with agreed methodology. Prepare and repaint ceiling.</p>

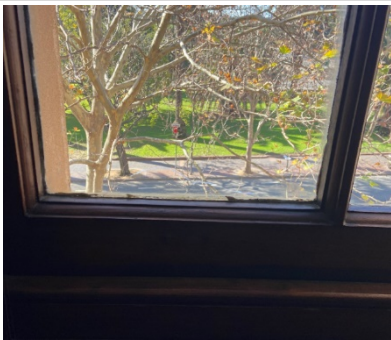
CE22.	W91 – Replace broken glazing. Any other areas of broken glazing are to be repaired in accordance with conservation notes below.

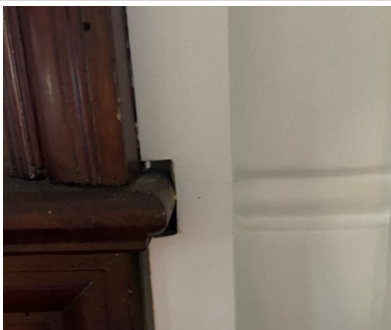
CE23.	W96 – Improve junction with services ducting which is crudely scribed around sill.

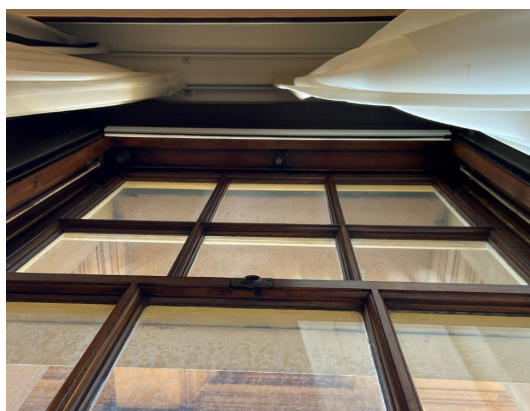
Figure 5 Existing hardware to centre of top sash to be retained.

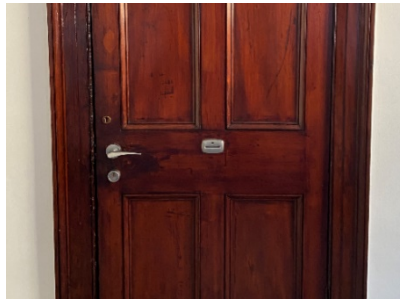
CE27.	<p>From a heritage perspective it would be ideal to replace all later and missing door hardware and later lever handles in the Original Treasury Building with new to be specified by HC and based on evidence. This will need to be negotiated with BCA consultant.</p>

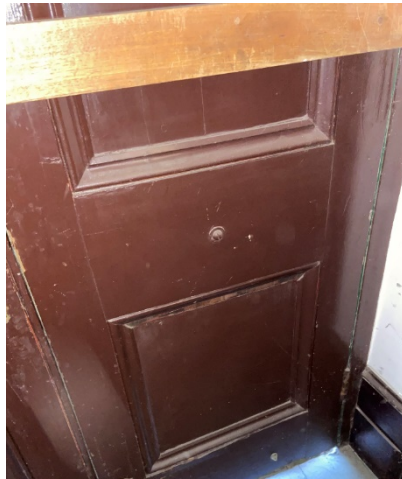
Specific Conservation Elements/Actions		
CE28.	<p>D17 – Double timber doors to Macquarie Street (main doors to Original Treasury Building) are generally in good condition. As doors of exceptional significance, the inside face should be prepared and repainted to improve presentation.</p> <p>Movement is restricted by a timber length fixed into frame. Develop methodology for sympathetic locking device in consultation with HC.</p>

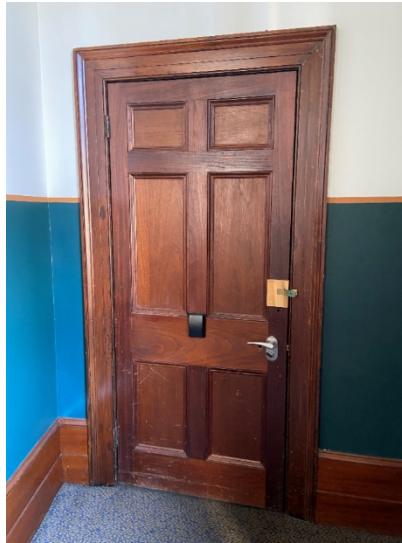
CE29.	<p>D19 – Remove intrusive plant on lock and patch penetrations. If locking mechanism is required specify new in consultation with HC.</p>

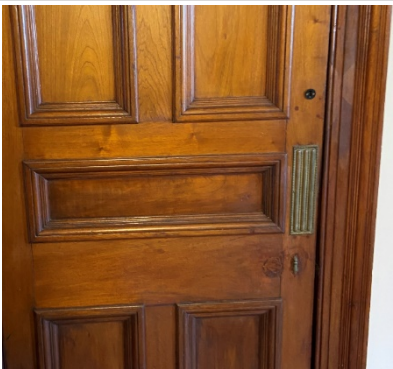
CE33.	D78 – Replace missing door knob. Specify hardware in consultation with HC.

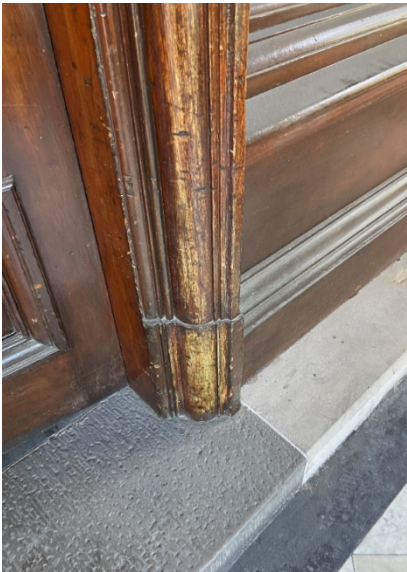
CE34.	D65 – Double timber doors to Macquarie Street (main doors to Link Building) are generally in good condition on inside face. Joinery surrounding external face likely to require refinishing. Refer to Schedule of conservation works for external areas provide by Apex under separate cover.

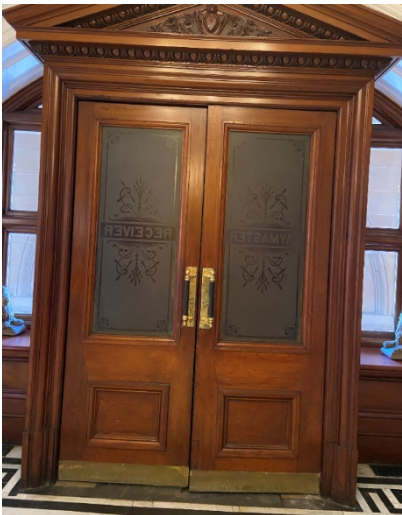
CE35.	D66 – Original doors of high significance. Specifically requires investigation and potentially adjudgment to hinges to ensure doors are hanging evenly.

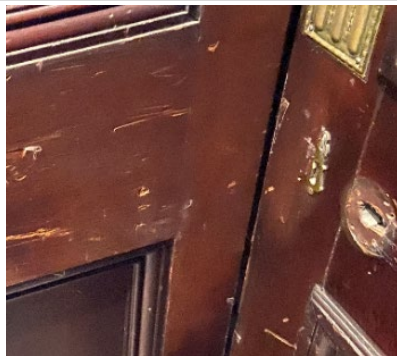
CE38.	D81 – Replace missing hardware to match adjacent. Specify hardware in consultation with HC.

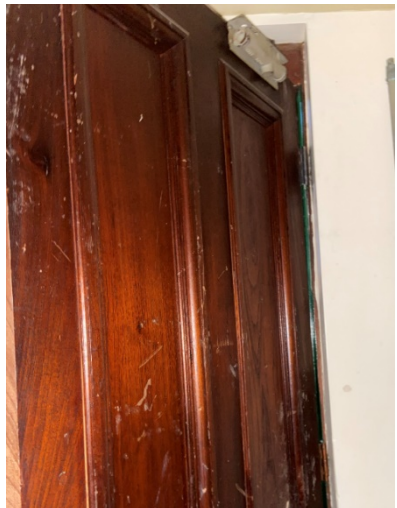
CE39.	D86 – Lightly sand back inside (east) facade and refinish TME.

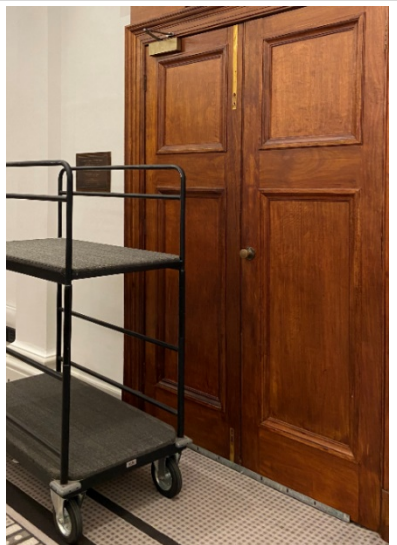
CE40.	D126 and D 127 – Remove later plant on to bottom of door leafs. If replacement is required for operational purposes sympathetic replacement to be specified in consultation with HC.

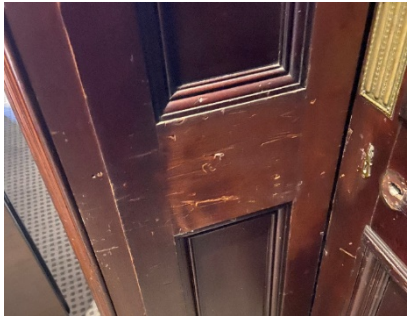
Conservation Element/Action Number	Description	Thumbnail Image
General Conservation Element/Actions		
CE41.	All joinery is to be cleaned in accordance with methodology below.	N/A
Specific Conservation Elements/Actions		
CE42.	Damage to timber reveals between door opening (x3) between S3.13 and S.14. Reveals to be stripped back to timber (refer guidelines in conservation notes below). Timber to be lightly sanded, prepared and polished to match existing. Product and sample to be provided to HC for approval prior to application.

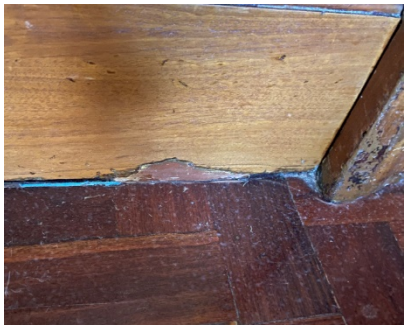
CE43.	Part original timber skirtings in S3.5 to be checked over and new skirtings spliced in where necessary in accordance with conservation notes below.	N/A
CE44.	Poorly patched timber skirting to west wall in S3.14 (Former Premier's Room). Replace with new patch in accordance with the below. Any other poor patches in this room to be replaced.

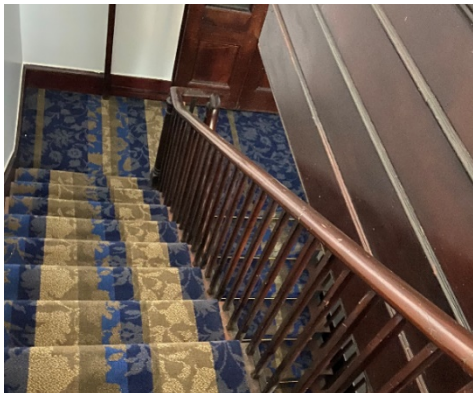
Conservation Element/Action Number	Description	Thumbnail Image
CE45.	<p>S3.34 and S2.5 – Imperial staircase to be conserved and French polished in accordance with conservation notes below.</p> <p>Existing carpet may be retained and protected during works however preference to remove carpet and install runner.</p>

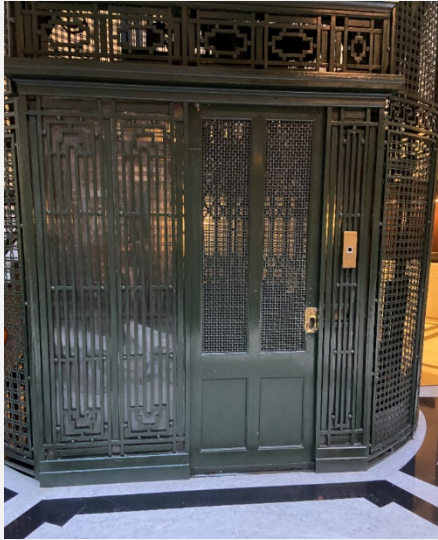
Conservation Element/Action Number	Description	Thumbnail Image
CE46.	Regularly maintain lift in accordance with regular plan of maintenance and under the guidance of the Director of Engineering.

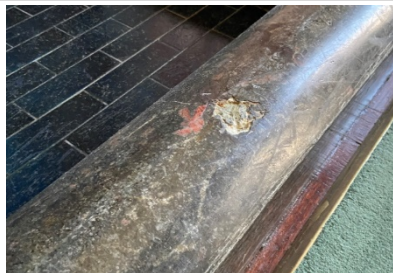
Conservation Element/Action Number	Description	Thumbnail Image
General Conservation Element/Actions		
CE48.	All fireplaces including surrounds, hearths and inserts to be cleaned in accordance with existing program of maintenance works.	N/A
Specific Conservation Elements/Actions		
CE49.	<p>Fireplace to premier's room (3.14).</p> <p>Generally clean over.</p> <p>Patch repair marble bunding. Synthetic marble by specialist contractor.</p> <p>Investigate replacement of damaged tiles. Tiles are to be replaced to match existing exactly otherwise epoxy patch. Samples are to be provided to HC for approval prior to determining methodology.</p>

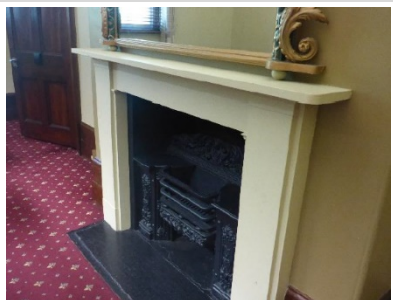
CE50.	Potential to replace fireplace 12 surround in Former Treasurer's Room (S3.1) in accordance with reconstruction methodology at Section 8).

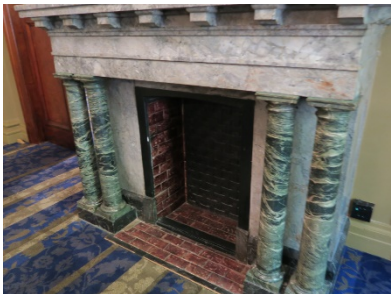
cool room fitout in S1.1. If present notify HC and develop methodology for conservation based on condition.	
CE52.	Remove intrusive paint from exposed sandstone mantle (fireplace 3) in S1.14 and (fireplaces 4 and 5) in S1.15. Painted removal to be undertaken in accordance with conservation notes below.	N/A
CE53.	Replace missing fireplace insert to fireplace 15 in S3.20. Insert to be specified by HC.

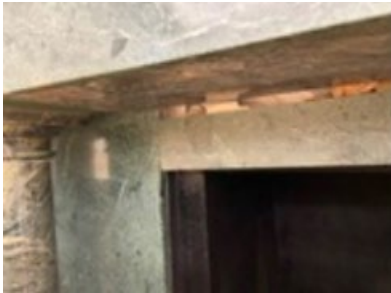
CE54.	Replace missing fireplace insert to fireplace 16 in S3.21. Insert to be specified in consultation with HC. Marble repair required to panel above void. Specialist to refix existing panel.

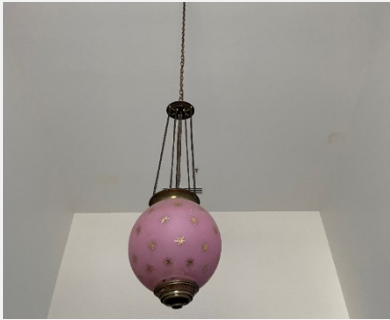
Conservation Element/Action Number	Description	Thumbnail Image
CE55.	S3.4 – Original light fitting of exceptional significance to be retained. Carefully clean and ascertain any further repair requirements (to be reported to HC).

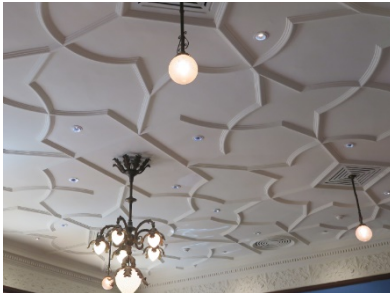
CE56.	S3.14 – Original light fittings of high significance to be retained. Carefully clean and ascertain any further repair requirements (to be reported to HC).

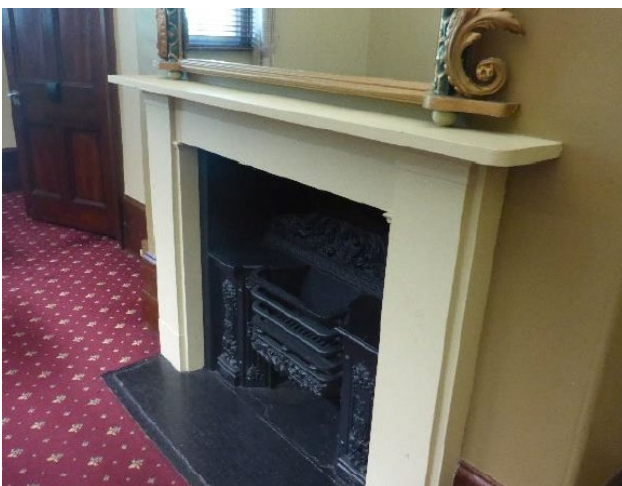
The existing fireplace is a later reproduction Victorian fireplace with later cast iron insert, painted timber surround, timber mantle. The original stone hearth remains however appears to have original been tiled. Retain and protect the original stone hearth and bunding. Surround may be retained or replaced surround to be sourced which matches that in the image below. HC to specify appropriate insert and style of tiles to be applied to hearth.

Figure 8 Fireplace 12 (note fireplace has been painted since this photo was taken).
