Report on
Geotechnical Investigation

Upper Australia Habitat, Taronga Zoological Park
Bradleys Head Road, Mosman

Prepared for
Taronga Conservation Society Australia

Project 86625.00
December 2018

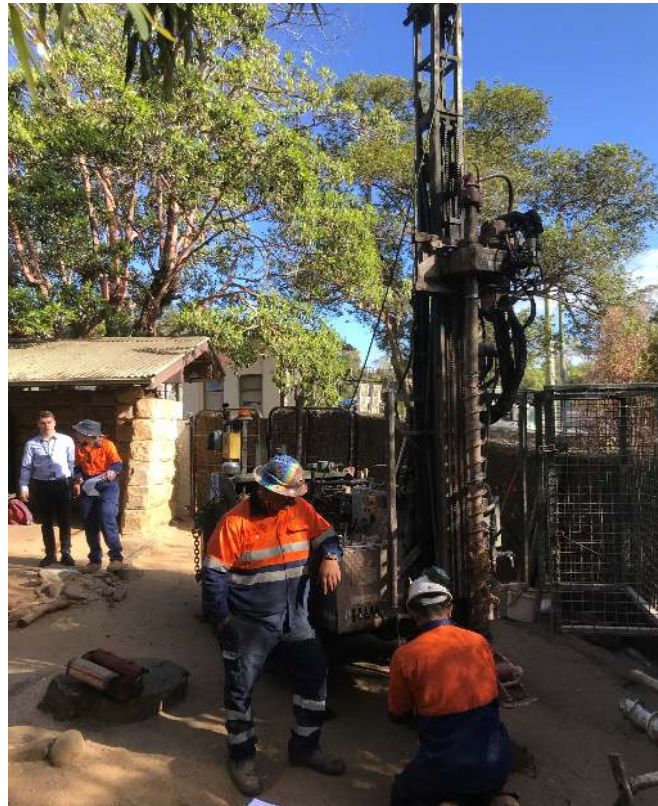
Boreholes UA1 to UA6 were drilled in accessible areas such as pedestrian pathways using a bobcat-mounted drilling rig (refer Photo 1, Appendix D). Boreholes located within paved areas were commenced by drilling a 150 mm diameter concrete core hole (diatube) through the pavers. These borehole locations and those located within the asphalt pathway were then drilled into the underlying soils using solid flight augers and terminated on practical auger refusal. Standard penetration tests (SPT's) were undertaken within the overburden filling and soil within Borehole UA1 only and discontinued within the remaining bobcat drilled boreholes at the request of the zoo keepers due to the noise impacting on the animals during SPT testing.

Photo 1: Drilling of borehole UA1

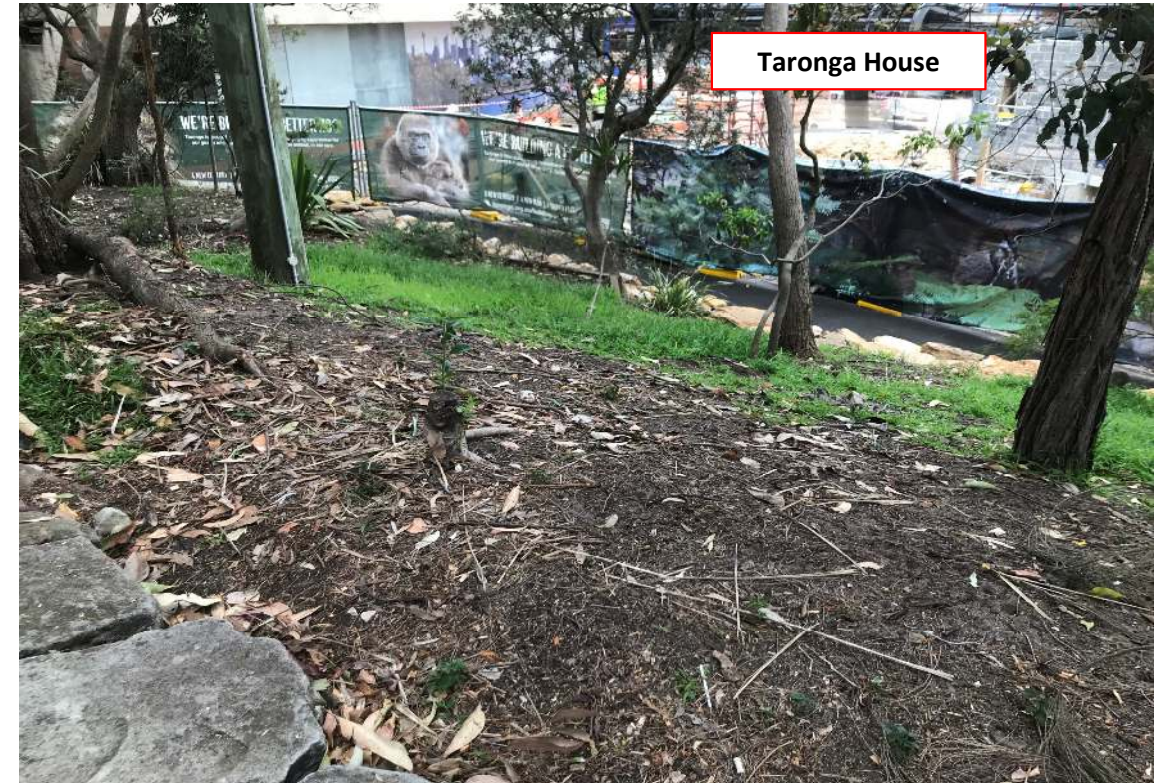
- Rock outcrop was not observed within the area of the proposed Upper Australia Habitat redevelopment, however, sandstone outcrop is exposed throughout other parts of the zoo including to the west of the subject site (within the bird aviary) and to the south where Taronga House was undergoing some construction work (refer Photo 2, Appendix D);

Photo 2: Excavation of sandstone in the Taronga House development

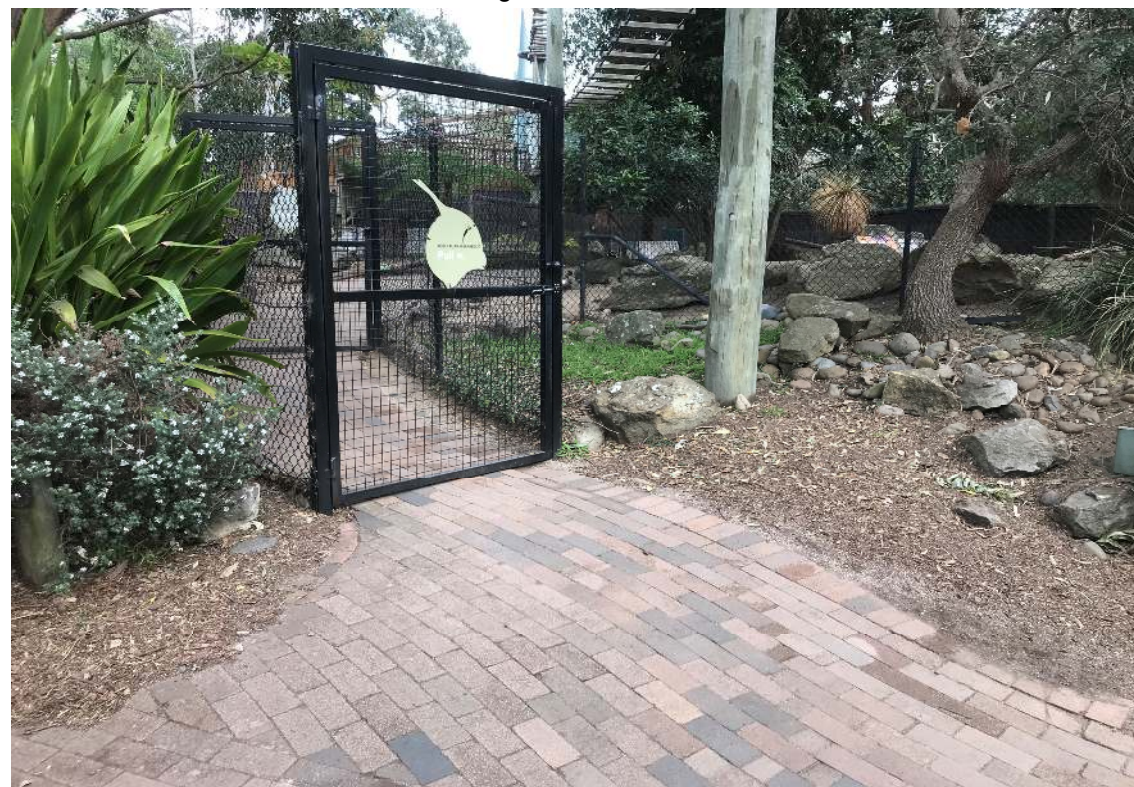
- Sandstone floaters are located in many areas of the site, however, they are unlikely to be in their original position but placed by machine within the landscaped gardens (Photo 3, Appendix D) and enclosures;

Photo 3: Sandstone floaters within the gardens of the Marsupial enclosure

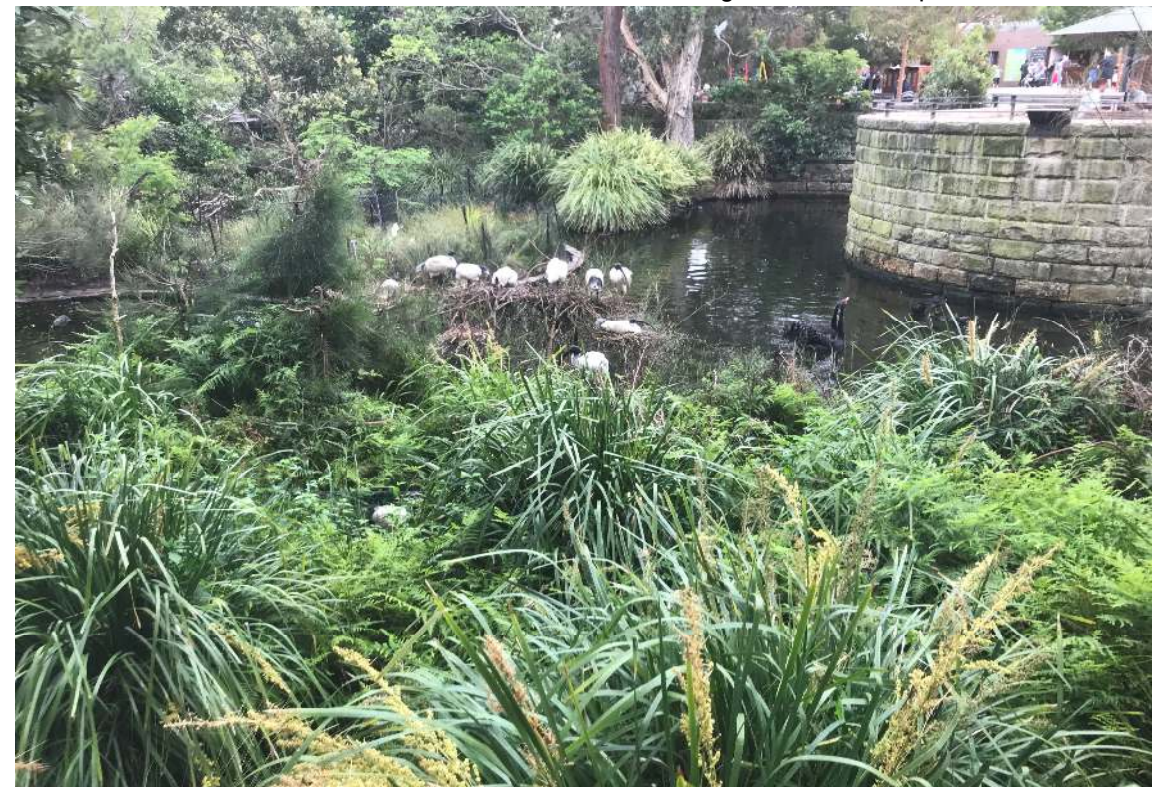
- A curved, sandstone block retaining wall approximately 2.5 m high and 40 m long is located between the zoo plaza and the 'Wetland' exhibit (refer Photo 4, Appendix D). The wall appears to be in good condition;

Photo 4: Retaining wall between the wetlands and the Plaza

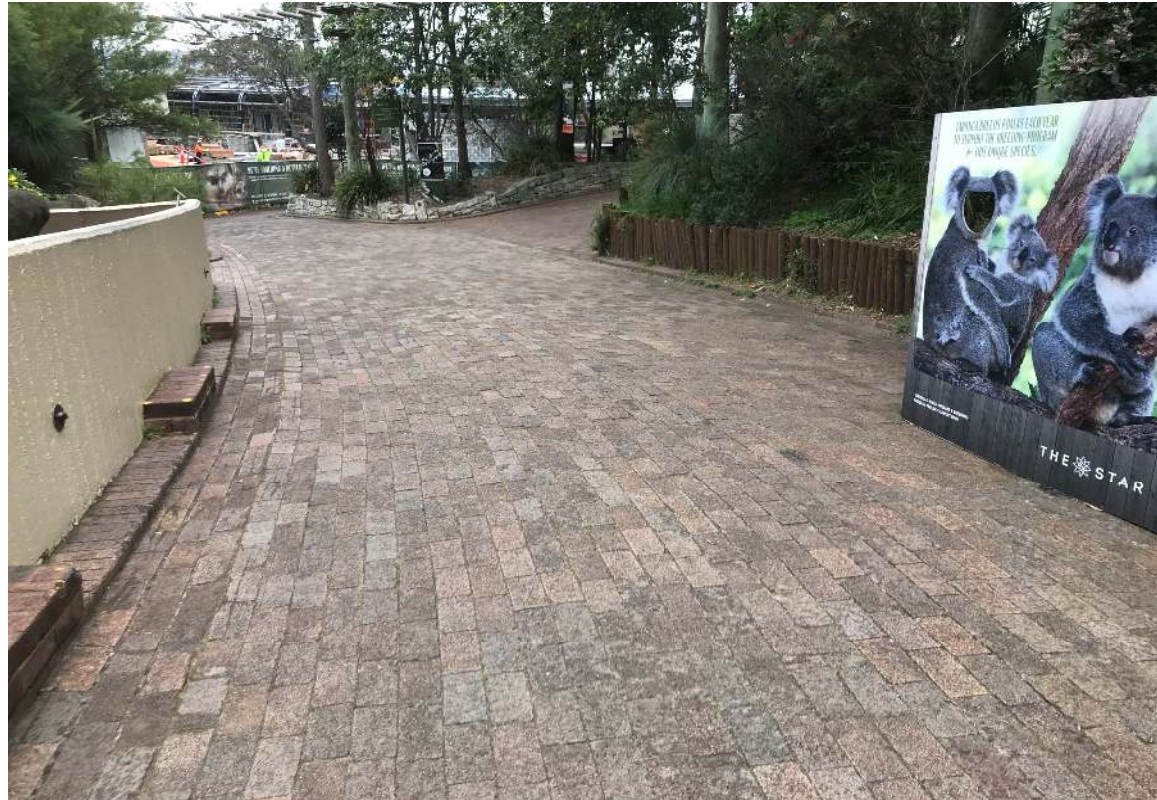
- Existing structures located within the subject area include the Nocturnal House (underground), the Platypus House (above ground), the High Ropes Course, paved pathways (refer Photo 5, Appendix D) and asphalt pathways (refer Photo 6, Appendix D), animal enclosures, ponds, boardwalks and small retaining walls. All of these structures appeared to be in a relatively good condition;

Photo 5: Paved pathway near the Koala exhibit

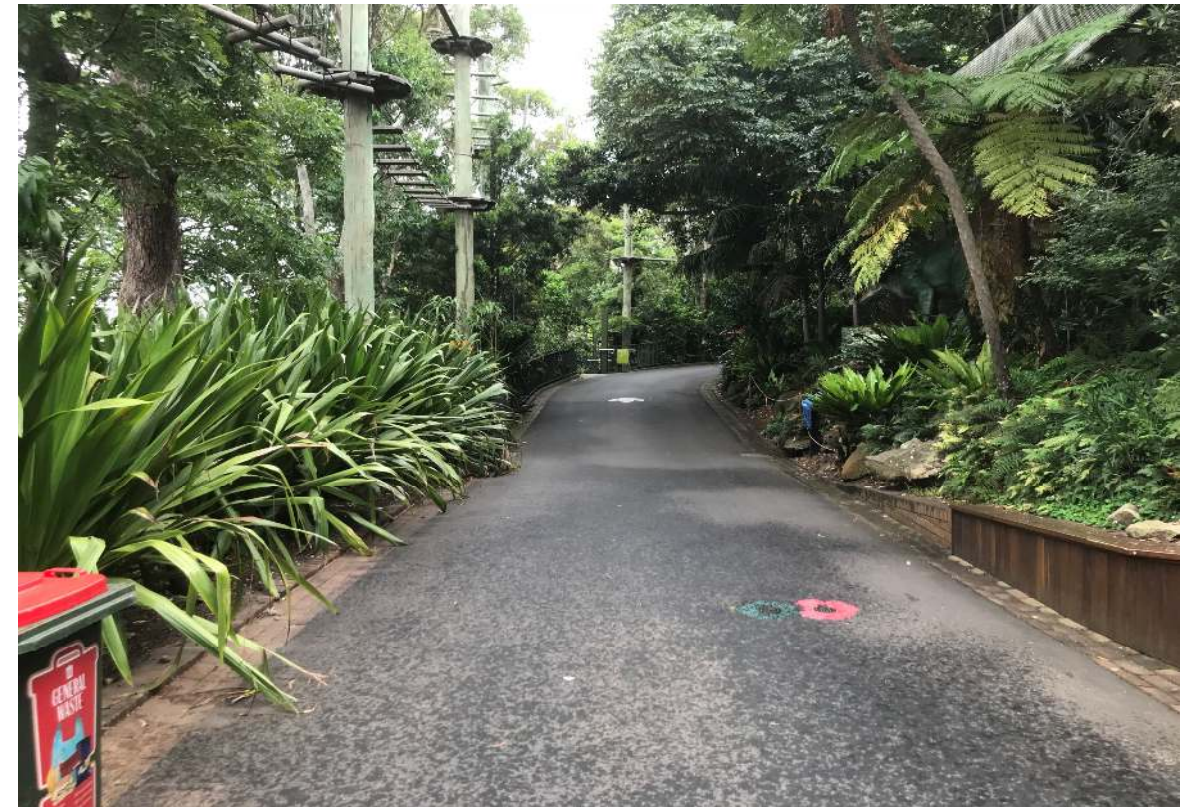
Photo 6: Asphalt pathway near the Nocturnal House
