DILAPIDATION REPORT

74 EDINBURGH ROAD, MARRICKVILLE NSW 2204

Docui	ment Information
Job Number	221079
Document Number	1
Report Title	Dilapidation Report
Site Address	74 Edinburgh Road, Marrickville NSW 2204
Lot	202 in DP1133999

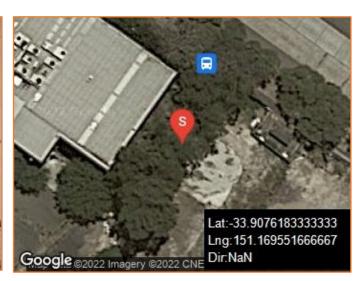
Figure 3: Reasonable - General condition of driveway layback.

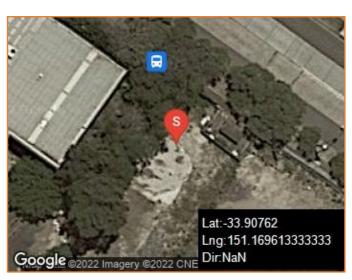
Figure 4: Reasonable - General condition of driveway layback. Minor cracking observed.

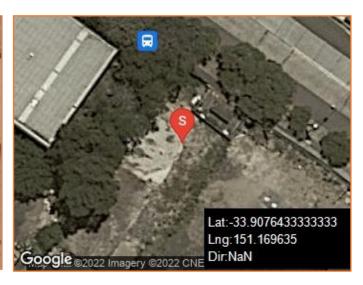
Figure 5: Reasonable - General condition of driveway layback. Minor cracking observed.

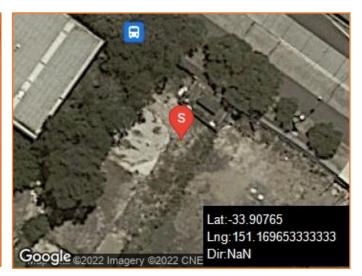
Figure 6: Reasonable - General condition of driveway layback.

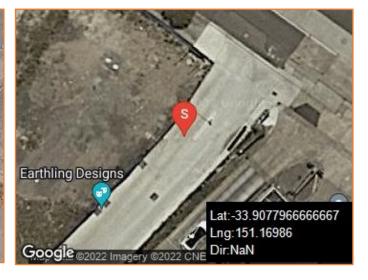
Figure 9: Reasonable - General condition of driveway splay. Minor cracking and spalling observed.

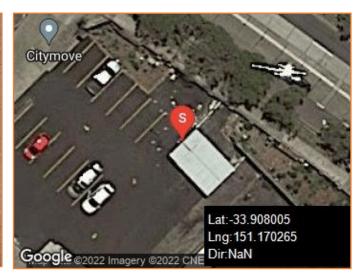
Figure 21: Reasonable - General condition of flexible pavement. Minor physical damage observed.

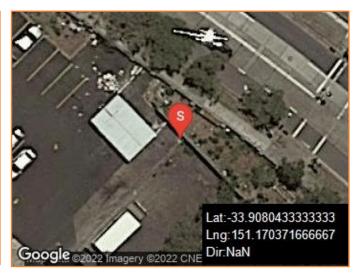
Figure 24: Reasonable - General condition of kerb and gutter. Minor spalling observed.

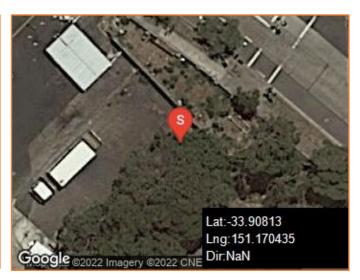
Figure 26: Reasonable - General condition of kerb and gutter. Minor spalling observed.

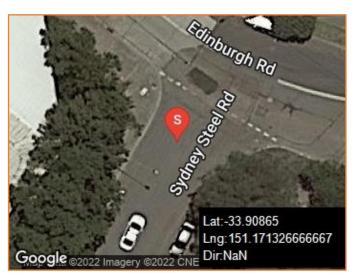
Figure 46: Poor - General condition of flexible pavement. Extensive cracking observed. Previous repairs observed.

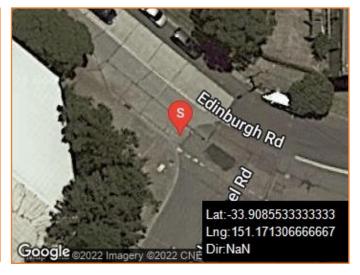
Figure 51: Reasonable - General condition of flexible pavement. Minor cracking observed.

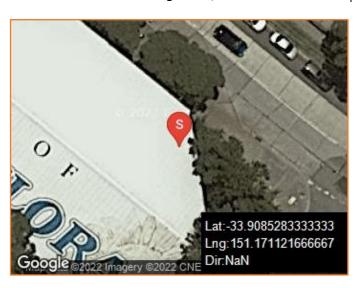
Figure 58: Reasonable - General condition of rigid pavement. Minor cracking observed.

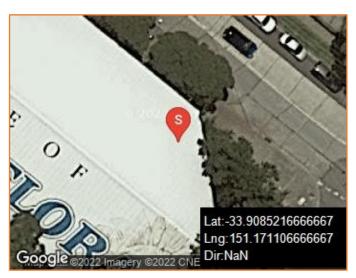
Figure 59: Reasonable - General condition of rigid pavement. Minor cracking observed.

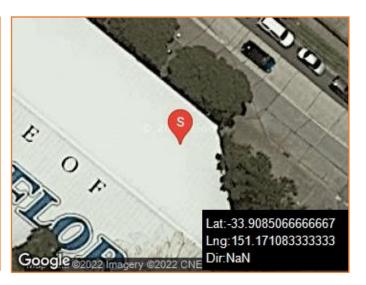
Figure 60: Reasonable - General condition of rigid pavement. Minor cracking observed.

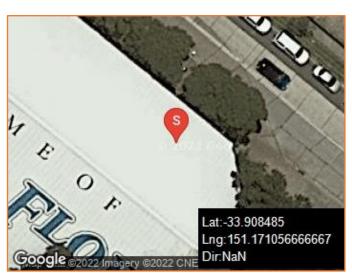
Figure 61: Reasonable - General condition of rigid pavement. Minor cracking observed.

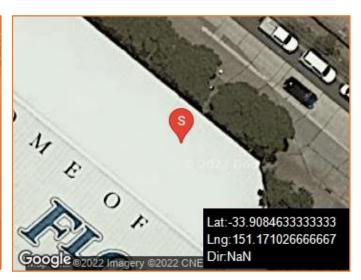
Figure 62: Reasonable - General condition of flexible and rigid pavement. Minor cracking observed

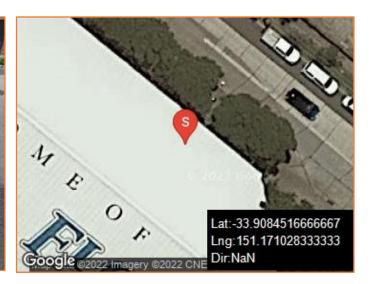
Figure 63: Reasonable - General condition of flexible and rigid pavement. Minor cracking observed.

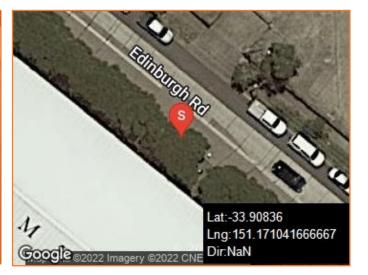
Figure 69: Reasonable - General condition of flexible and rigid pavement. Minor physical damage observed.

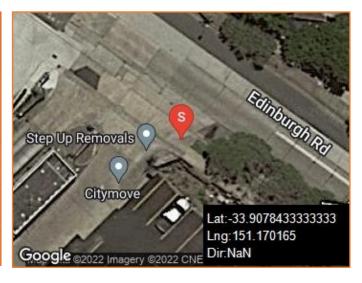
Figure 99: Reasonable - General condition of rigid pavement. Extensive cracking observed.

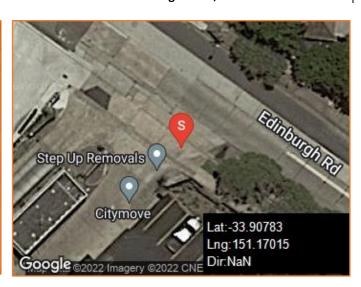
Figure 124: Reasonable - General condition of footpath. Major cracking observed.

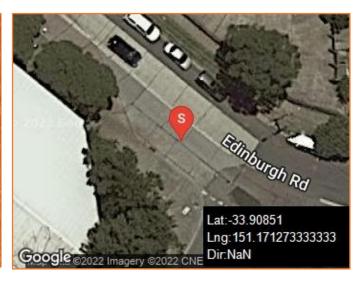
Figure 188: Reasonable - General condition of footpath. Minor cracking observed.

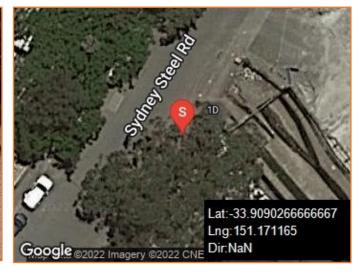
Figure 215: Reasonable - General condition of flexible pavement. Minor physical damage observed.

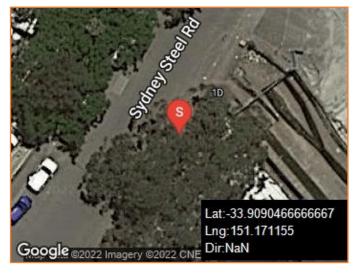
Figure 218: Reasonable - General condition of flexible pavement. Minor cracking observed.

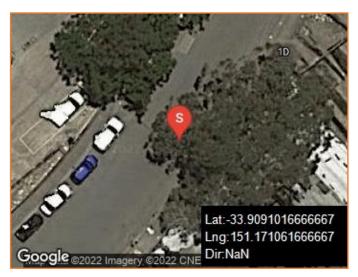
Figure 221: Reasonable - General condition of flexible pavement. Major cracking observed.

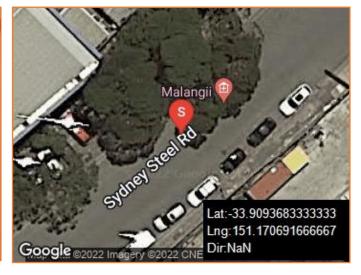
Figure 245: Reasonable - General condition of flexible pavement. Minor cracking observed.

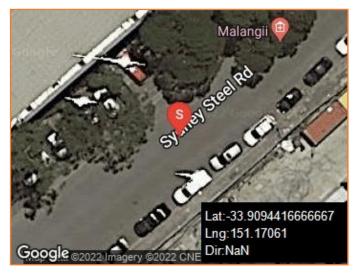
Figure 248: Reasonable - General condition of flexible pavement. Previous repairs observed.

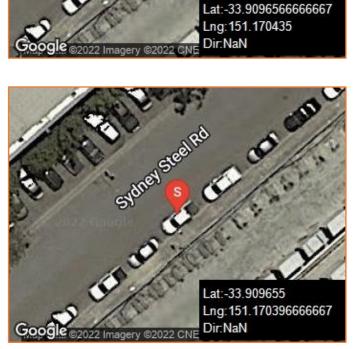
Figure 260: Reasonable - General condition of flexible pavement. Major cracking observed.

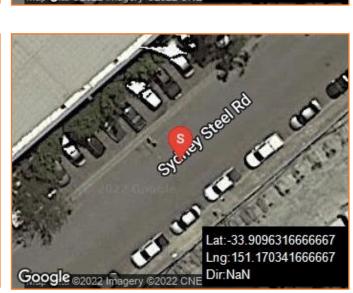
Figure 261: Reasonable - General condition of flexible pavement. Previous repairs observed.

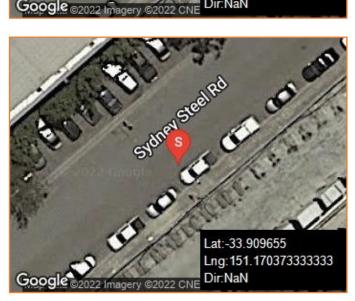
Figure 263: Reasonable - General condition of flexible pavement. Minor cracking observed.

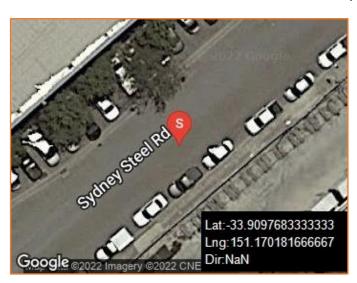
Figure 270: Reasonable - General condition of flexible pavement. Major cracking observed.

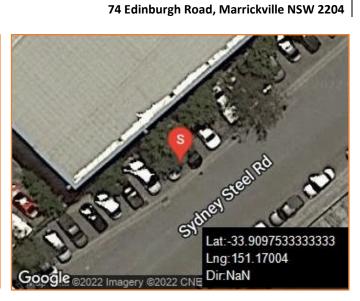
Figure 273: Reasonable - General condition of flexible pavement. Major cracking observed.

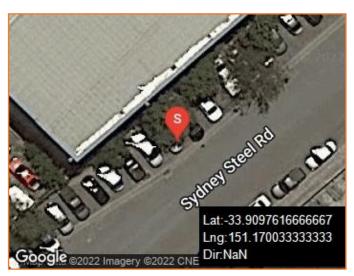
Figure 274: Reasonable - General condition of flexible pavement. Major cracking observed.

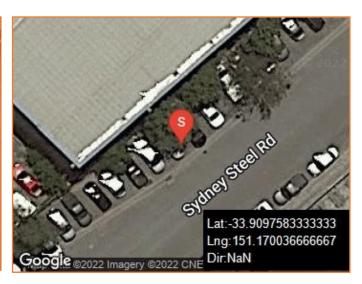
Figure 275: Reasonable - General condition of service pit. Minor cracking observed.

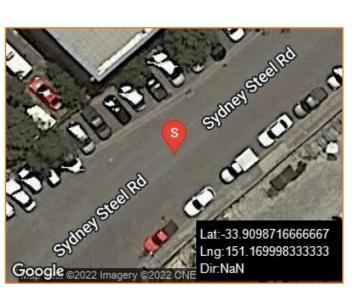
Figure 279: Reasonable - General condition of flexible pavement. Minor cracking observed.

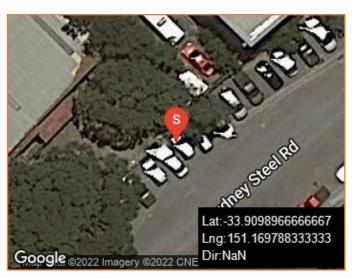
Figure 300: Reasonable - General condition of kerb and gutter. Minor cracking observed.

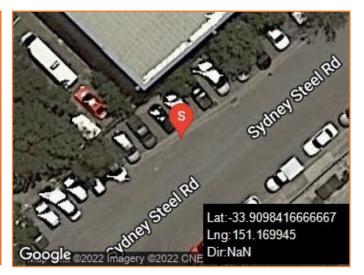
Figure 308: Reasonable - General condition of grated inlet pit. Minor cracking observed.

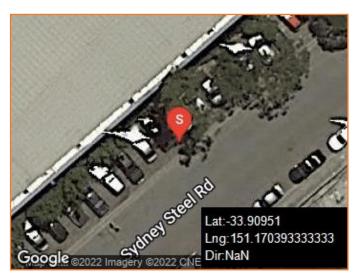
Figure 323: Reasonable - General condition of kerb and gutter. Minor cracking observed.

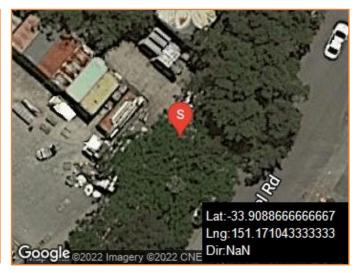
Figure 362: Reasonable - General condition of kerb and gutter. Minor cracking observed.

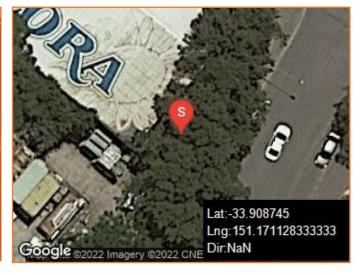
Figure 371: Reasonable - General condition of kerb and gutter. Minor cracking observed.

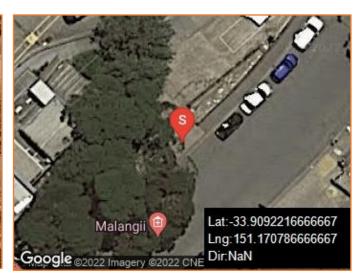
Figure 422: Poor - General condition of footpath. Extensive cracking observed.

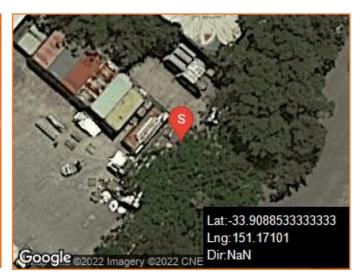
Figure 434: Reasonable - General condition of footpath. Previous repairs observed.
