## DILAPIDATION REPORT

MUSEUM DISCOVERY CENTRE

MONDAY, 9 AUGUST 2021

Document Information	
Job Number	210722
Document Number	3
Report Title	Dilapidation Report
Site Address	172 Showground Road and 2 Green Road Castle Hill, NSW, 2154
Lot	1 in DP1066281 & 102 in DP1130271

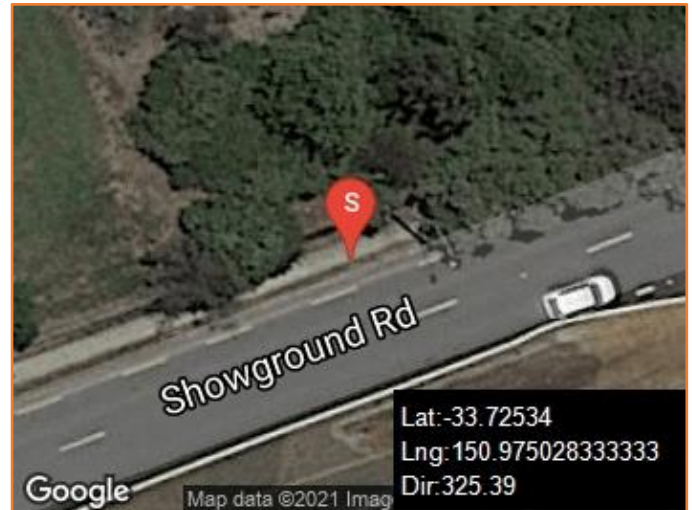
Figure 1: Good - General condition of footpath.

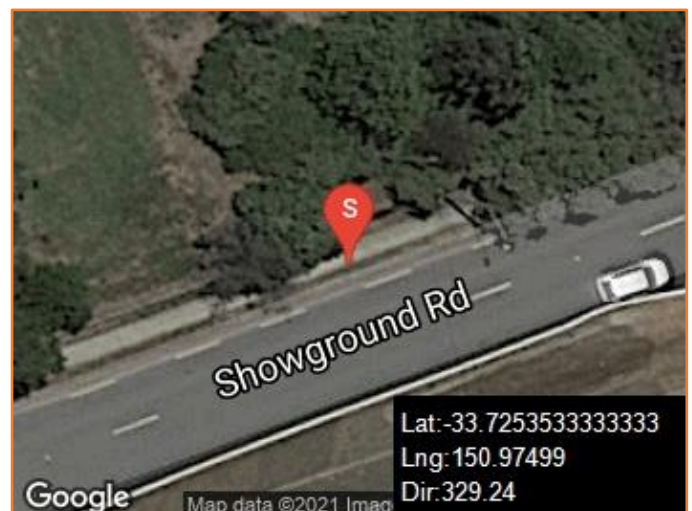
Figure 3: Reasonable - General condition of footpath. Moderate cracking and physical damage observed.

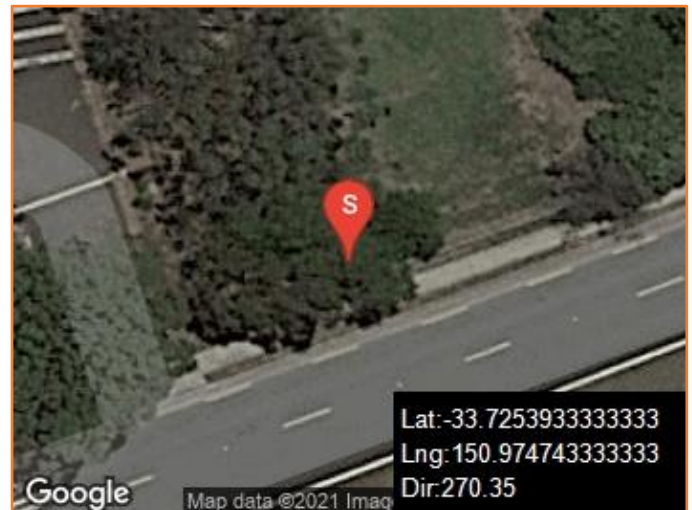
Figure 8: Good - General condition of footpath.

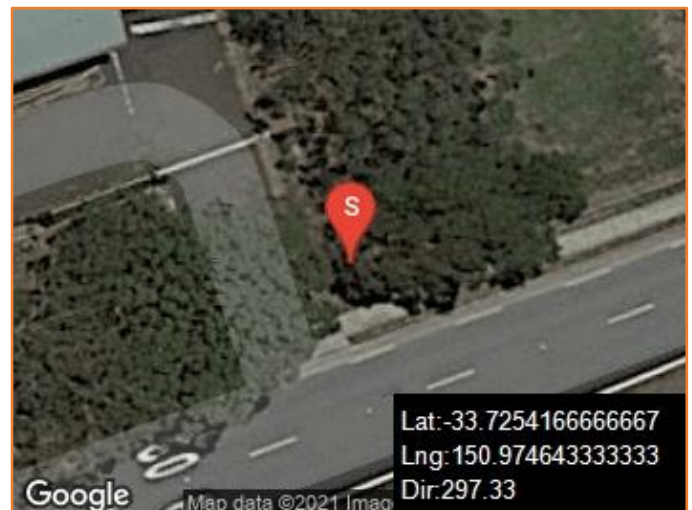
Figure 11: Reasonable - General condition of driveway crossover.

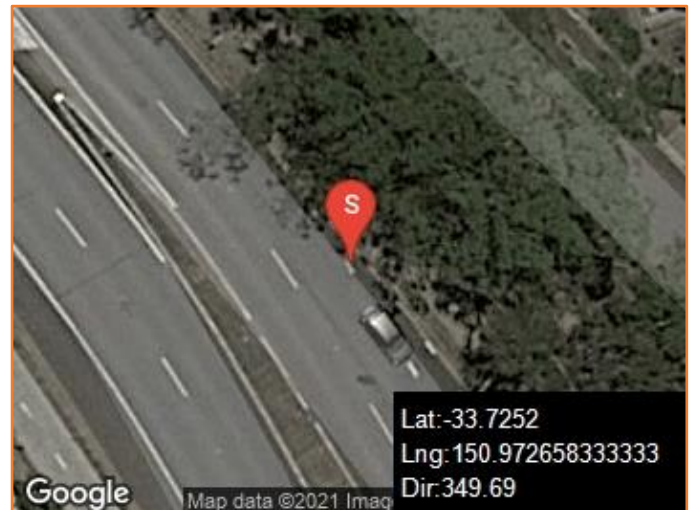
Figure 86: Good - General condition of footpath.

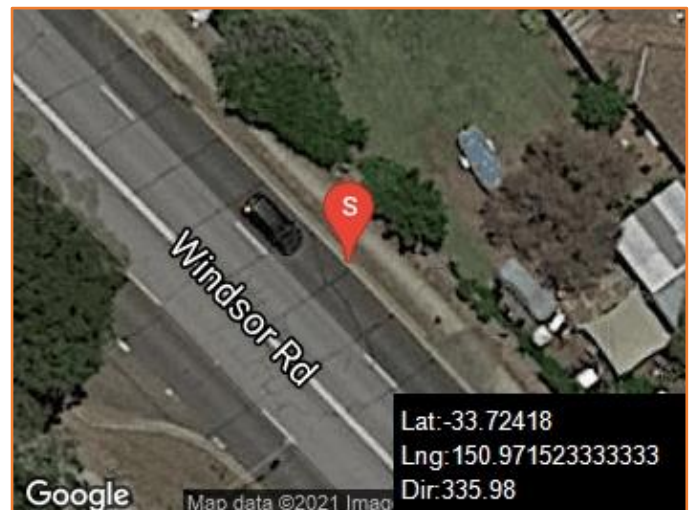
Figure 152: Poor - General condition of footpath and service pit. Moderate cracking observed.

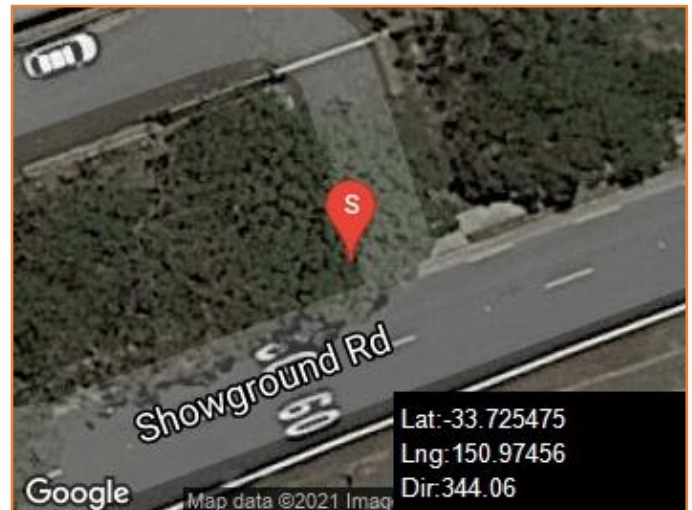
Figure 242: Poor - General condition of kerb and gutter. Moderate loss of material observed.

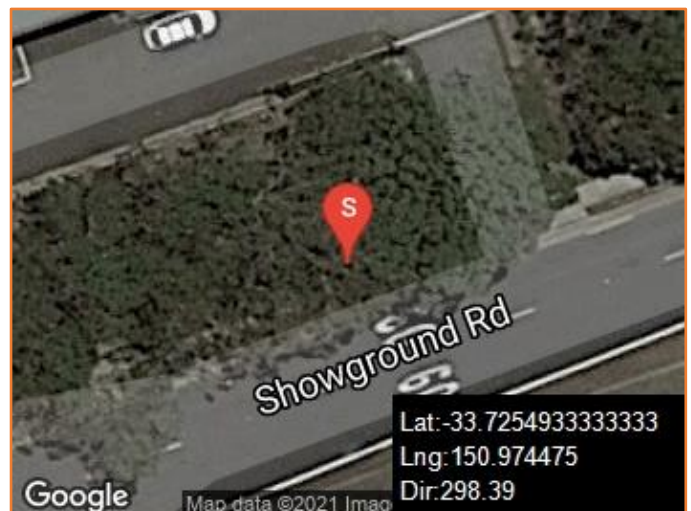
Figure 246: Poor - General condition of kerb and gutter. Moderate cracking and spalling observed.

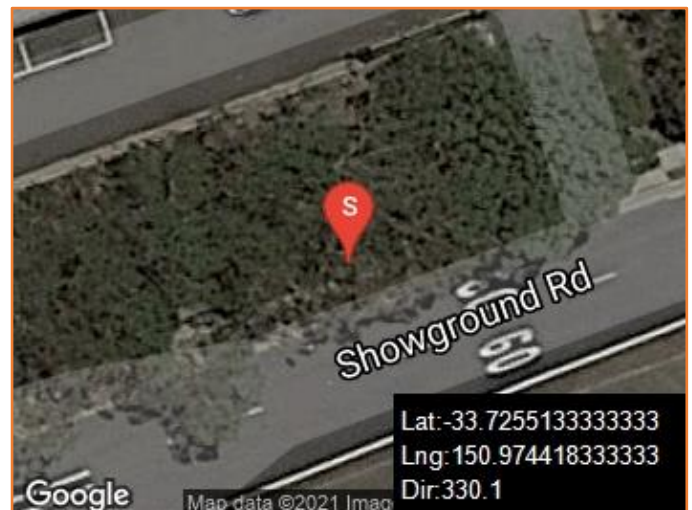
Figure 248: Reasonable - General condition of kerb and gutter. Minor hairline cracking observed.

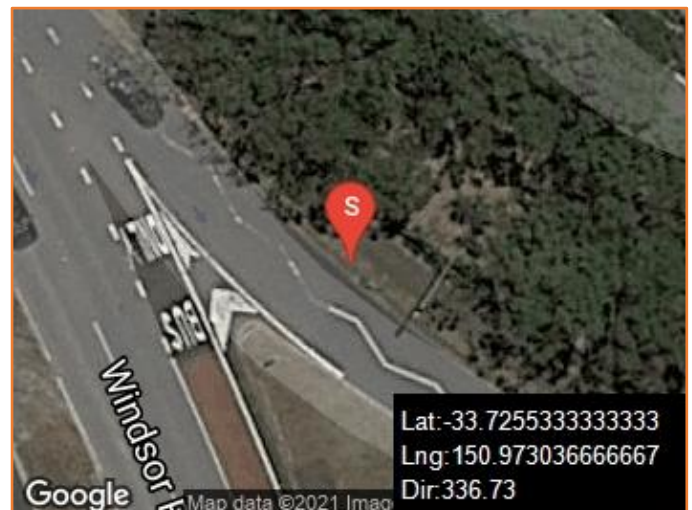
Figure 290: Reasonable - General condition of kerb and gutter. Moderate cracking and loss of material observed.

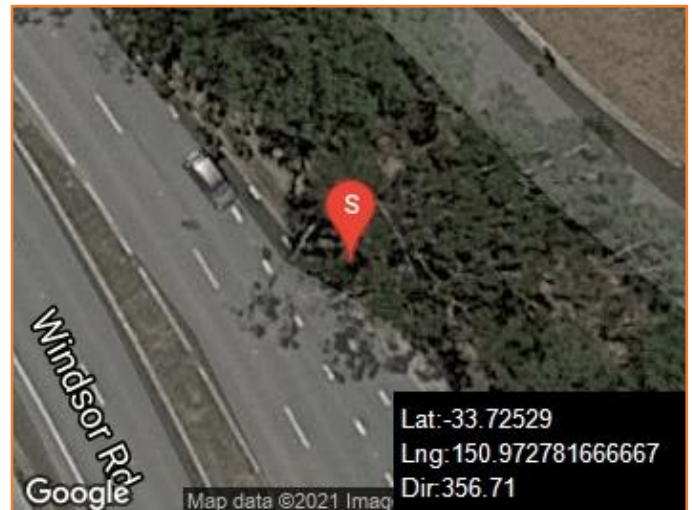
Figure 308: Reasonable - General condition of kerb and gutter and footpath crossover.

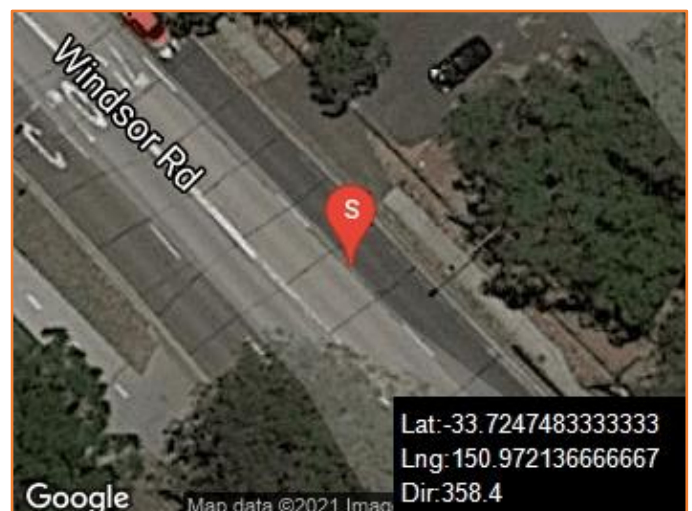
Figure 336: Reasonable - General condition of kerb and gutter. Minor hairline cracking observed.
