AGL Broken Hill BESS – Dilapidation Survey – Broken Hill Council Consultation

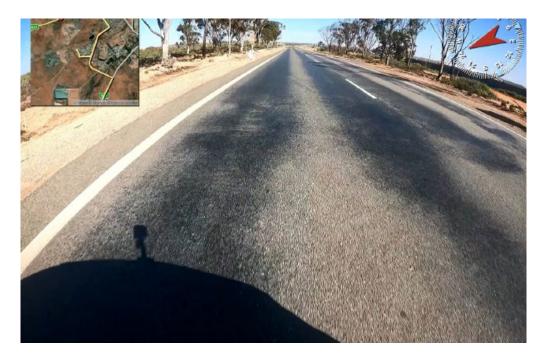
Bleeding/flushing in the roadway on Barrier Highway.

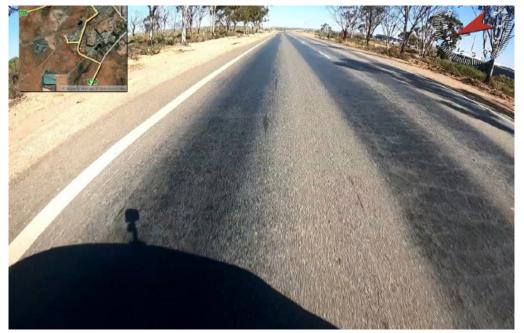
Alligator cracking in the roadway on Barrier Highway.

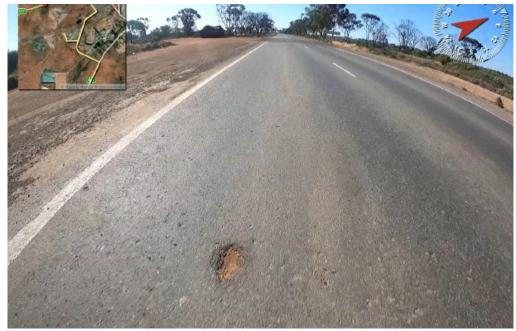
Figure: 0183

Pot hole in the roadway on Barrier Highway.

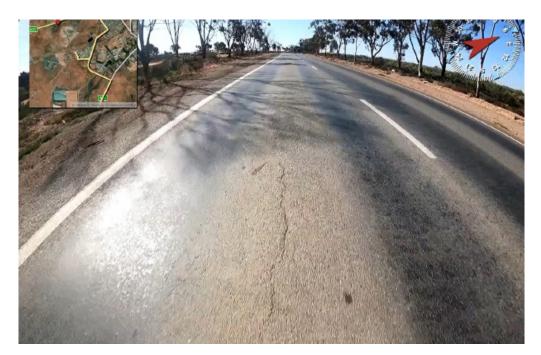
Longitudinal cracking in the roadway on Barrier Highway.

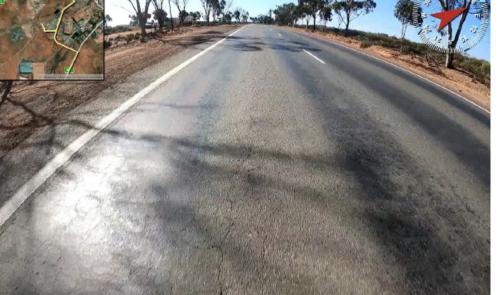
Figure: 0185

Longitudinal cracking in the roadway on Barrier Highway.

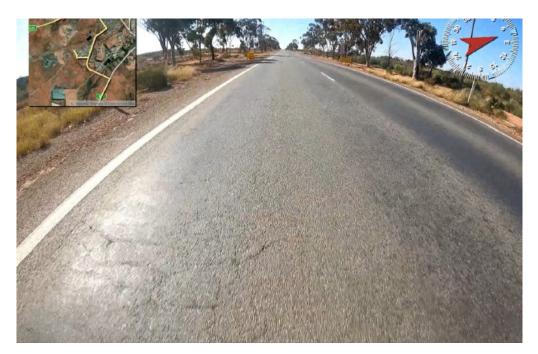
Alligator cracking in the roadway on Barrier Highway.

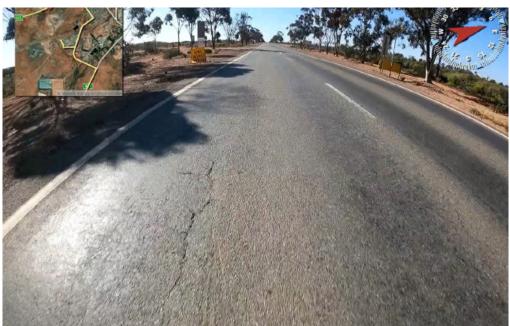
Figure: 0188

Legendary cracking in the roadway on Barrier Highway.

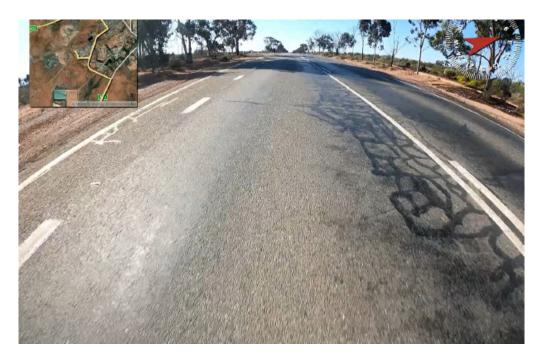
Alligator cracking in the roadway on Barrier Highway.

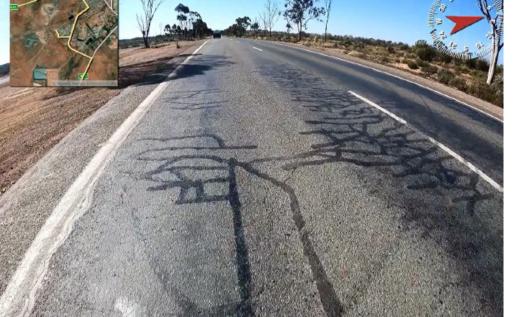
Figure: 0191

Alligator cracking in the roadway on Barrier Highway.

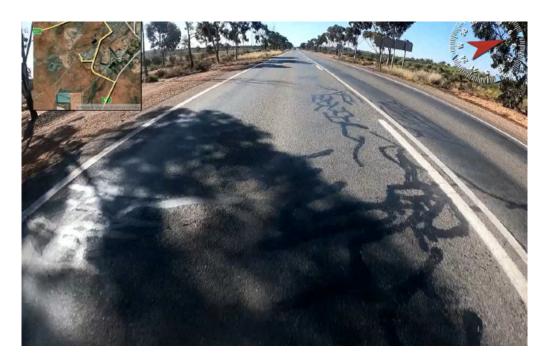
Alligator cracking in the roadway on Barrier Highway.

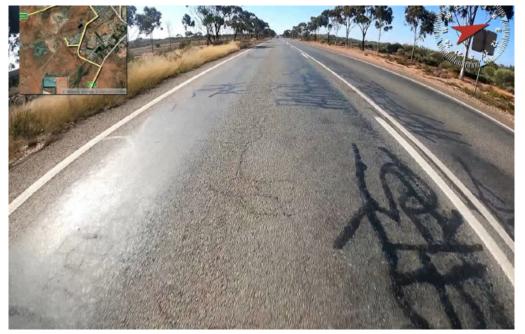
Figure: 0194

Alligator cracking in the roadway on Barrier Highway.

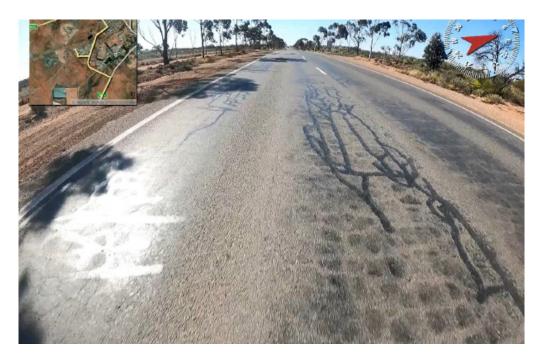
Alligator cracking in the roadway on Barrier Highway.

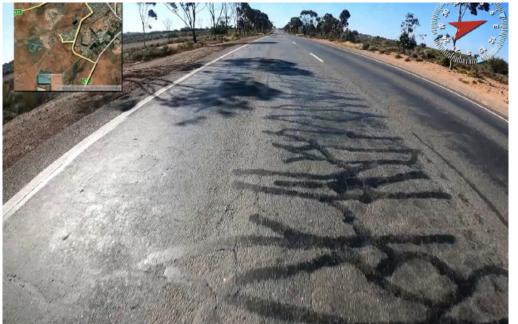
Figure: 0197

Alligator cracking in the roadway on Barrier Highway.

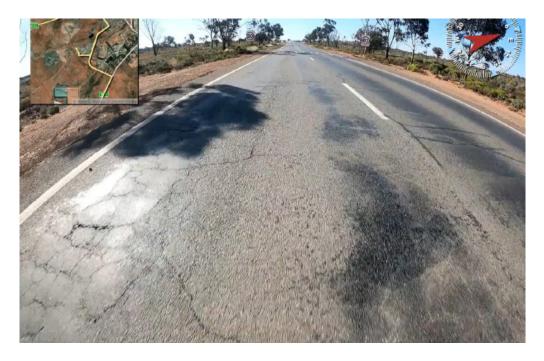
Alligator cracking in the roadway on Barrier Highway.

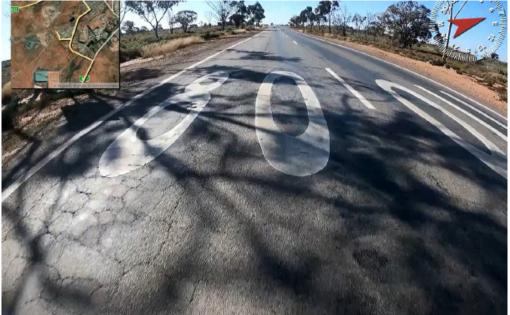
Alligator cracking in the roadway on Barrier Highway.

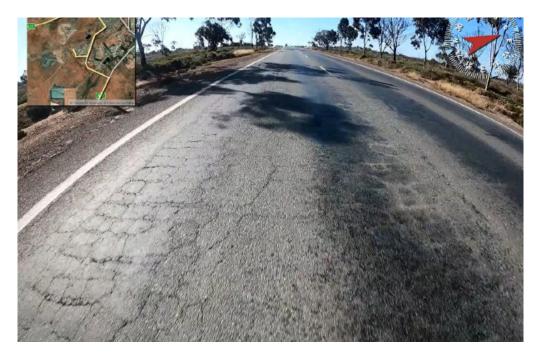
Alligator cracking in the roadway on Barrier Highway.

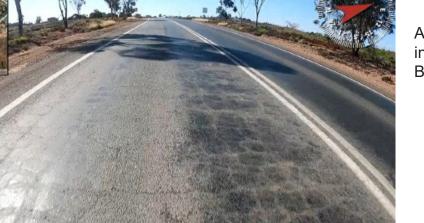
Figure: 0203

Alligator cracking in the roadway on Barrier Highway.

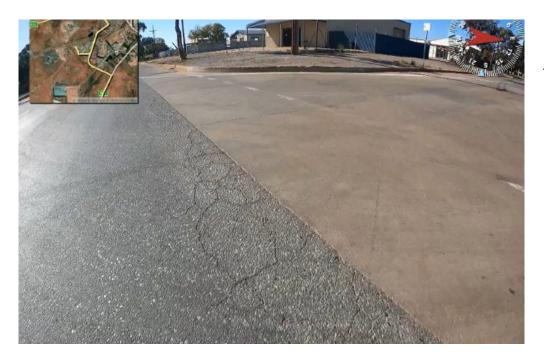
Alligator cracking in the roadway on Barrier Highway.

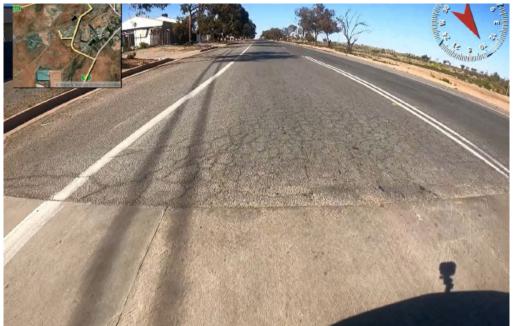
Figure: 0206

Alligator cracking in the roadway on Creedon Street.

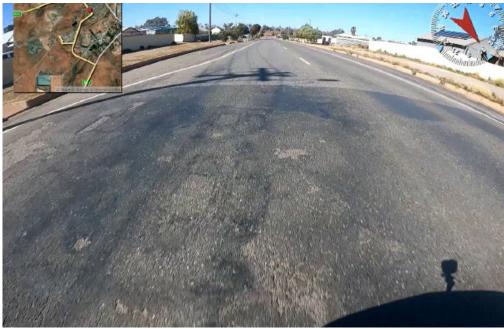
Figure: 0207

Porous asphalt and raveling in the roadway on Kanadah Street.

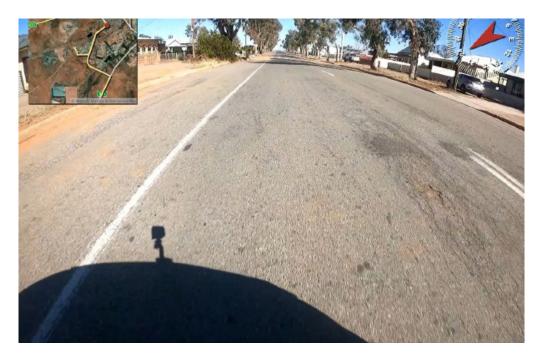
Asphalt depression and alligator cracking in the roadway on Kanadah Street.

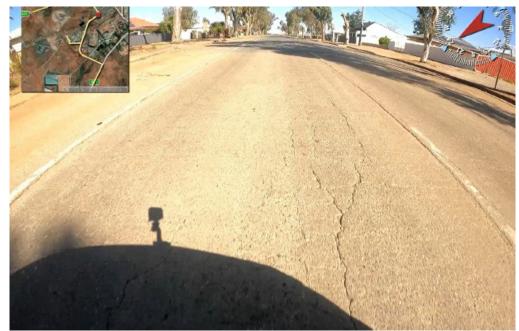
Figure: 0209

Longitudinal cracking in the roadway on Kanadah Street.

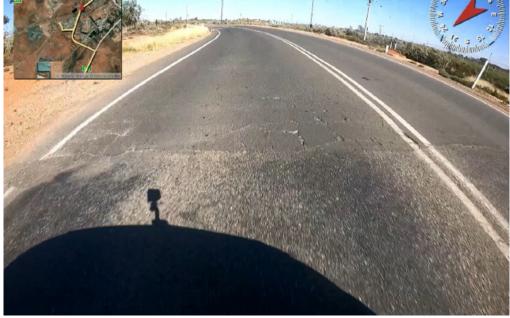
Figure: 0210

Tranverse cracking in the roadway on Kanadah Street.

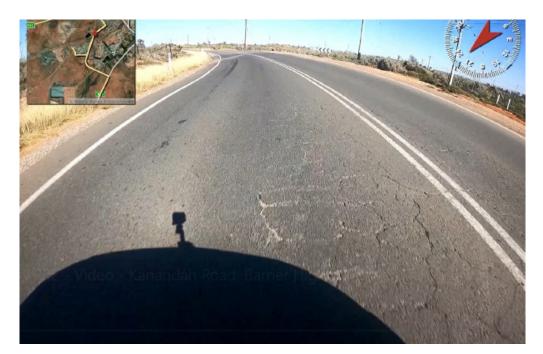
Alligator cracking in the roadway on Kanadah Street.

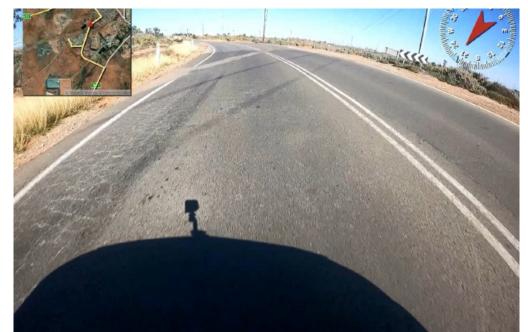
Figure: 0212

Alligator cracking in the roadway on Kanadah Street.

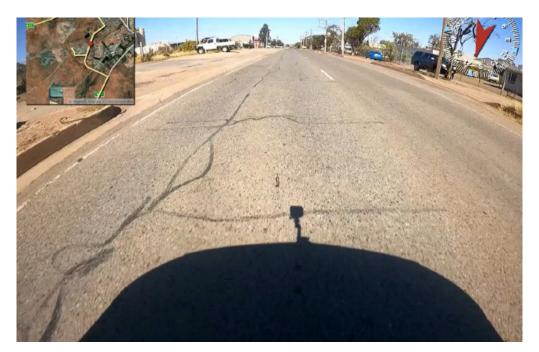
Longitudinal cracking in the roadway on Kanadah Street.

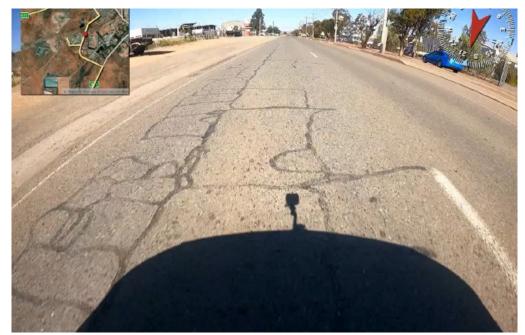
Figure: 0215

Longitudinal cracking in the roadway on Kanadah Street.

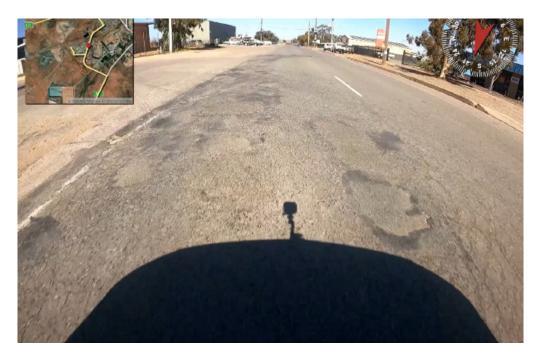
Failed patching in the roadway on Kanadah Street.

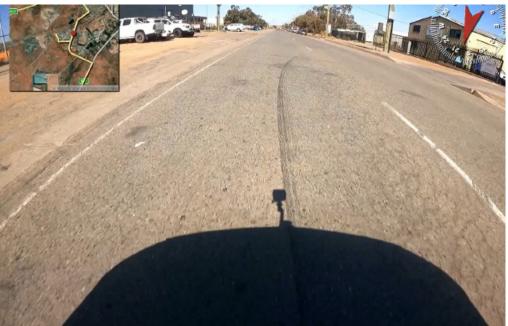
Alligator cracking in the roadway on Kanadah Street.

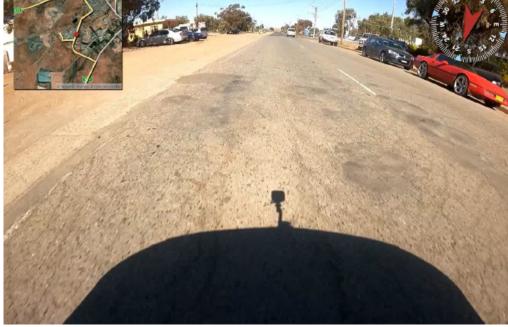
Figure: 0219

Alligator cracking in the roadway on Kanadah Street.

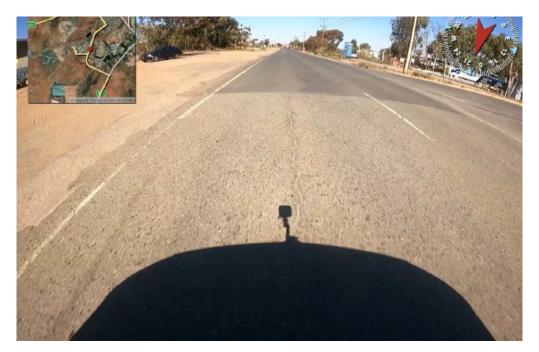
Longitudinal cracking in the roadway on Kanadah Street.

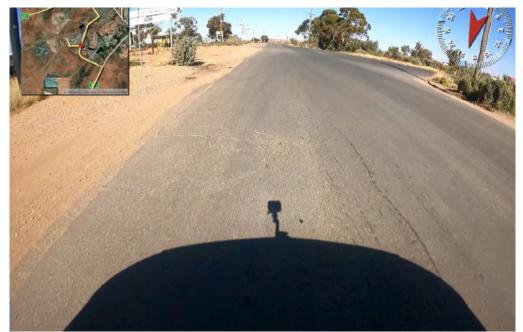
Figure: 0221

Longitudinal cracking in the roadway on Kanadah Street.
