# North Sydney Public School

## Preliminary Site Investigation

**Reference: SYDGE290593-R01**

16 August 2021

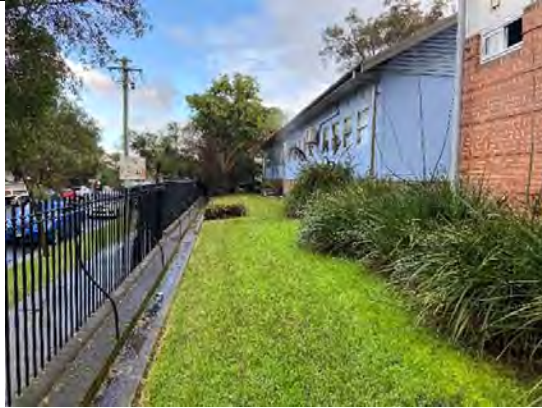
Photograph 1: Looking along the southern boundary adjacent to Bay Road

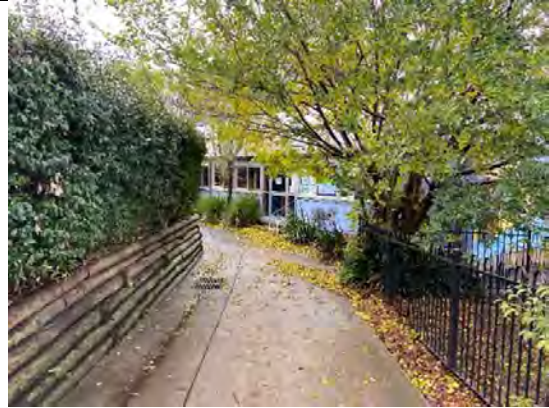
Photograph 2: Facing south at a building scheduled to be demolished

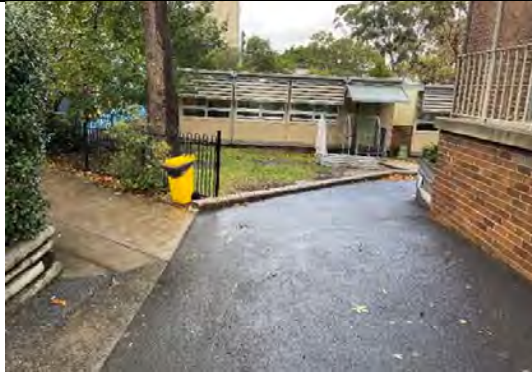
Photograph 3: Facing south at a building scheduled to be demolished

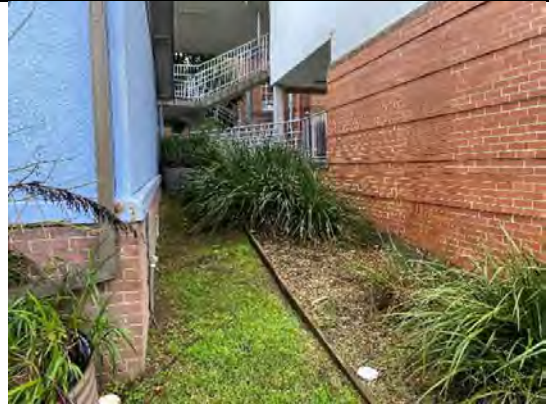
Photograph 4: View of the eastern boundary

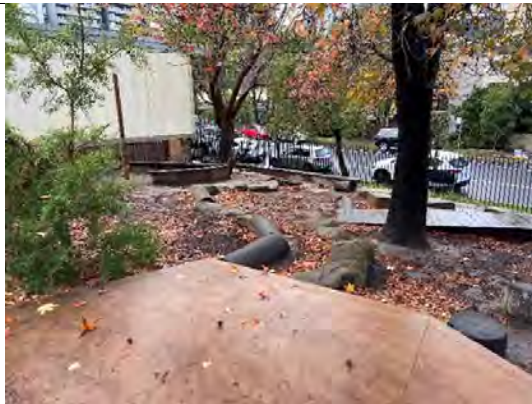
Photograph 5: Retaining walls on the western side of the development

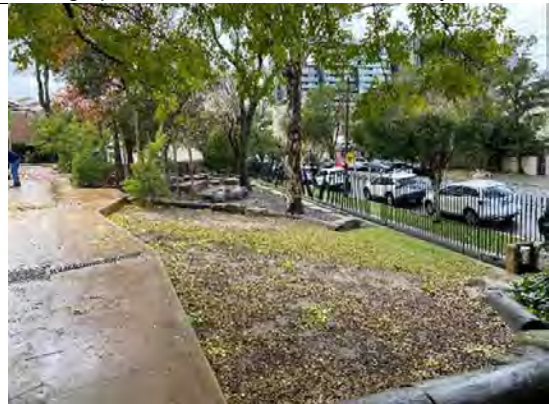
Photograph 6: Looking east from the western side of the development area

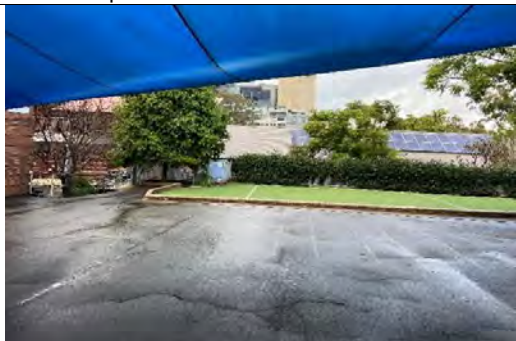
Photograph 7: Looking south from the northern side of the development area
