Arboriculture Impact Assessment Report

**Site Assessment Conducted and Report Prepared by:
The Tree MD Pty. Ltd. Geoffrey Ashton AQF 5 in Arboriculture**

**Hastings Secondary College Port Macquarie Campus
Owen St Port Macquarie NSW**

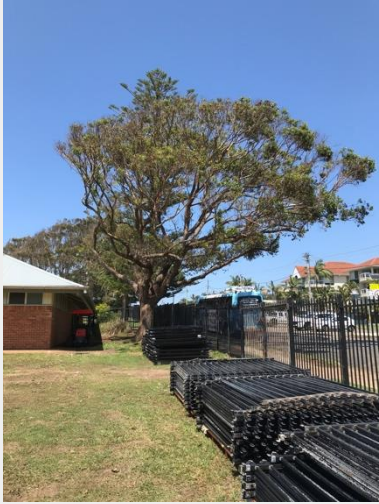
<p>4</p>

<p>Hard surfaces will need to be above great to avoid damage to read systems</p>

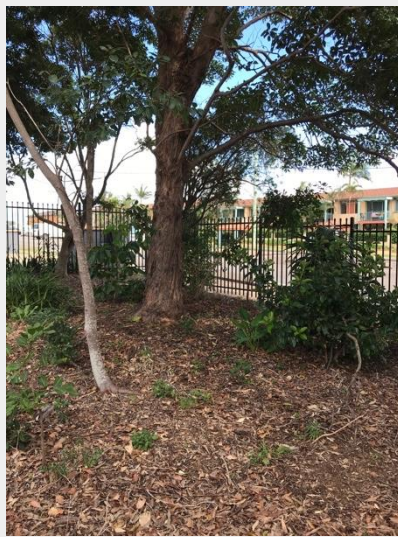
34

Proposed entrance is within 1 m of tree
redesign about grade for the non-invasive
investigation required

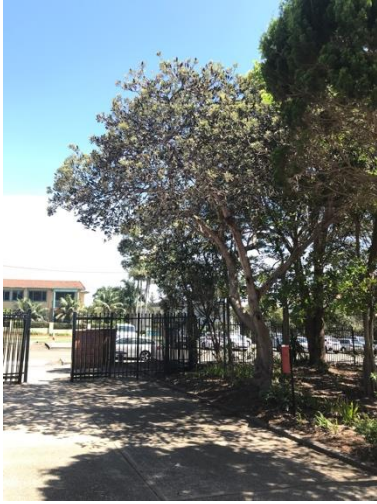
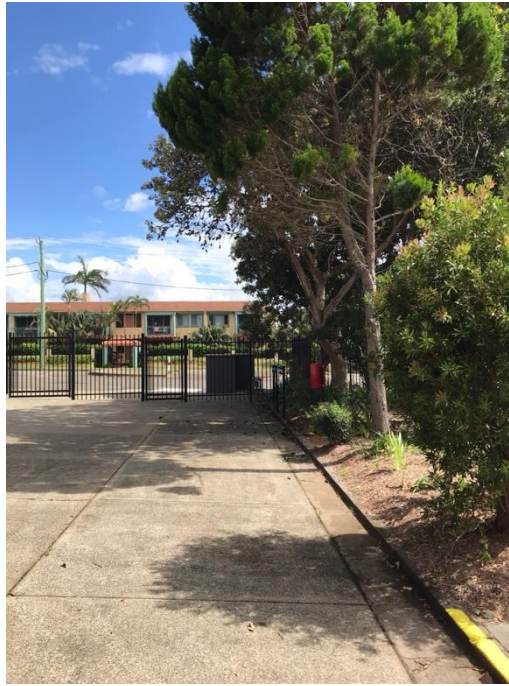
37

Previous branch failure to the south services will need to be located to the south within the existing hard surface

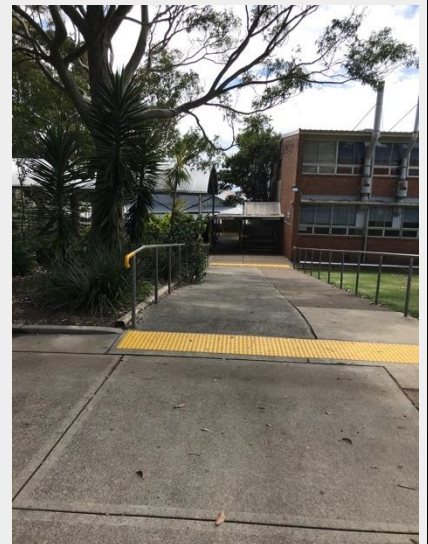
Flexible final pier location for
shelter, grade adjustment cut at top
at top of ramp is outside of SRZ
however will need non-invasive
assessment.

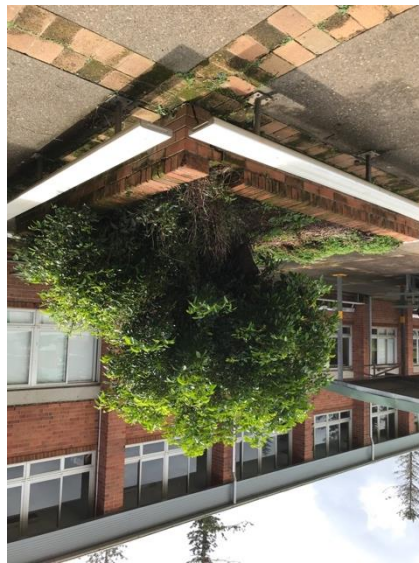
53

A lopped since first assessment

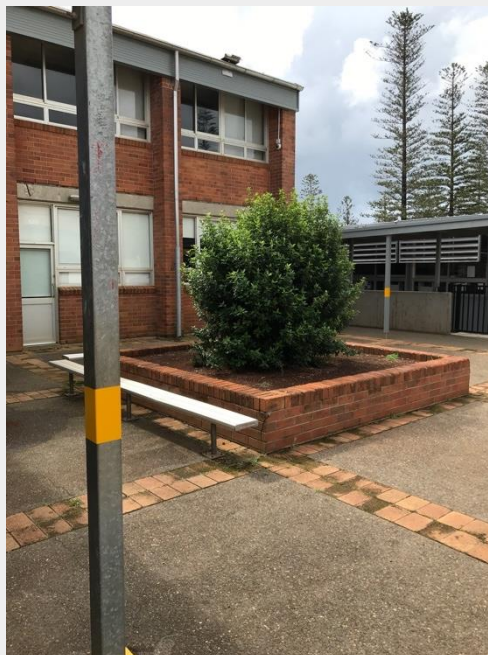
54

Lopped since first assessment

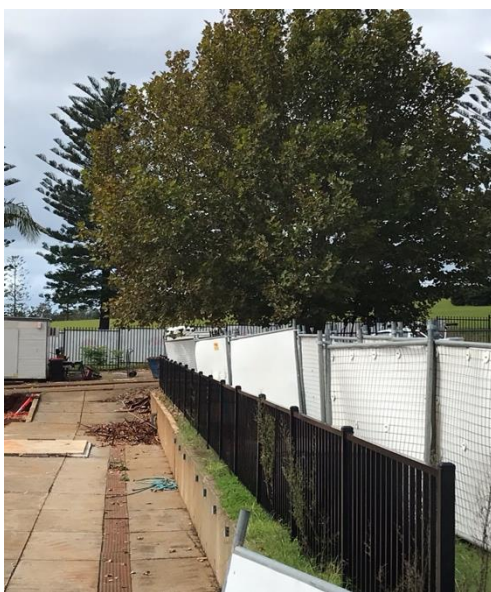
Cutting towards tree of less than a meter of retaining wall rounding the corner

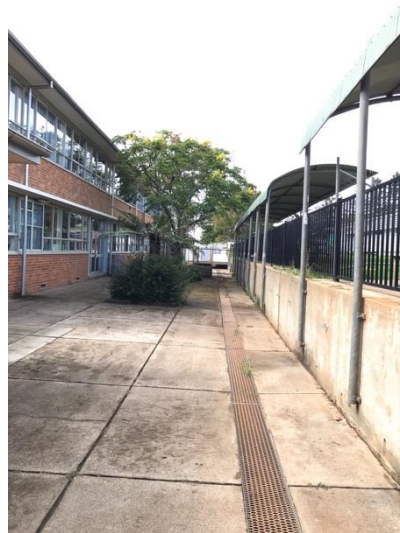
Services are a major encroachment
