Report on  
Hazardous Building Materials (HBM) Survey

Hastings Secondary College - Port Macquarie Campus  
16 Owen Street, Port Macquarie

Prepared for  
School Infrastructure NSW  
on behalf of Department of Education

Project 89754.01  
April 2021

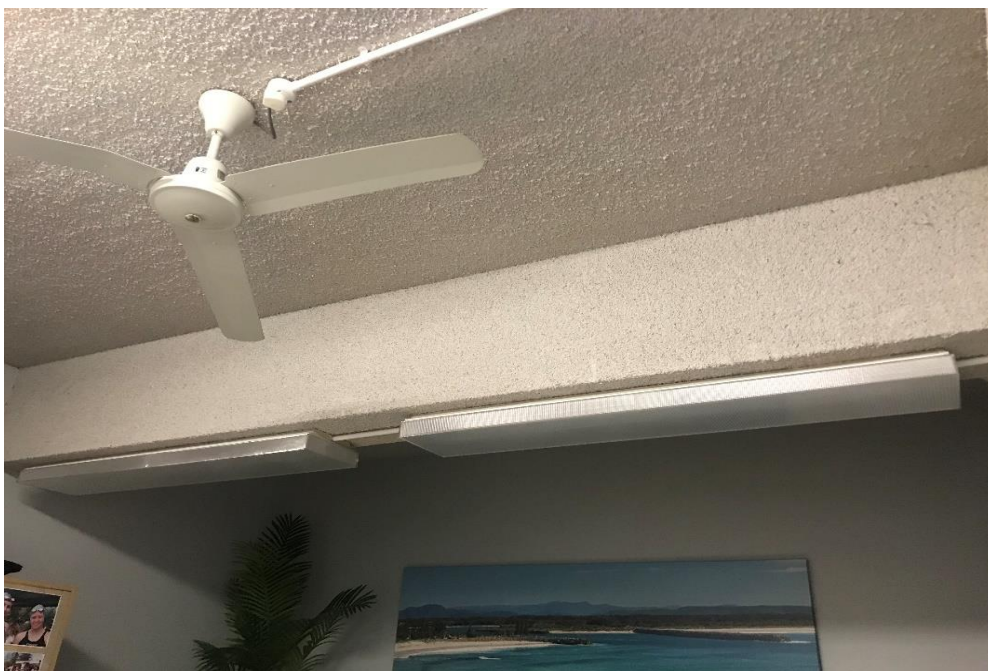
Photograph 1: B00A, rooms and areas in general, fluorescent light fittings in general, capacitors, insulating oil, PCB (assumed).

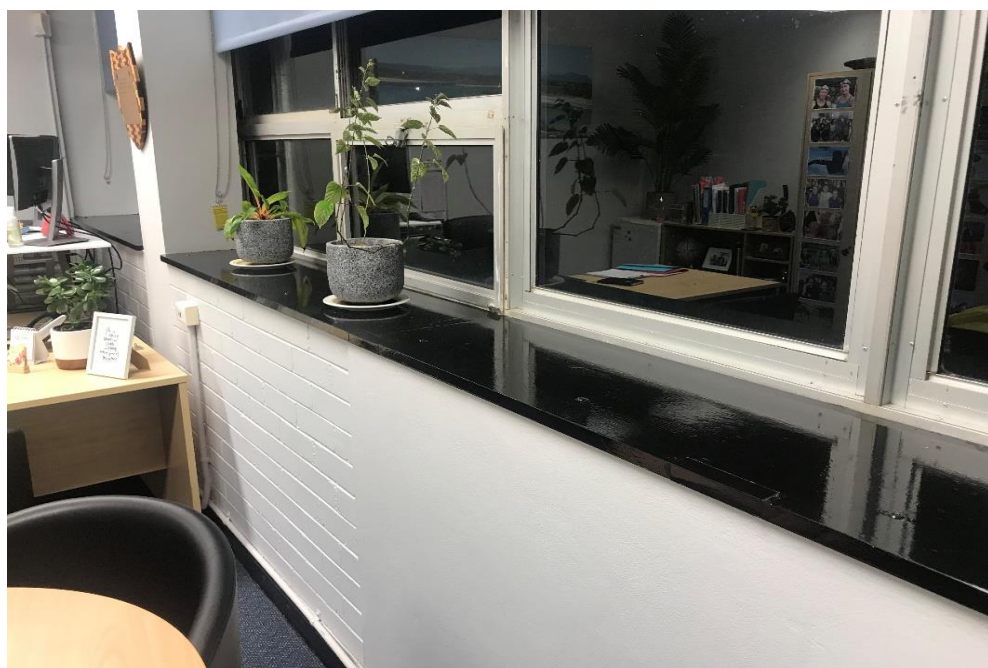
Photograph 2: B00A, AR0015, window sill, fibre cement board, asbestos detected by analysis.

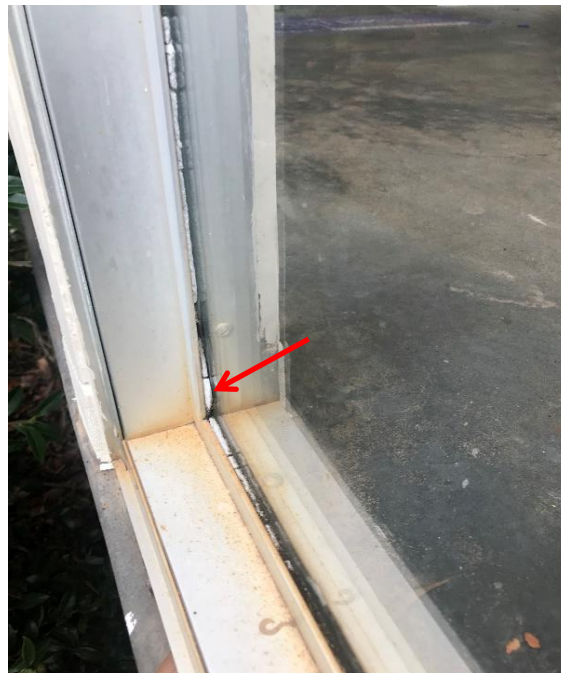
Photograph 8: B00A, AR0042, north side of room, window frame set, glazing putty, no asbestos detected by analysis, SMF detected.

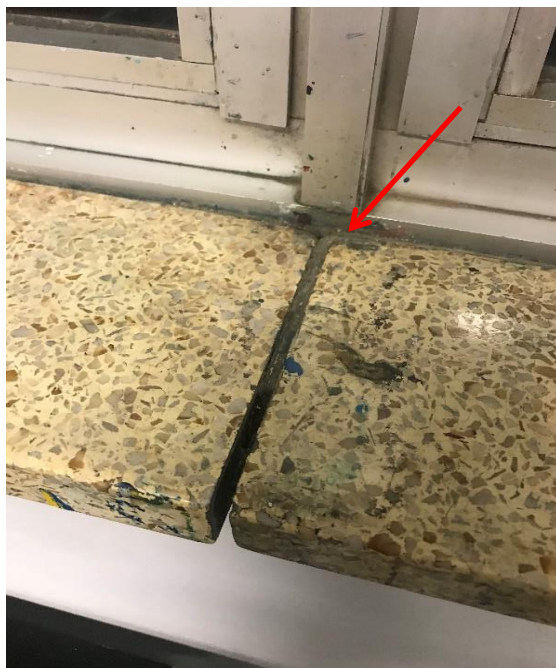
Photograph 5: Photograph shown is similar to B00B, BR0002, between window frame and terrazzo sill, putty, asbestos detected by analysis.

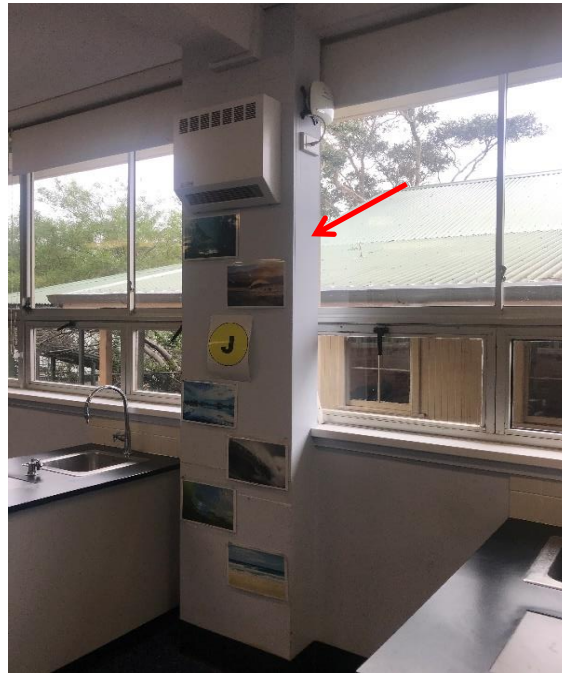
Photograph 7: B00B, BR0009, north and west wall, enclosed building boxes, internal material(s), unknown.

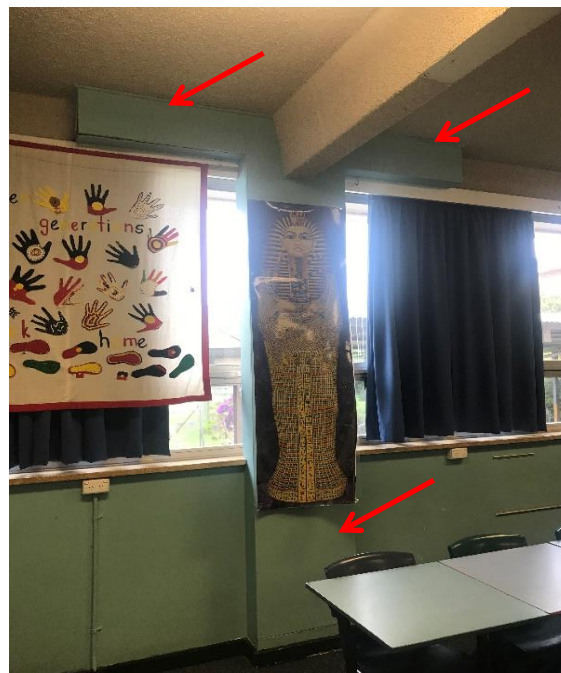
Photograph 8: B00B, BR0012, north wall, enclosed T-shape building box, internal material(s), unknown.

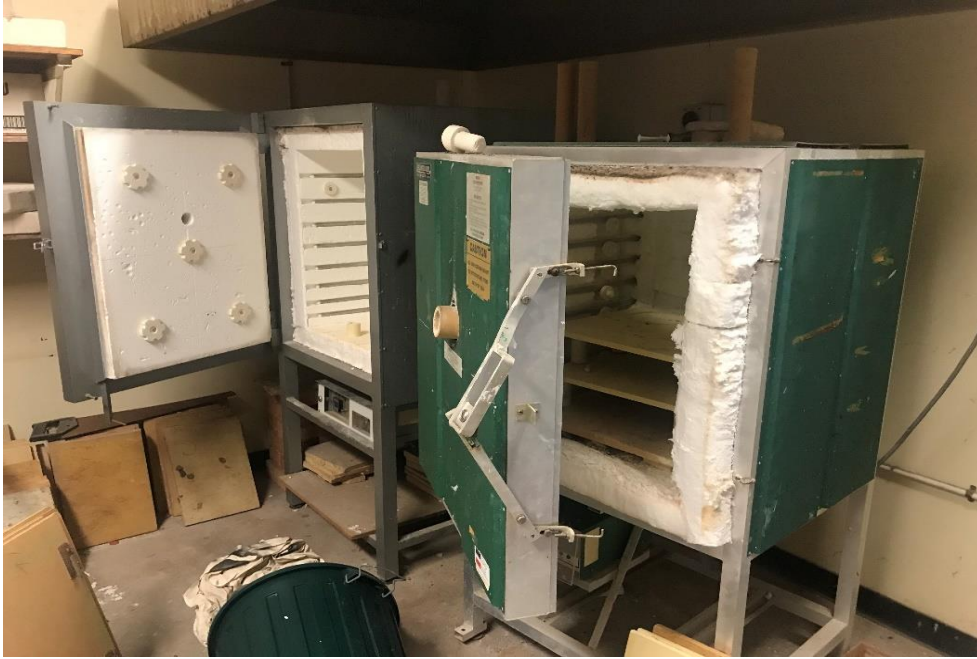
Photograph 15: B00B, BR1017, green and grey kilns, insulation, no asbestos detected by analysis, SMF detected.

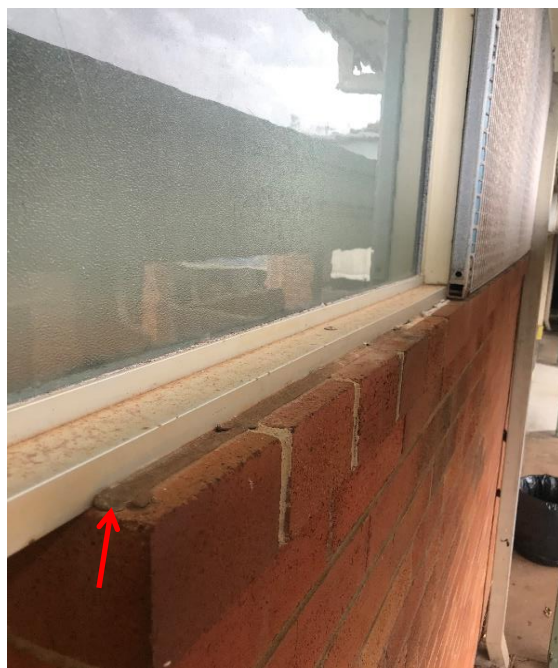
Photograph 2: B00C, exterior, northern façade, window frame, between window frame and wall, typical putty, asbestos detected by analysis.

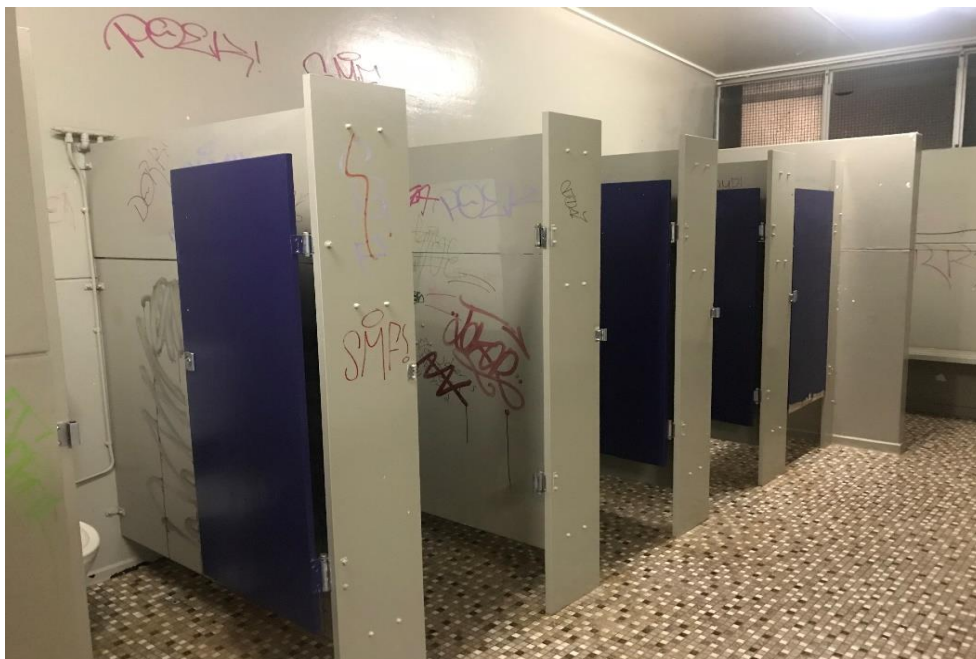
Photograph 7: B00C, CR0005, cubicles, partition walls, fibre cement board, asbestos detected by analysis.

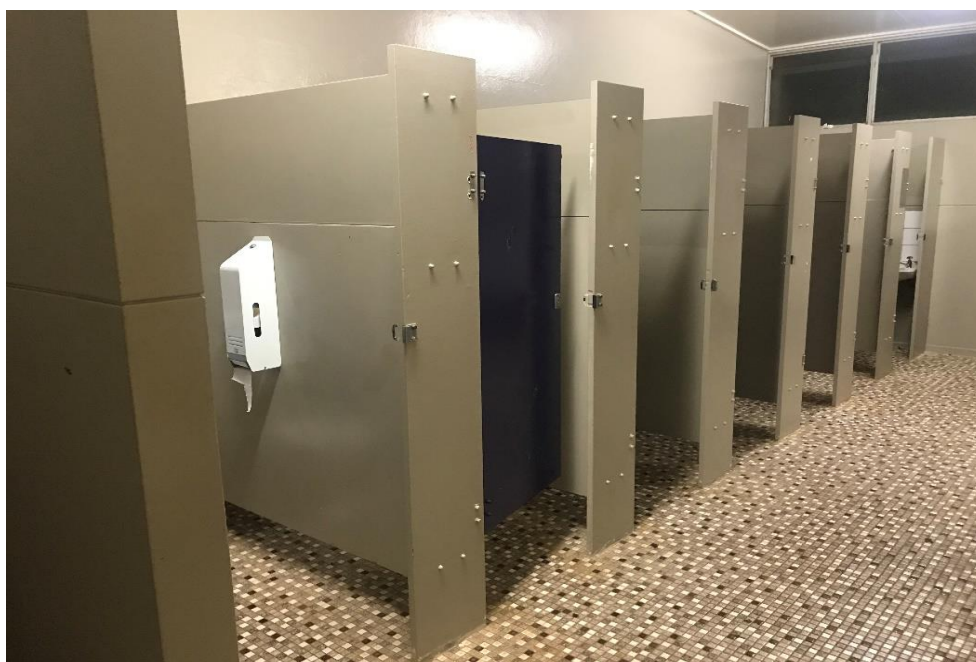
Photograph 8: B00C, CR0010, cubicles, partition walls, fibre cement board, asbestos detected by analysis.

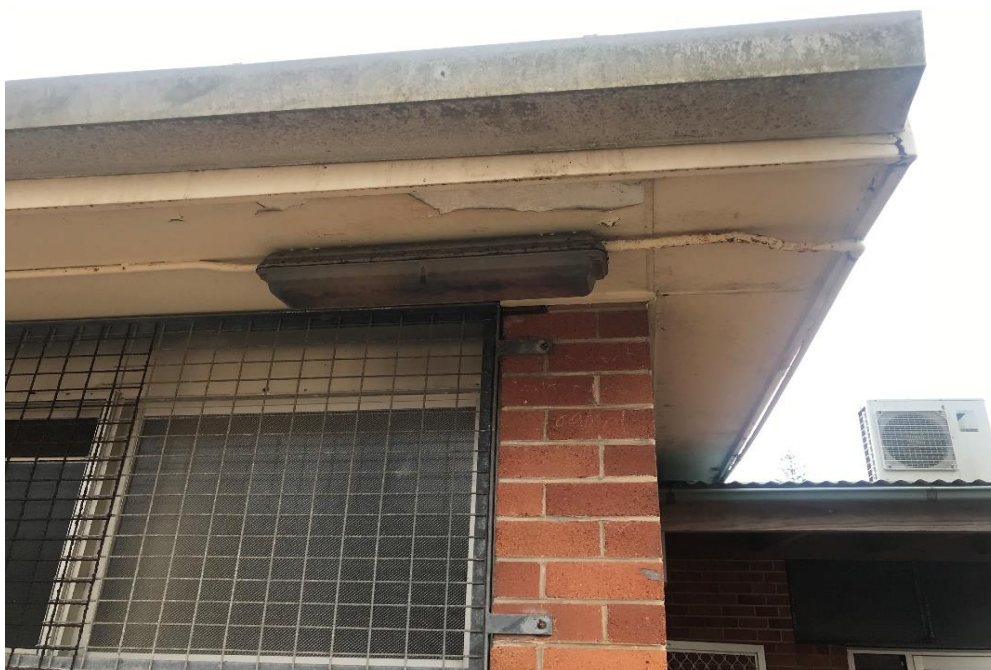
Photograph 12: B00C, rooms and areas in general, fluorescent light fittings in general, capacitors, insulating oil, PCB (assumed).

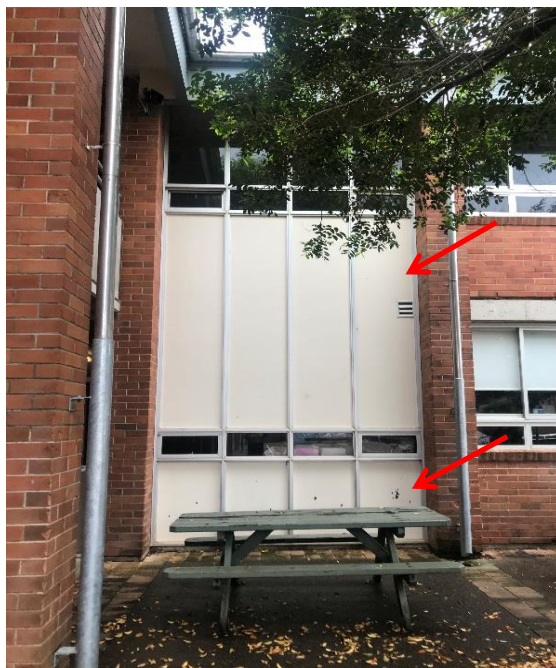
Photograph 5: B00L, exterior, window set at southern side of LR0044, infill panels, fibre cement, asbestos (assumed).

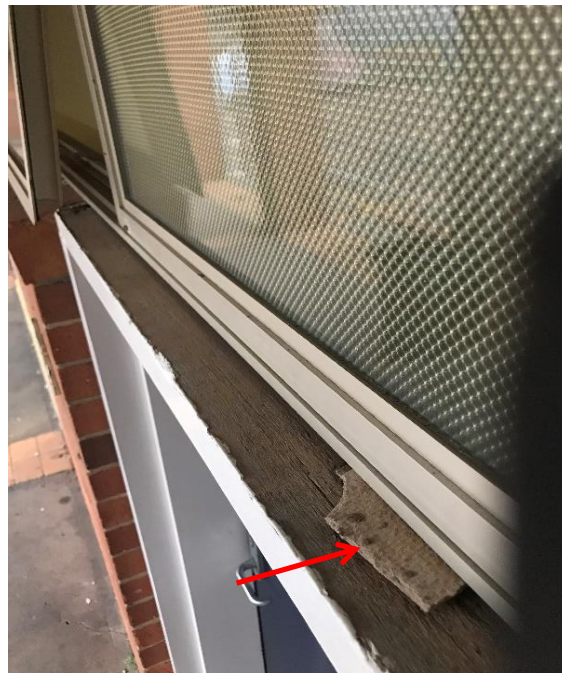
Photograph 10: B00L, LR0042, aluminium window/door frames, packing materials, fibre cement fragments, asbestos detected by analysis.

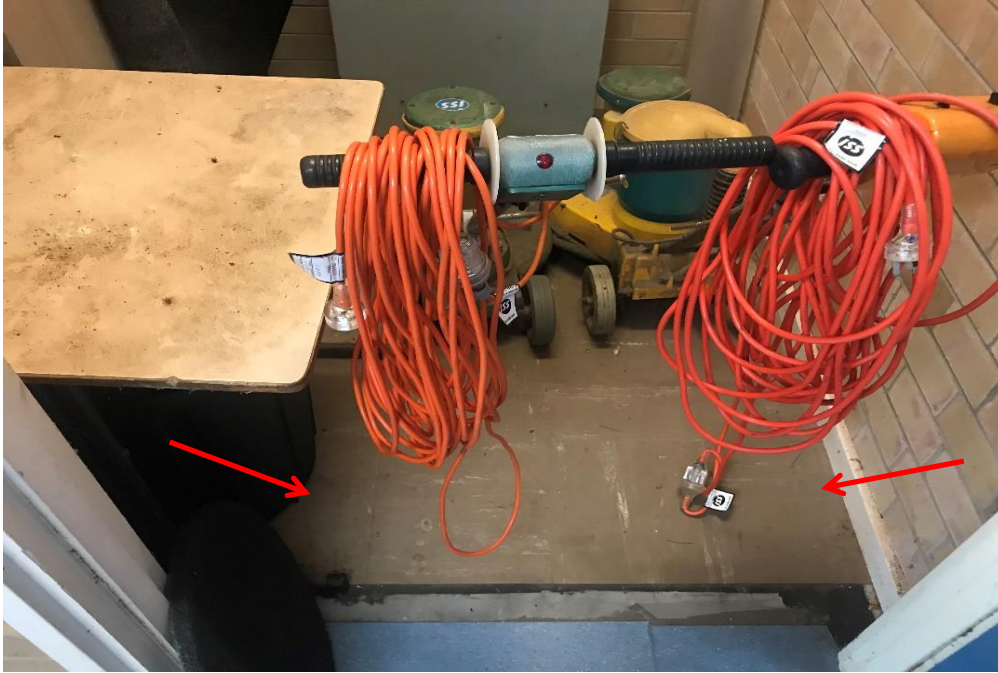
Photograph 11: Typical brown vinyl tile with white streaks to floors (including below carpets and vinyl sheeting), asbestos detected by analysis.

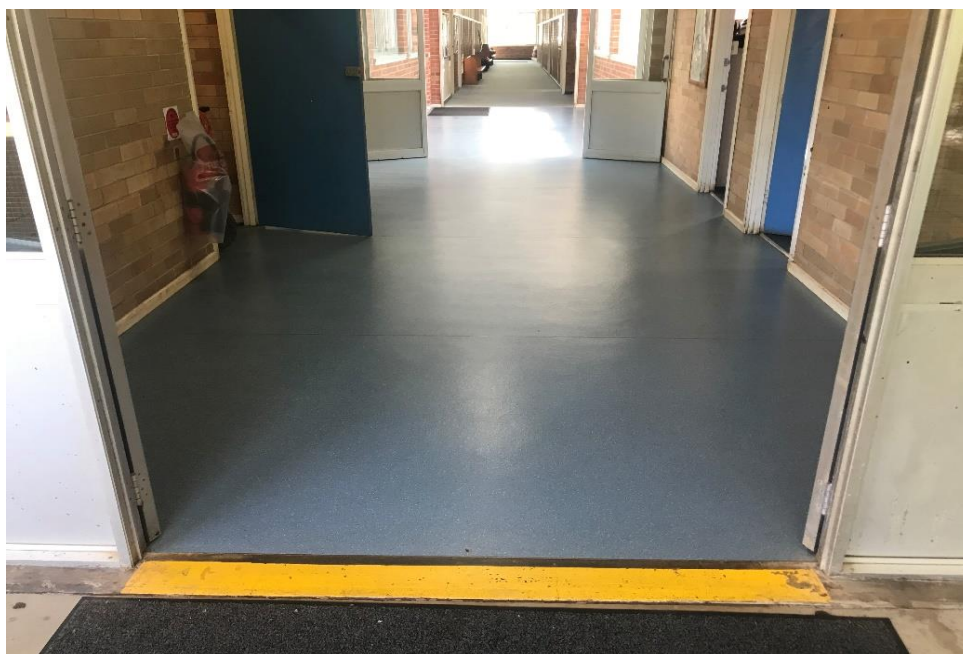
Photograph 18: B00L, LR1025, floor, below blue vinyl sheeting, vinyl tiles, asbestos detected by analysis.

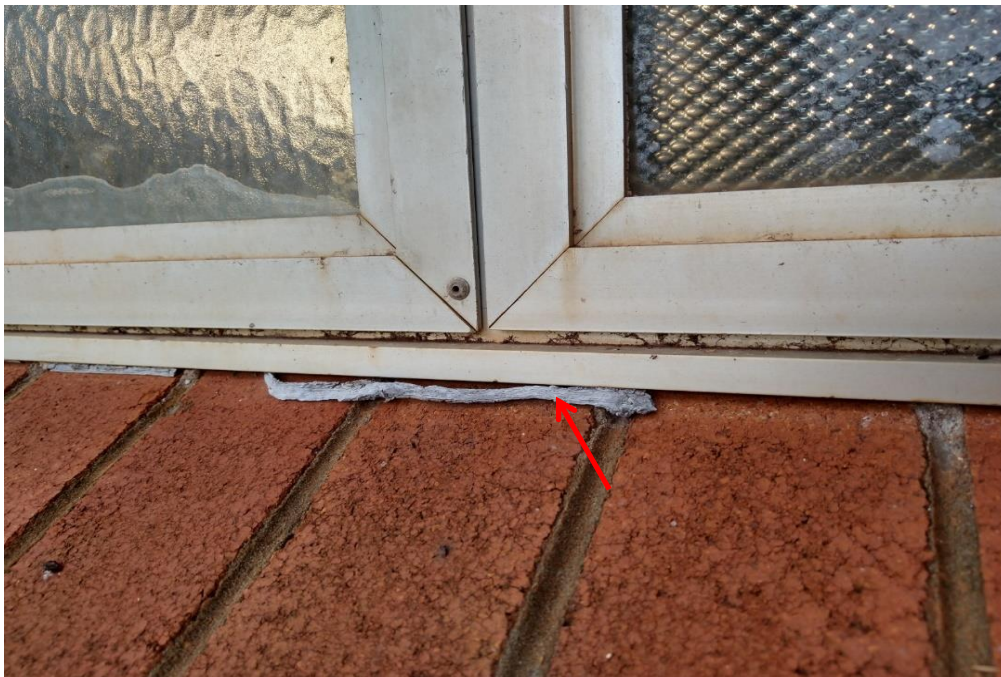
Photograph 4: B00T, exterior, window frames, putty/mastic, asbestos detected by analysis.

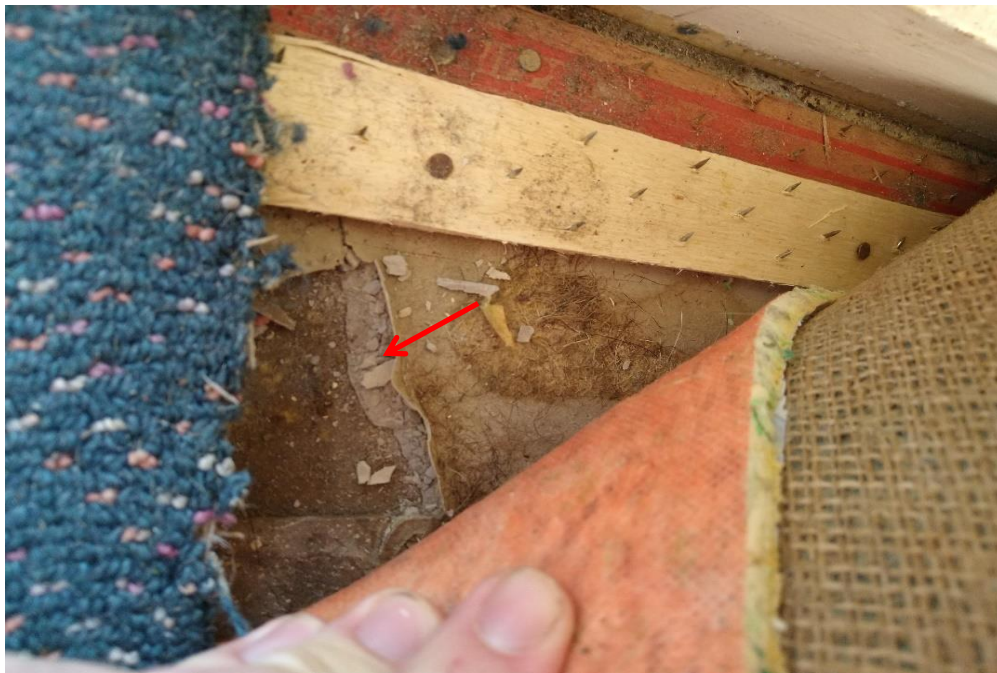
Photograph 6: B00T, R0018, under carpet, vinyl, asbestos detected by analysis.

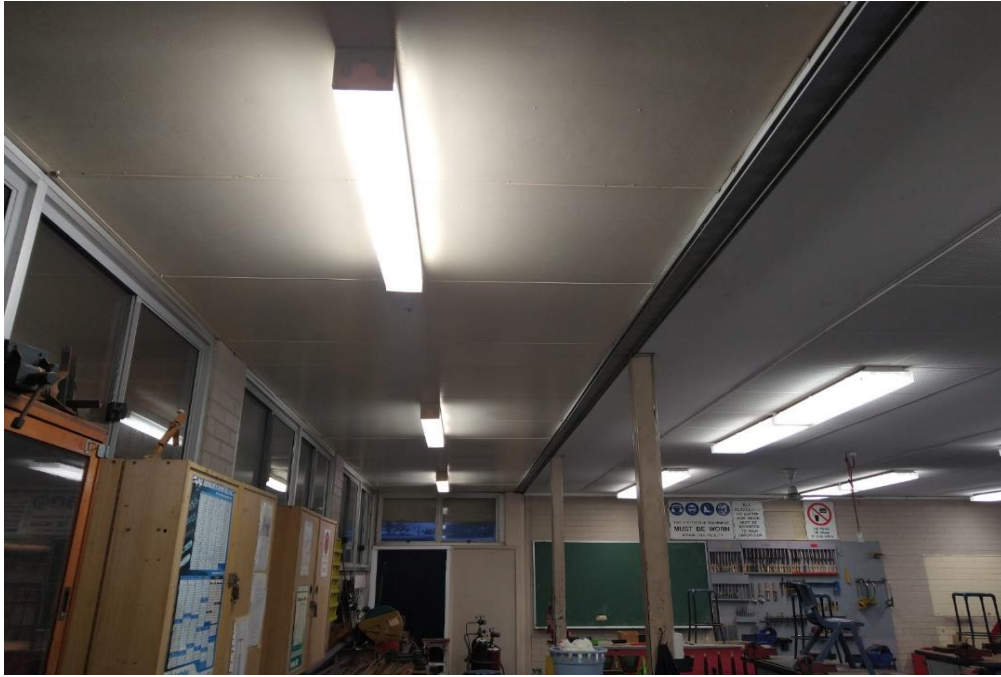
Photograph 7: B00T, R0014, ceiling panels along western side of room , fibre cement , asbestos detected by analysis.

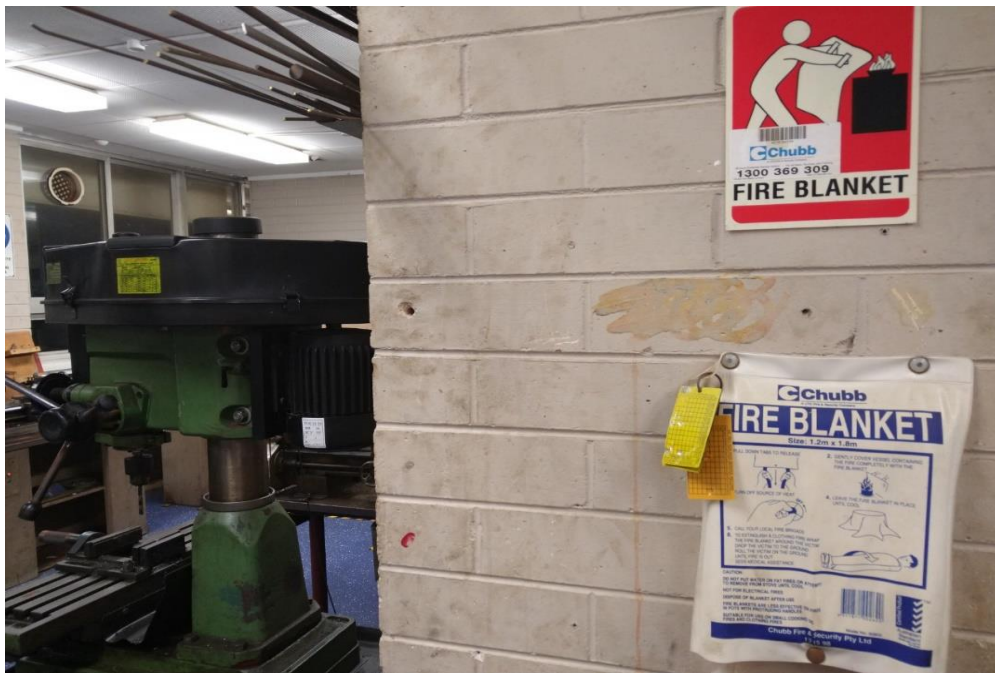
Photograph 8: B00T, R0014, walls, white/cream undercoats to walls, non-lead paint ( $\leq 0.1\%$  lead w/w).

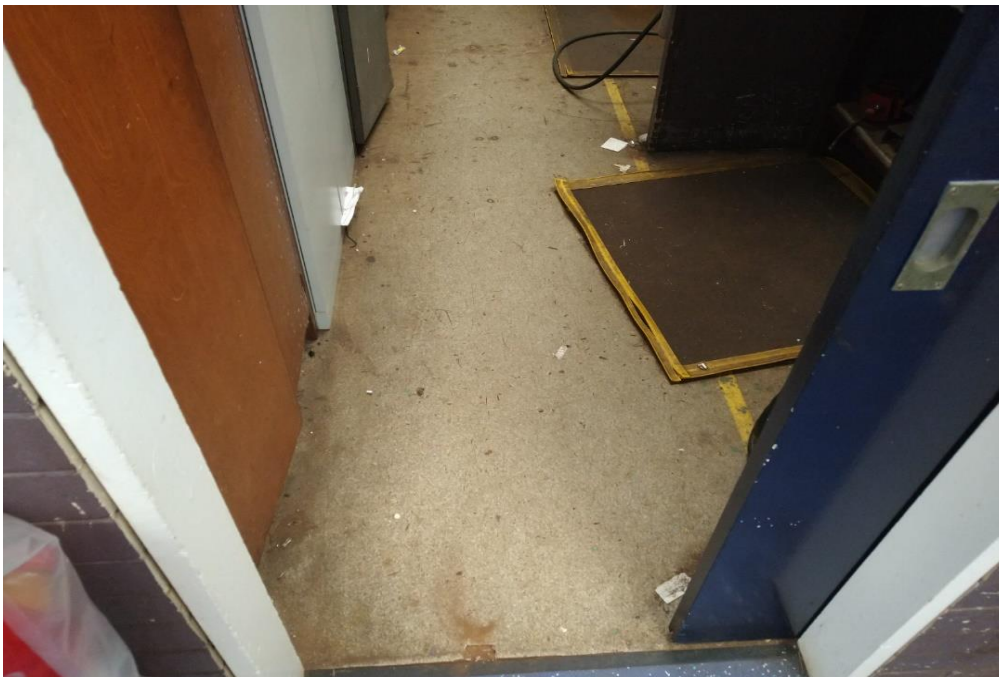
Photograph 10: B00T, R0006, flooring, vinyl flooring, asbestos detected by analysis.

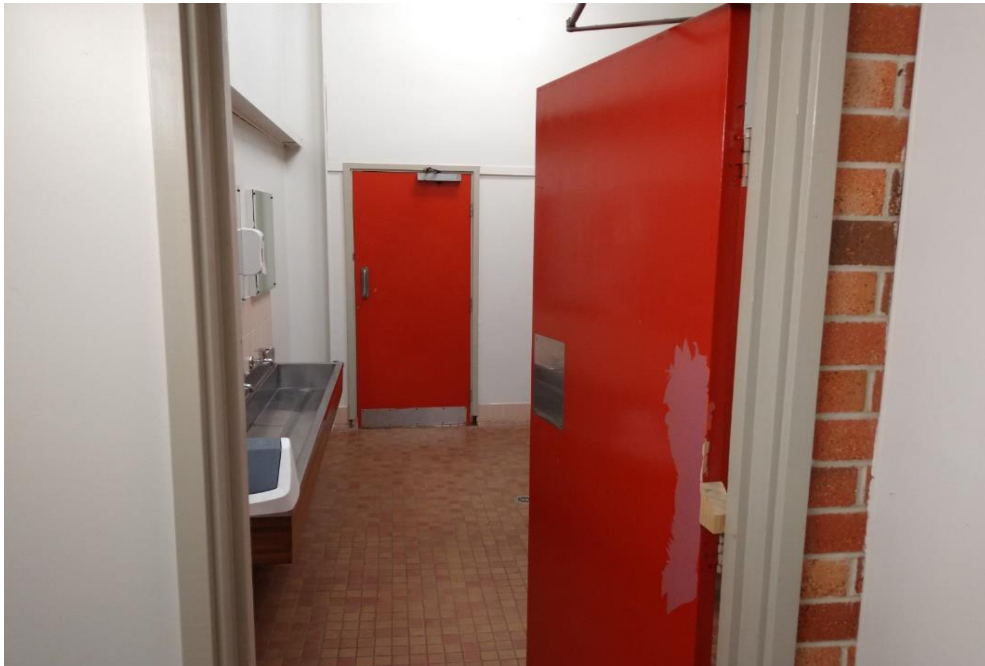
Photograph 5: BMPC, R0002, doors, red paint, non-lead paint (>0.1% lead w/w).

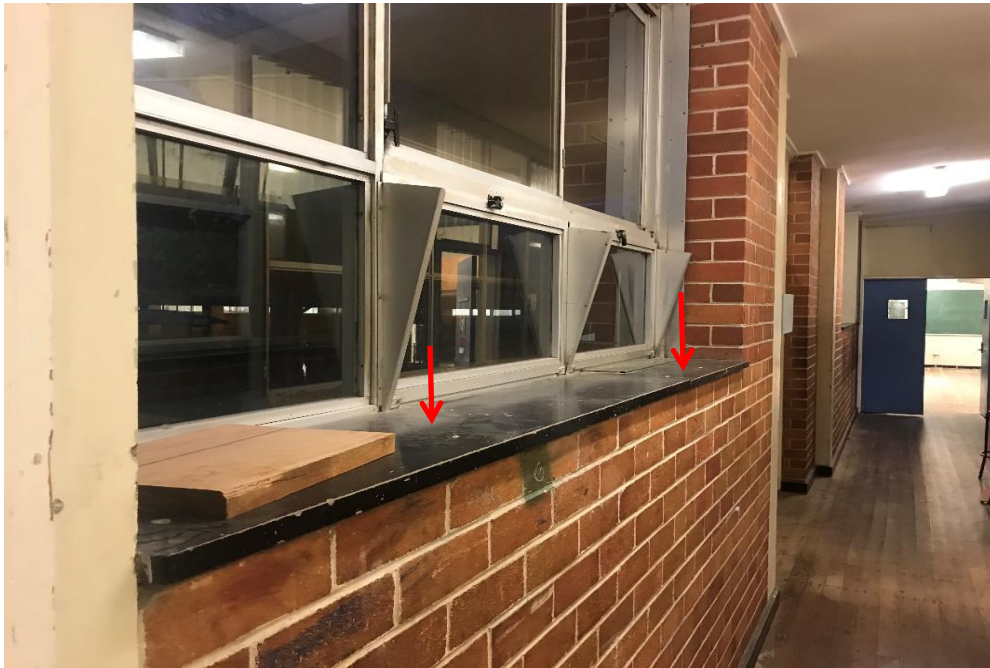
Photograph 1: BTAS, typical window sill lining(s), fibre cement, asbestos detected by analysis.

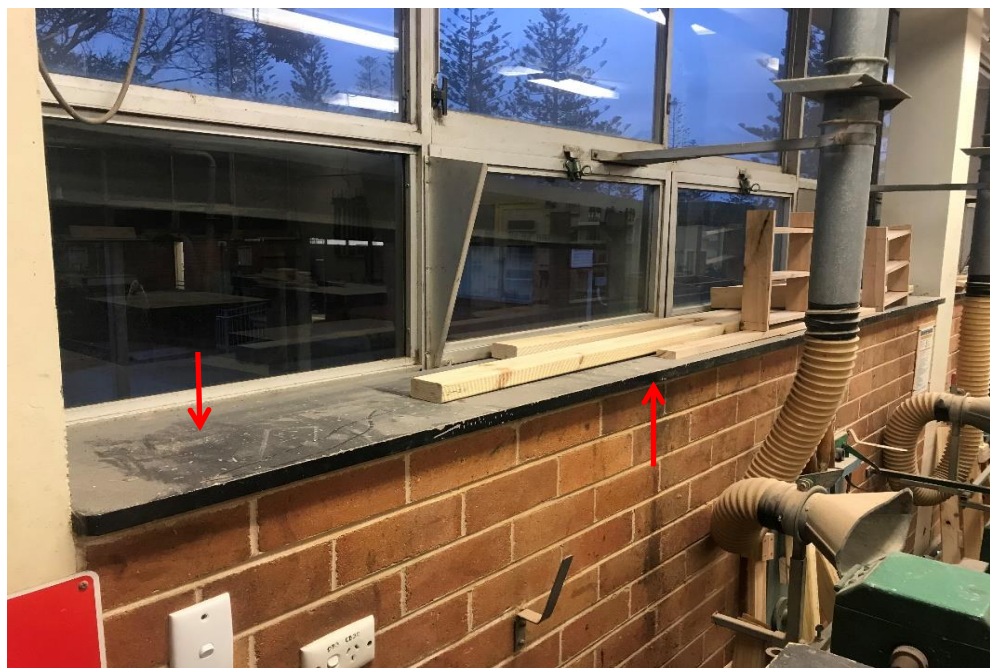
Photograph 2: BTAS, typical window sill lining(s), fibre cement, asbestos detected by analysis.

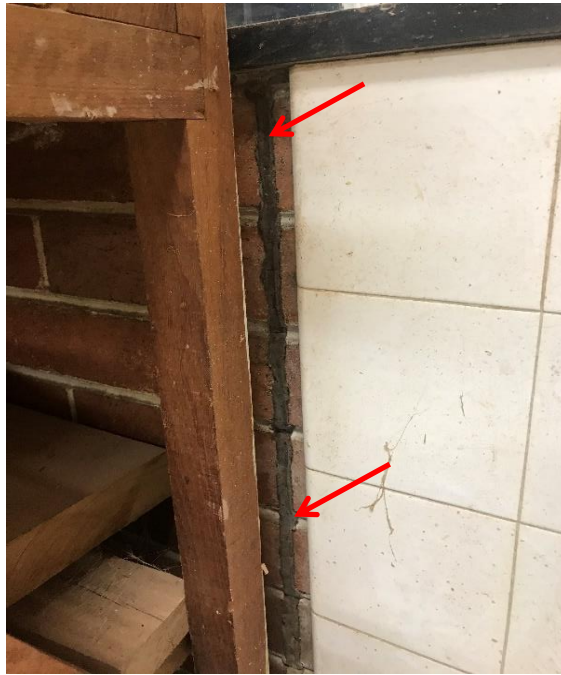
Photograph 7: BTAS, TAS-R0018, brick wall, expansion joint, mastic/sealant, asbestos detected by analysis.
