Hazardous Substances Management Plan

Newcastle Grammar School – Park Campus
Cnr. Union Street & Parkway Avenue
Cooks Hill NSW, 2300

May 2021

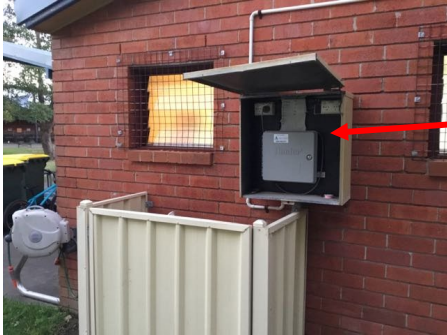
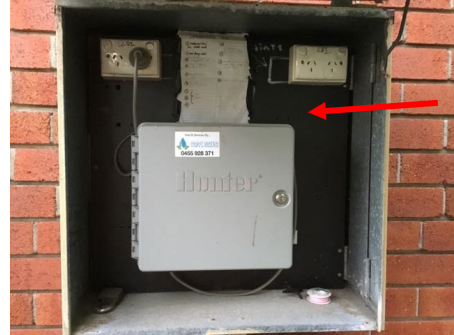
Admin/Library: Photo No. 001: Eastern elevation

- External – eastern elevation – electrical switchboard – Insulation Panel

The Insulation Panel to the electrical switchboard to the eastern elevation was presumed to contain asbestos and **as such SHALL be considered an asbestos-containing material until or unless it is proven otherwise.**

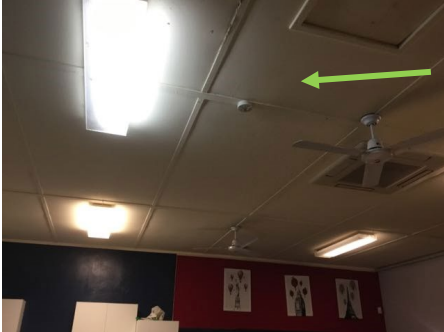
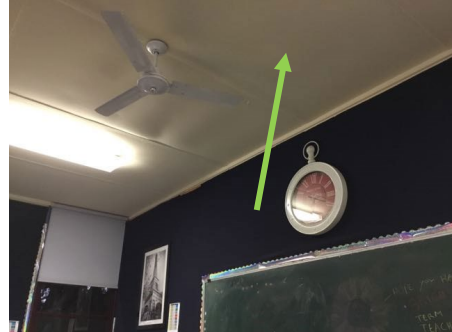
Photo No. 002: Throughout

The ceiling lining throughout was found to be Masonite®, a product known to be a manmade, timber-based proprietary product.

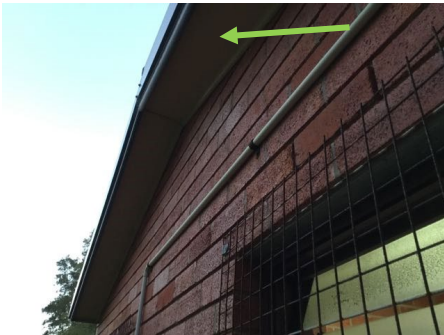
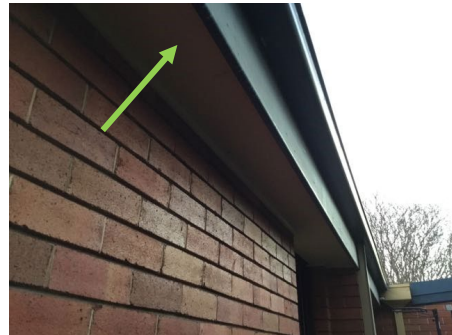
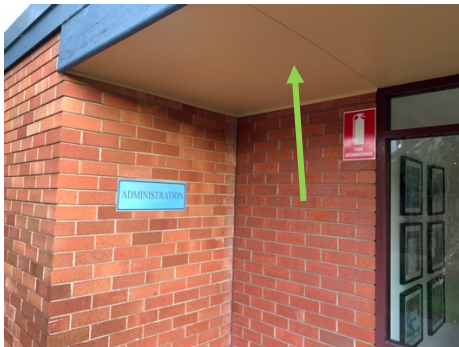
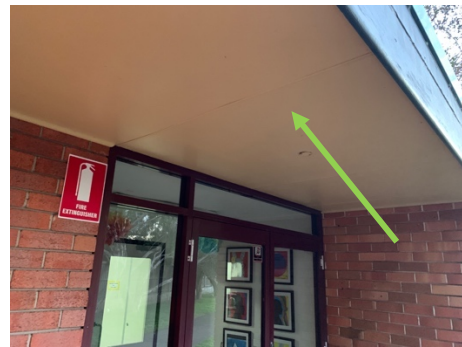
Photo No. 003: Eaves & Soffits

The Flat Fibre Cement Sheet soffit lining to the eaves was previously tested (by PES, 2014) and proved NOT to be an asbestos containing material.

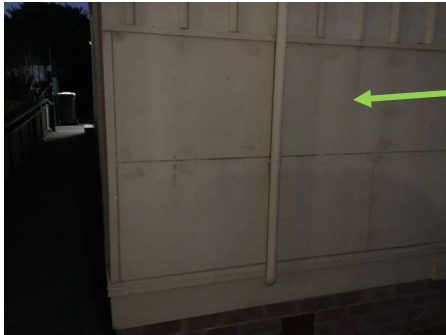
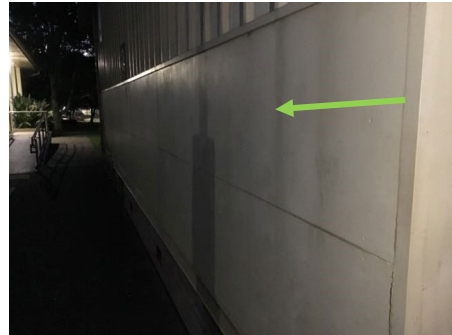
Photo No. 004: External

The Fibre Reinforced Cement cladding to the building's exterior was previously tested (by PES, 2014) and **proved NOT to be an asbestos containing material.**

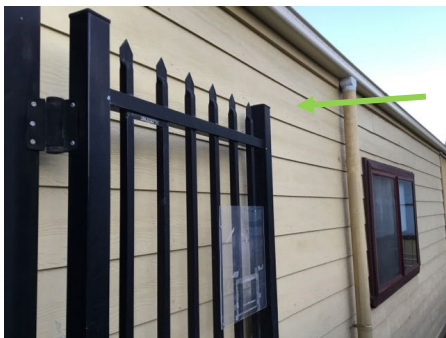
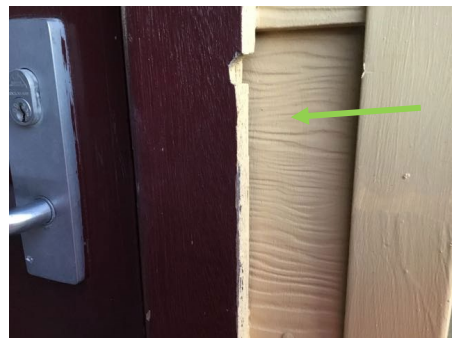
Photo No. 005: External

The Flat Fibre Cement Sheet external HardiPlank® wall board with a wood grain finish was previously tested (by PES, 2014) and **proved NOT to be an asbestos containing material.**

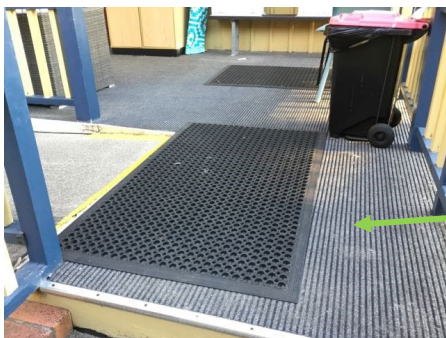
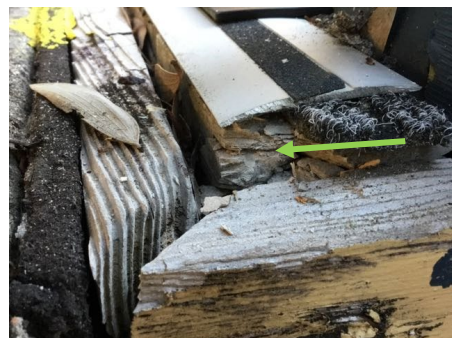
Photo No. 006: North-east elevation

The Fibre Reinforced Cement structural flooring to the north-east elevation was previously tested (by PES, 2014) and **proved NOT to be an asbestos containing material.**

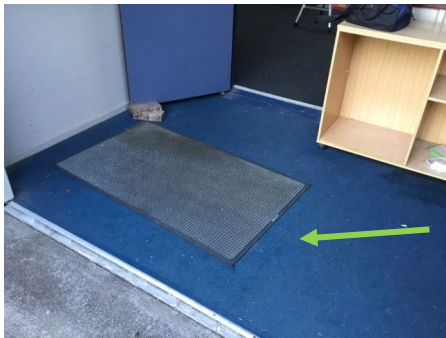
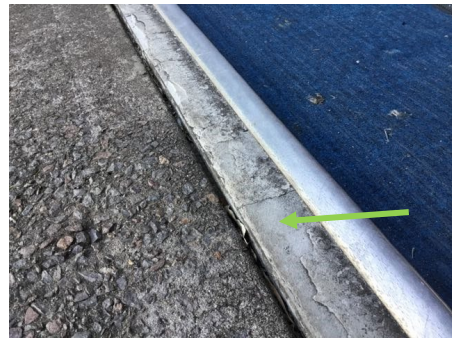
Photo No. 007: External western entry

The Fibre Reinforced Cement structural flooring to the western entry was previously tested (by PES, 2014) and **proved NOT to be an asbestos containing material.**

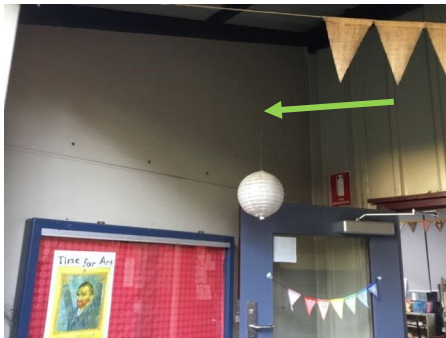
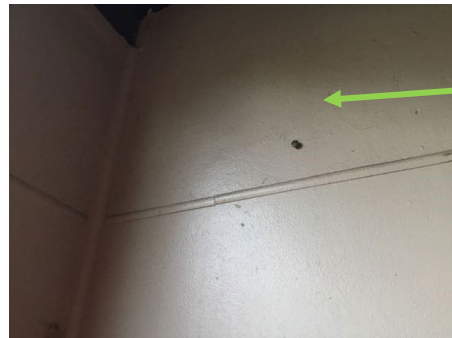
Photo No. 008: Western entry

The Flat Fibre Cement Sheet wall cladding in alcove to the western entry was previously tested (by PES, 2014) and **proved NOT to be an asbestos containing material.**

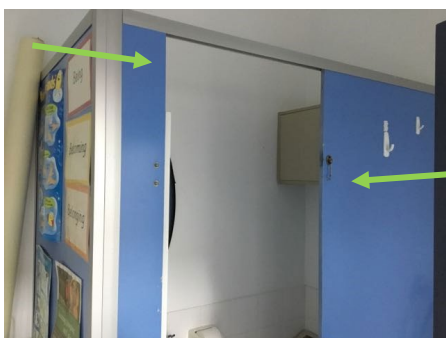
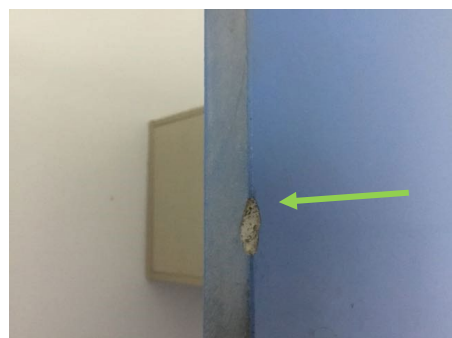
Photo No. 009: Bathroom

The Fibre Reinforced Cement blue partitions to the bathroom were tested (by PES 2021) and **proved NOT to be an asbestos containing material.**

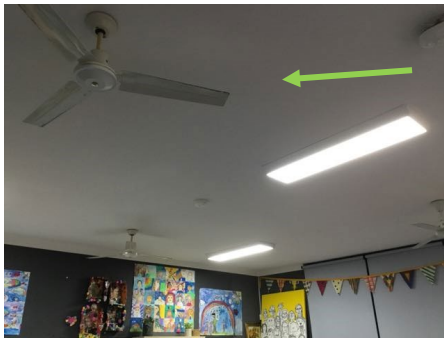
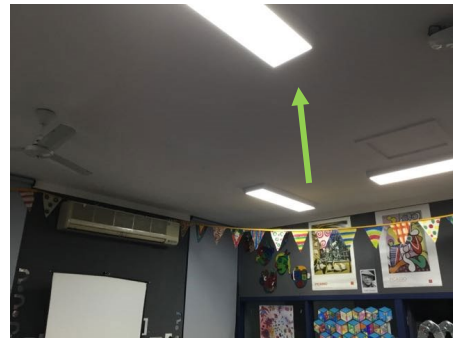
Photo No. 010: Ceiling void

Above the visible plasterboard ceiling lining is a secondary, remnant ceiling lining, which was found to be made of the timber-based proprietary product Masonite®, a non-asbestos-containing material.

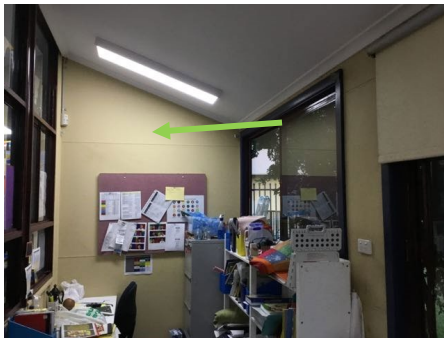
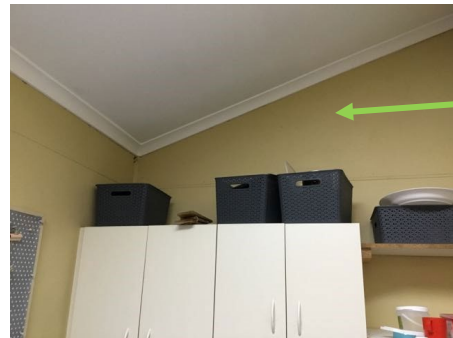
Photo No. 011: Kitchen

The Flat Fibre Cement Sheet wall lining to the kitchenette / office space was previously tested (by PES, 2014) and proved NOT to be an asbestos containing material.

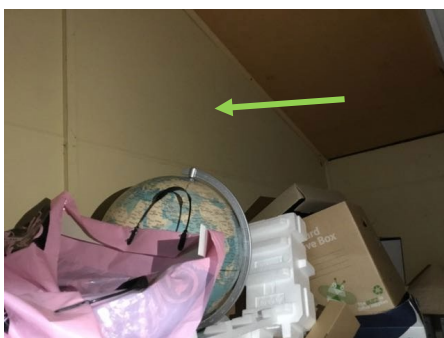
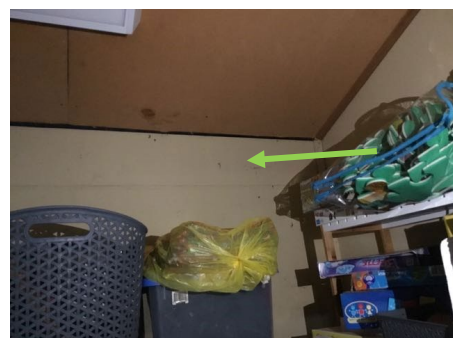
Photo No. 012: Storeroom

The Flat Fibre Cement Sheet wall lining to the storeroom was referred to a sample of like material in adjacent areas which proved NOT to be an asbestos containing material.

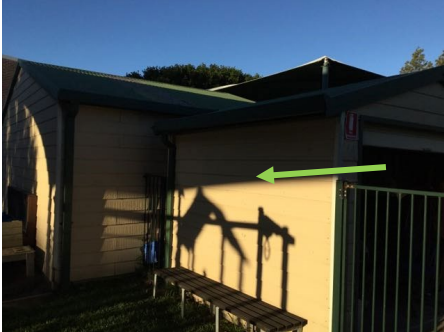
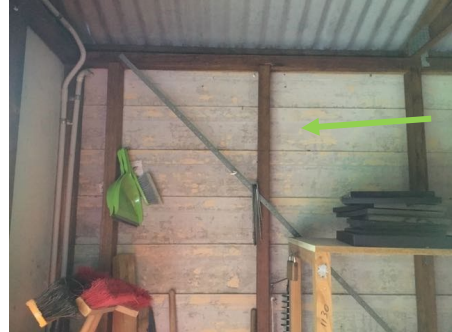
Photo No. 013: Hardiplank® wall cladding

The Flat Fibre Cement Sheet Hardiplank® cladding with wood grain finish was previously tested (by PES, 2014) and **proved NOT to be an asbestos containing material.**

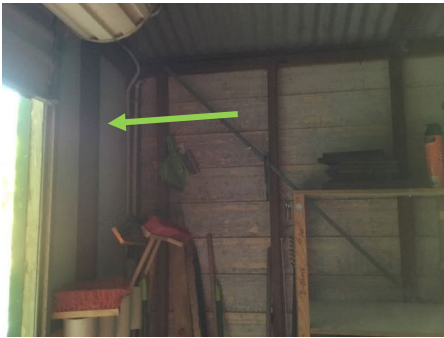
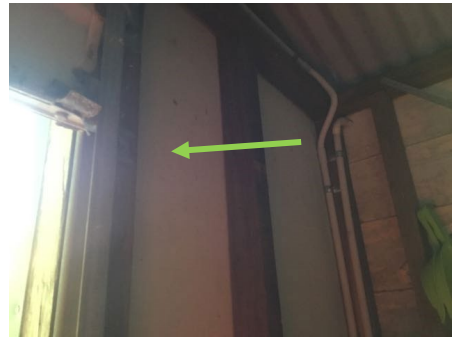
Photo No. 014: Inside left roller door

The Flat Fibre Cement Sheet wall lining to the inside left roller door was tested (PES 2021) and **proved NOT to be an asbestos containing material.**
