**State Significant Development (SSD No 15788005): Hazardous materials survey of existing aboveground buildings.**

**HAZARDOUS MATERIALS REGISTER  
AND ASBESTOS MANAGEMENT PLAN  
JINDABYNE SPORTS & RECREATION  
CENTRE  
THE BARRY WAY  
JINDABYNE NSW 2627**

Prepared for: Office of Communities  
Project Ref: ENAURHOD06240AA-Jindabyne  
Report Date: 16 December 2013

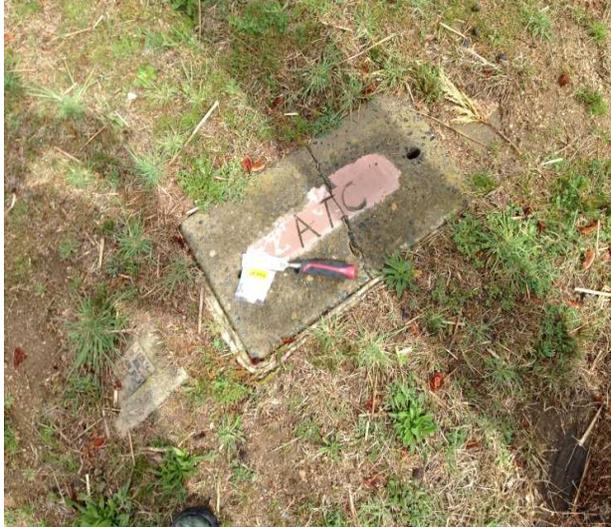
**Photograph 1:** Asbestos cement - External: adjacent to the main road through the site – telecommunication pit linings – **CH, AM**

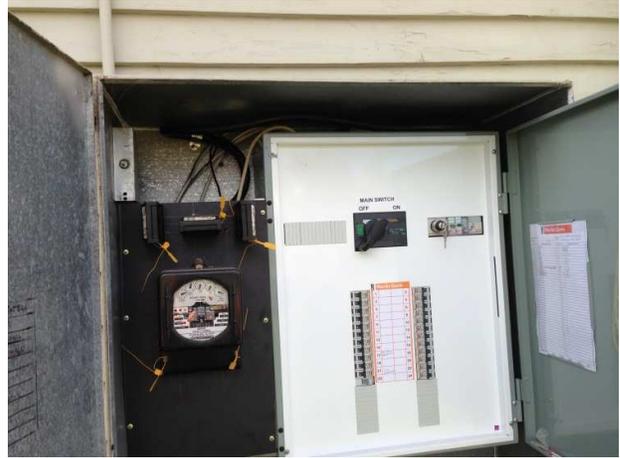
**Photograph 2:** Bituminous (black) electrical backing board - External: West side of facility in mounted metal box - **CH**

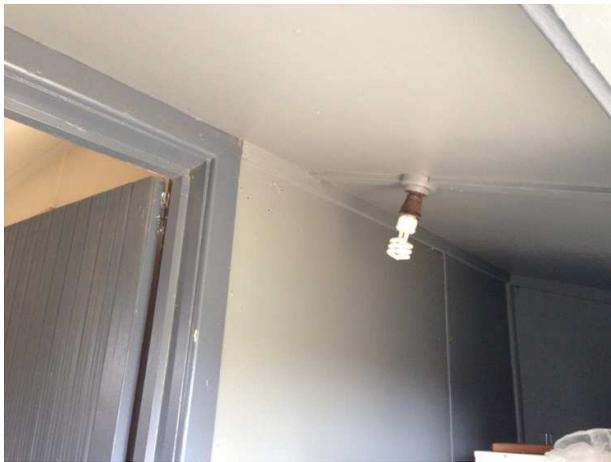
**Photograph 3:** Asbestos cement wall cladding (painted) – Clinic, External: North side porch – **CH, AM, CR**

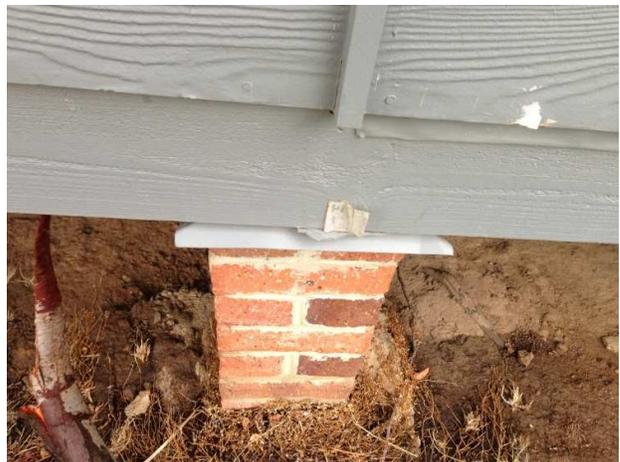
EP-133	CH, AM, CR	-	Asbestos cement levelling chocks	External: On top of Building footing	N	1	1	1	1	1	1	1	1	8	A3	3 m <sup>2</sup>	
Label/sign locations and			Label. Do Not disturb. Re-inspect at designated intervals. Encapsulate broken edges.

**Photograph 4:** Asbestos cement levelling chocks – TAFE, External: On top of Building footing – **CH, AM, CR**

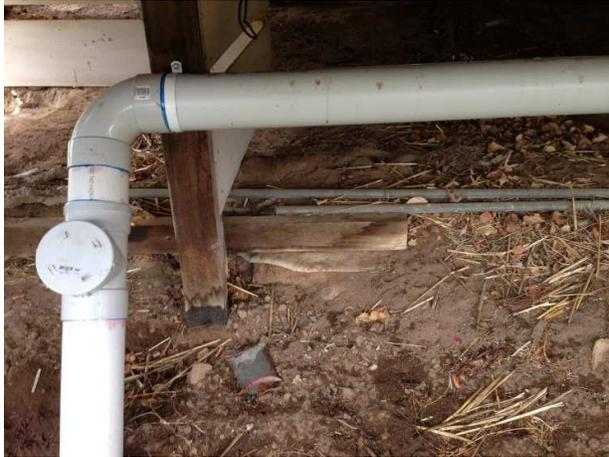
**Photograph 5:** Textile (hessian) – Hydro hut, External: beneath building – insulation lining to pipe work

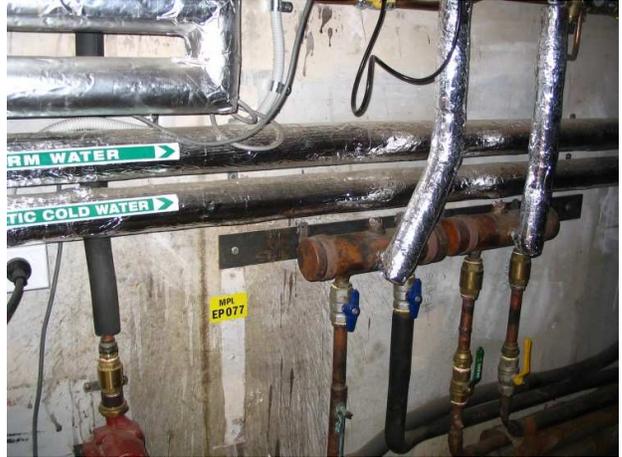
**Photograph 6:** Asbestos cement wall lining – Snow Gums Lodge, Basement 1; Boiler Room - CH

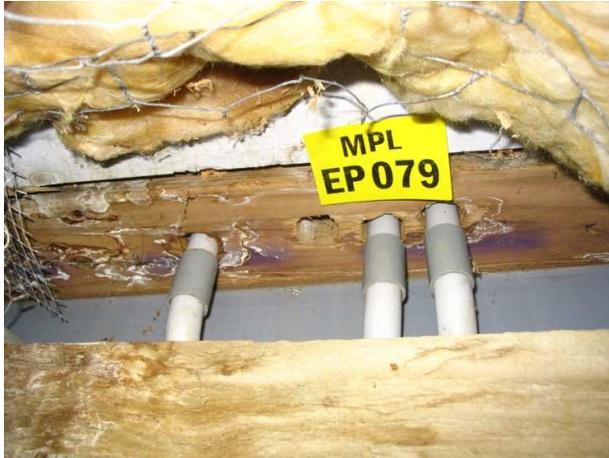
**Photograph 7:** Compressed asbestos cement floor slab – Snow Gums Lodge, Basement 1; Boiler Room and upper levels - CH

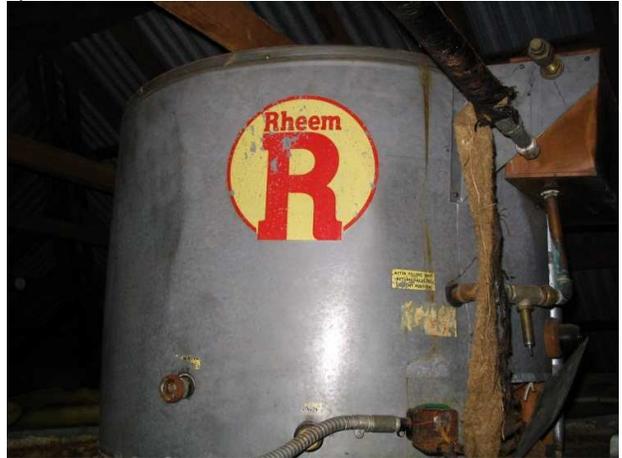
**Photograph 8:** Suspect asbestos insulation within old 'Rheem' hot water service – Staff Cottage 7, Internal: Ceiling space

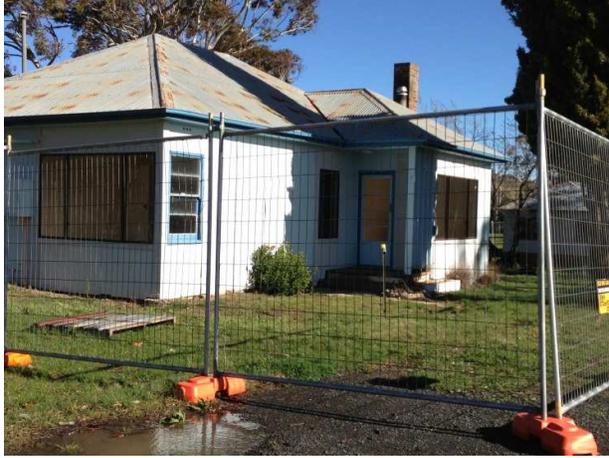
Refer to EP-092	CH, CR	9	Asbestos cement walls, joinery and eaves lining (painted)	External: All elevations of cottage	N	3	1	0	0	1	0	0	1	6	A4	160 m <sup>2</sup>		
Label/sign locations and recommendations			Label. Do Not disturb. Re-inspect at designated intervals.															
Refer to EP-094	CH, CR	-	Asbestos cement walls lining	Internal: Throughout	N	3	1	0	0	1	0	0	1	6	A4	180 m <sup>2</sup>

**Photograph 9:** Asbestos cement walls, joinery and eaves lining (painted) – Staff Cottage 7, External: All elevations of cottage – CH, CR

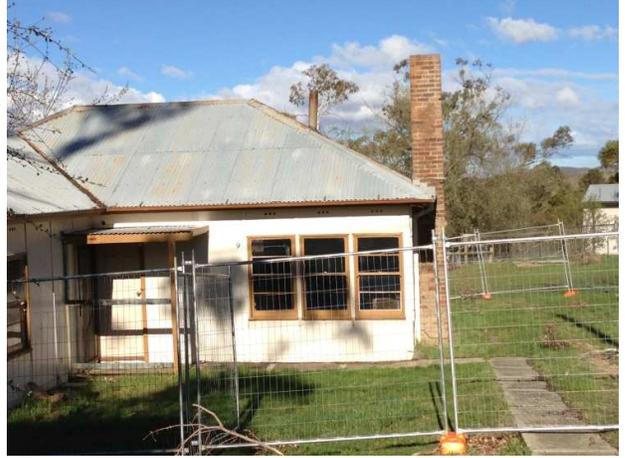
**Photograph 10:** Asbestos cement walls, joinery and eaves lining (painted) – Staff Cottage 9, External: All elevations of cottage – CH, CR

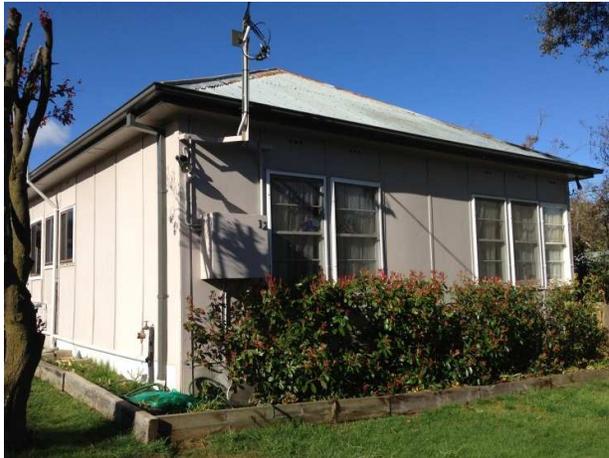
**Photograph 11:** Bituminous (black) electrical backing board - External: South side of Staff Cottage 12, in mounted metal box - CH

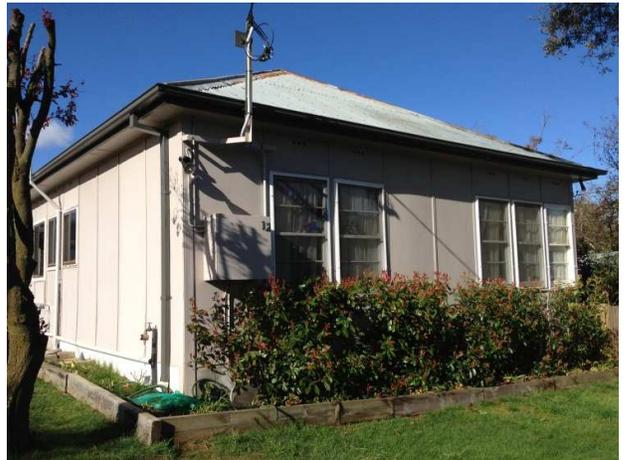
**Photograph 12:** Asbestos cement walls, joinery and eaves lining (painted) – Staff Cottage 12, External: All elevations of cottage – CH, CR

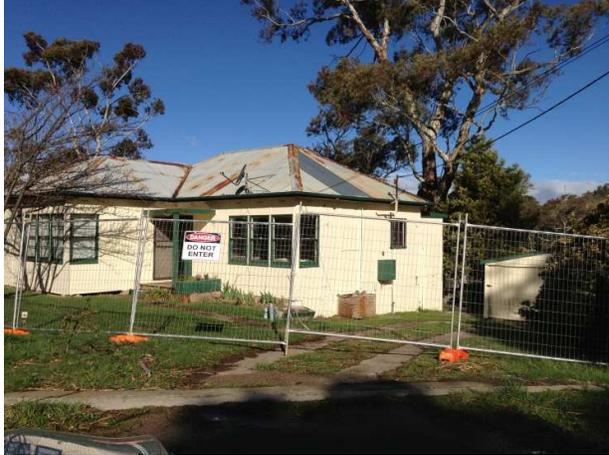
**Photograph 13:** Asbestos cement walls, joinery and eaves lining ( painted) – Staff Cottage 13, External: All elevations of cottage (excluding rear extension) - **CH, CR**

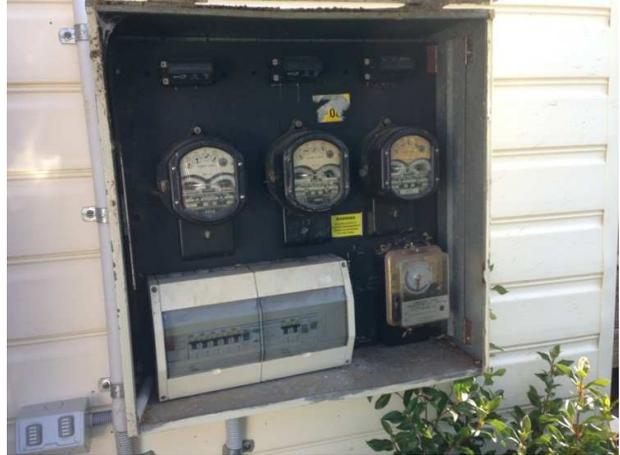
**Photograph 14:** Bituminous (black) electrical backing board - External: North side of Cottage in mounted metal box - **CH**

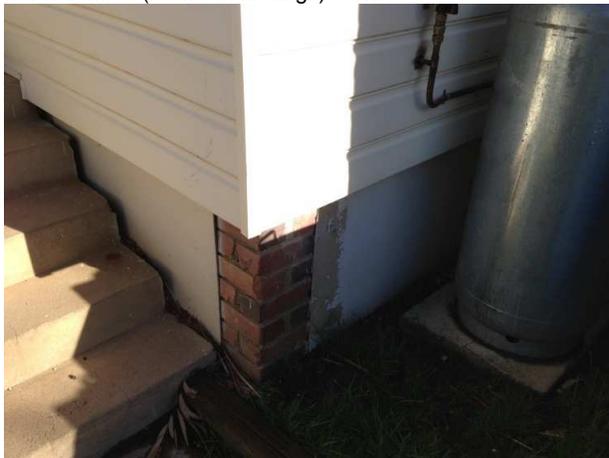
**Photograph 15:** Asbestos cement infill panels (painted) – Staff Cottage 17, External: North, east and west sides – lower section (between footings) - **CH**

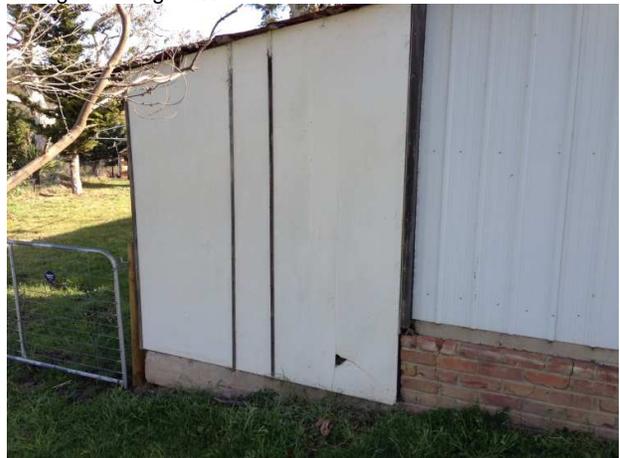
**Photograph 16:** Asbestos cement wall cladding (painted) – Staff Cottage 17, External: Garage facility to the rear of the cottage building - **CH**

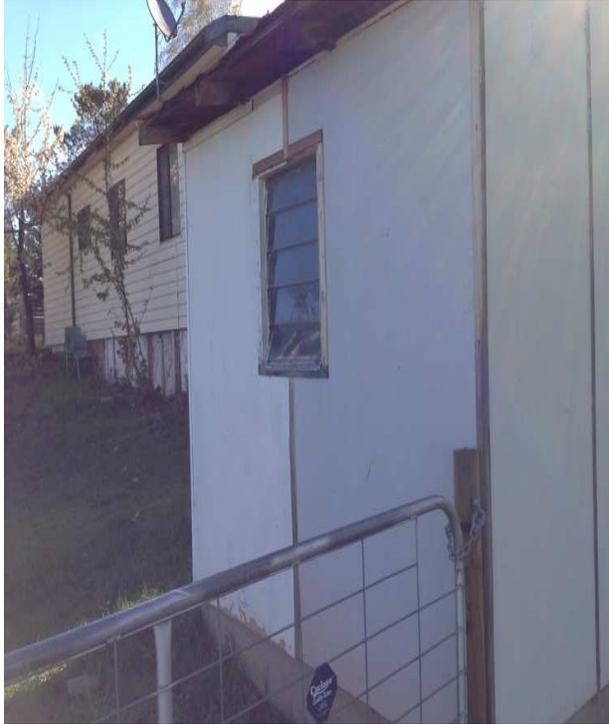
Label/sign locations and recommendations			Label. Do Not disturb. Re-inspect at designated intervals.														
EP-086	CH	17	Asbestos cement wall lining (painted)	To the external shed: One sheet only	N	1	1	0	0	1	0	0	1	4	A4	2 m <sup>2</sup>	(Variation on material sampled as EP-086 (Above))
Label/sign locations and recommendations			Label. Do Not disturb. Re-inspect at designated intervals.														
EP-090	CH	-	Asbestos insulation board panel	Internal: Dining room backing to Rinnai gas fire	N	1	1	0	0	1	0	0	1	4	A4	1 m <sup>2</sup>	
Label/sign locations and			Label. Do Not disturb. Re-inspect at designated intervals.

**Photograph 17:** Asbestos cement wall lining (painted) - To the external shed, Staff Cottage 17: One sheet only - **CH**

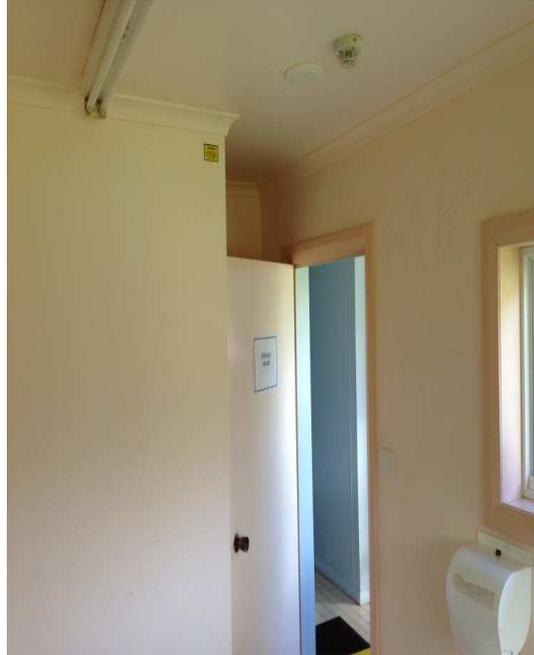
**Photograph 18:** Asbestos cement wall and ceiling lining (older sheets only) – Lodge 5 Internal: Throughout Toilet block – **CH, AM, CR**

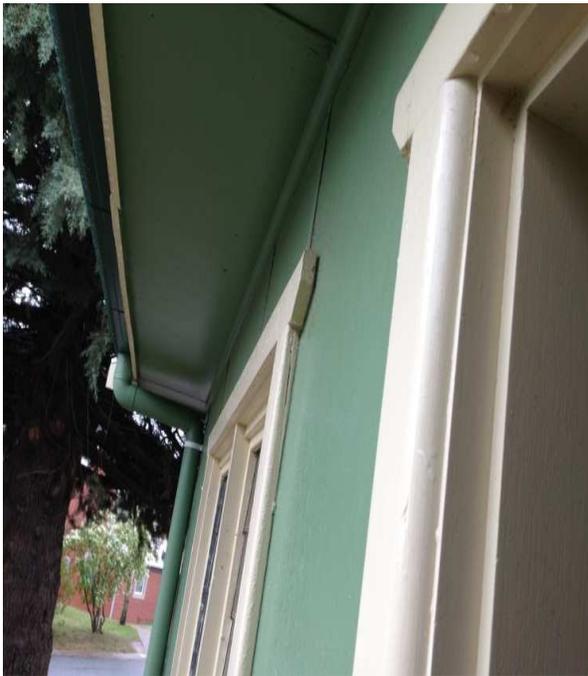
<b>Asbestos Containing Materials</b>																		
EP-127	CH, AM, CR	19	Asbestos cement wall cladding and eaves lining	External: Various locations mixed with EP-126 (above)	N	3	1	0	0	1	0	0	1	6	A4	30 m <sup>2</sup>		
Label/sign locations and recommendations			Label. Do Not disturb. Re-inspect at designated intervals.

**Photograph 19:** Asbestos cement wall cladding and eaves lining – Lodge 6, Laundry, External: Various locations mixed with EP-126 (above) – **CH, AM, CR**

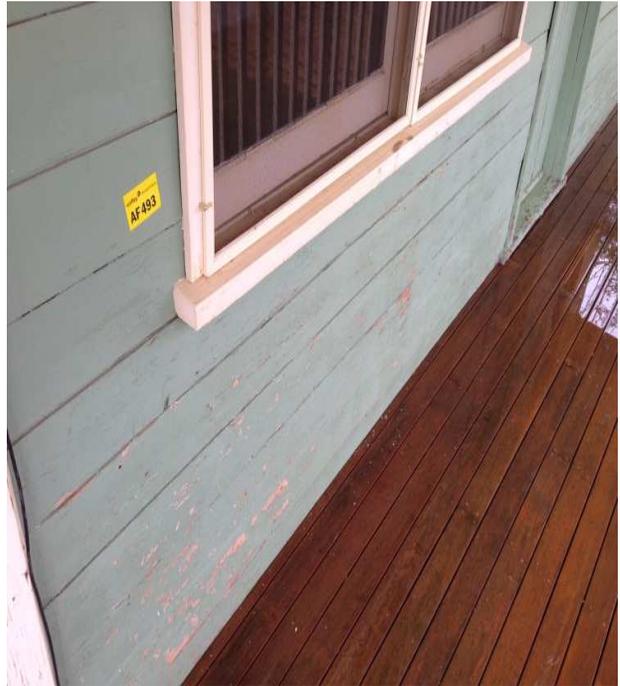
**Photograph 20:** Paint (pale green) – Lodge 6, External: toilet block – paint to external walls – **Pb**

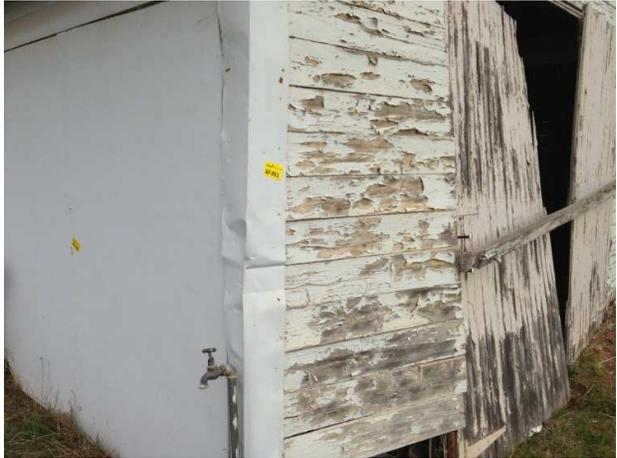
**Photograph 21:** Paint (white) – Mattress and Salvage Store, External: perimeter of store – paint to walls and window frames - **Pb**
