MU GROUP CONSULTING PTY LTD

Road Safety Audit Report

**Mixed-Use Development,
Hills Showground Station Precinct**

Issue 2: June 2021

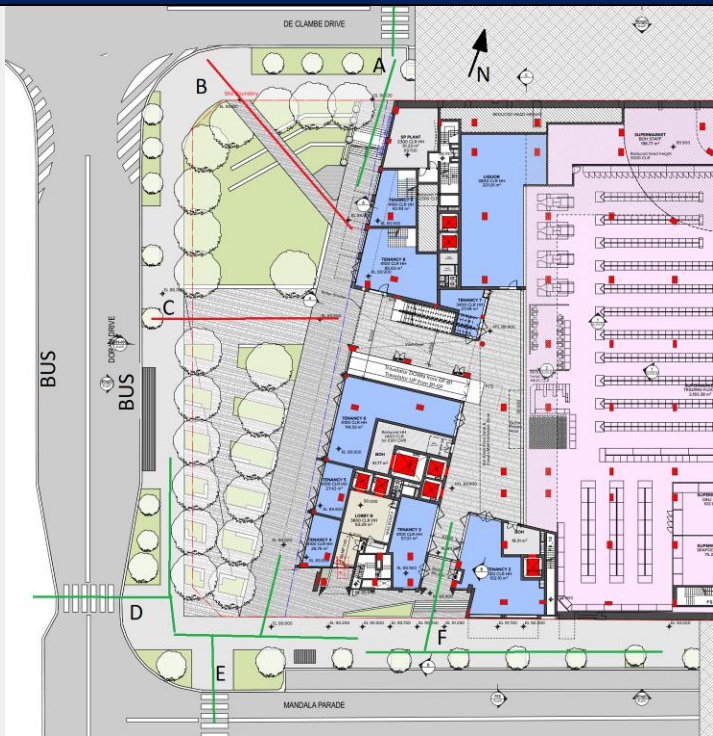
<p>Above: Extract from the ground level plan showing the various pedestrian access-egress points from the mixed-use development.</p>	<p>The mixed-use development will have several access-egress points for pedestrians. These may influence pedestrian-decisions on road crossing movements, including whether they conform and use designated zebra crossings, or resort to jaywalking. Jaywalking movements introduce the risk of <i>vehicle-pedestrian</i> crashes. They may also involve pedestrians emerging into moving traffic from obscured locations such as from behind sight-obstructing trees or stopped/parked vehicles and buses.</p> <p>Examples of pedestrian crossing decisions are discussed as follows (following page) with respect to the design extract (ground floor level) to the left.</p>	Pedestrian infrastructure	Yearly	Serious	Medium

Ref No.	Corrective Action Response (CAR)	Priority for action (To be completed by Project Manager)	Residual risk (if any)
1	Publicly accessible plaza has been redesigned to conduct the pedestrians to the safe crossing points.	Immediate	N/A
2	Pedestrian sight lines and car sightlines have been incorporated.	Immediate	N/A
3	Mirrors and flashlights have been provided.	Immediate	N/A
4	Truck size has been decreased to 12.5m from 17.5m. This has a positive result on the swept path of the trucks existing the loading dock.	Immediate	N/A
5	Trees will be regularly maintained to ensure sightlines are not interrupted.	Immediate	N/A
Project Manager / Sponsor Name		Poonam Chauhan	Signature
Concurring Client Name		Greg Colbran	Signature

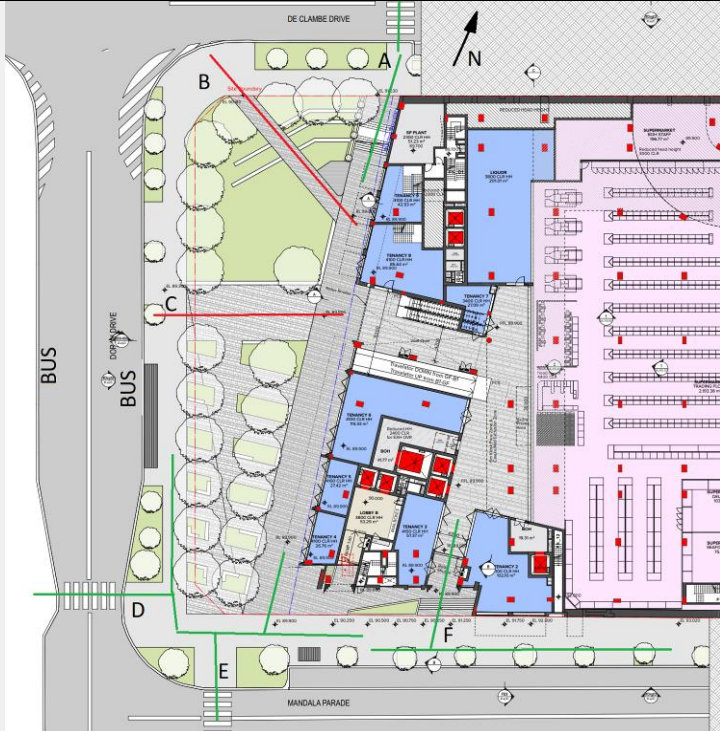
<p>Above: Extract from the ground level plan showing the various pedestrian access-egress points from the mixed use development.</p>	<ul style="list-style-type: none"> The main north-south walkway at the western end of the site offers good connections to the zebra crossings at A, D and E and as such, the zebra crossing layout and the walkway are complementary. By contrast, the walkway leading to the Doran Drive/ De Clambe Drive intersection (point B) leads pedestrians to a point which is quite distant from any marked foot crossing. Pedestrians may resort to uncontrolled crossing movements over this intersection. The walkway to point C would be advantageous for pedestrians moving to or from buses at this bus stop. However, there are no other convenient onward journeys from this point. Similarly, the staircase at F leads pedestrians to the indented parking bay, but is quite distant from the zebra crossing at E. Pedestrians emerging at this point may resort to jaywalking. This includes those moving to the railway station on the southern side of Mandala Parade. 	Pedestrian infrastructure	Yearly	Serious	Medium

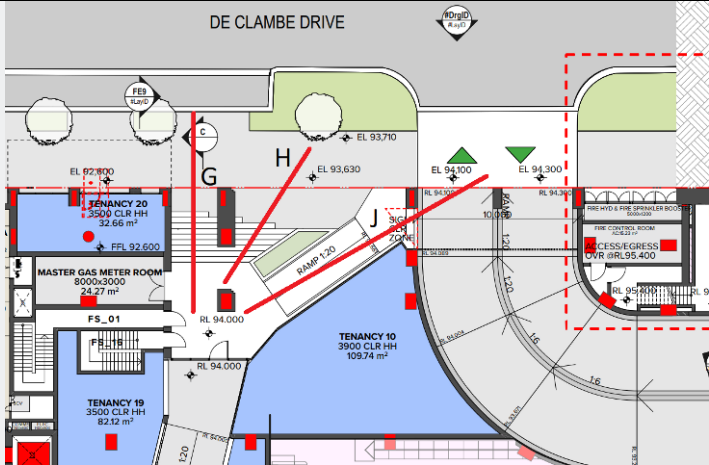
<p>Above: Extract from the upper-level plan showing the various pedestrian access-egress points from the mixed use development to De Clambe Drive.</p>	<p>Further to item 1a, there are also pedestrian access-egress points from the upper level.</p> <p>Examples of pedestrian crossing decisions are discussed as follows with respects to the design extract (upper floor level) to the left.</p> <ul style="list-style-type: none"> The 1:20 ramp from RL 94.000 to the southern footpath of De Clambe Drive leads pedestrians directly into the outbound lane from the basement car park. If the clear sight triangle/ zone is unobstructed (ie. clear space), this may even allow pedestrians to emerge suddenly into the path of the outbound vehicle. The pedestrian may also resort to a diagonal and prolonged crossing path over the driveway ramp. This would have increased exposure to vehicle-pedestrian crashes. Further to the above point, even if the pedestrian enters the footpath first before crossing the driveway, they may emerge from behind the sight-obstructing column (red rectangle). The column may obscure them from the visibility of outbound drivers. 	Pedestrian infrastructure	Yearly	Serious	Medium

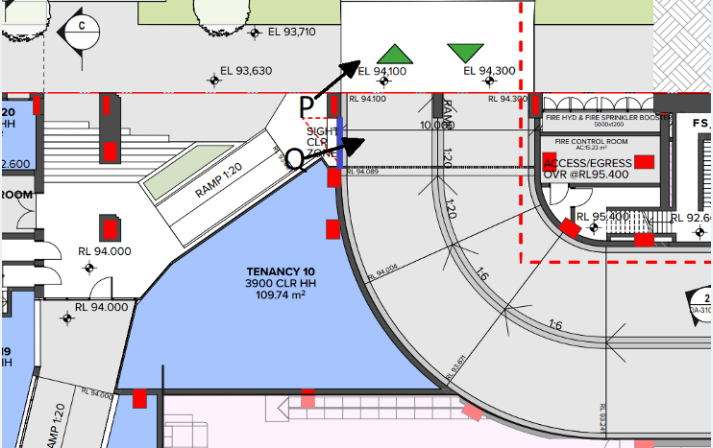
<p>Above: Pedestrians emerging into the car park ramp at point Q would emerge into the ramp from behind a concealed wall.</p>	<p>The design for the upper-level shows that a sight clear zone (triangle) will be provided at the end of the ramp from the basement car park. This sight triangle is intended to improve advanced visibility from outbound drivers and pedestrians that emerge in front of the ramp as per walk-path "P". With this advanced visibility, the outbound driver can adjust their speed accordingly.</p> <p>However, the sight triangle does not provide the same advanced visibility to pedestrians that emerge along the walk-path "Q". These pedestrians would be effectively entering from a concealed location ("blind corner"). This could increase the risk of <i>vehicle-pedestrian</i> crashes. Ideally, the gap between P and Q should be see-through to achieve the sight triangle, but it should not be penetrable. This suggests that the gap P-Q should be treated with Perspex or a see-through fence.</p>	Pedestrian infrastructure	Yearly	Serious	Medium

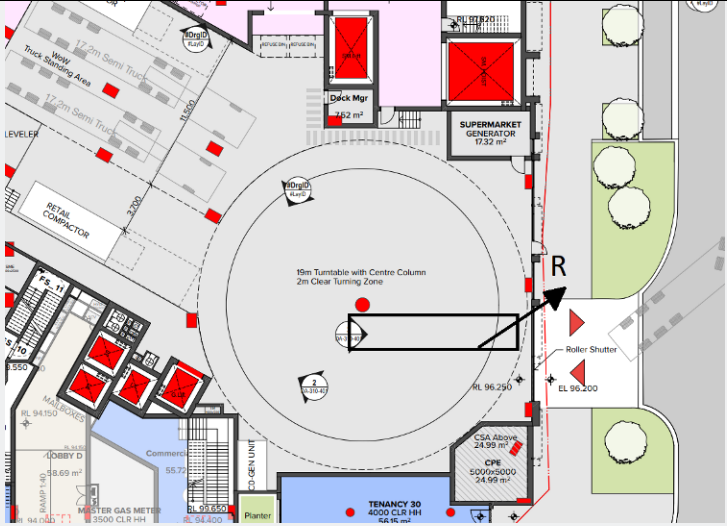
<p>Above: An egressing driver at the loading dock (off Andalusian Way) may have limited visibility to pedestrians on the footpath due to the sight-obstructing walls either side.</p>	<p>The image to the left is an extract of the design for Level 1 including the loading dock access-egress via Andalusian Way. There appears to be a sight-obstructing wall adjacent to the access-egress driveway. This may obstruct the sight line from an egressing driver to a pedestrian on the footpath. Any pedestrian at point R, moving towards the driveway could be exposed to impacts by the egressing vehicle. Also, as most of the vehicles using this facility would be trucks, these vehicles often have poor driver sightlines to the sides and rear of the vehicle. Pedestrians standing close to or moving towards or around the vehicle could be exposed to impacts. The audit team is uncertain of whether any additional safeguards or warning devices will be used, such as boom arms, flashing lights and beacons.</p> <p>The risk to pedestrians is exacerbated since most egressing truck drivers would be required to stop at the kerbline to assess for gaps in Andalusian Way. This prolongs their presence in the area between the turn table and the trafficable area of Andalusian Way.</p>	Pedestrian infrastructure	Yearly	Serious	Medium
