**2 MANDALA PARADE, CASTLE HILL
(DORAN DRIVE PRECINCT)
PRE-DILAPIDATION REPORT
Of Sydney Metro and Hills Shire Council Assets
DEICORP PROJECTS SHOWGROUND
PTY LTD.**

Job No. 200124.3
07/07/2021

ACE Structural Services Pty Ltd

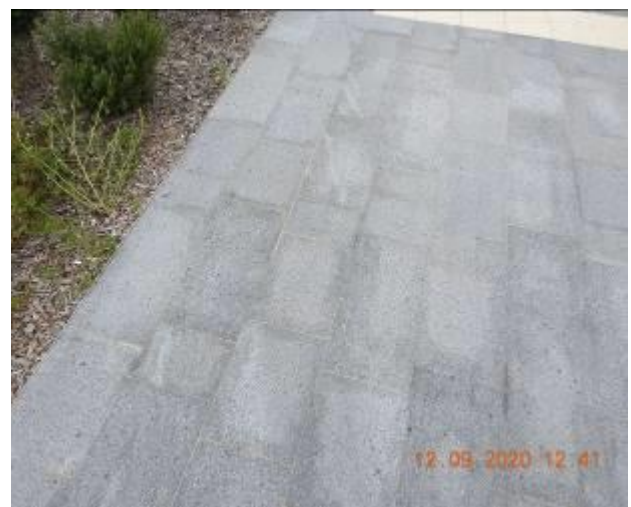
Figure 5 – General condition of footpath pavement

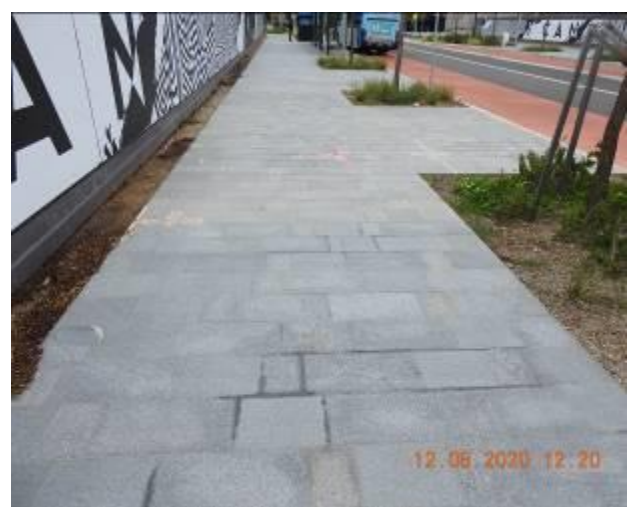
Figure 477 – Efflorescence, crack propagation and loss of material through footpath pavement

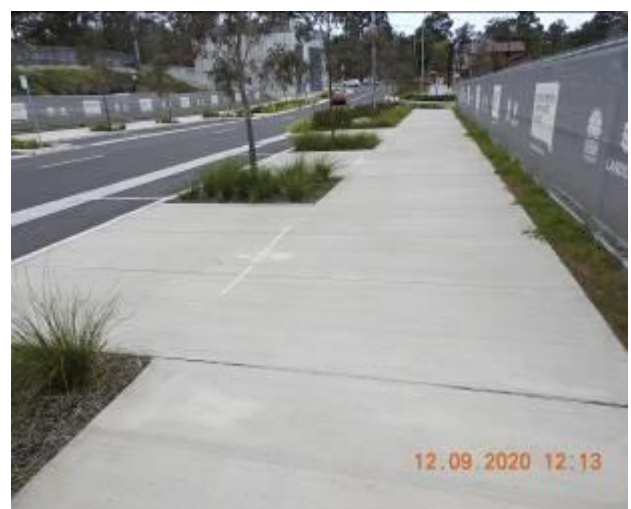
Figure 886 – Crack propagation and loss of material through footpath pavement

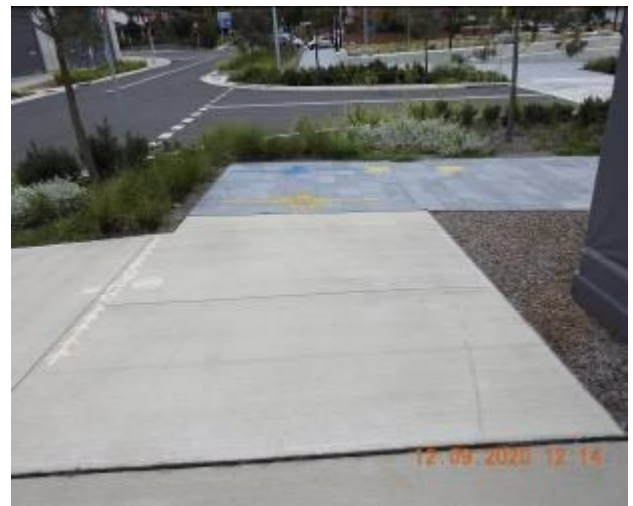
Figure 896 – Loss of material through service pit pavement

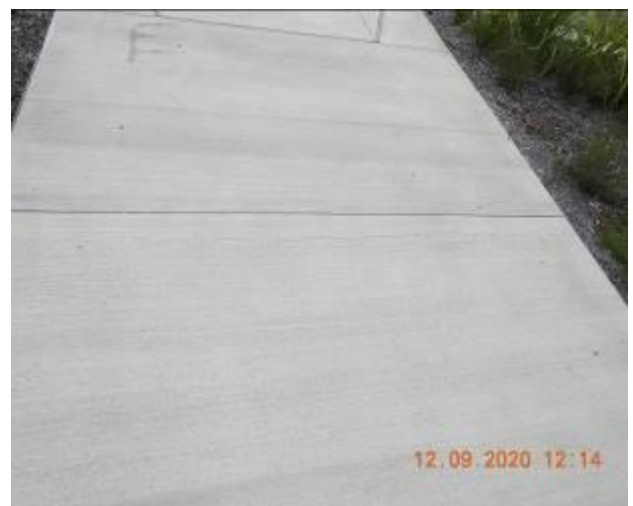
Figure 899 – Crack propagation and loss of material through footpath pavement

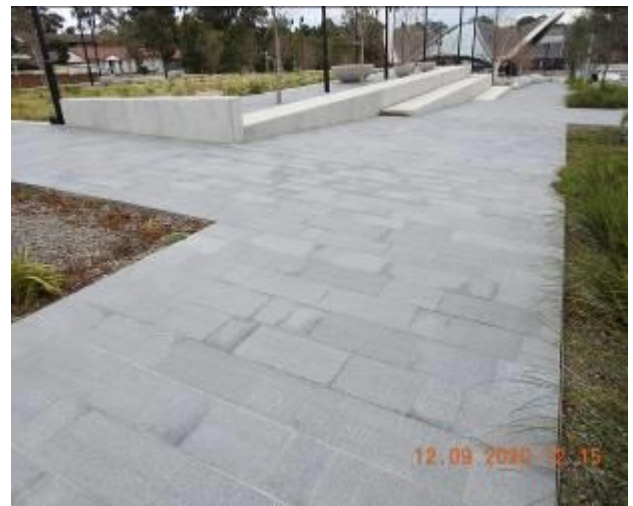
Figure 903 – Efflorescence and crack propagation through footpath pavement

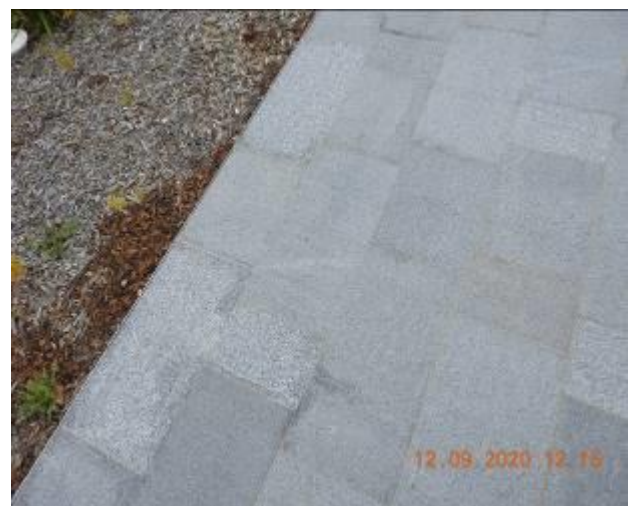
Figure 904 – Loss of material through footpath pavement

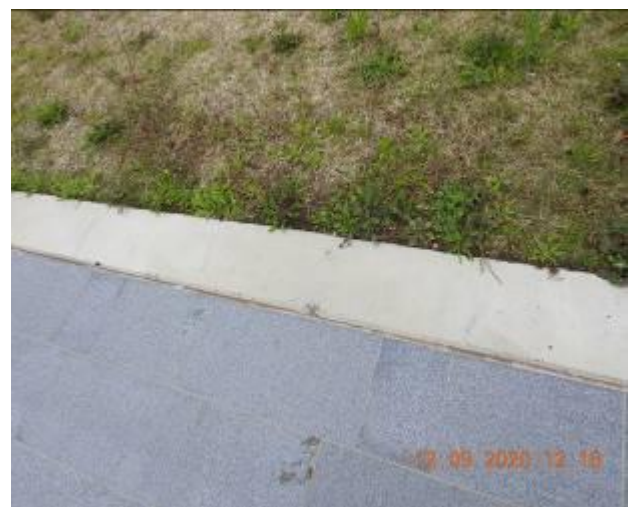
Figure 911 – Crack propagation and loss of material through footpath pavement

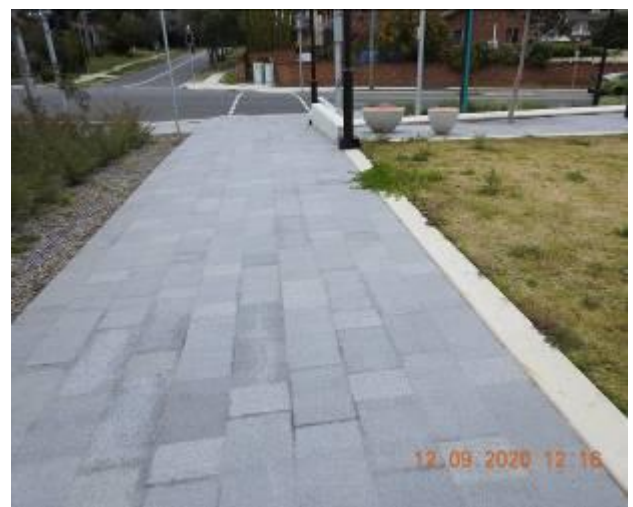
Figure 916 – Crack propagation and loss of material through footpath pavement

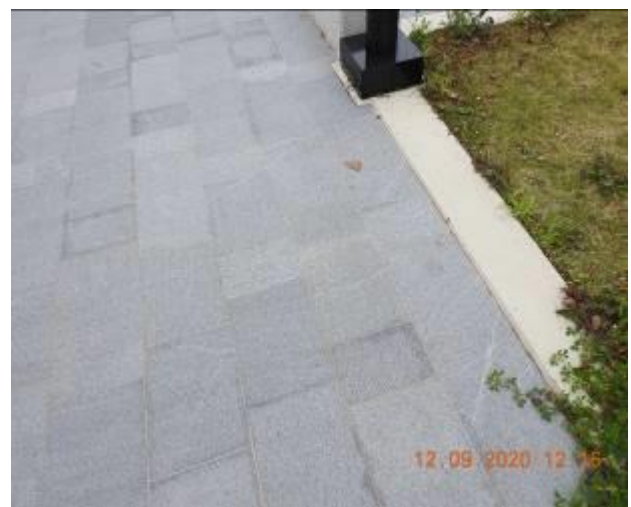
Figure 923 – Efflorescence and crack propagation through footpath pavement

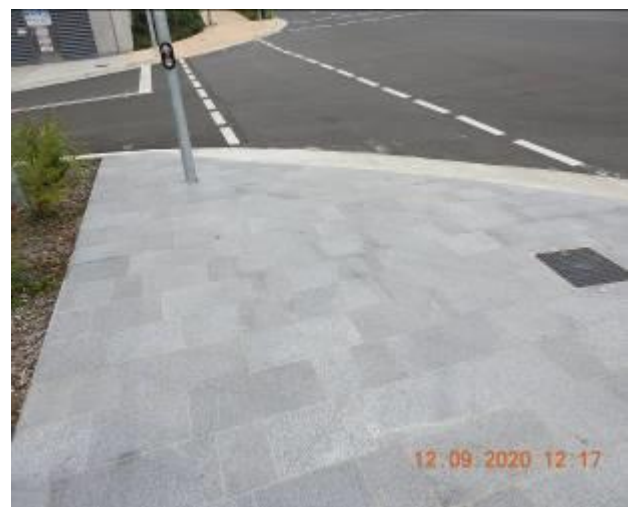
Figure 928 – Hairline crack propagation through footpath pavement

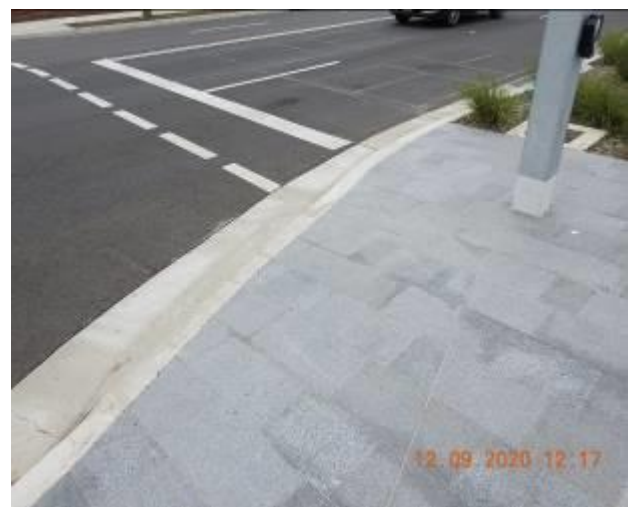
Figure 934 – Crack propagation and loss of material through footpath pavement

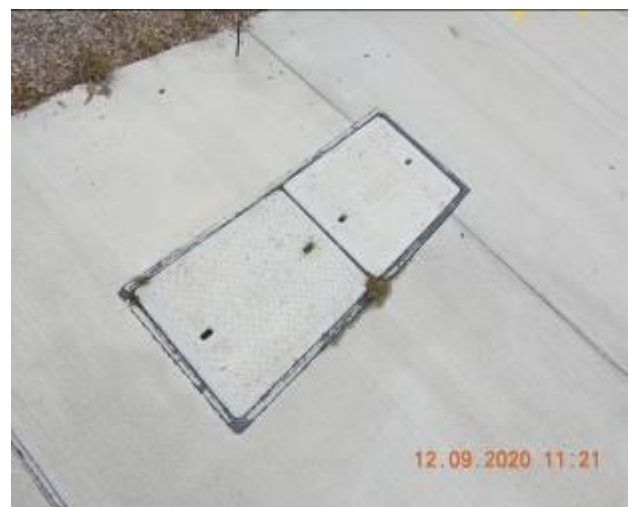
Figure 1058 – Crack propagation and loss of material through service pit pavement

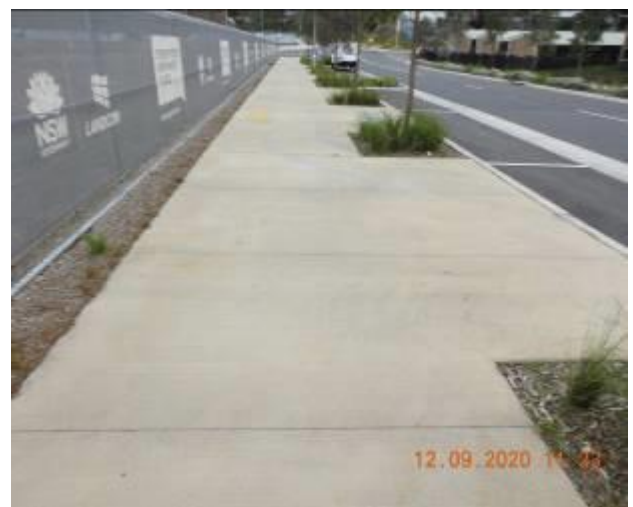
Figure 1069 – Crack propagation through footpath pavement

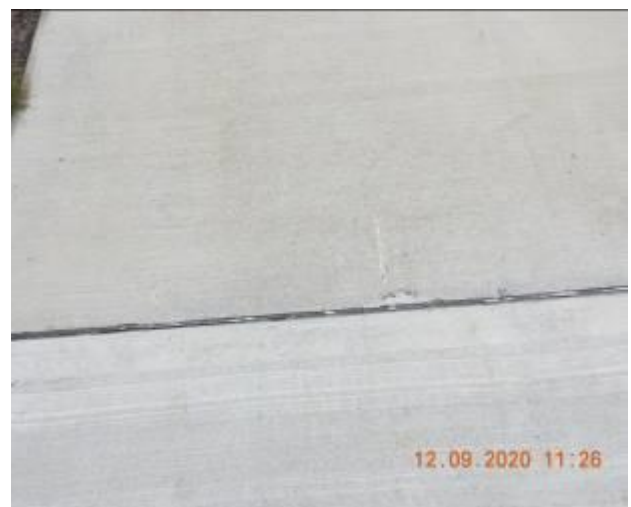
Figure 1100 – Loss of material through footpath pavement

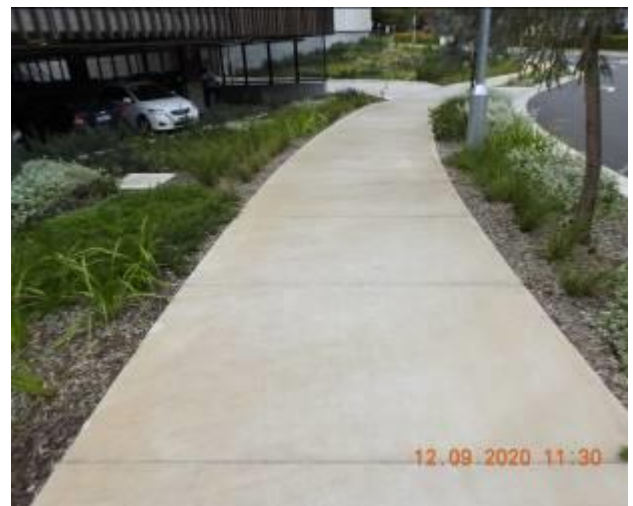
Figure 1145 – Loss of material through footpath pavement

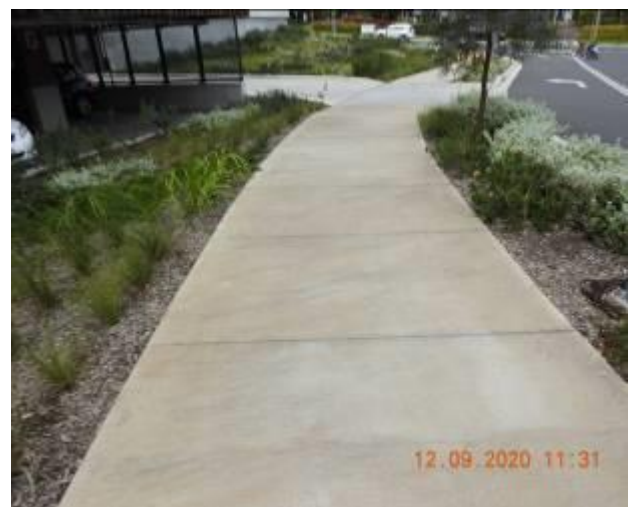
Figure 1147 – Evidence of patchwork through footpath pavement

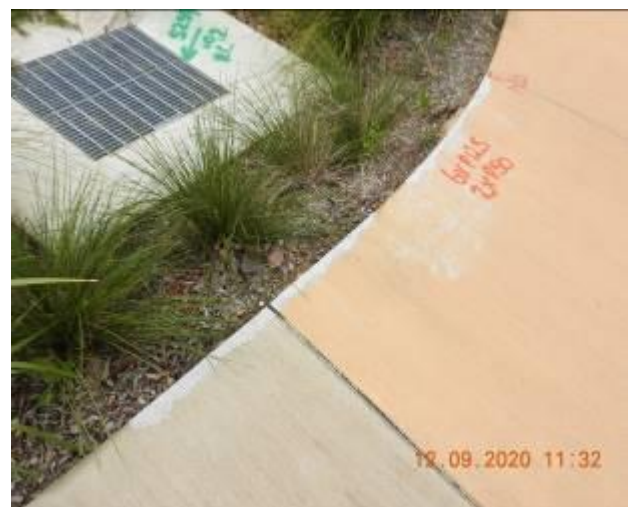
Figure 1160 – Loss of material through footpath pavement

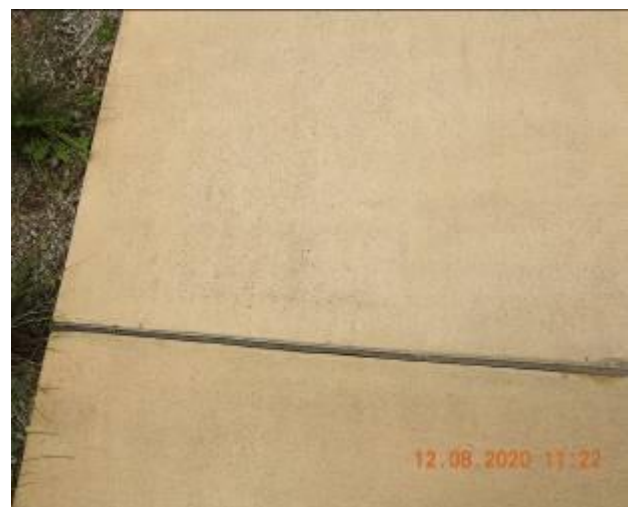
Figure 1522 – Separation through footpath pavement

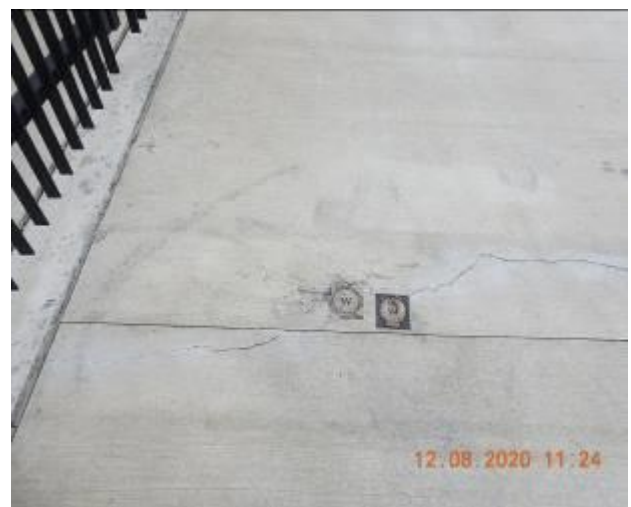
Figure 1539 – Loss of material through driveway pavement

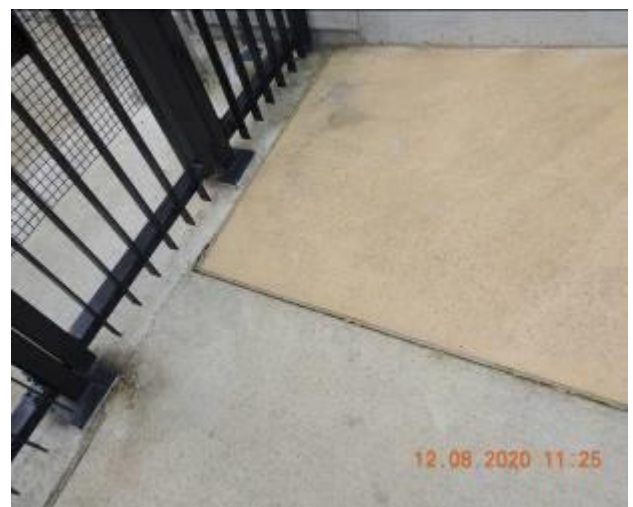
Figure 1546 – Crack propagation and loss of material through footpath pavement

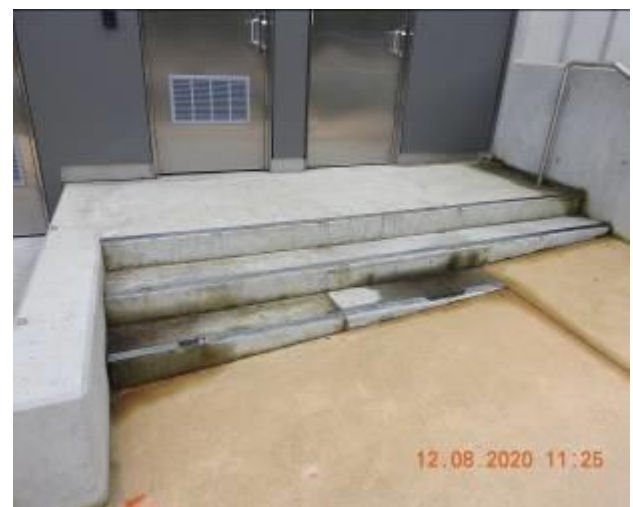
Figure 1551 – Crack propagation and loss of material through steps pavement

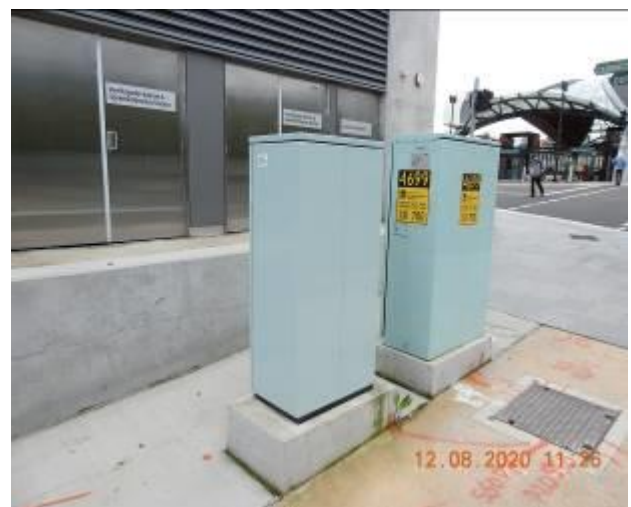
Figure 1557 – Crack propagation and loss of material through footpath pavement

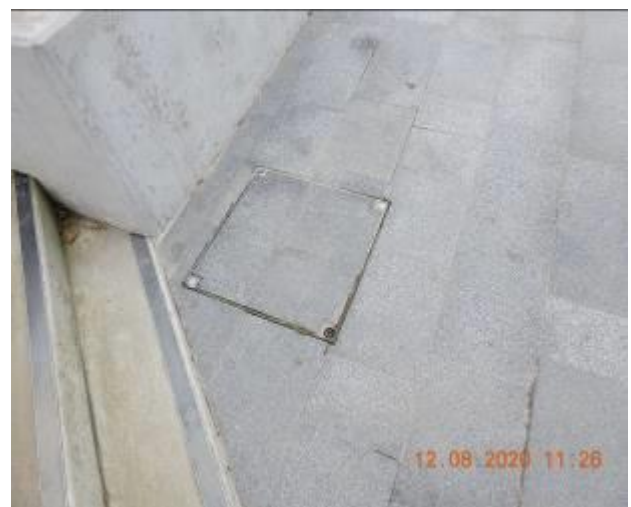
Figure 1563 – Loss of material through footpath pavement

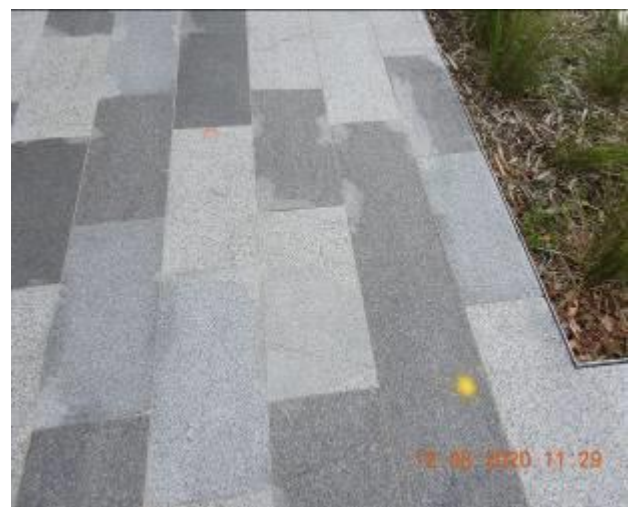
Figure 1582 – Hairline crack propagation through footpath pavement

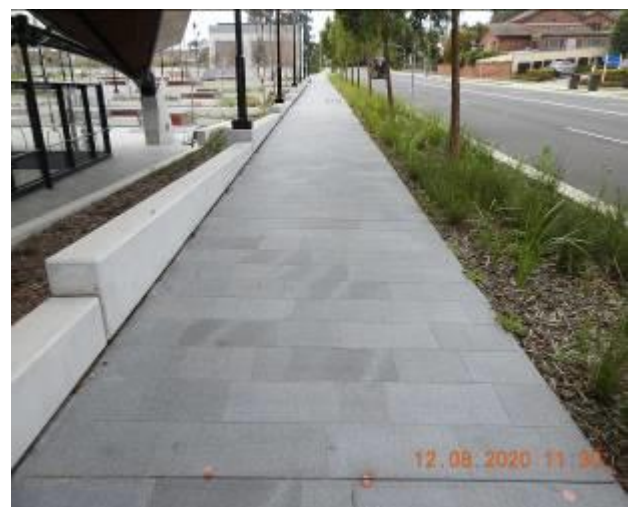
Figure 1587 – Hairline crack propagation through footpath pavement

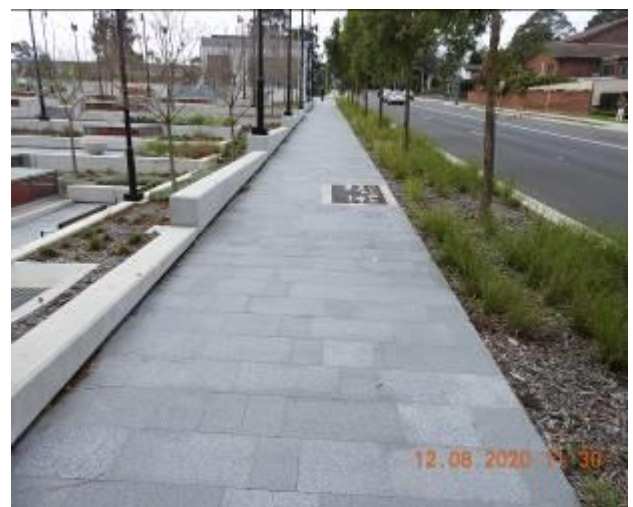
Figure 1593 – Crack propagation and loss of material through footpath pavement

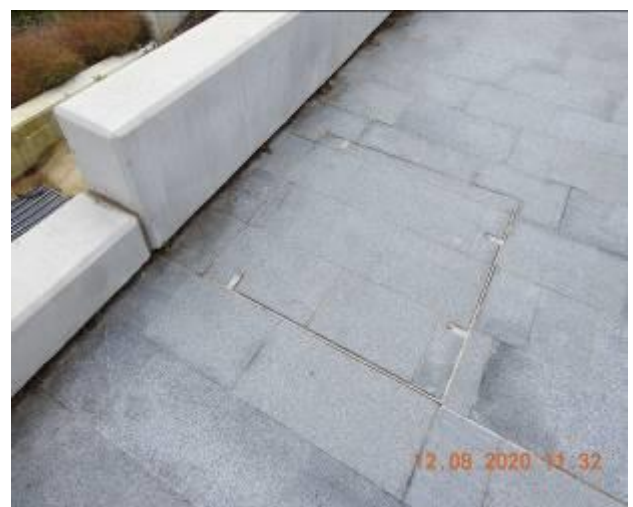
Figure 1600 – Loss of material through service pit pavement

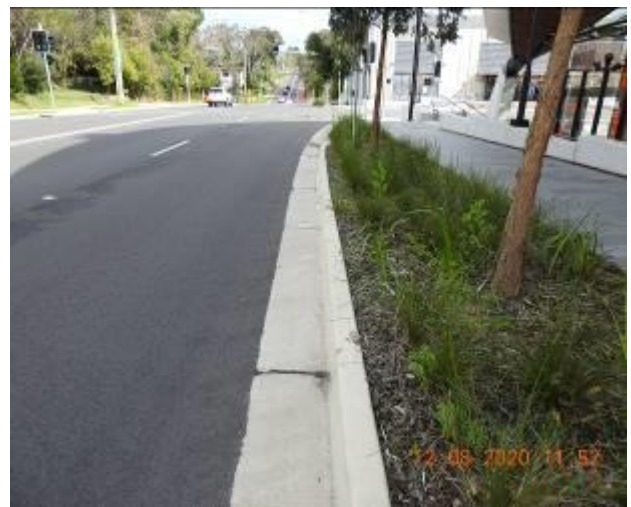
Figure 1731 – Evidence of patchwork through kerb

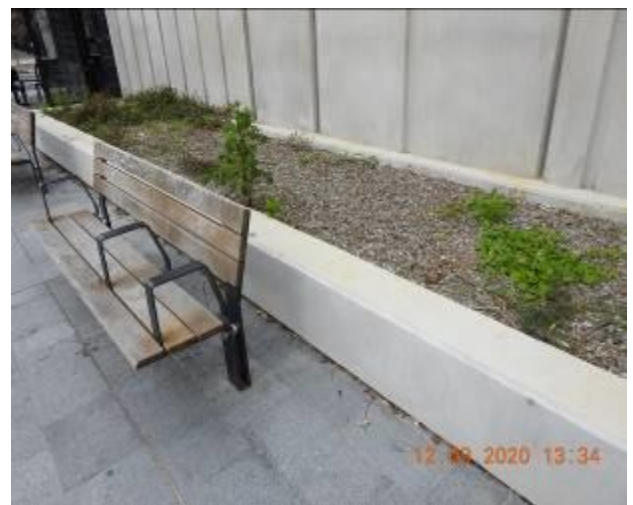
Figure 2357 – Crack propagation through retaining wall

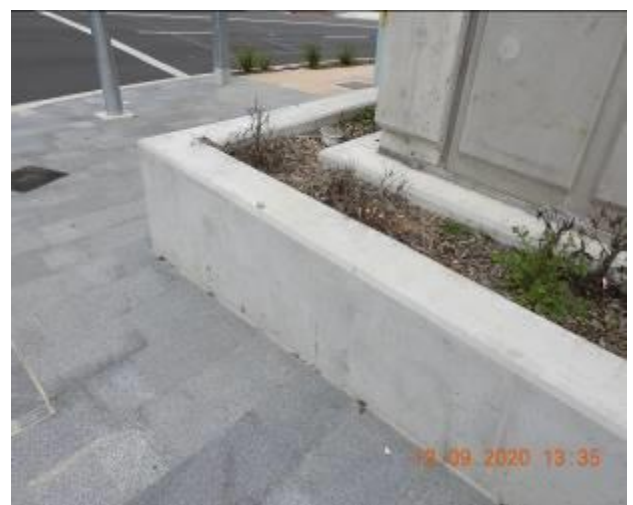
Figure 2364 – Crack propagation and loss of material through retaining wall
