Built Pty Ltd  
**State Significant Development  
Murwillumbah Education Campus Development**

**Hazardous Building Materials Survey**

Buildings A, E, F & AY  
Murwillumbah High School  
86 Riverview Street  
Murwillumbah, NSW

16 March 2022  
60882/144,319 (Rev 0)  
**JBS&G Australia Pty Ltd**

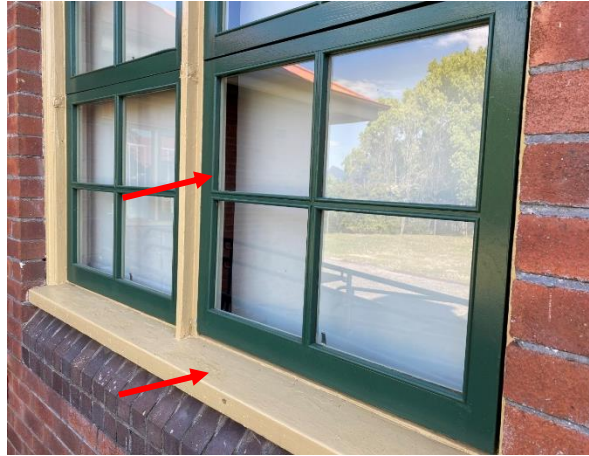
Photo 2: Building A - Lead based green and yellow timber window frames

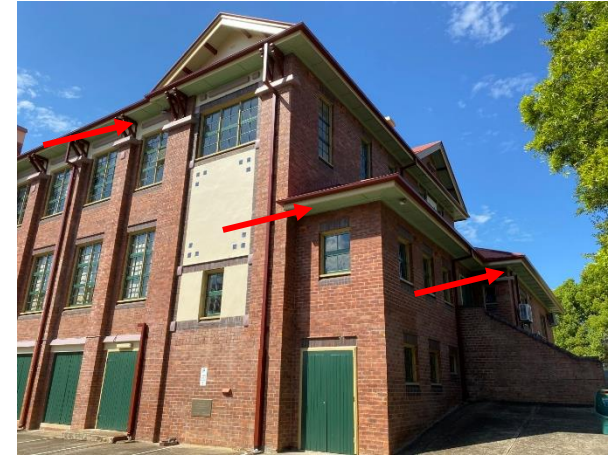
Photo 3: Building A – Asbestos flat sheet eaves to all levels and faces

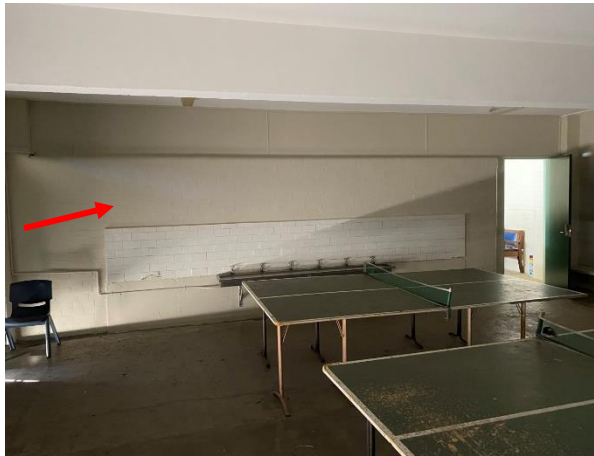
Photo 4: Building A - Example of cream lead based painted walls to Building A Basement level (AR9007 shown)

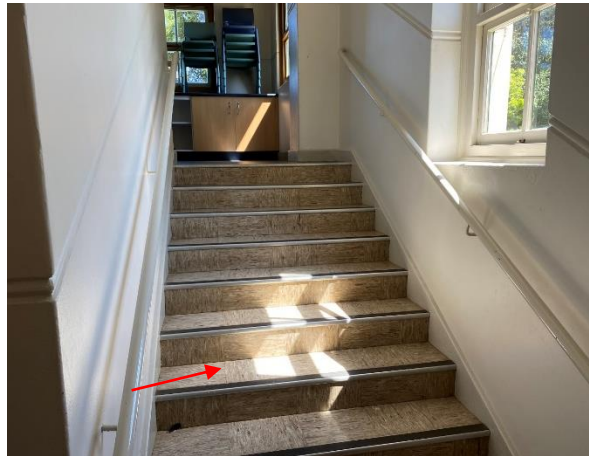
As per sample A-10	AR9014 – Basement level	12" vinyl floor tiles	5	Yes	Non-Friable	<b>Assumed to contain asbestos</b>	Good	10 m <sup>2</sup>	Maintain in good condition OR Remove prior to demolition in accordance with SWNSW 2019a	5/10/2021 JBS&G MS & AS	
As per sample A-10	AR9015 – Basement level	12" vinyl floor tiles	5	Yes	Non-Friable	<b>Assumed to contain asbestos</b>	Good	10 m <sup>2</sup>	Maintain in good condition OR Remove prior to demolition in accordance with SWNSW 2019a	5/10/2021 JBS&G MS & AS	
As per sample A-10	AR9016 – Basement level	12" vinyl floor tiles	5	Yes	Non-Friable	<b>Assumed to contain asbestos</b>	Good	25 m <sup>2</sup>	Maintain in good condition OR Remove prior to demolition in accordance with SWNSW 2019a	5/10/2021 JBS&G MS & AS	
A-15 (refer DoE 2020)	AR9016 – Basement level	Flat sheet in fill panels surrounding door to AR9017	-	Yes	Non-Friable	No asbestos detected <i>Assume asbestos is present due to previous DoE 2020 results</i>	Good	3m <sup>2</sup>	Maintain in good condition OR Remove prior to demolition in accordance with SWNSW 2019a	5/10/2021 JBS&G MS & AS

Photo 5: Building A - Asbestos containing 12" vinyl floor tiles to stairs and movement areas throughout

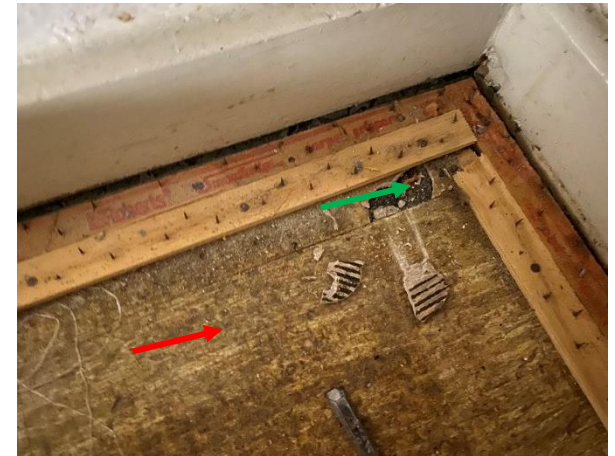
Photo 6: Building A - Asbestos containing vinyl floor tiles with non asbestos (black) adhesive found throughout Building A beneath carpeted floors

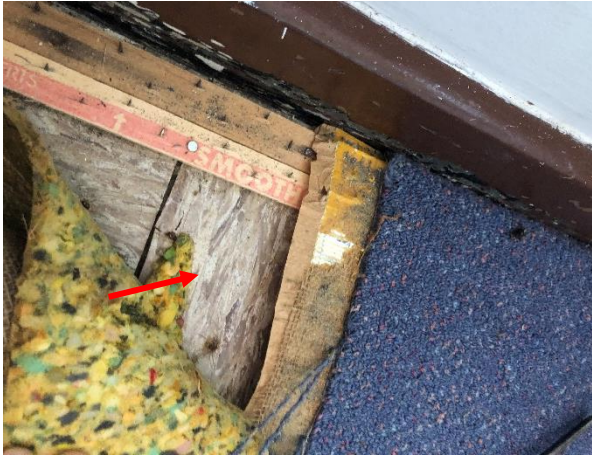
As per sample A-08	AR0008 – Ground level	Brown vinyl floor tile beneath carpet	7	No	Non-friable	Assumed to contain asbestos	Good	55m <sup>2</sup>	Maintain in good condition OR Remove prior to demolition in accordance with SWNSW 2019a	5/10/2021 JBS&G MS & AS	
As per sample A-08	AR0009 – Ground level	Brown vinyl floor tile beneath carpet	7	No	Non-friable	Assumed to contain asbestos	Good	55m <sup>2</sup>	Maintain in good condition OR Remove prior to demolition in accordance with SWNSW 2019a	5/10/2021 JBS&G MS & AS	
A-06	AR0009 – Ground level	Render like cement material to internal wall of redundant fireplace flue	12	-	-	No asbestos detected	-	-	-	5/10/2021 JBS&G MS & AS	
As per sample A-08	AR0010 – Ground level	Brown vinyl floor tile beneath carpet	7	No	Non-friable	Assumed to contain asbestos	Good	50m <sup>2</sup>	Maintain in good condition OR Remove prior to demolition in accordance with SWNSW 2019a	5/10/2021 JBS&G MS & AS

As per sample A-08	AR0011 – Ground level	Brown vinyl floor tile beneath carpet	7	No	Non-friable	Assumed to contain asbestos	Good	15m <sup>2</sup>	Maintain in good condition OR Remove prior to demolition in accordance with SWNSW 2019a	5/10/2021 JBS&G MS & AS	
As per sample A-08	AR0013 – Ground level	Brown vinyl floor tile	-	Yes	Non-friable	Assumed to contain asbestos	Good	1m <sup>2</sup>	Maintain in good condition OR Remove prior to demolition in accordance with SWNSW 2019a	5/10/2021 JBS&G MS & AS	
A-05	AR0016 – Ceiling space	Black membrane sarking	-	-	-	No asbestos detected	-	-	-	5/10/2021 JBS&G MS & AS

Photo 7: Building A - Asbestos containing vinyl floor tiles with non asbestos (black) adhesive found throughout Building A beneath carpeted floors

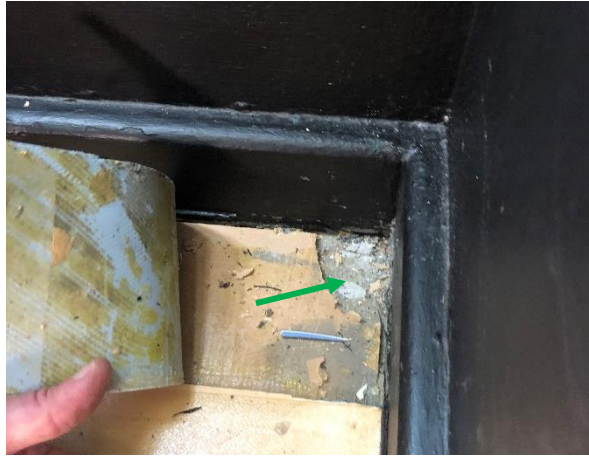
A-09	AR0019 – Ground level	Fibre cement board beneath overlying fibre board and vinyl floor sheeting	8	-	-	No asbestos detected	-	-	-	5/10/2021 JBS&G MS & AS	
As per sample A-08	AR0021 – Ground level	Brown vinyl floor tile beneath carpet	7	No	Non-friable	<b>Assumed to contain asbestos</b>	Good	20m <sup>2</sup>	Maintain in good condition OR Remove prior to demolition in accordance with SWNSW 2019a	5/10/2021 JBS&G MS & AS	
As per sample A-10	AR0023 – Ground level	12" vinyl floor tiles	5	Yes	Non-friable	<b>Assumed to contain asbestos</b>	Good	10m <sup>2</sup>	Maintain in good condition OR Remove prior to demolition in accordance with SWNSW 2019a	5/10/2021 JBS&G MS & AS	
As per sample A-10	AR0024 – Ground level	12" vinyl floor tiles	5	Yes	Non-friable	<b>Assumed to contain asbestos</b>	Good	11m <sup>2</sup>	Maintain in good condition OR Remove prior to demolition in accordance with SWNSW 2019a	5/10/2021 JBS&G MS & AS

Photo 8: Building A - Non-asbestos fibre board lining beneath vinyl floor sheet and fibre board to AR0019

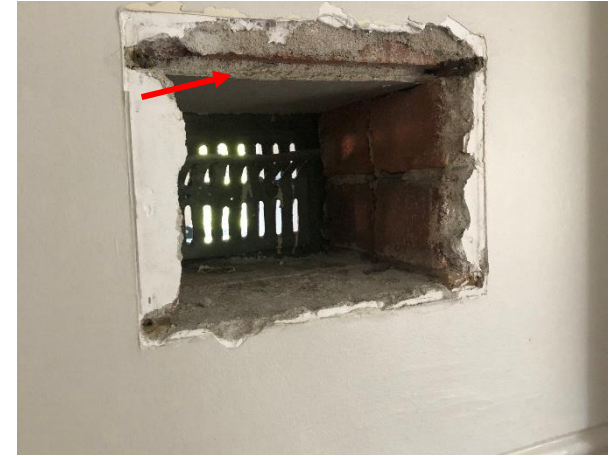
- AR1014 – asbestos containing fibre board (A-12) to top of cross ventilation points along hallway southern wall. Consistent asbestos fibre boards are assumed to also be present within cross ventilation points to southern structure wall (i.e. extending to exterior from rooms AR1002-AR1006). Total of 20 cross ventilation points observed.
- AR1014 – lead based white painted walls (A-L04, 1.8% w/w).
- AR1015 – asbestos containing 12” vinyl floor tiles (A-13).

Photo 9: Building A - Asbestos fibre board to top of cross ventilation points along southern hallway (AR1014) to second level of Building A.

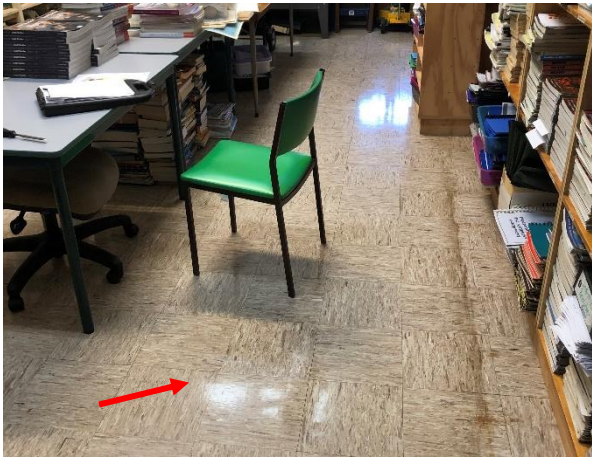
Photo 10: Building A - Asbestos vinyl floor tiles to AR1005

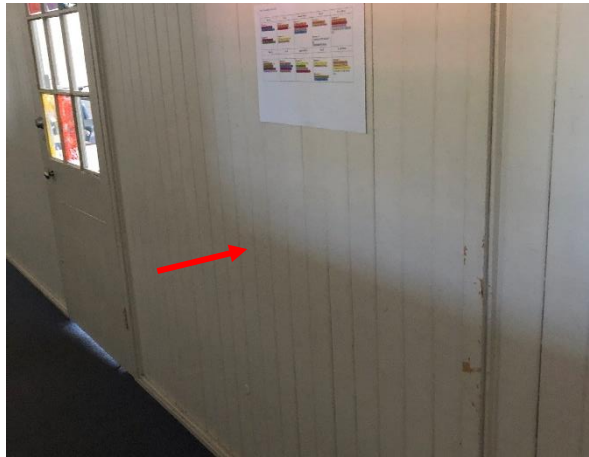
Photo 11: Building A - Lead based white painted walls to AR1014

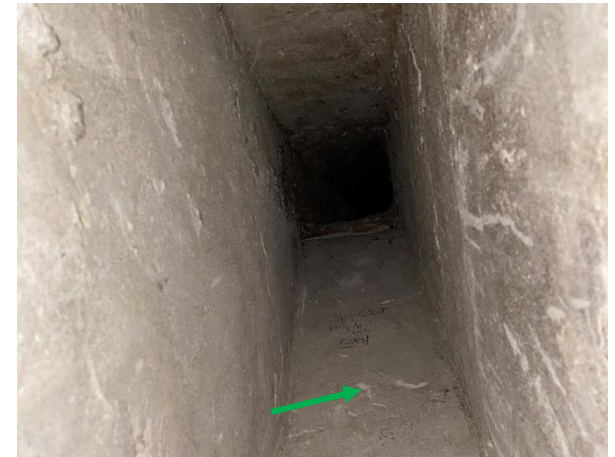
Photo 12: Building A - Non-asbestos render material to internal surface of fireplace flue to Second level of Building A

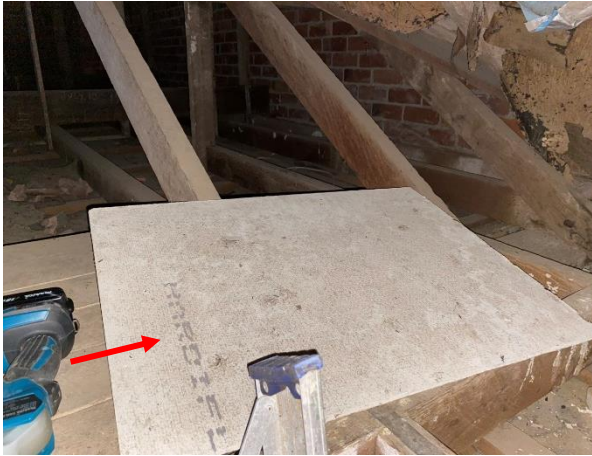
Photo 13: Building A - Assumed ACM access hatch to ceiling space from AR1007

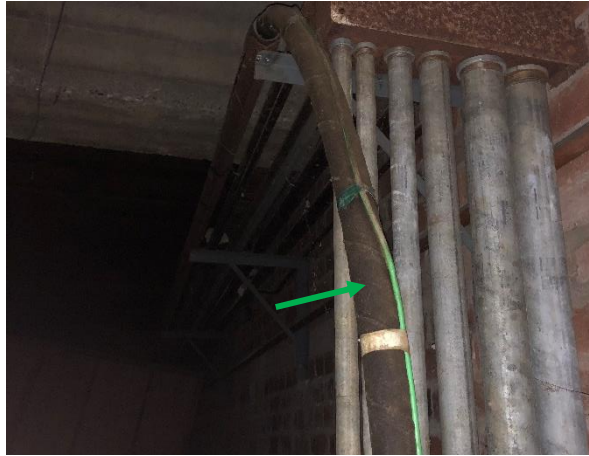
Photo 14: Building A - Non-asbestos bituminous cable sheathing to Building A sub floor

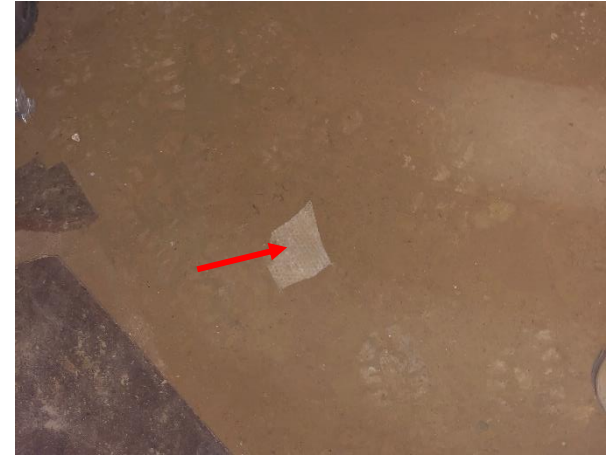
- Non identified sub floor area accessed via AR9005:
  - Non-asbestos containing bituminous cable sheathing (A-17).
  - Loose asbestos containing fibre cement debris to ground surface (A-18).

A-17	Sub floor area accessed via AR9005	Bituminous cable sheathing	14	-	-	No asbestos detected	-	-	-	5/10/2021 JBS&G MS & AS	
A-18	Sub floor area accessed via AR9005	Loose fibre cement debris to ground surface	15	No	Non-friable	<b>Chrysotile and Amosite asbestos detected</b>	Fair	<1m <sup>2</sup>	Remove in accordance with SWNSW 2019a	5/10/2021 JBS&G MS & AS

Photo 15: Building A - Loose ACM debris to Building A sub floor

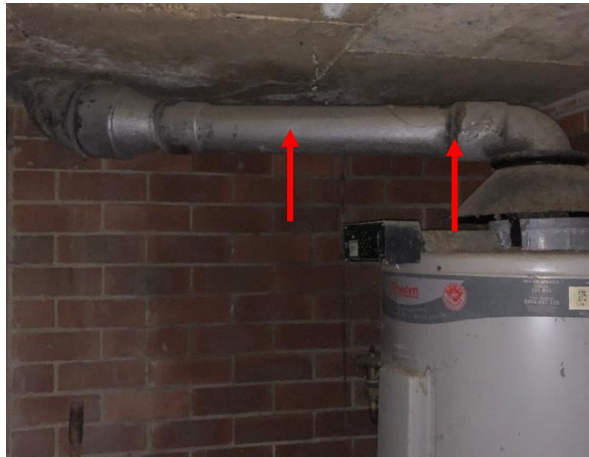
- Two asbestos containing ventilation pipes were observed to protrude from the western and eastern extents of the roof lining that are assumed to be associated with the hot water ventilation pipes identified in the basement level (sub-floor) areas ER9001 and ER9002 (refer **Section 3.2.2.1**).
- An additional suspected asbestos containing ventilation pipe was also observed to the western extent of the roof lining, however, no evidence of this ventilation pipe could be identified in underlying interiors of the structure.
- Suspected asbestos waterproofing membrane beneath pebblecrete roof lining above administration portion of Building E. No access was available at time of inspection.

Photo 17: Building E - Asbestos ventilation pipe with asbestos mastic to collar joints extending from hot water unit in sub floor areas to roof lining. One unit observed to each of ER9001 and ER9002

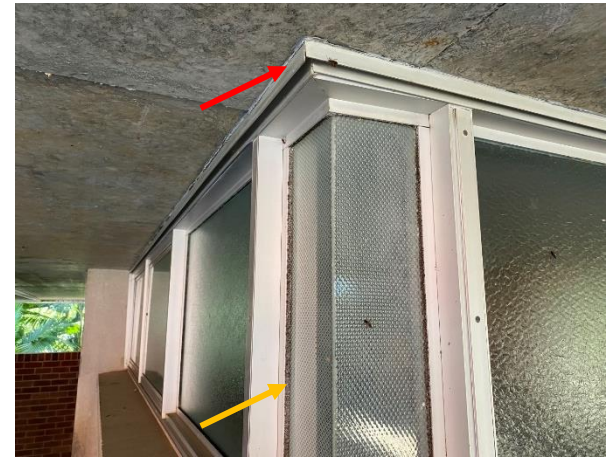
- Asbestos external window frames mastic sealant (E-01). *Although E-01 returned a negative result for presence of asbestos, materials are of consistent appearance and characteristics to those observed in Building B as detailed in JBS&G 2021 which returned a positive result for asbestos (refer sample B-01, JBS&G 2021) and are therefore assumed to also contain asbestos.*

Photo 18: Building E - Asbestos grey putty/filler to top seal of aluminium windows (red) and window mastic with no asbestos detected but consistent with Building B (JBS&G 2021) which reported asbestos present (orange).

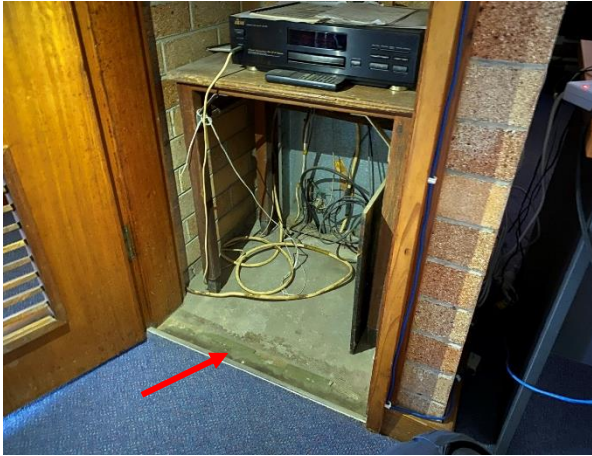
Photo 19: Residual asbestos green vinyl floor tiles to unlabelled data cupboard area (ER1024)

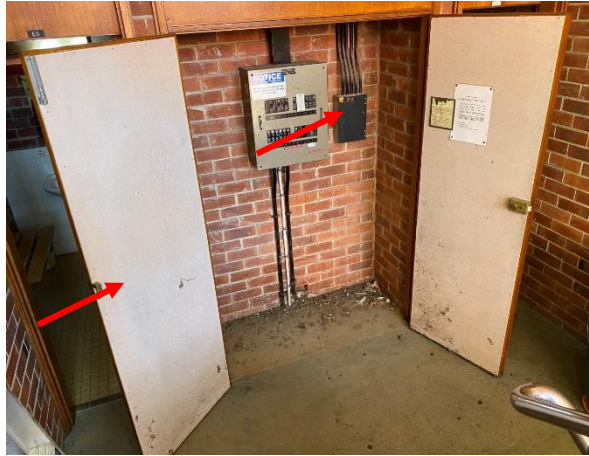
- ER2010 – assumed SMF internal insulation to hot water unit.
- ER2011 – assumed asbestos containing resinous electrical backing board (no sample collected due to electrical hazard) and asbestos containing internal door lining to electrical cupboard (E-07). Noted to not previously be identified in DoE 2020.

Photo 20: Building E – Asbestos flat sheet internal door linings and asbestos resinous backing board to ER2011

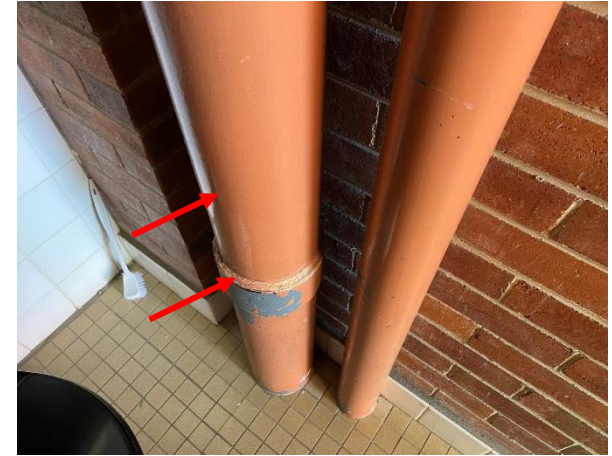
Photo 21: Building E – Asbestos ventilation pipe with asbestos mastic seals to collar joint extending from basement level through ER2009

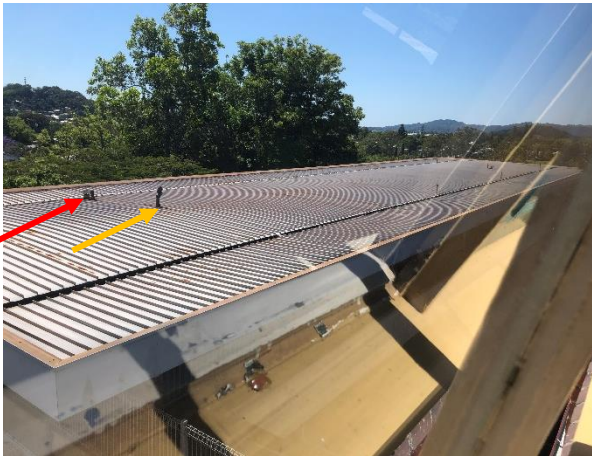
Photo 22: Building E – Asbestos ventilation pipes from basement level (red arrows) and additional suspected asbestos pipe (orange) to roof lining

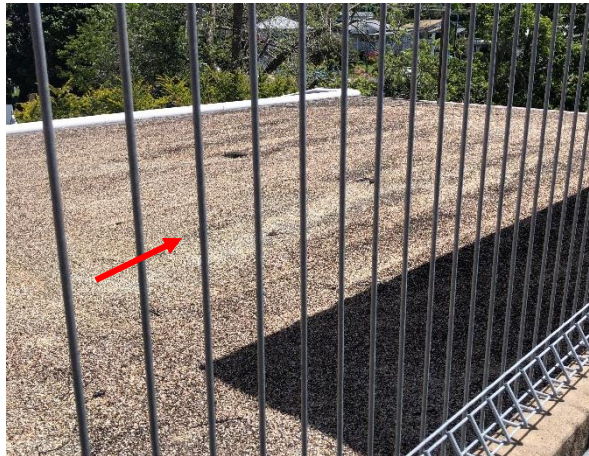
Photo 23: Building E – Suspected asbestos containing waterproofing membrane to pebblecrete roof lining above administration portion. No access available.

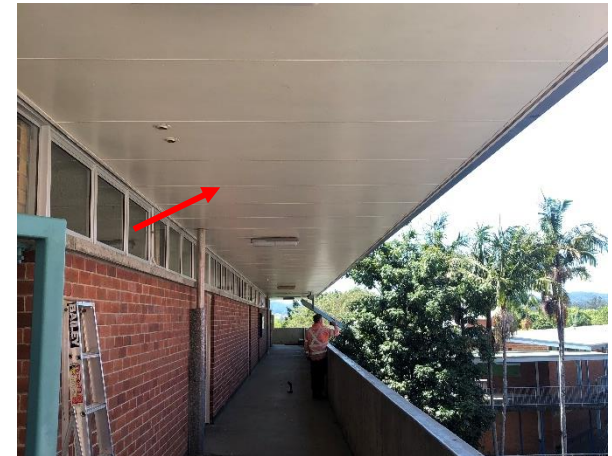
Photo 24: Building E – Asbestos containing flat sheet ceiling lining to ER2015

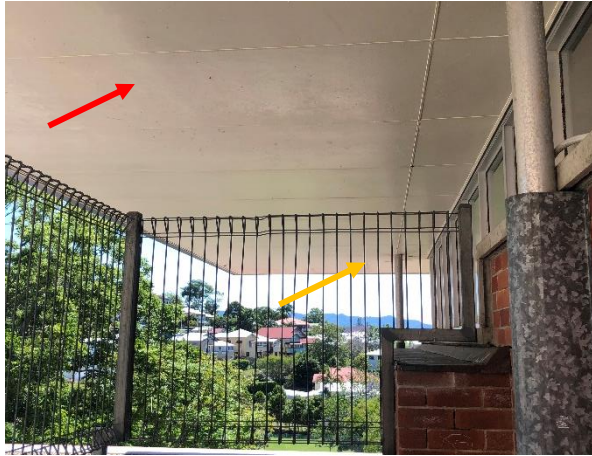
Photo 25: Building E – Asbestos containing flat sheet ceiling lining to ER2017 (red) and assumed asbestos containing flat sheet eave linings to northern extent of second level (orange)

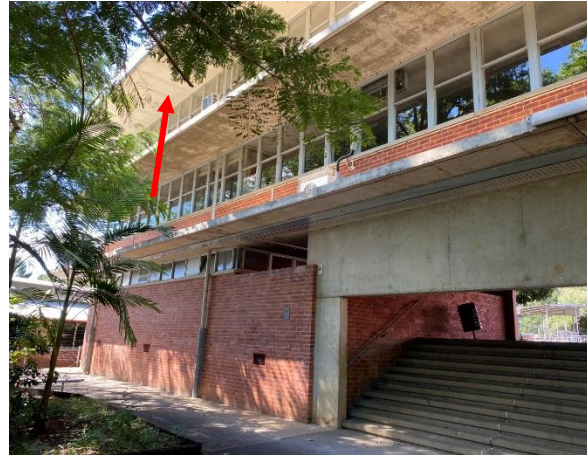
Photo 26: Assumed asbestos containing flat sheet eave linings to northern extent of second level

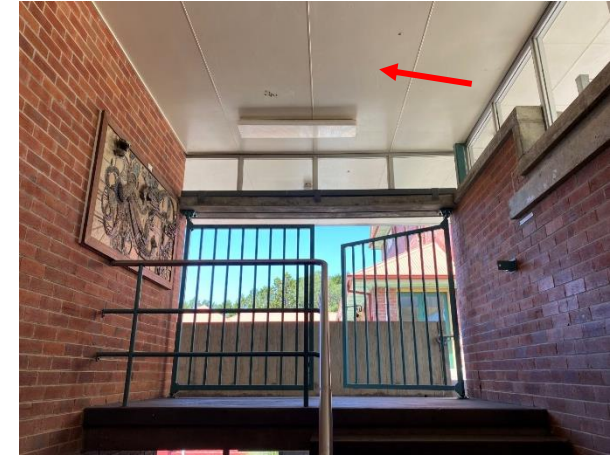
Photo 27: Asbestos containing flat sheet ceiling lining to ER201

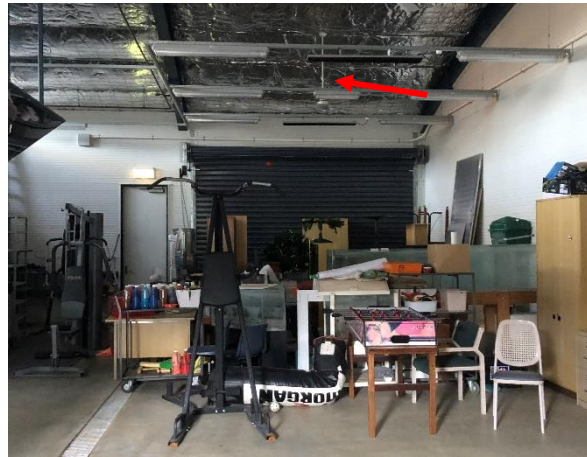
Photo 29: Building F – Suspected SMF insulation to aluminium sarking over ceiling lining

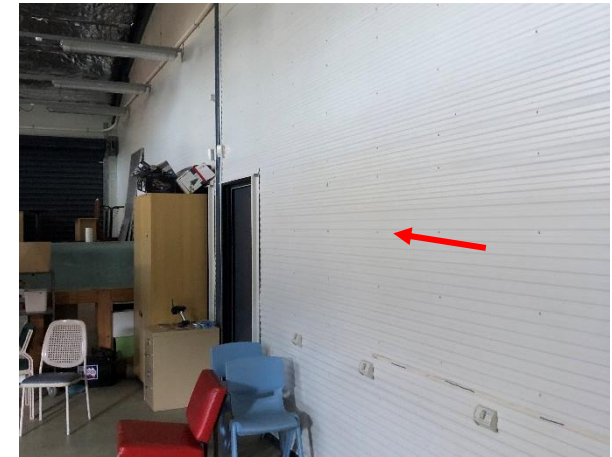
Photo 30: Building F – Suspected SMF internal insulation to dividing wall

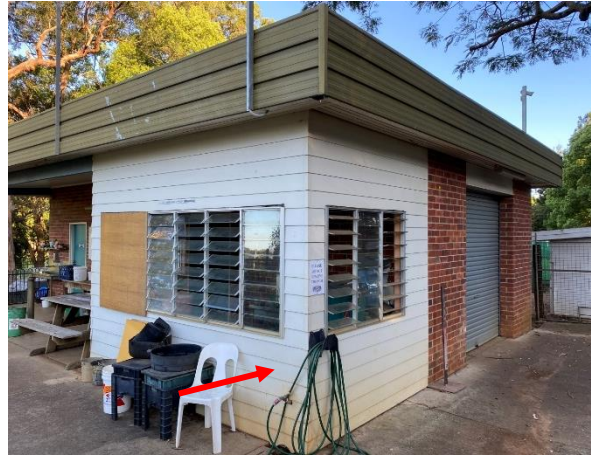
Photo 32: Building AY – Asbestos white weatherboard cladding to NW exterior

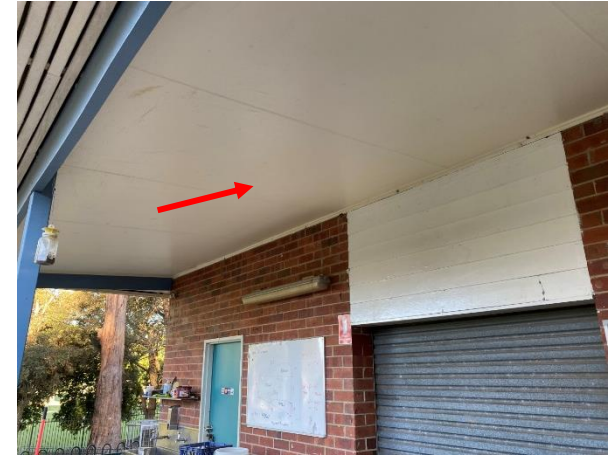
Photo 33: Building AY – Asbestos flat sheet ceiling lining to AYR0001

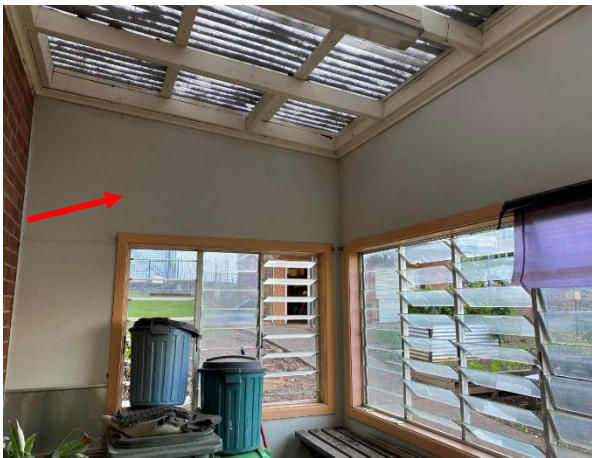
Photo 34: Building AY – Asbestos flat sheet wall linings to AYR0004
