Report on  
Hazardous Building Materials (HBM) Survey

Lot 100 DP1261496, Maitland Street, Muswellbrook,  
NSW

Prepared for  
Pacific Brook Christian School Ltd

Project 91601.01  
July 2021

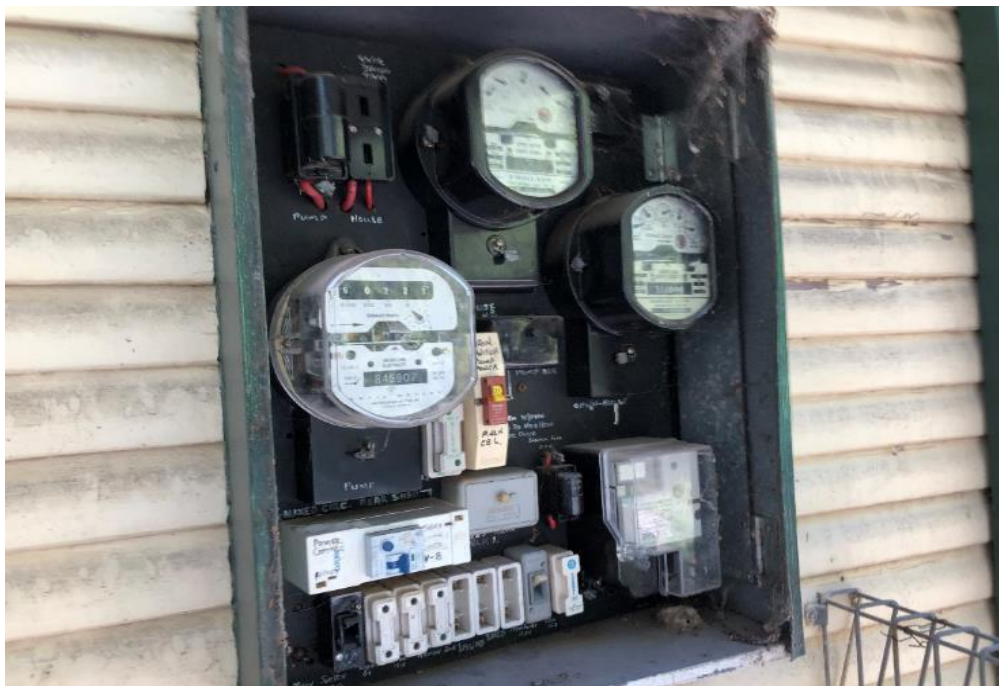
Photograph 2: Residential Dwelling, external south wall, electrical backing board, zelemite, asbestos (assumed).

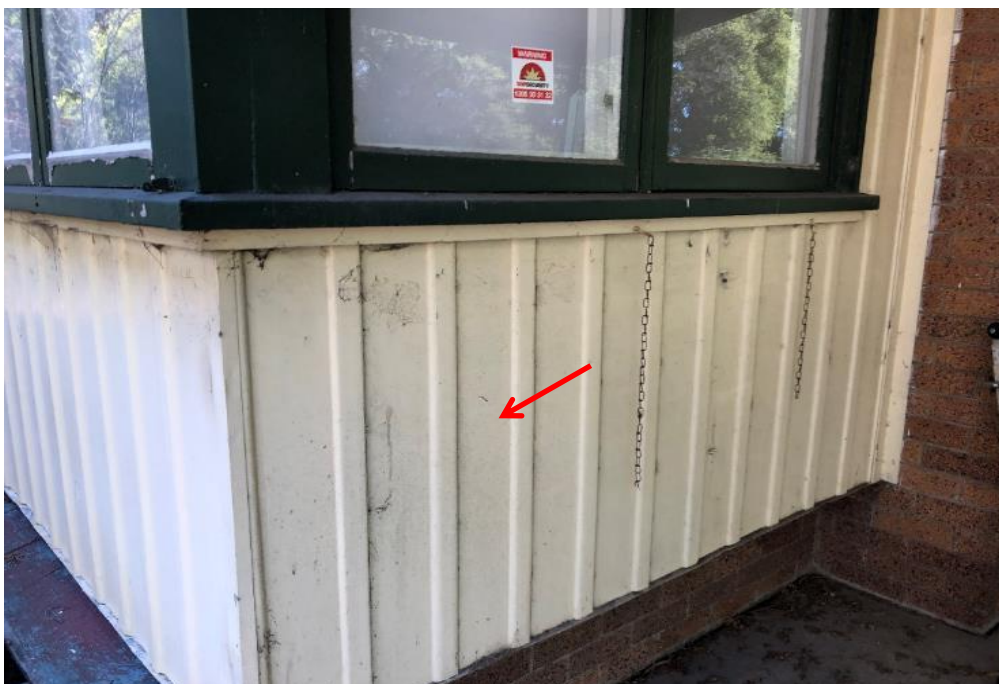
Photograph 3: Residential Dwelling, external , walls, fibre cement sheet, asbestos detected by analysis.

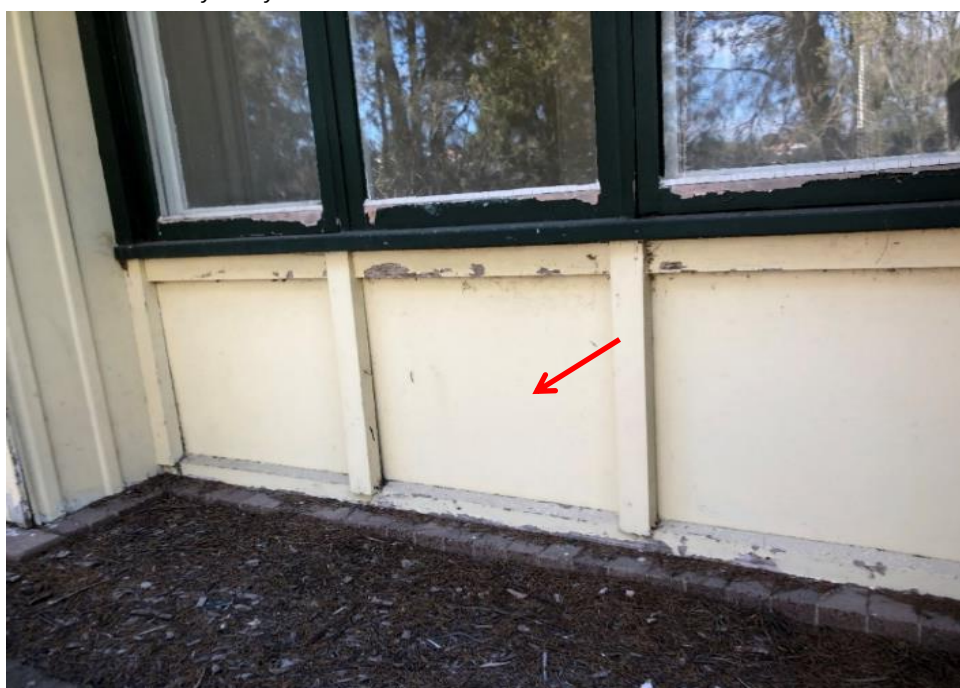
Photograph 4: Residential Dwelling, external, infill panel below windows, fibre cement sheet, asbestos detected by analysis.

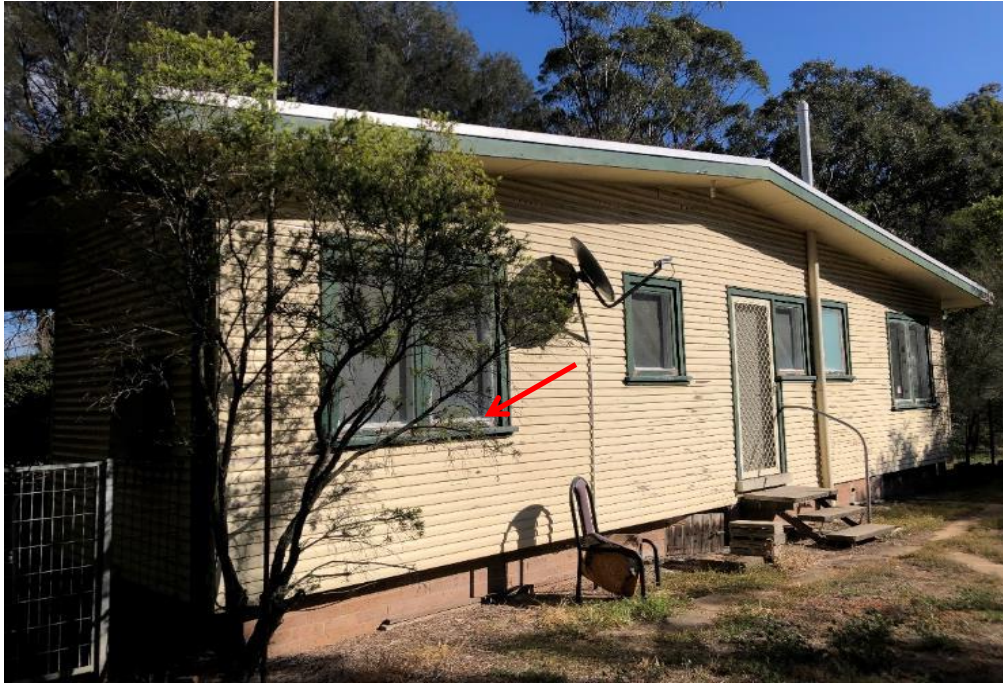
Photograph 9: Residential Dwelling, external , windows, putty, no asbestos detected by analysis.

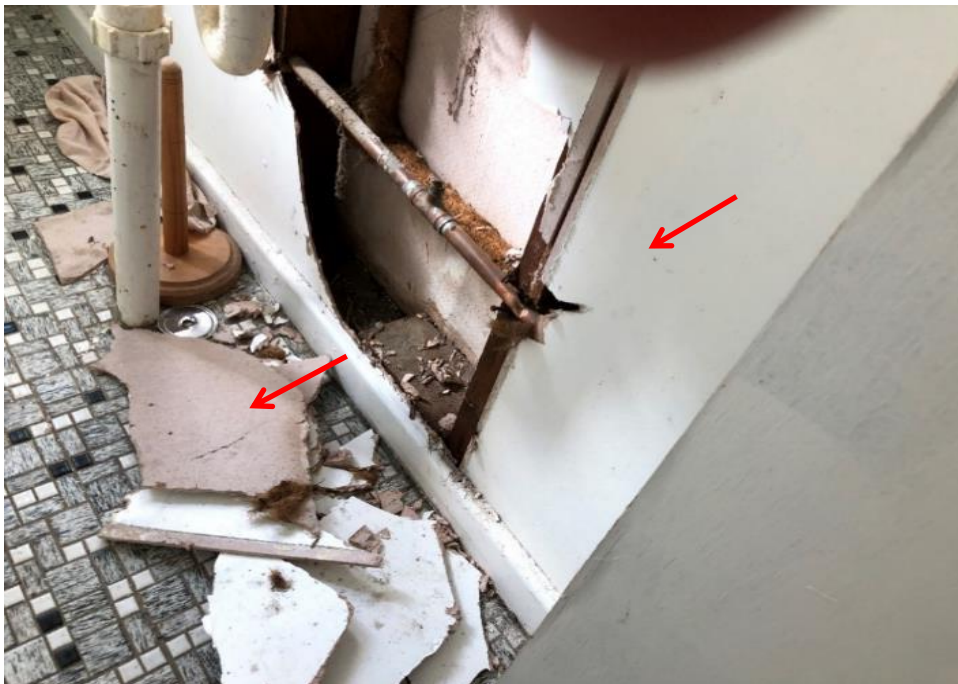
Photograph 10: Residential Dwelling, internal , walls to bathroom, fibre cement sheet, asbestos detected by analysis.

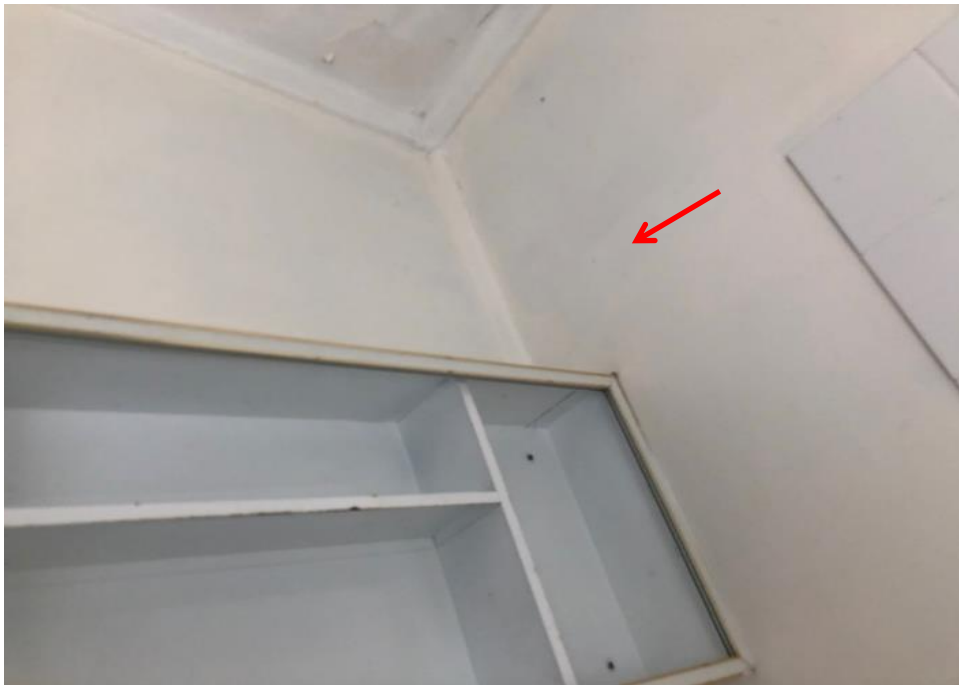
Photograph 11: Residential Dwelling, internal , walls to laundry, fibre cement sheet, no asbestos detected by analysis.

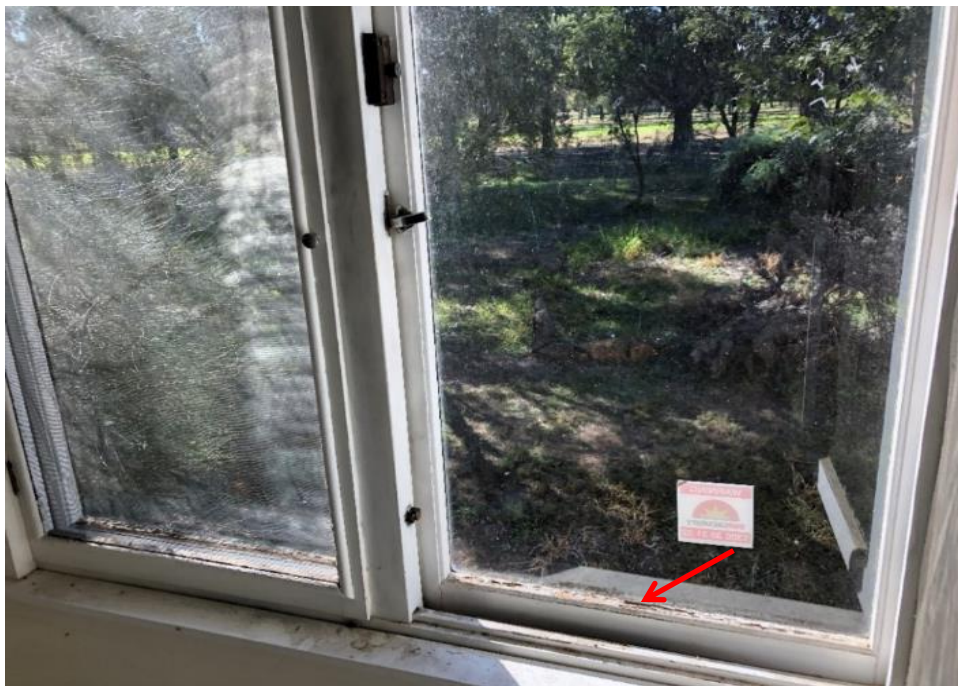
Photograph 12: Residential Dwelling, internal , windows and architraves, white paint, non-lead paint (≤0.1% lead w/w).

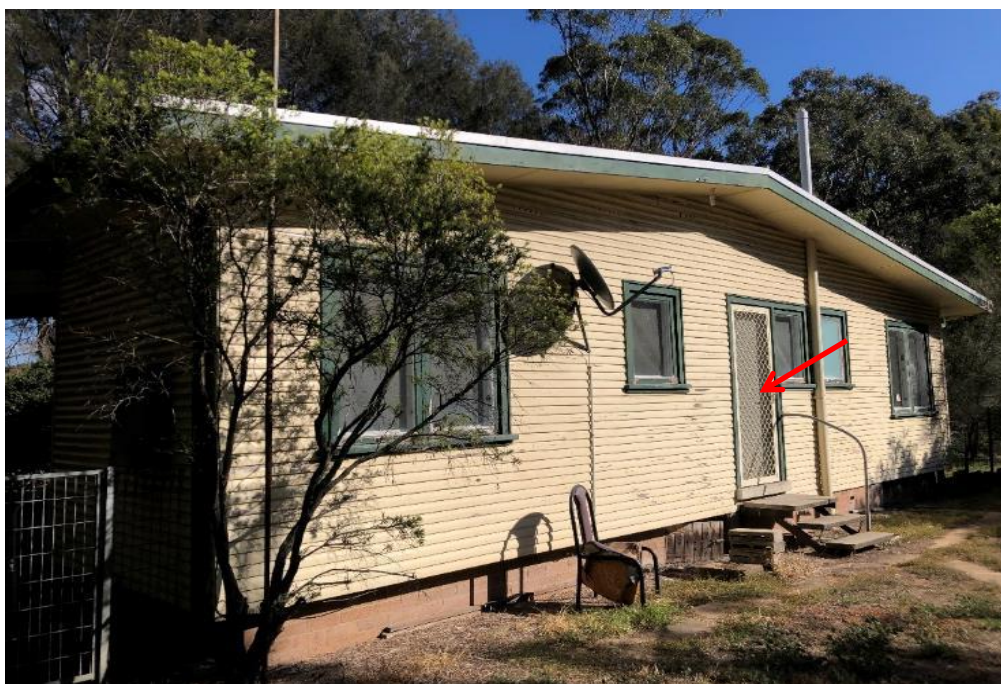
Photograph 13: Residential Dwelling, internal , laundry door, beige paint, lead paint (>0.1% lead w/w).

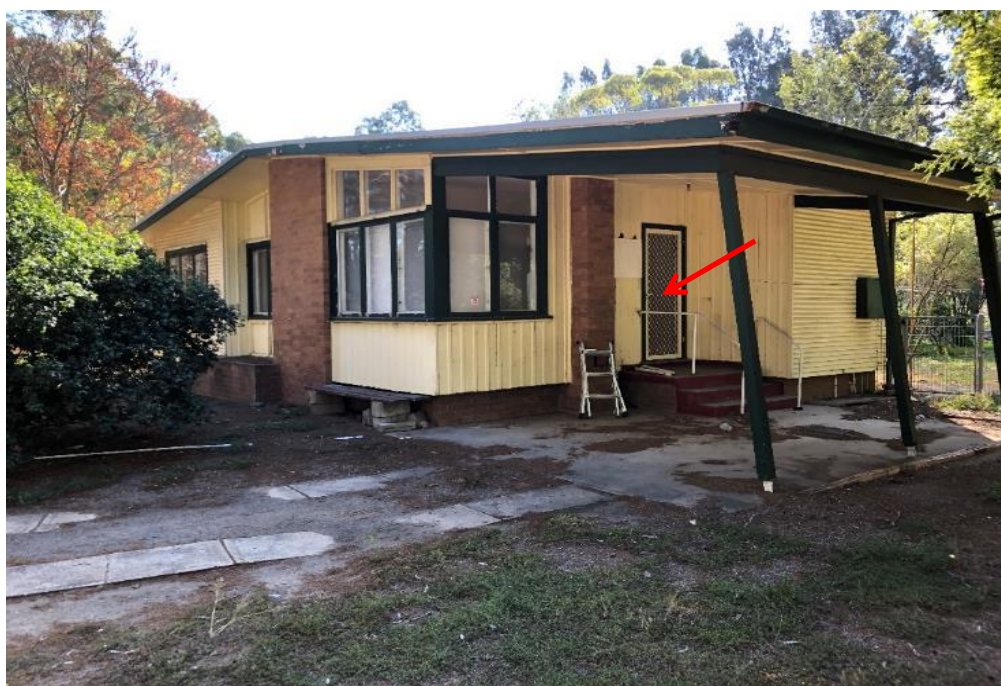
Photograph 14: Residential Dwelling, external , front door, cream paint, non-lead paint (≤0.1% lead w/w).

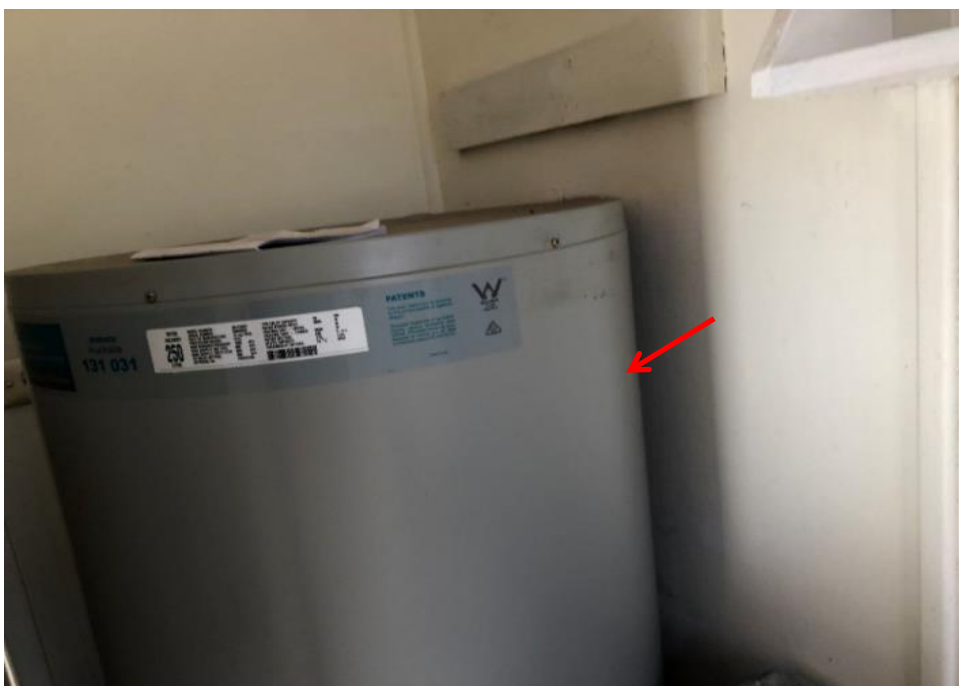
Photograph 15: Residential Dwelling, external , north east wall, hot water unit, SMF (assumed).

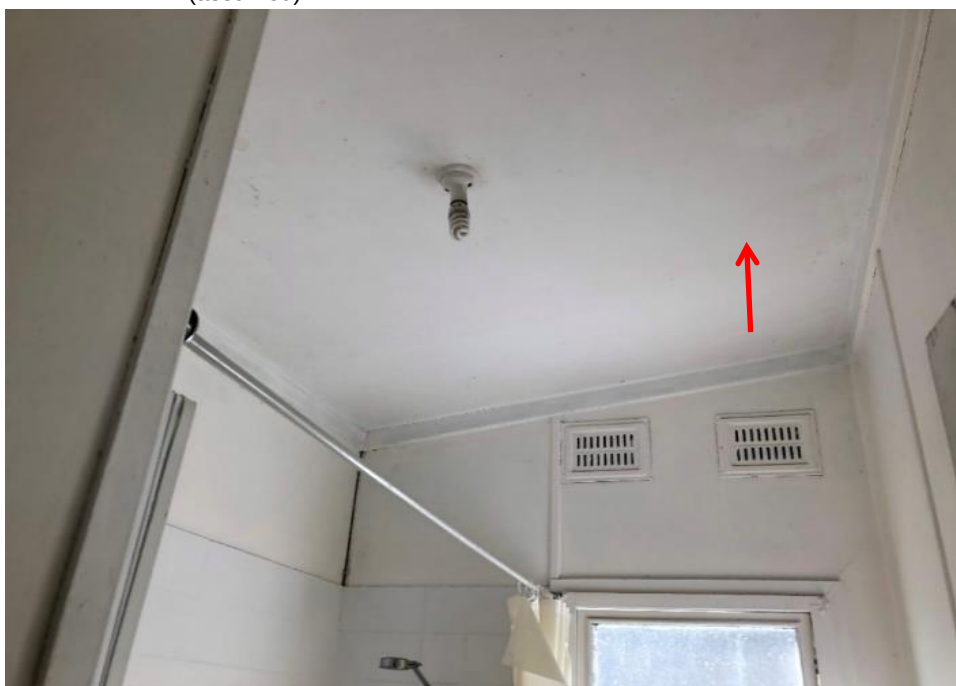
Photograph 16: Residential Dwelling, internal , ceiling cavity, insulation material, SMF (assumed).

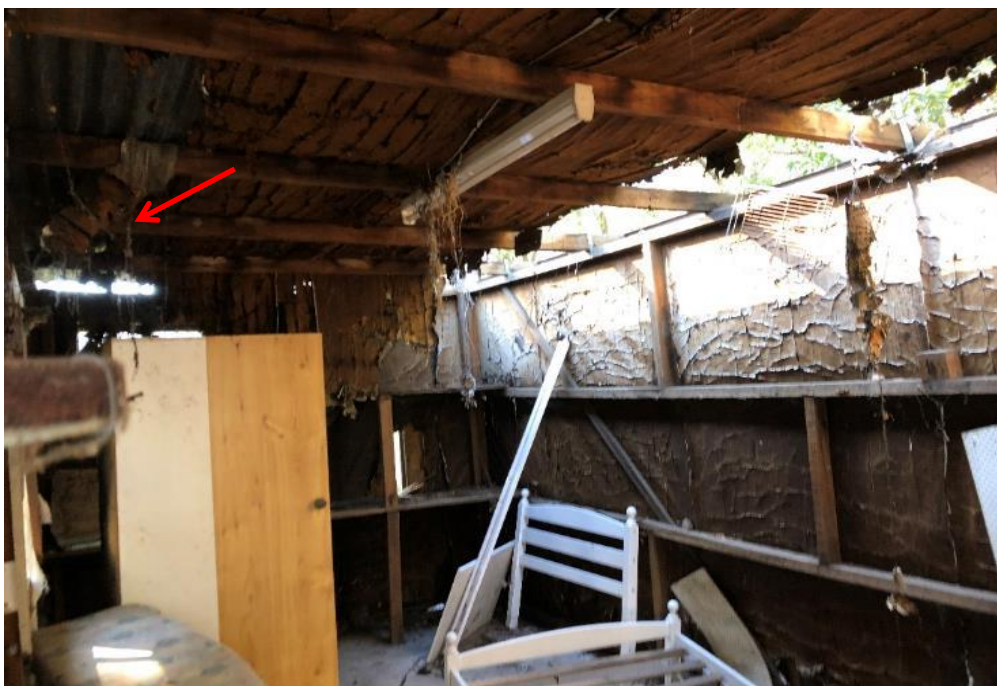
Photograph 18: Rear Shed, roof, insulation blanket, insulation, SMF (assumed).

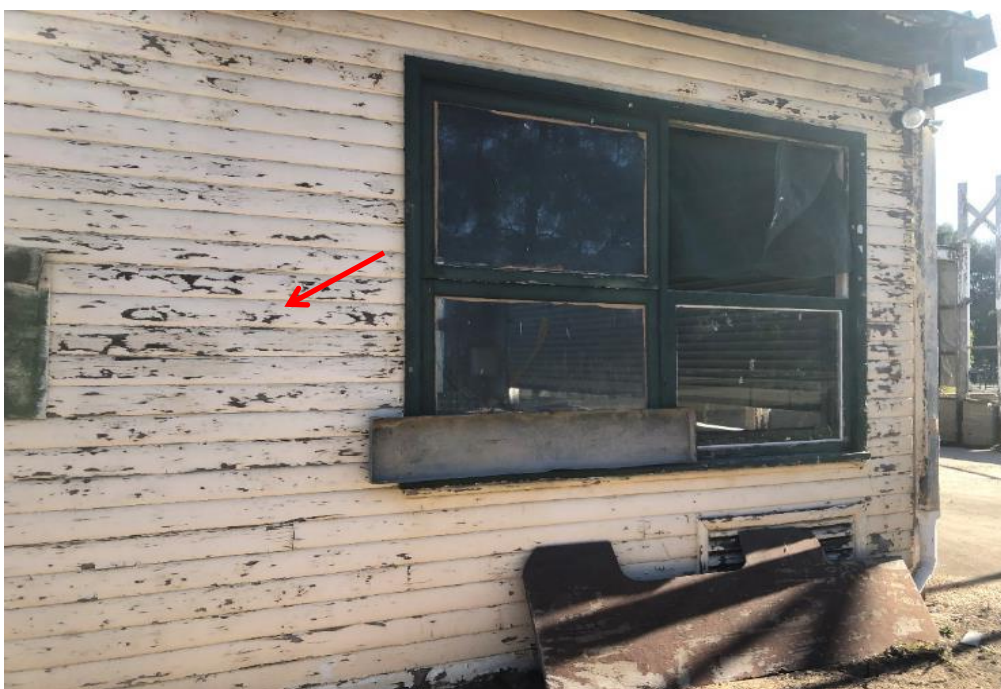
Photograph 22: Potting shed, external , walls, cream paint, lead paint (>0.1% lead w/w).

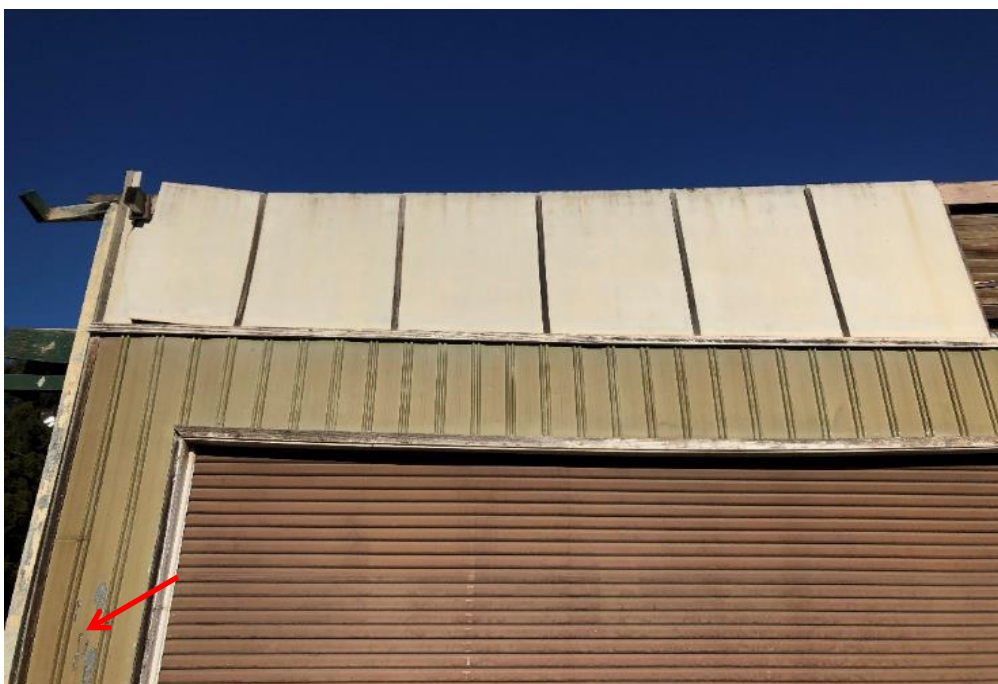
Photograph 23: Potting shed, external , corrugated sheet metal, green paint, lead paint (>0.1% lead w/w).

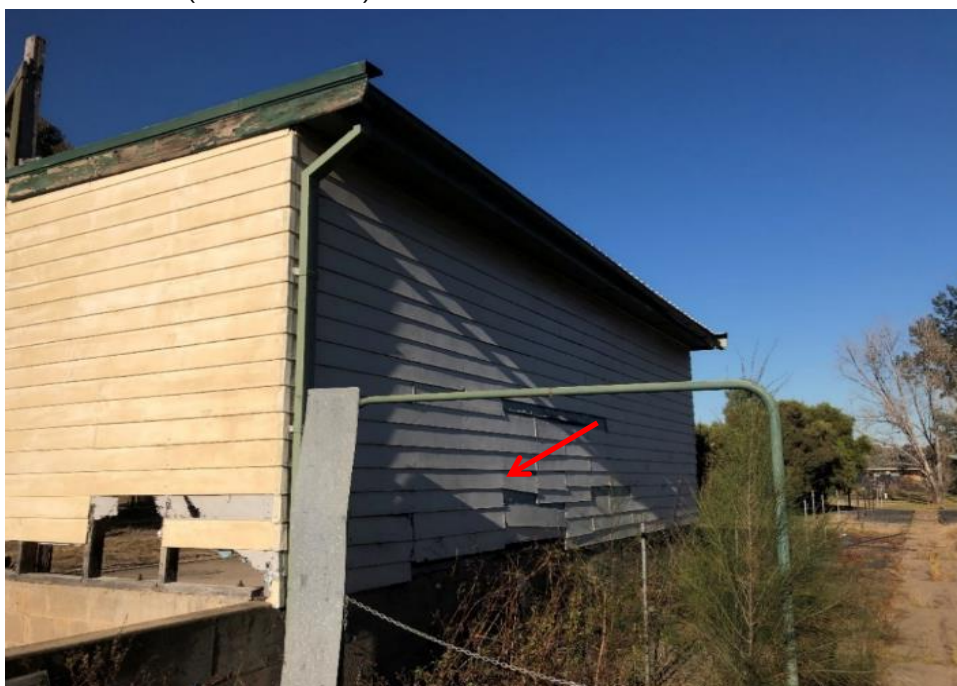
Photograph 24: Potting shed, external , weatherboard, fibre cement sheet, no asbestos detected by analysis.

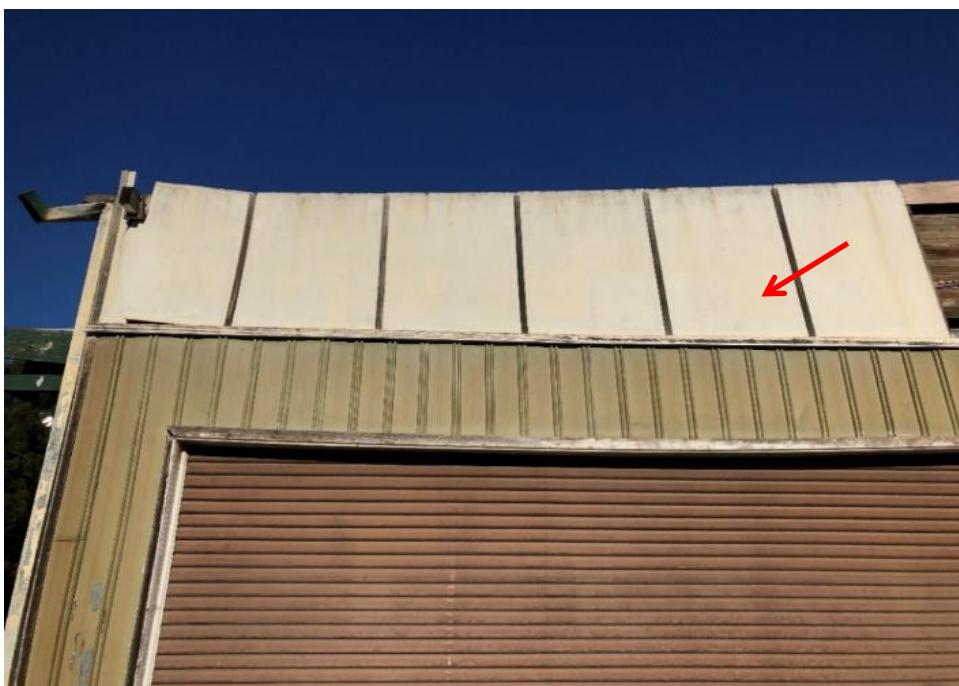
Photograph 25: Potting shed, external , walls, fibre cement sheet, no asbestos detected by analysis.

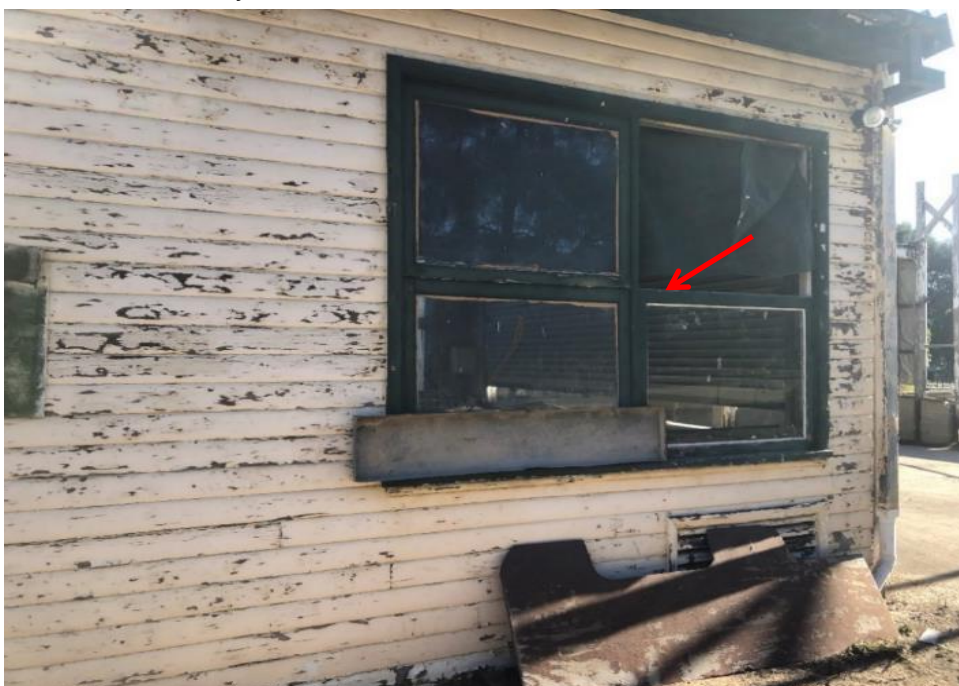
Photograph 26: Potting shed, external , windows, green paint, lead paint (>0.1% lead w/w).

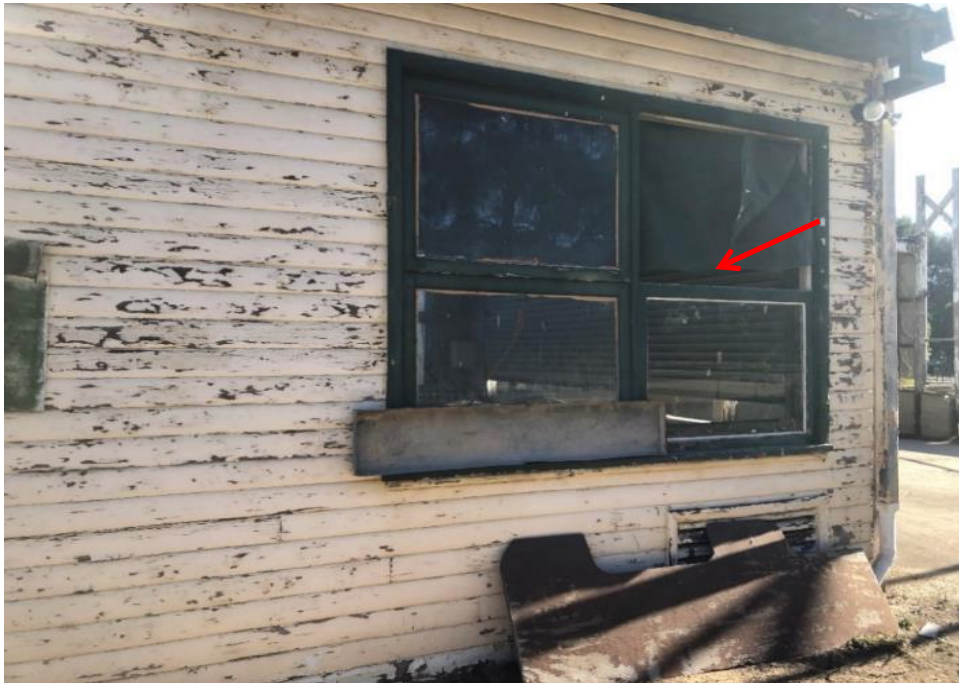
Photograph 27: Potting shed, external , windows, putty, non-lead paint ( $\leq 0.1\%$  lead w/w).

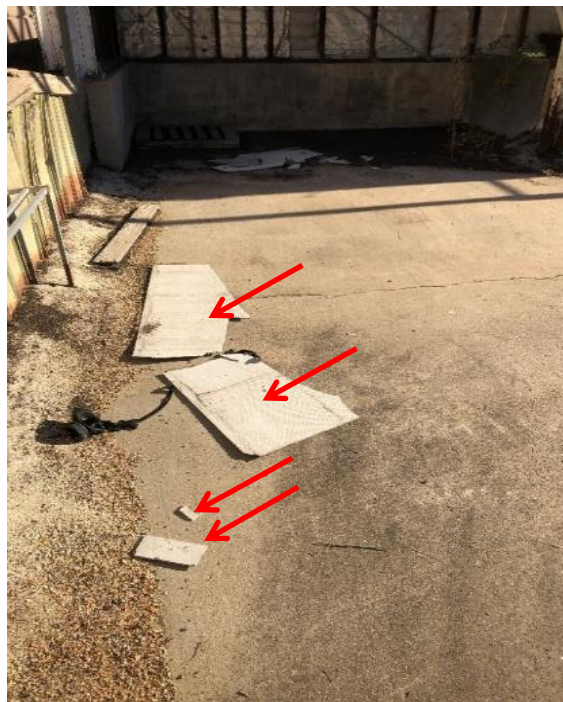
Photograph 28: Potting shed, external , ground surface, fibre cement sheet debris, asbestos detected by analysis.

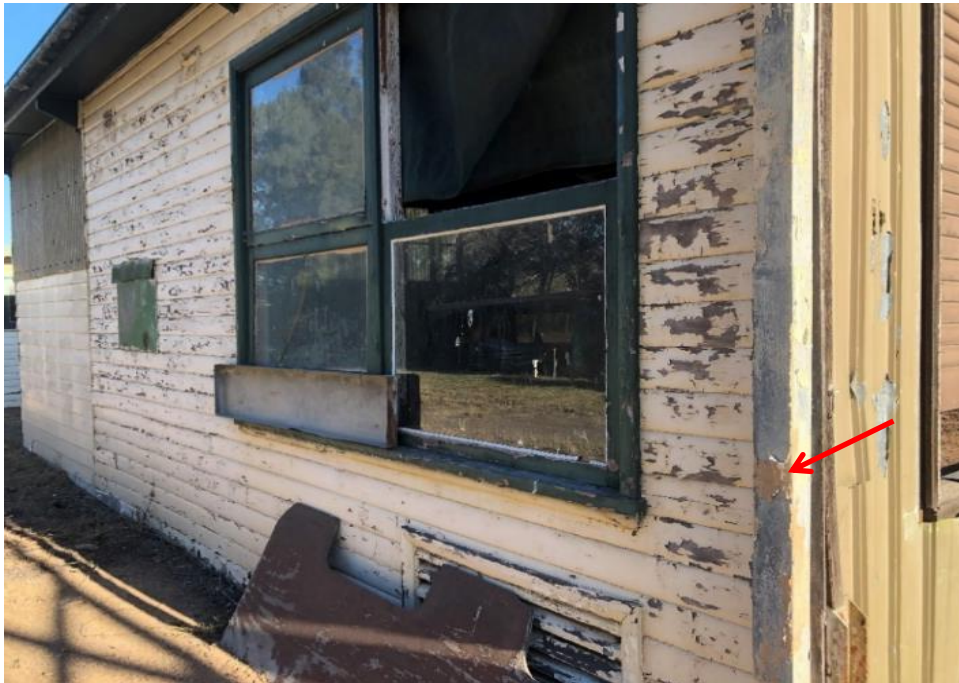
Photograph 29: Potting shed, external , downpipes, brown paint, lead paint (>0.1% lead w/w).

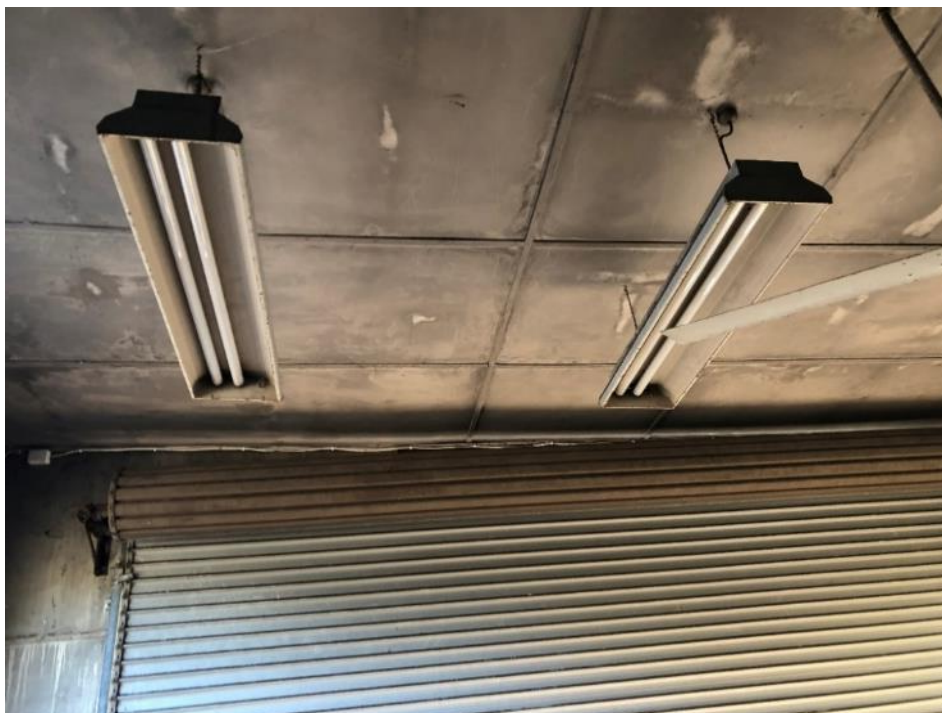
Photograph 30: Potting shed, internal , light fittings, capacitors, insulating oil, PCB (assumed).

Any PCB containing capacitors that exhibit leakage should be removed and replaced by a suitably qualified and experienced contractor as soon as possible. Access to areas containing leaking capacitors should be suitably restricted.

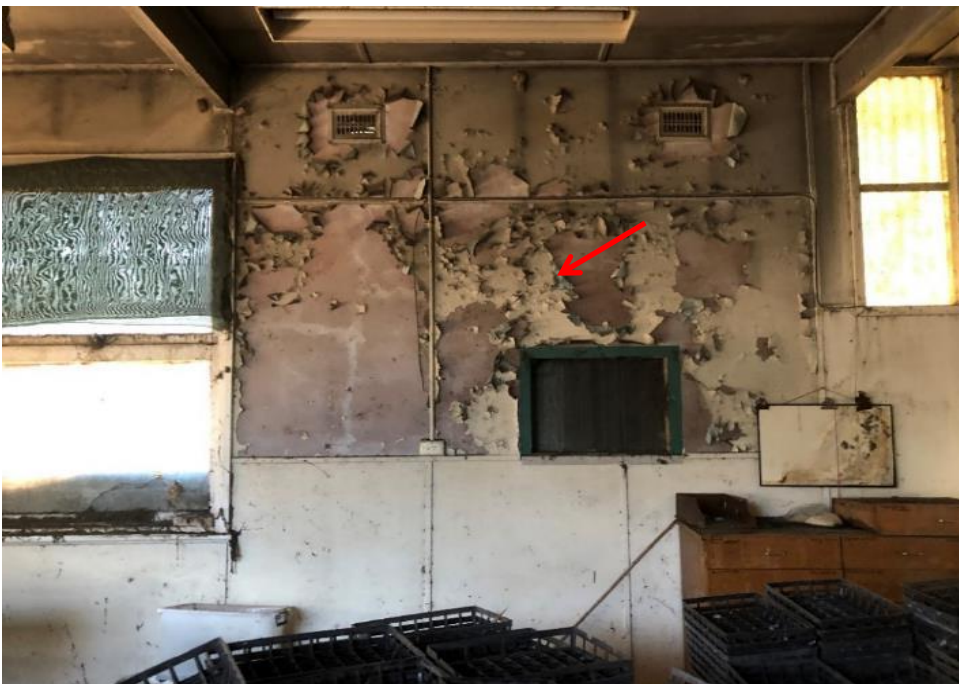
Photograph 32: Potting shed, internal , walls, beige paint, lead paint (>0.1% lead w/w).

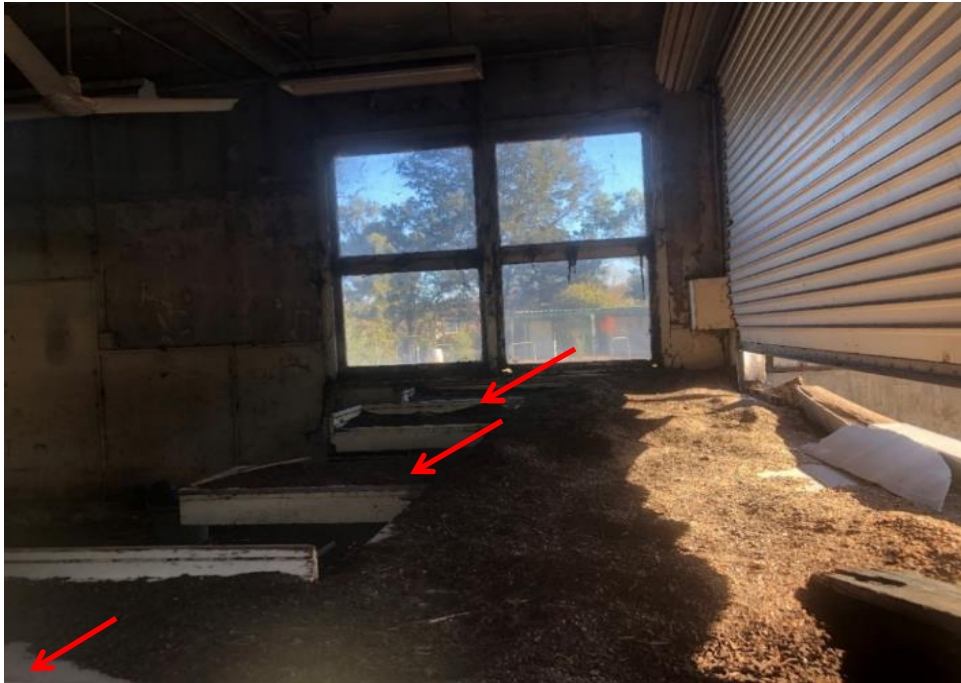
Photograph 33: Potting shed, internal , potting shelf, fibre cement sheet, no asbestos detected by analysis.

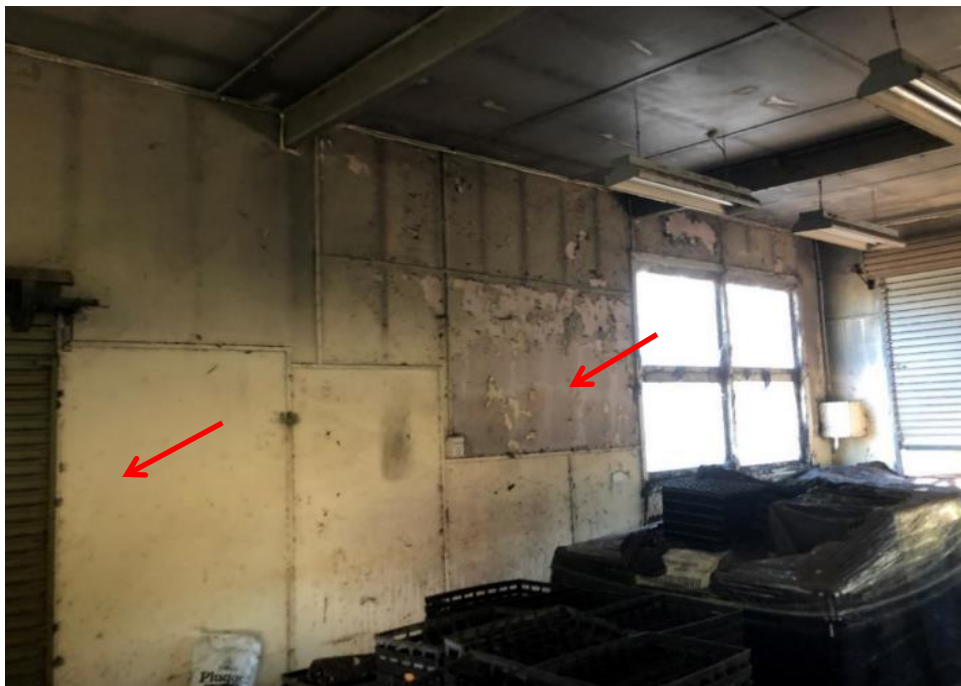
Photograph 34: Potting shed, internal , walls, fibre cement sheet, no asbestos detected by analysis.

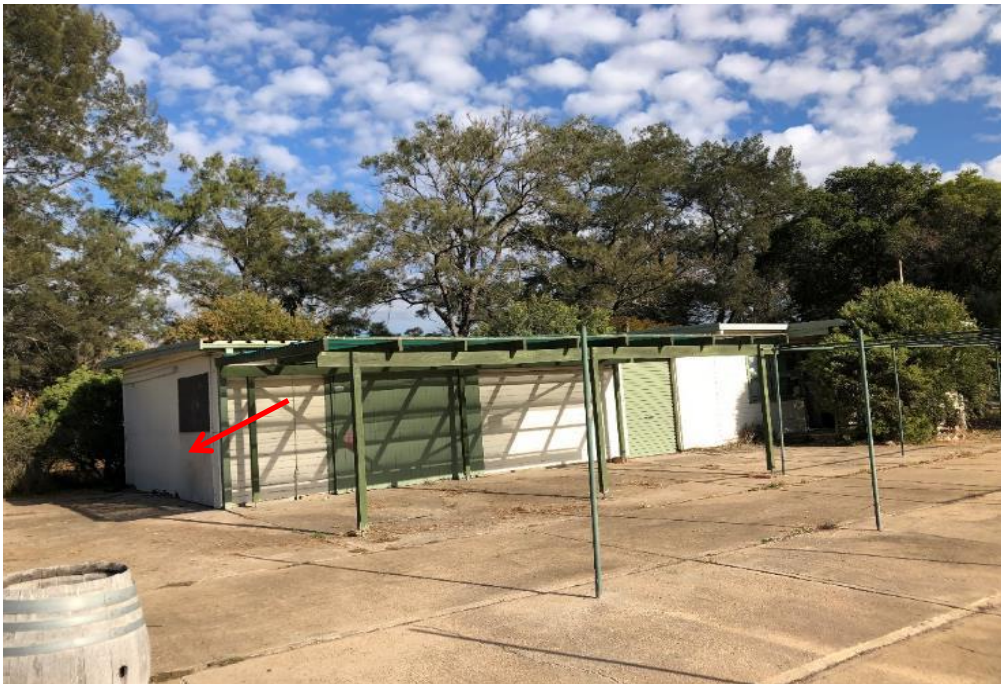
Photograph 36: Front Office, external, walls, south end, fibre cement sheet, no asbestos detected by analysis.

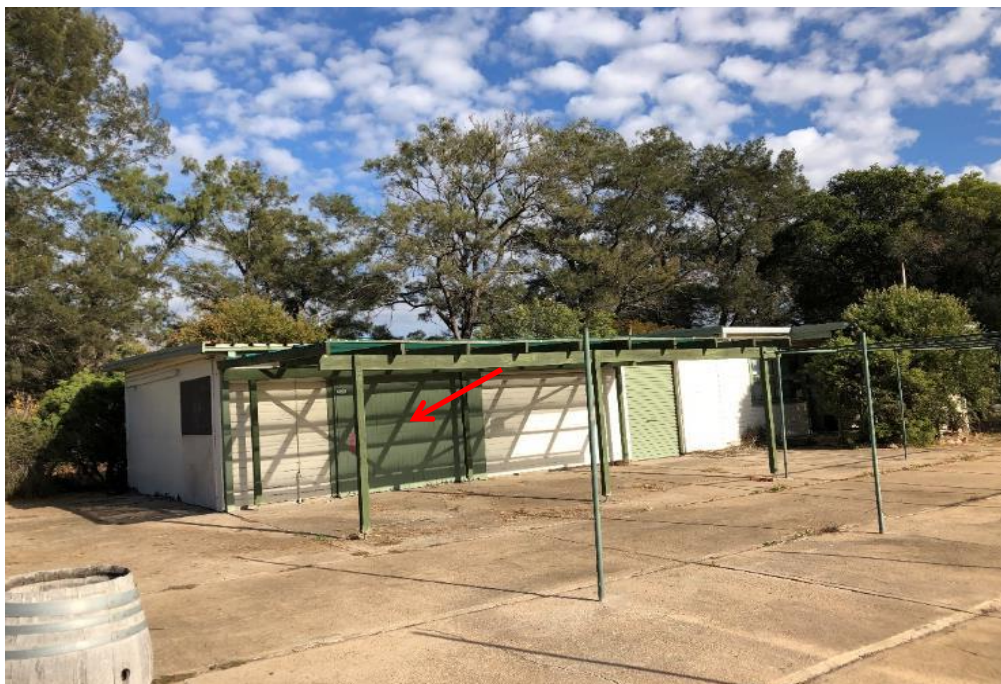
Photograph 37: Front Office, external, sliding door, pale green paint, non-lead paint ( $\leq 0.1\%$  lead w/w).

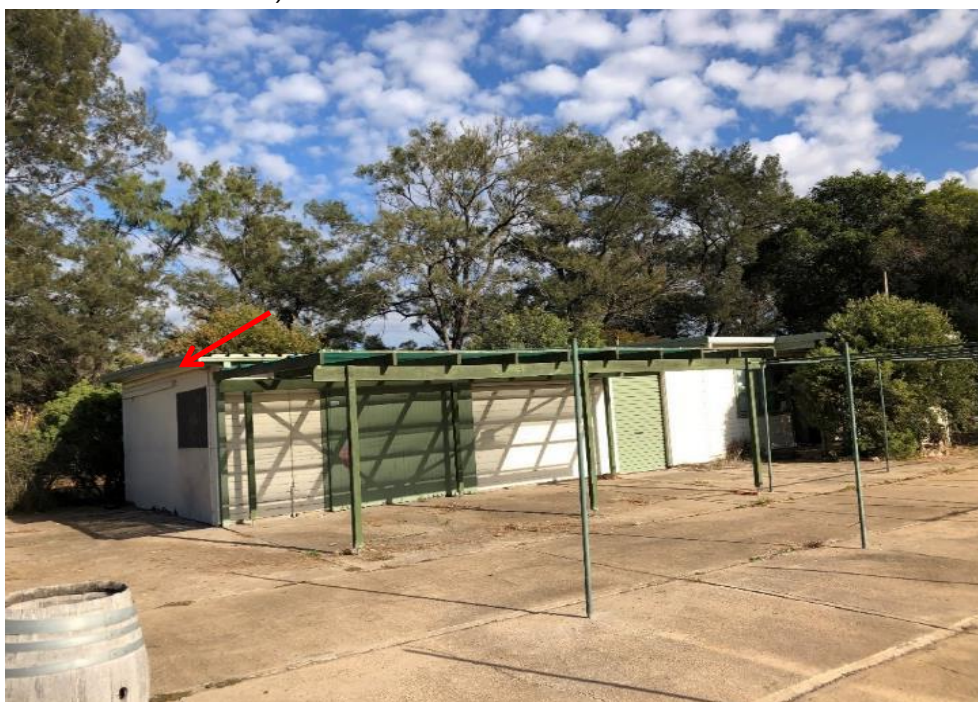
Photograph 38: Front Office, external, eaves, fibre cement sheet, no asbestos detected by analysis.

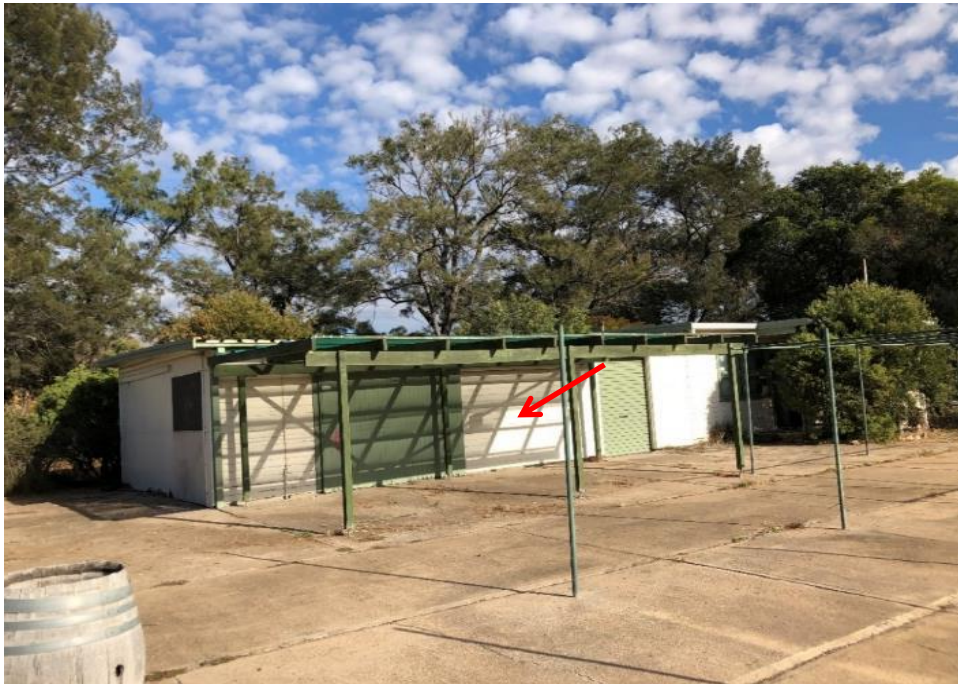
Photograph 39: Front Office, external, walls, cream paint, non-lead paint ( $\leq 0.1\%$  lead w/w).

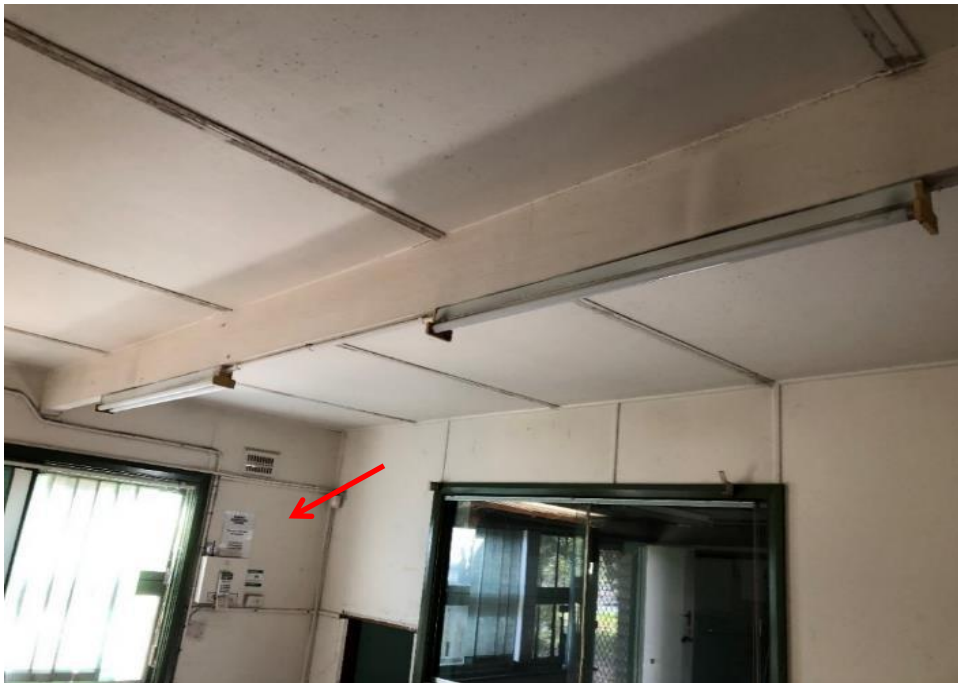
Photograph 41: Front Office, internal , wall cavities, insulation material, SMF (assumed).

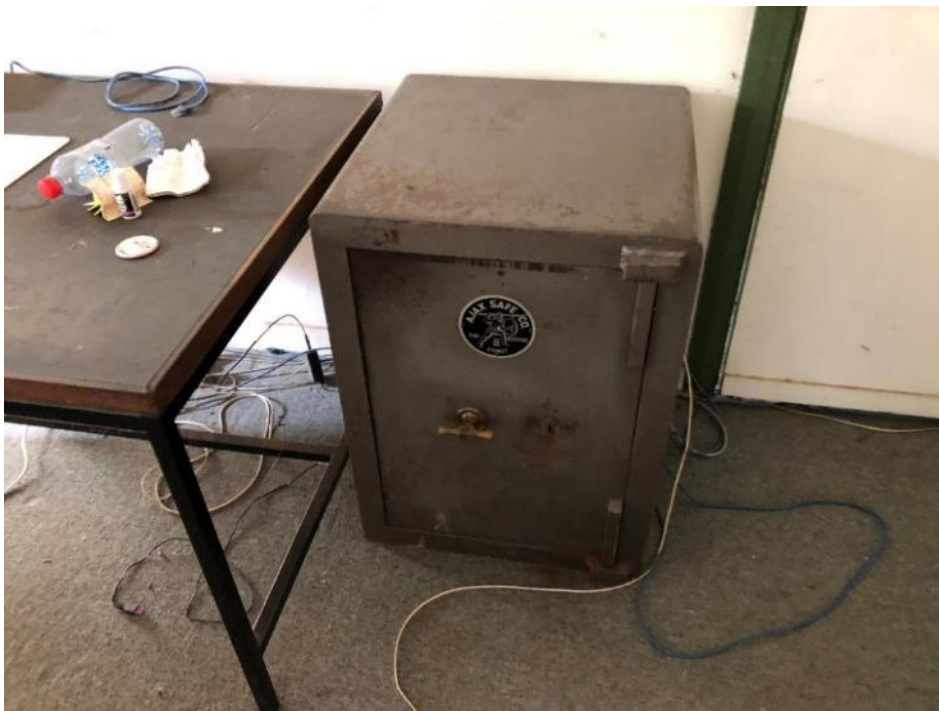
Photograph 42: Front Office, internal , "Ajax" brand safe, internal insulation, asbestos (assumed).

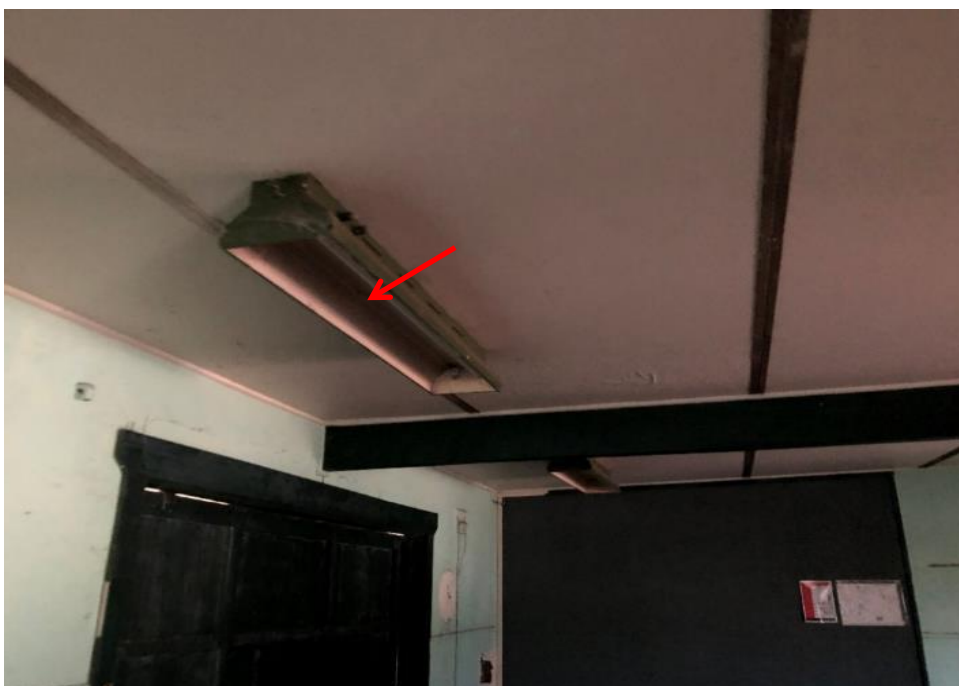
Photograph 43: Front Office, internal , fluorescent light fittings, capacitors, insulating oil, PCB (assumed).

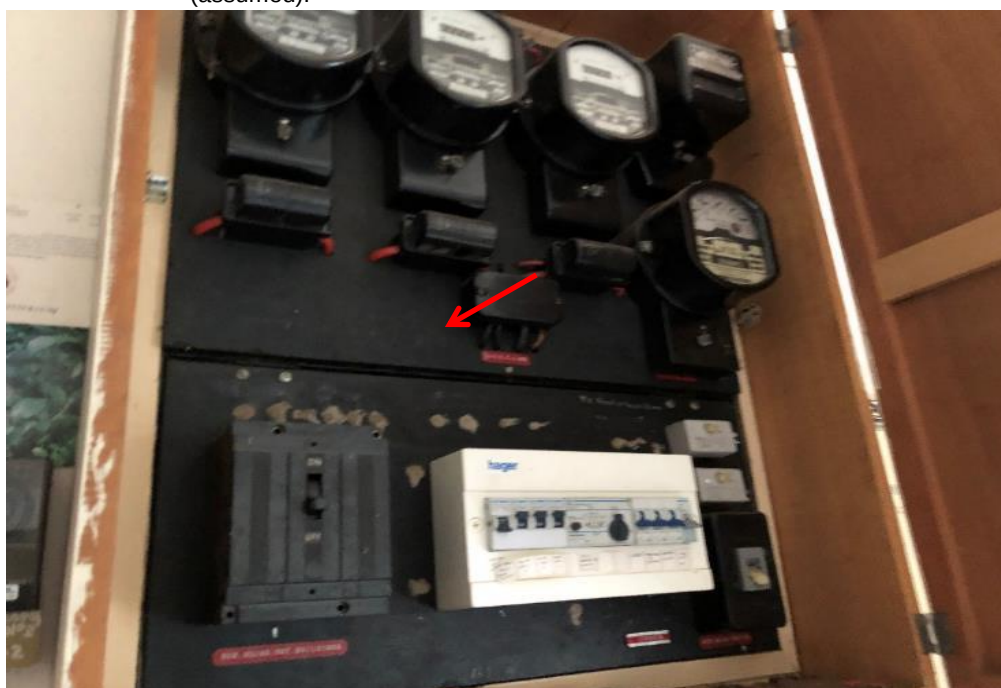
Photograph 44: Front Office, internal , electrical panel, electrical backing board, asbestos (assumed).

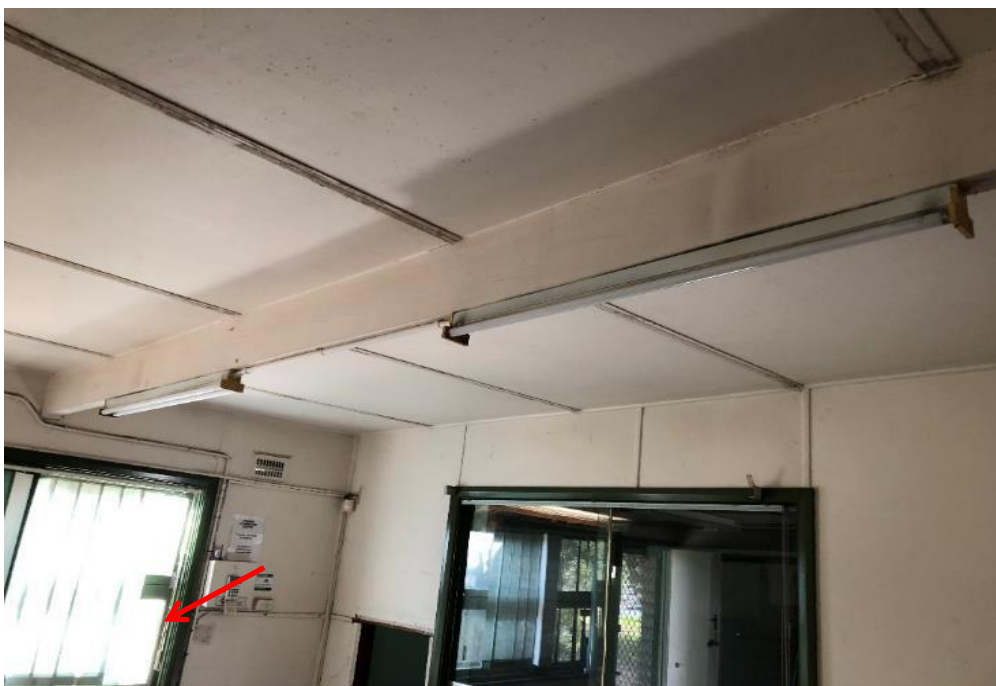
Photograph 45: Front Office, internal , windows and architraves, green paint, non-lead paint (≤0.1% lead w/w).
