Report on  
Hazardous Building Materials (HBM) Survey

Lot 100 DP1261496, Maitland Street, Muswellbrook,  
NSW

Prepared for  
Pacific Brook Christian School Ltd

Project 91601.01  
July 2021

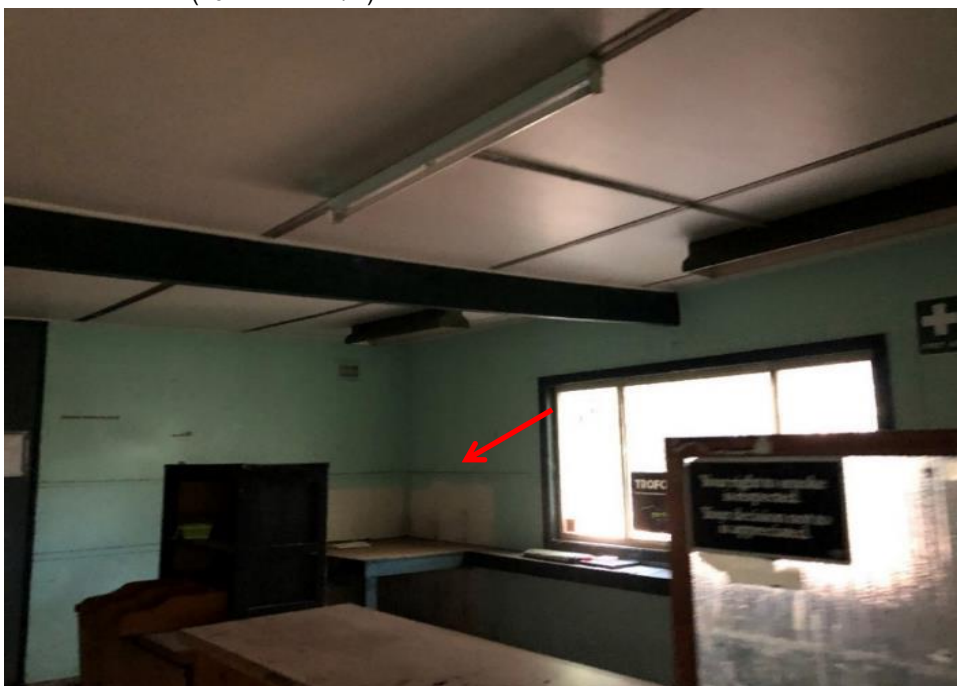
Photograph 46: Front Office, internal , walls, south end, green painted fibre cement sheet, no asbestos detected by analysis.

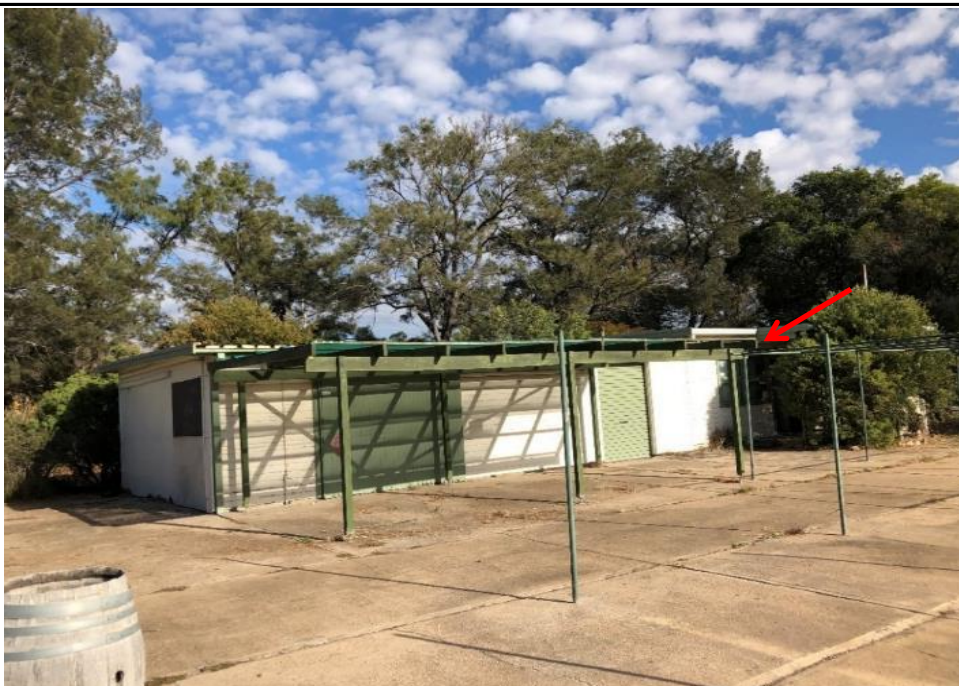
Photograph 47: Front Office, external, eaves to north, fibre cement sheet, no asbestos detected by analysis.

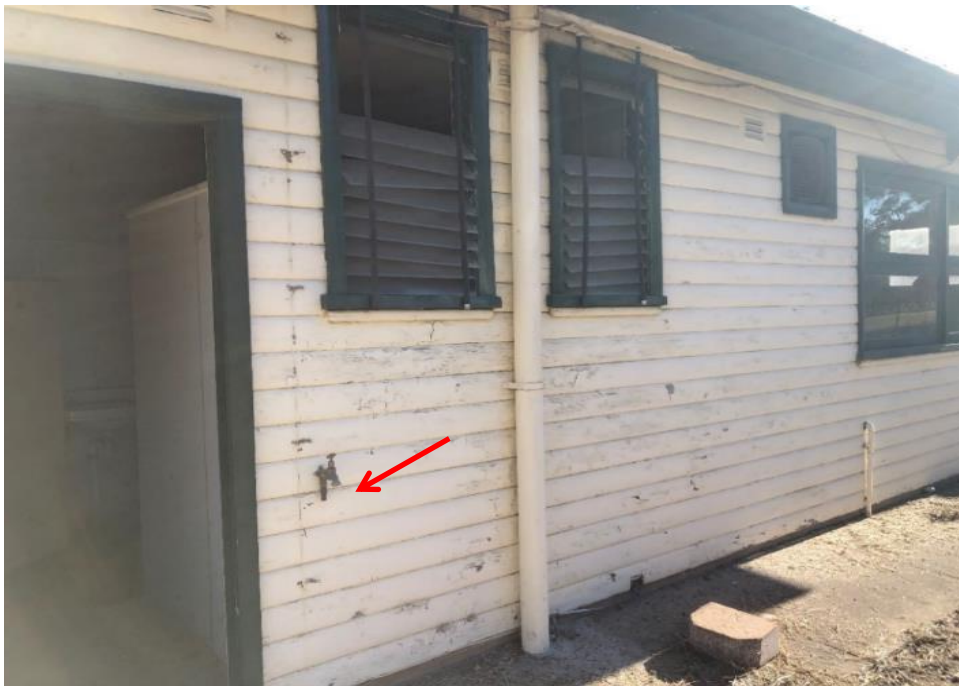
Photograph 51: Rear Office, external, walls, beige paint, lead paint (>0.1% lead w/w).

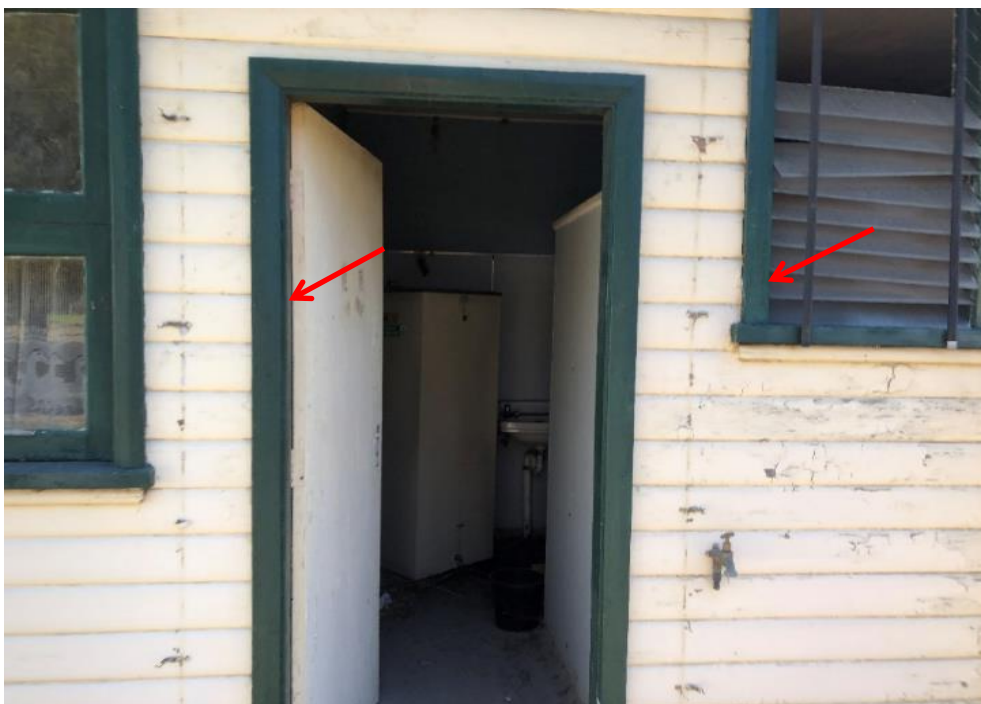
Photograph 52: Rear Office, external, windows, green paint, lead paint (>0.1% lead w/w).

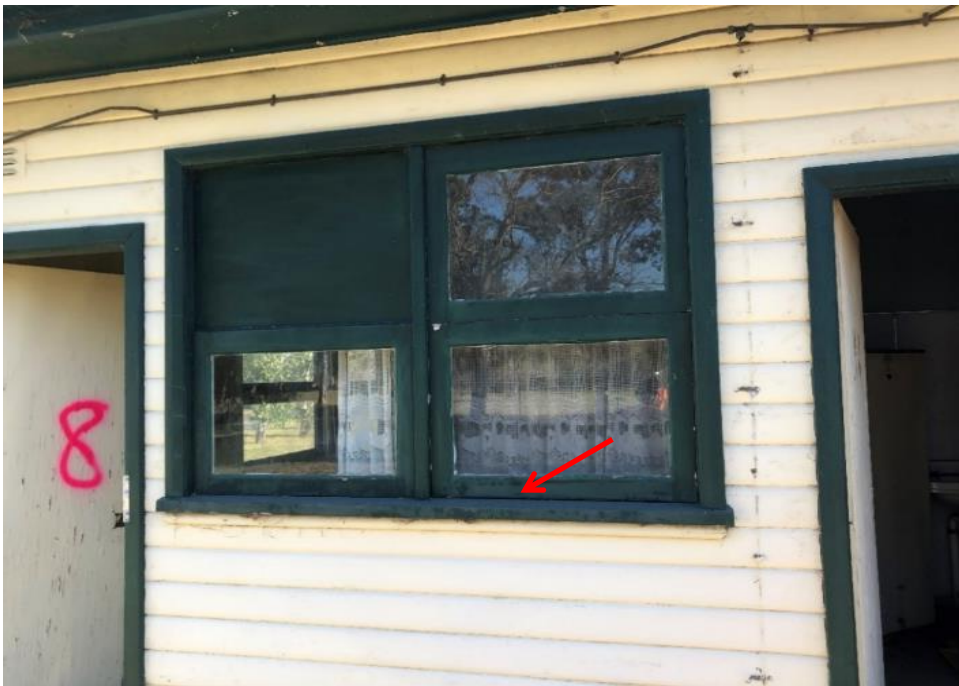
Photograph 53: Rear Office, external , windows, putty, no asbestos detected by analysis.

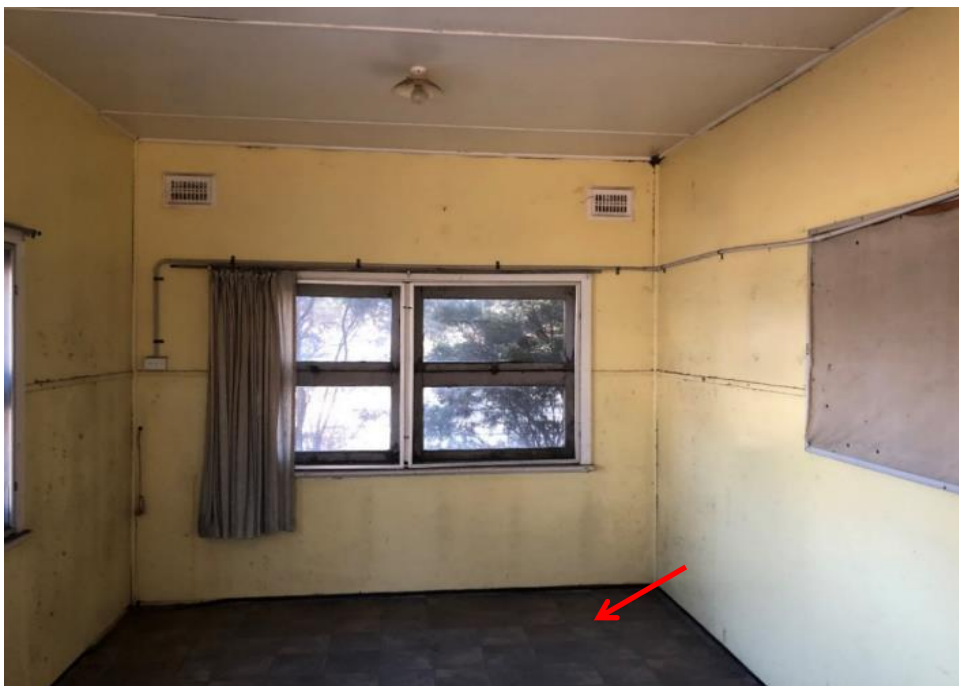
Photograph 54: Rear Office, internal , floors, vinyl floor sheet, no asbestos detected by analysis.

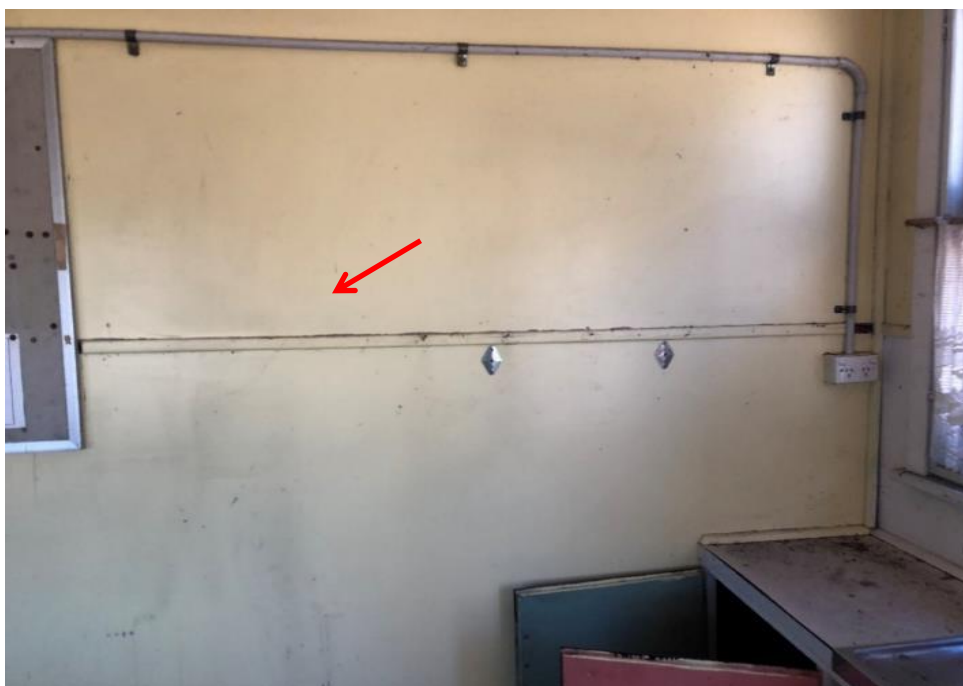
Photograph 55: Rear Office, internal , walls, yellow paint, lead paint (>0.1% lead w/w).

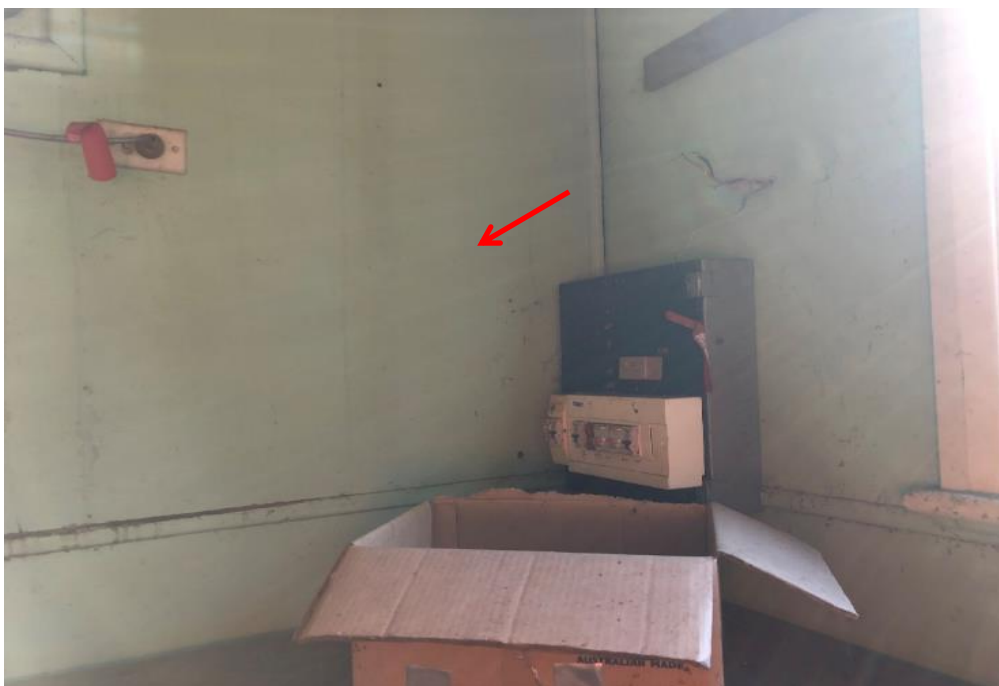
Photograph 57: Rear Office, internal , walls, fibre cement sheet, asbestos detected by analysis.

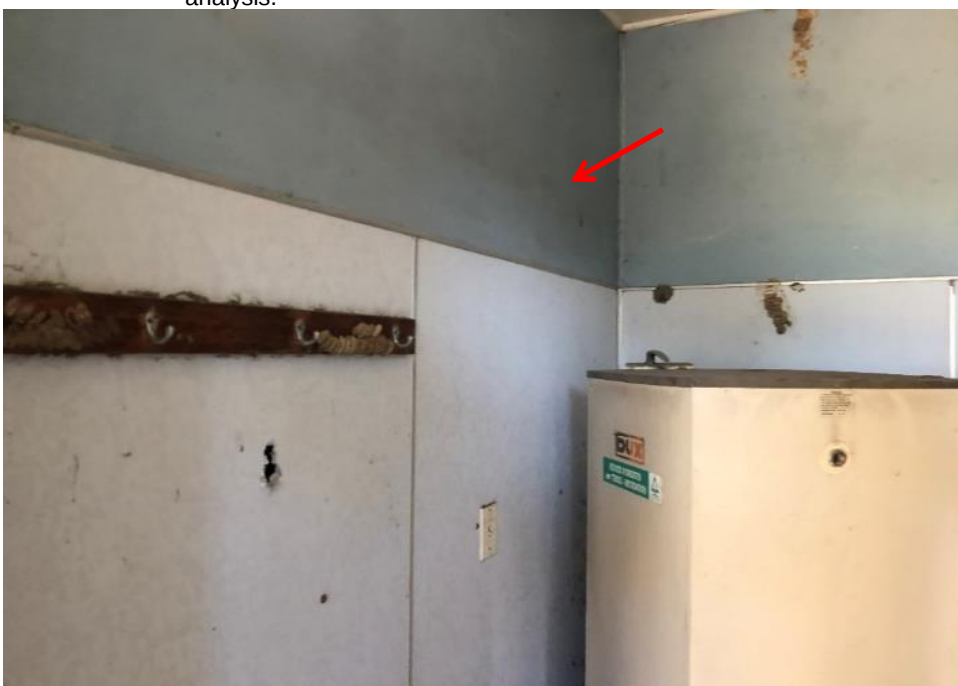
Photograph 58: Rear Office, internal , wet room, upper walls, fibre cement sheet, asbestos detected by analysis.

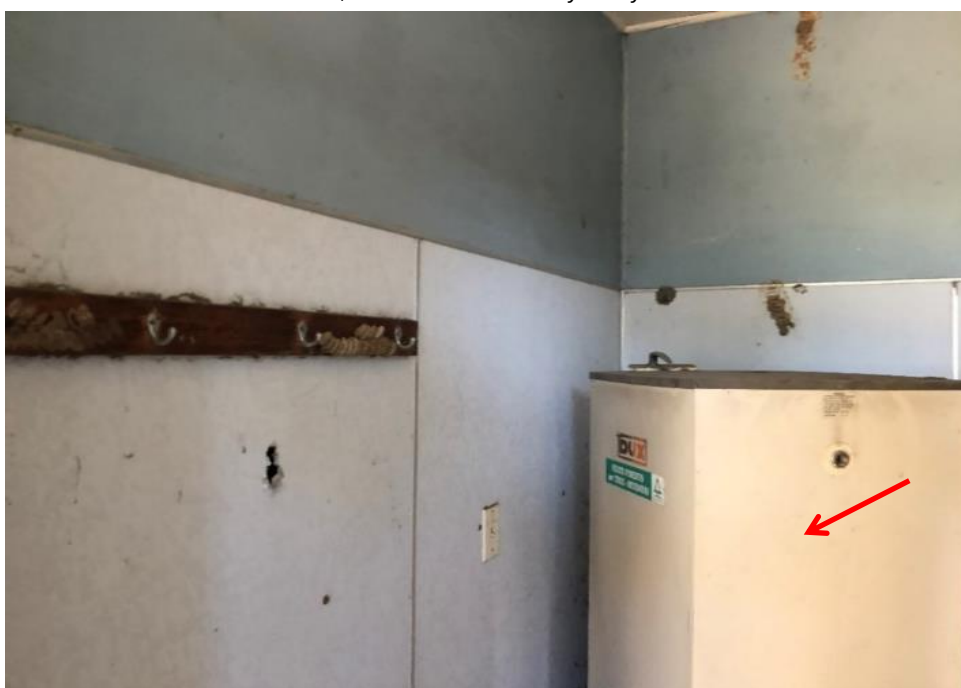
Photograph 60: Rear Office, internal, hot water unit, internal insulation, SMF (assumed).

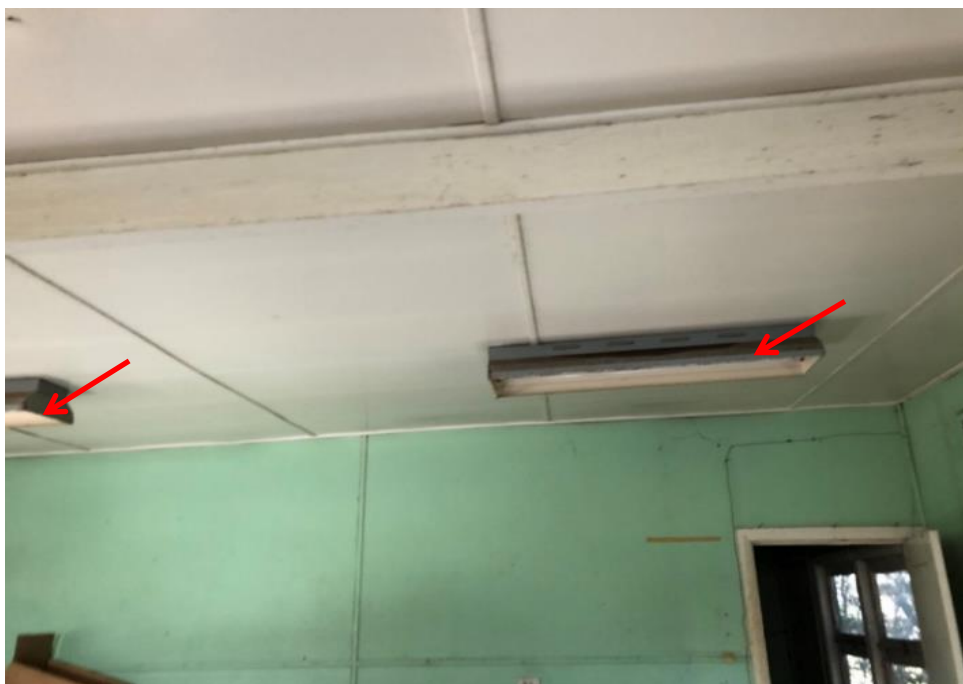
Photograph 61: Rear Office, internal , light fittings, capacitors, insulating oil, PCB (assumed).

Any PCB containing capacitors that exhibit leakage should be removed and replaced by a suitably qualified and experienced contractor as soon as possible. Access to areas containing leaking capacitors should be suitably restricted.

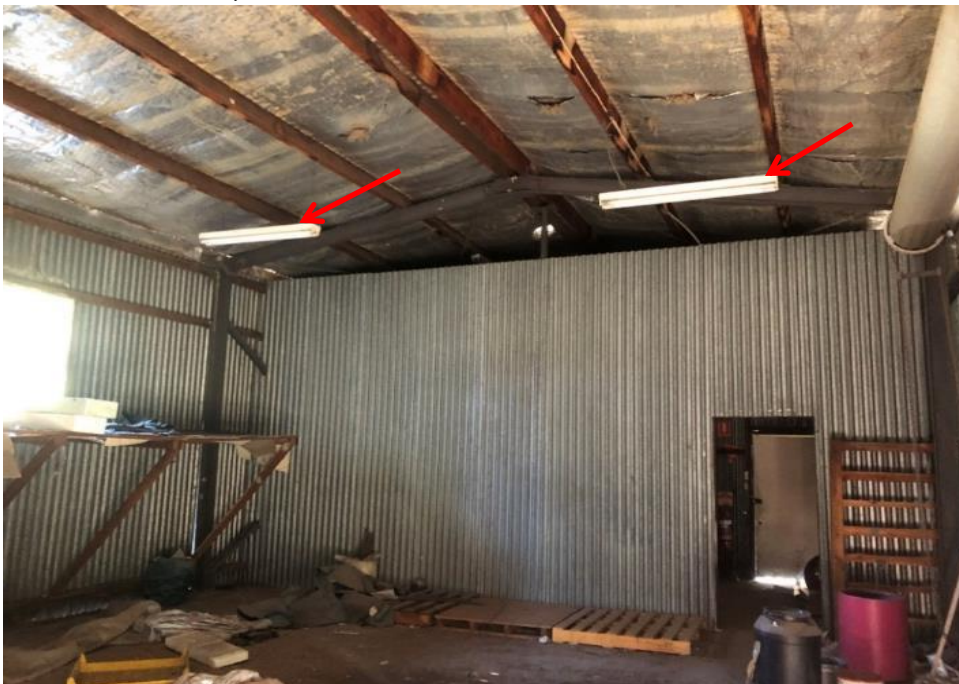
Photograph 64: HAZCHEM shed, internal , light fittings, capacitors, insulating oil, PCB (assumed).

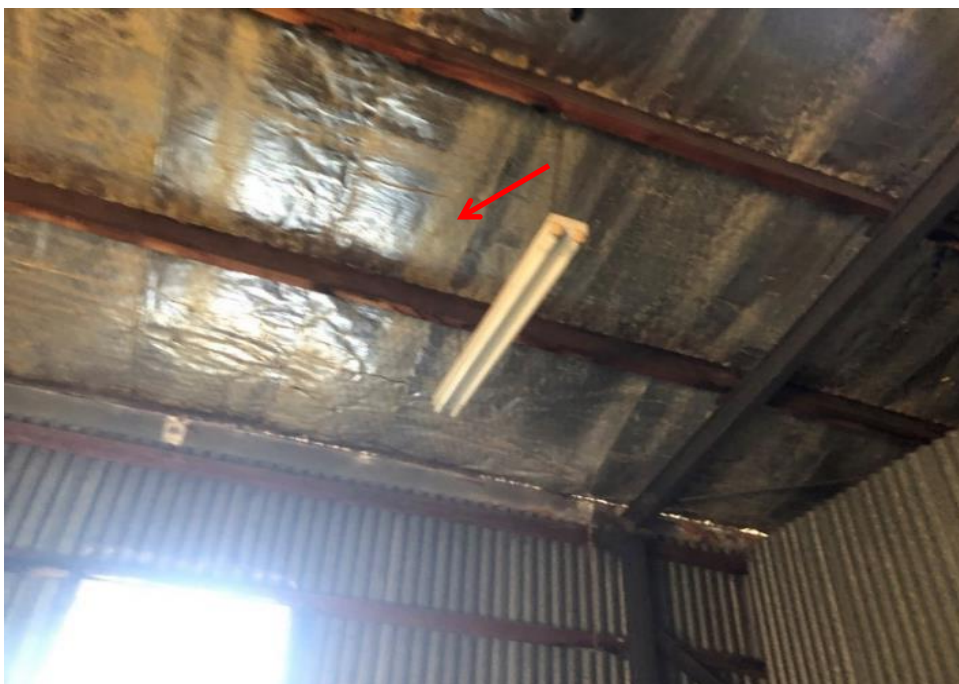
Photograph 65: HAZCHEM shed, internal , roof, insulation material, SMF identified visually.

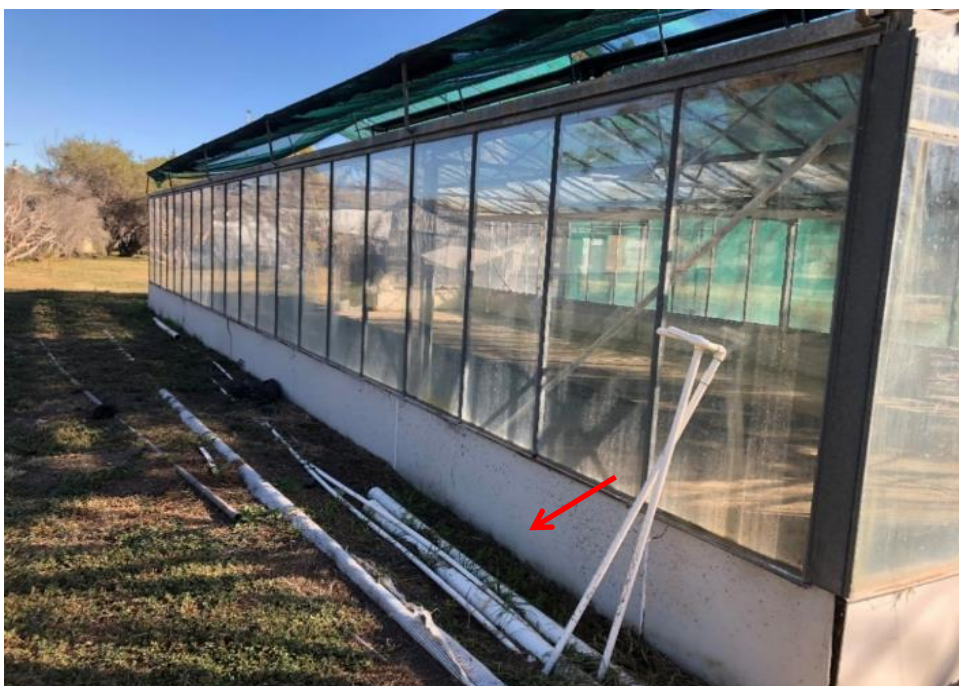
Photograph 67: Glasshouse, external , walls, fibre cement sheet, no asbestos detected by analysis.

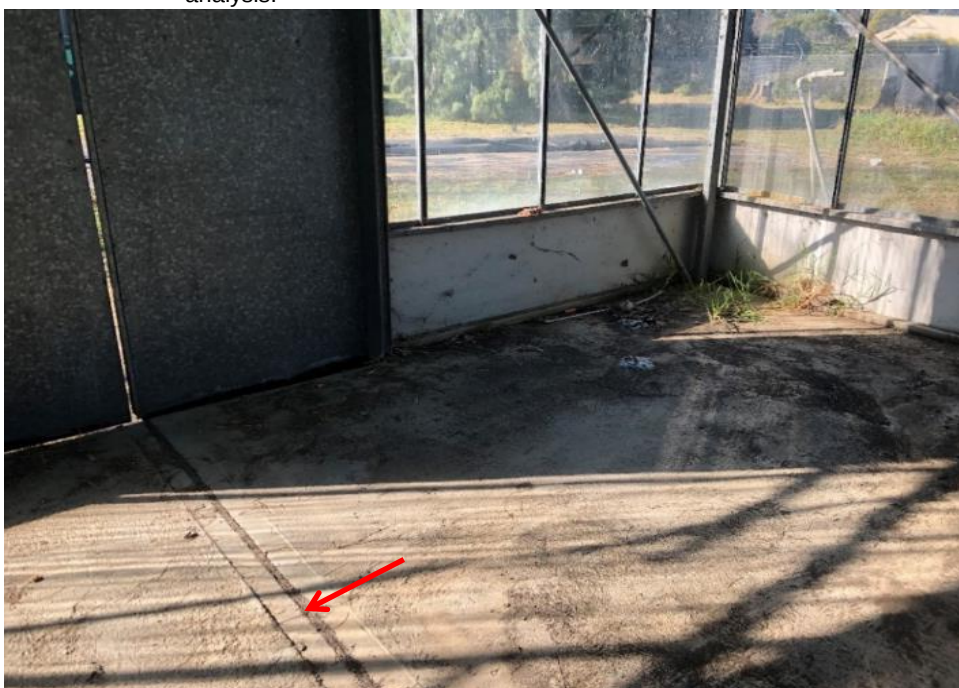
| | | | | | | Asbestos Risk Assessment | | | | | | | | | |
|---|---|---|---|---|---|---|---|---|---|---|---|---|---|---|---|
| Glasshouse | internal | concrete expansion joint | fibrous mastic | 10.2 | no asbestos detected by analysis | N/A | N/A | N/A | N/A | N/A | N/A | N/A | N/A | 68 | No hazardous material identified. |

Photograph 68: Glasshouse, internal , concrete expansion joint, fibrous mastic, no asbestos detected by analysis.
