Revised Remediation Action Plan

Proposed School
Lot 100, DP1261496 Maitland Street, Muswellbrook

Prepared for
Pacific Brook Christian School

Project 91601.04
September 2021

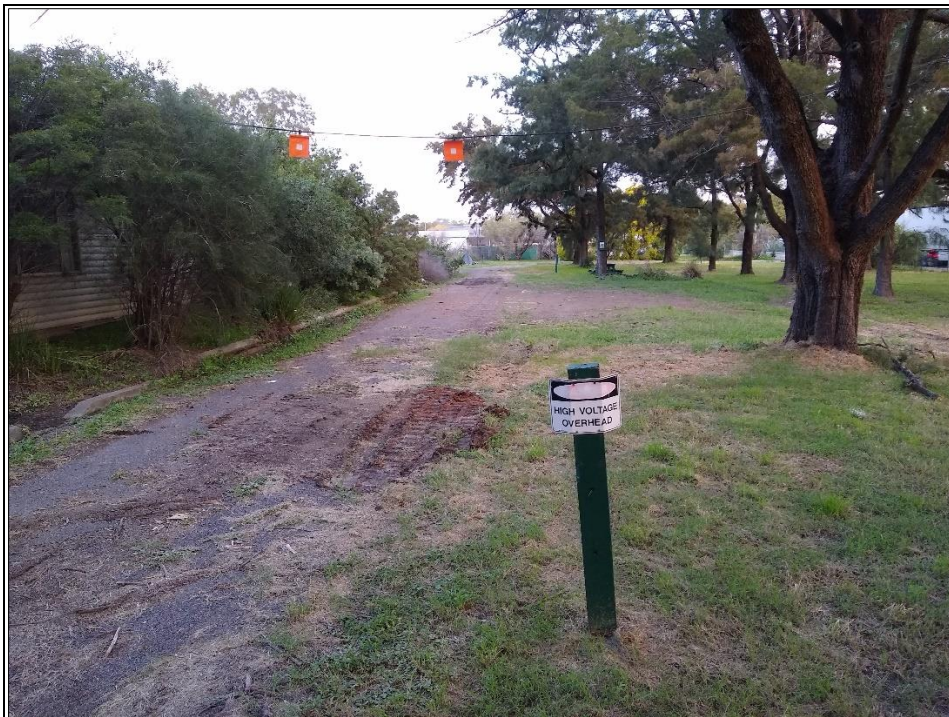
Figure 4: General condition of asphalt access track, south of the buildings, looking east.

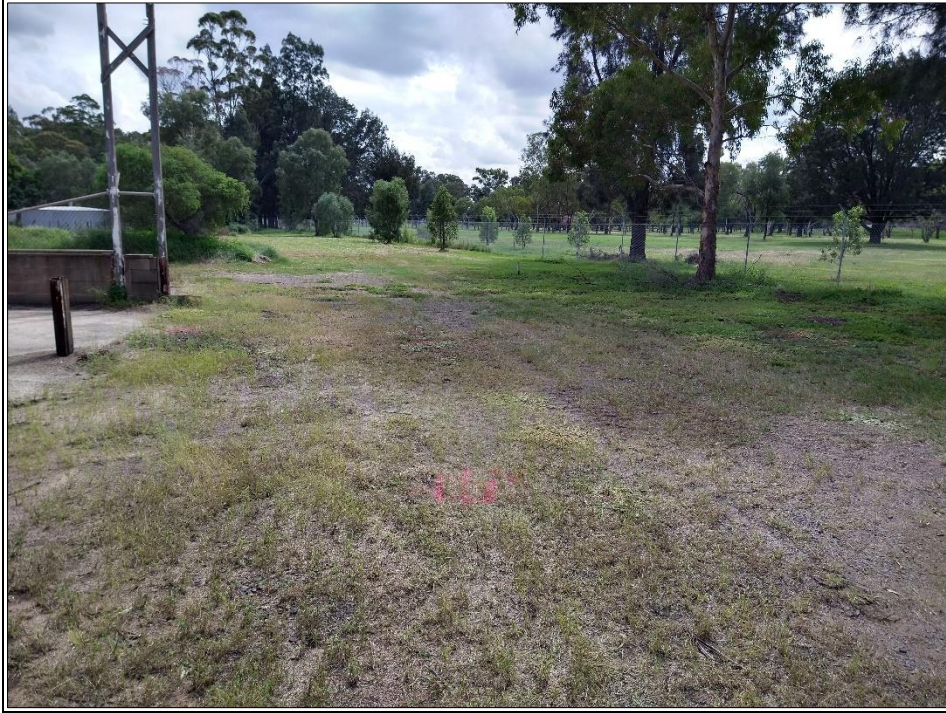
The buried asphalt lenses (associated with a former pavement) were identified within pits north-west of Building 5 (Pits 406, 407, 408, 409, 106 and 106A). The lenses varied in thickness from 20 mm to 100 mm and were generally located below clean granular soils. The lenses were observed from depths of 0.05/0.3 m to depths of 0.1/0.4 m. Refer to Logs in Appendix A for details.

Figure 5: Area of buried asphalt access track, north of the Building 5, looking west.

As a precautionary measure, it was therefore proposed to place the asphalt impacted materials beneath the proposed carpark pavement. It is noted that placement of the materials within the carpark area does not constitute remediation nor attract long term management requirements.

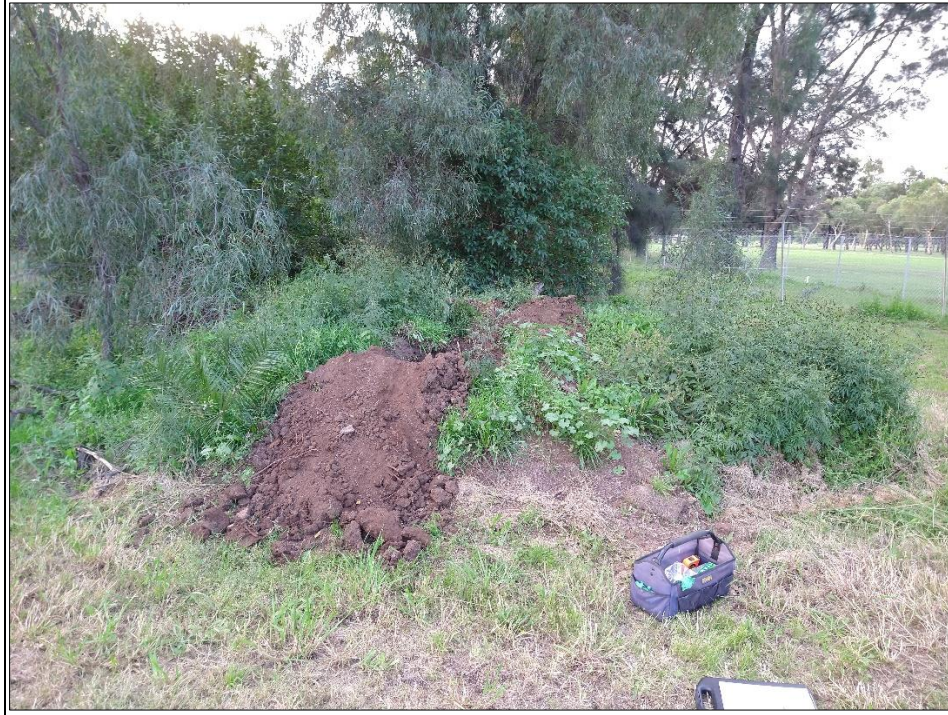
Figure 13: Stockpile 306 located in the central northern portion of the site, generally comprising silty sand and gravel and intermixed clay with trace asphalt.

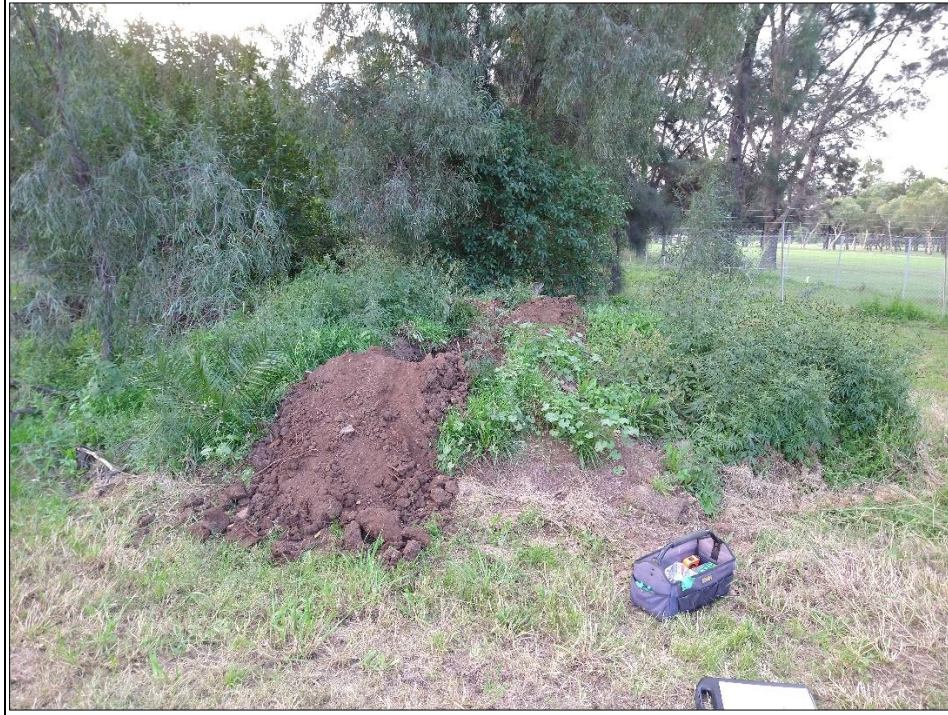
Figure 13: Stockpile 306 located in the central northern portion of the site, generally comprising silty sand and gravel and intermixed clay with trace asphalt.

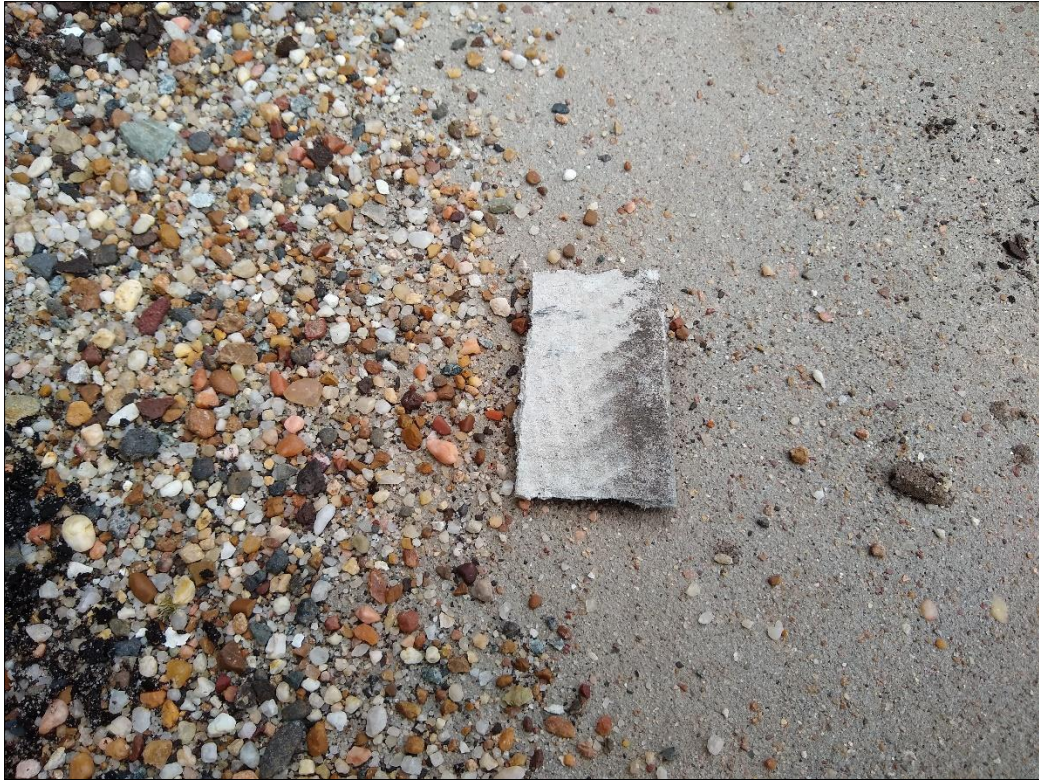
- Presence of ACM in two fibro fragments observed at the surface adjacent to Buildings 5 and 8 (samples F1/JRK and F2/JRK respectively). The minor ACM identified are likely to be associated with the poor condition of the adjacent buildings, and do not appear to be related to impacts within underlying soil/fill;

Figure 19: Fragment F1/JRK identified on the concrete slab along the north western face of Building 5.

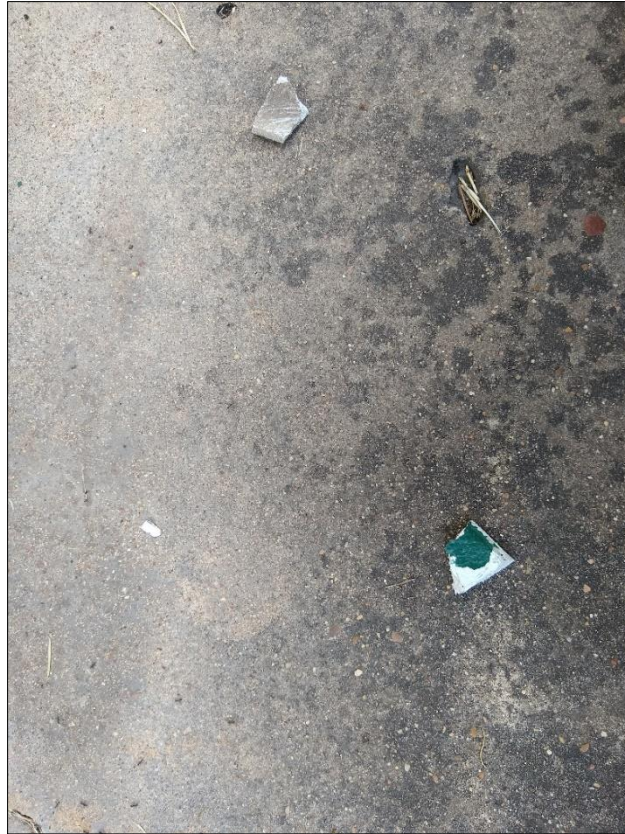
Figure 23: Fibro fragments F2/JRK identified on concrete pavement along the north eastern side of Building 8.

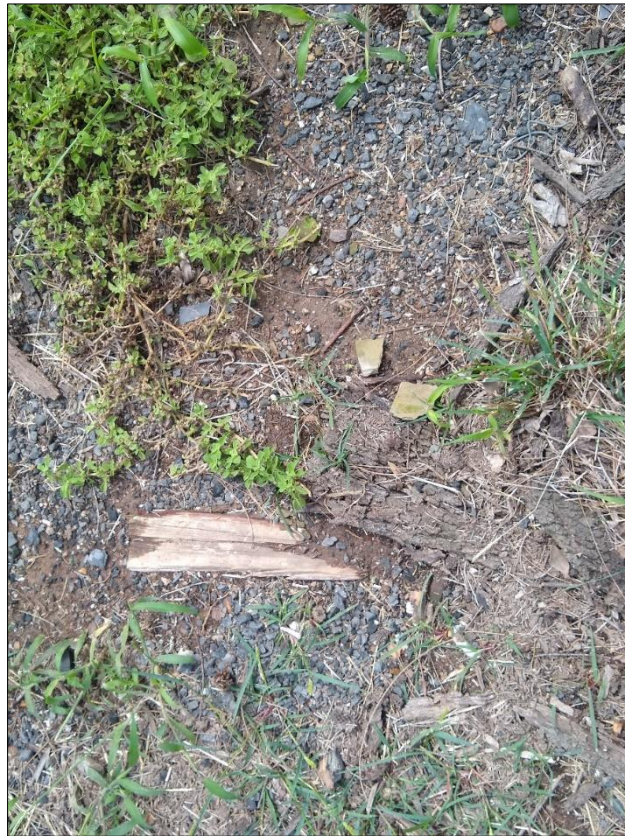
Figure 26: Fibro fragment F3/JRK found along the north eastern face of Building 9.

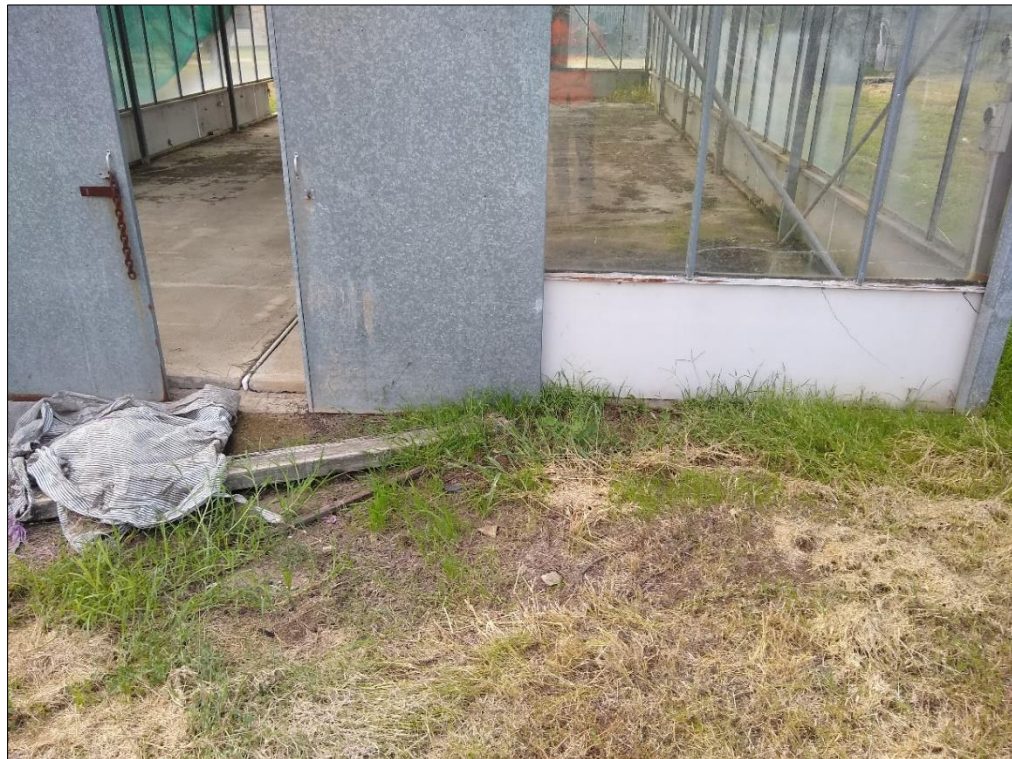
Figure 28: Fibro fragment F4/JRK located along the southern side of Building 10.

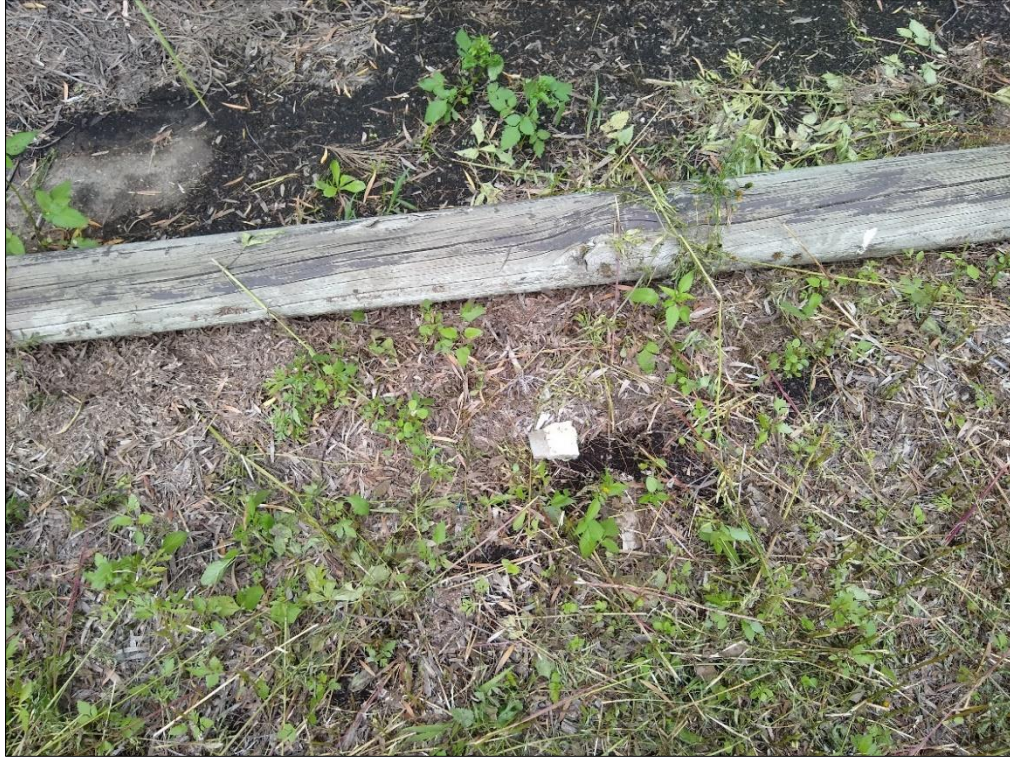
Figure 31: Fibro fragment F6/JRK located in the garden near the north western corner of Building 6.

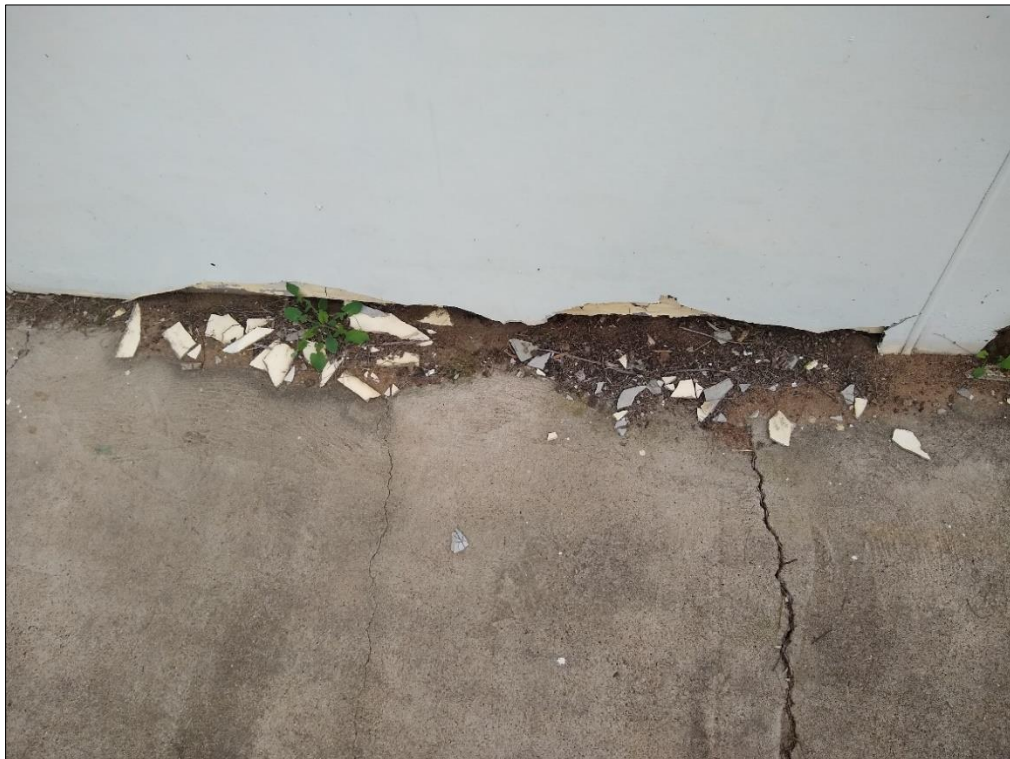
Figure 32: Damaged external wall located along the southern face of Building 6. Sampling location for fibro sample F5/JRK.

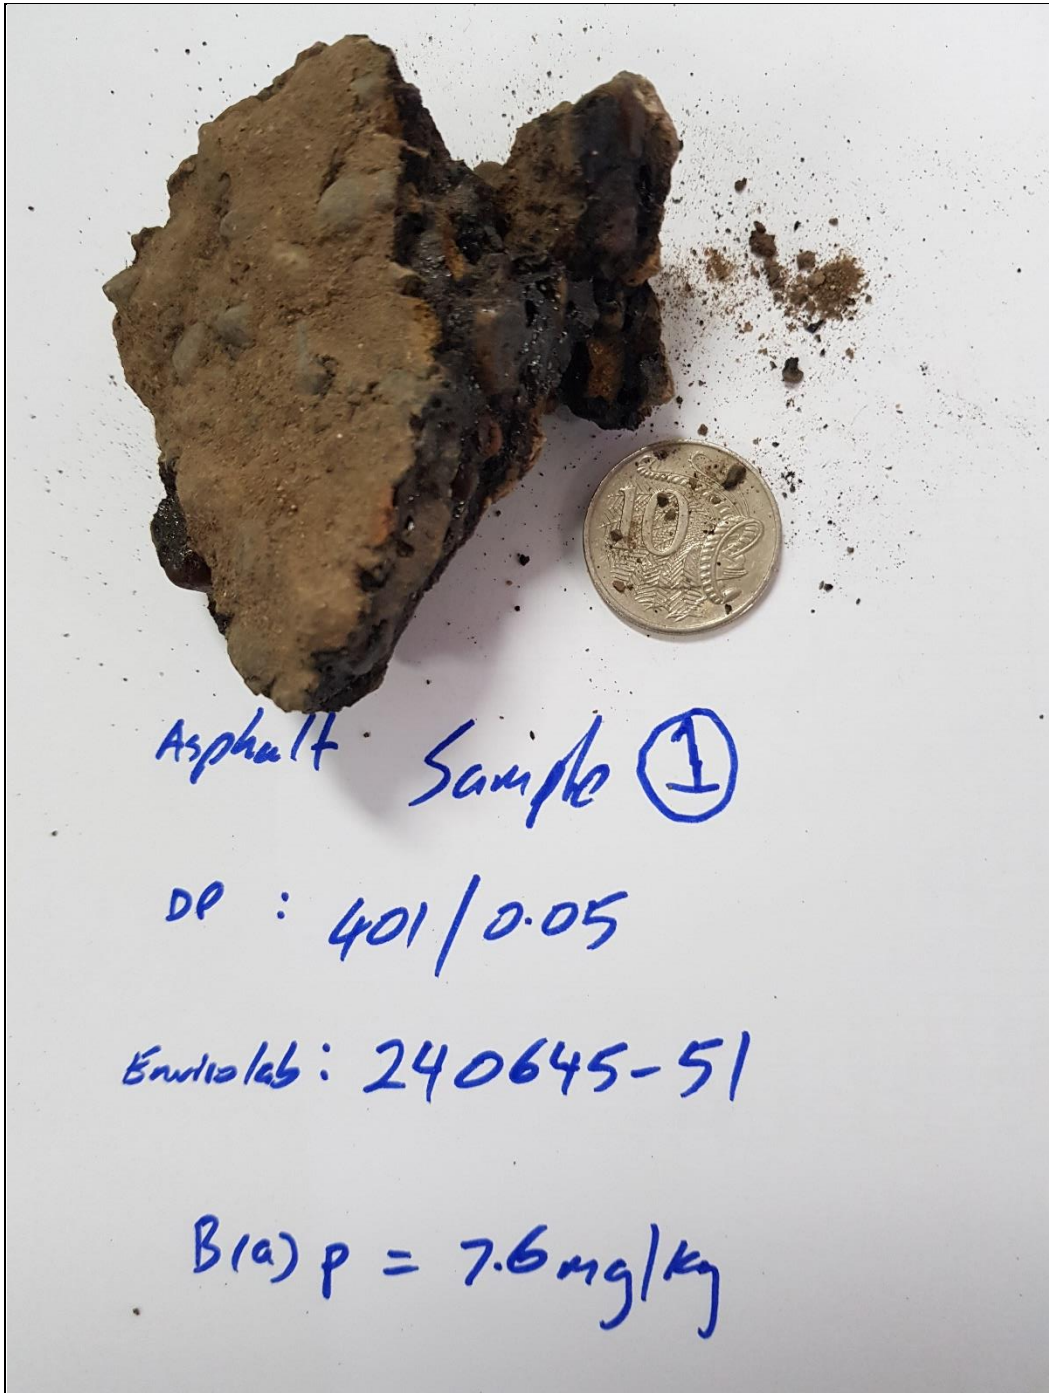
Figure 35: Photo of surface asphalt from test pit 401.

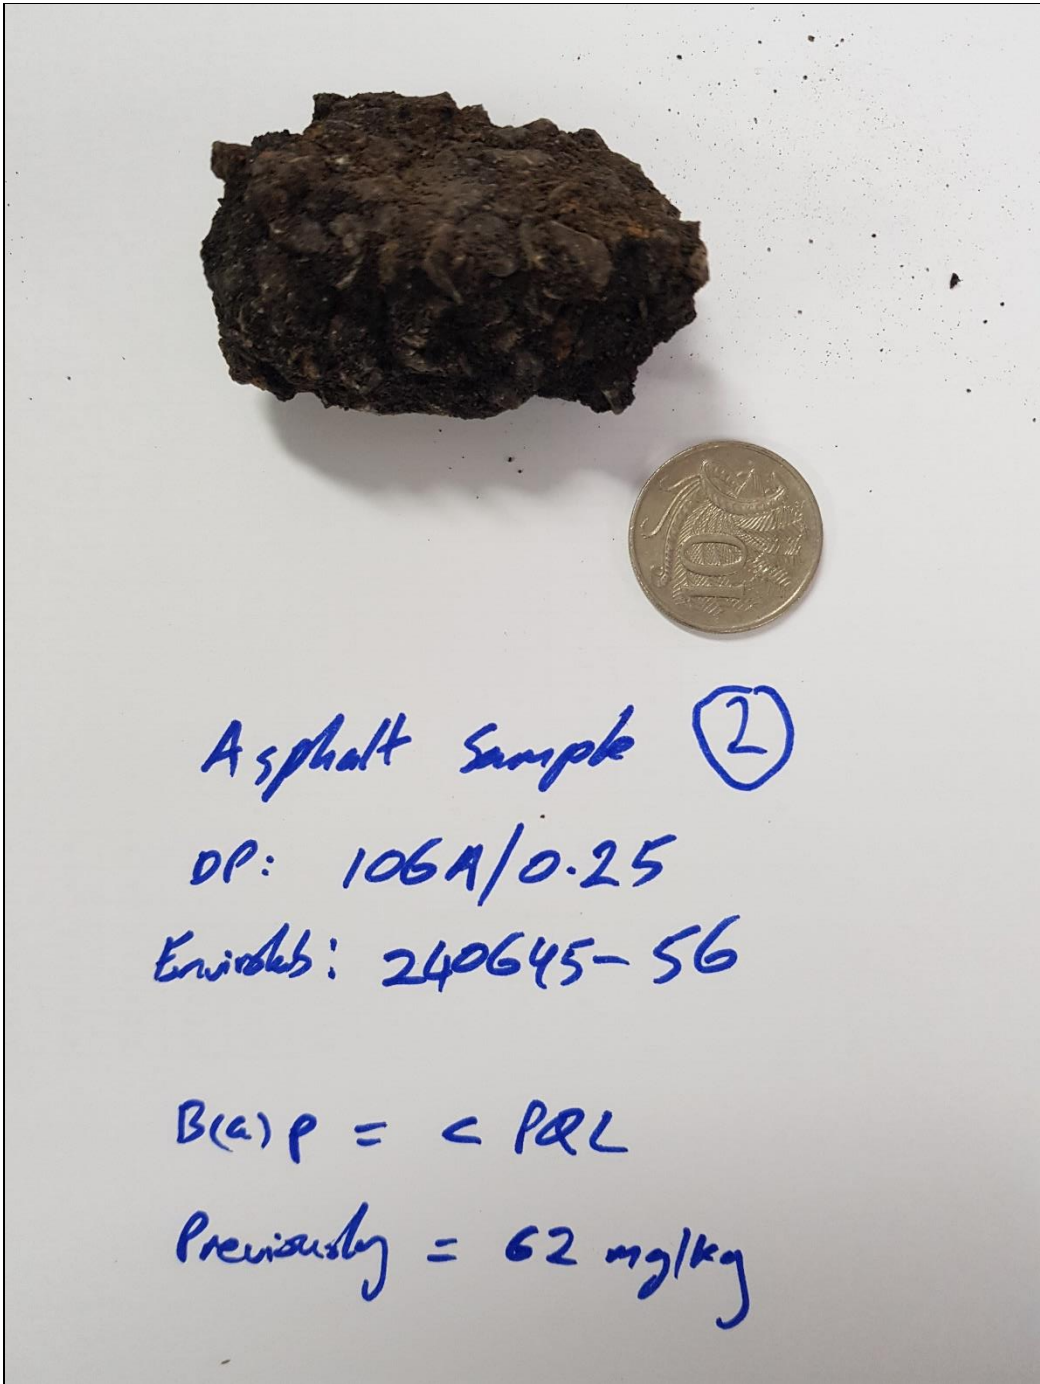
Figure 36: Photo of buried asphalt from test pit 106A.

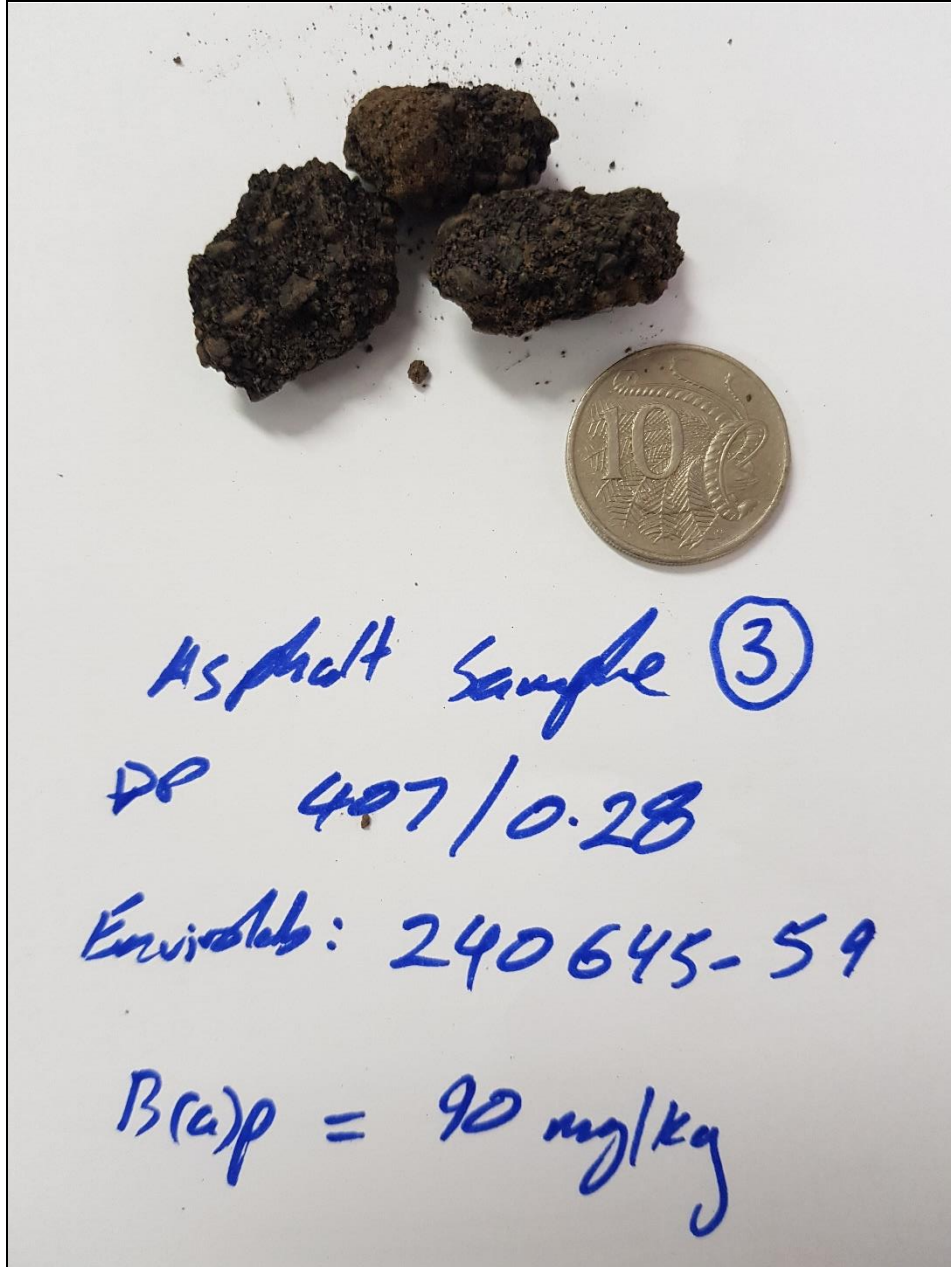
Figure 37: Photo of buried asphalt from test pit 407.

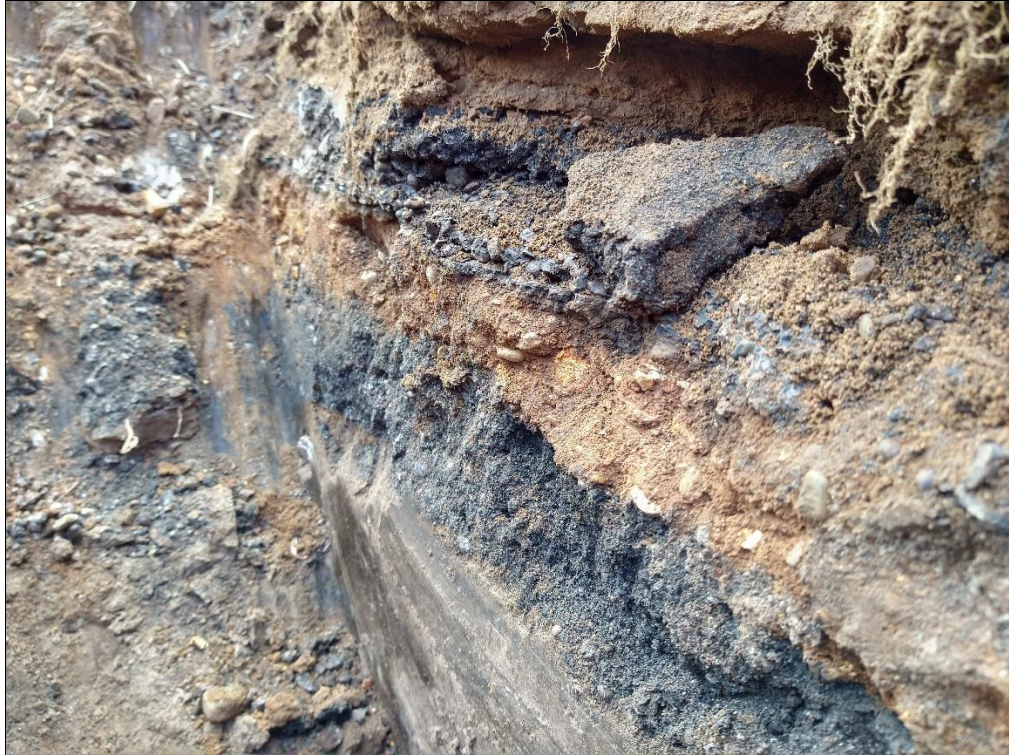
Figure 37: Photo of buried asphalt from test pit 106A (upper dark grey materials and ash filling (lower dark grey materials)).
