12 October 2021

Arboricultural Impact Assessment Report regarding thirty-one (31) trees located within the vicinity of the Grey House Precinct Project at Pymble Ladies' College, Avon Road, Pymble

Andrew Clark
Consulting Arborist

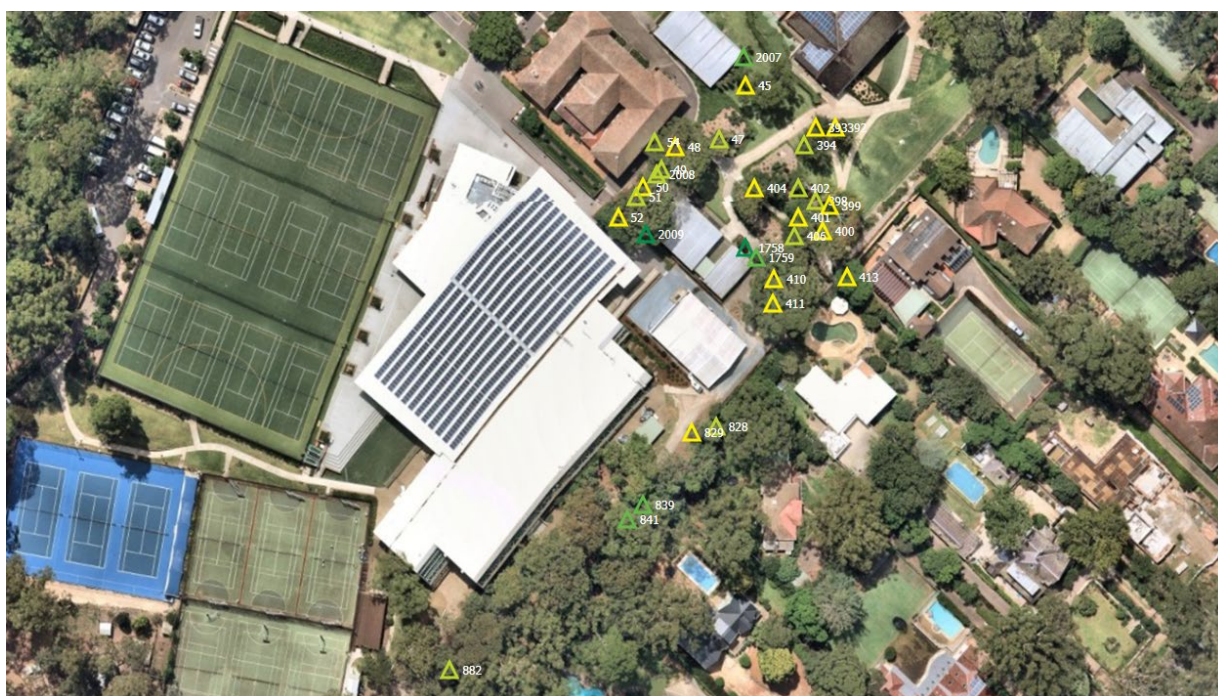
Figure 2. Site map showing subject trees. Note that icon colour indicates trees current risk rating (not Retention Value). Tree attributes are to be obtained from Appendix E – Tree Assessment Data. (ArborPlan, May 2021).

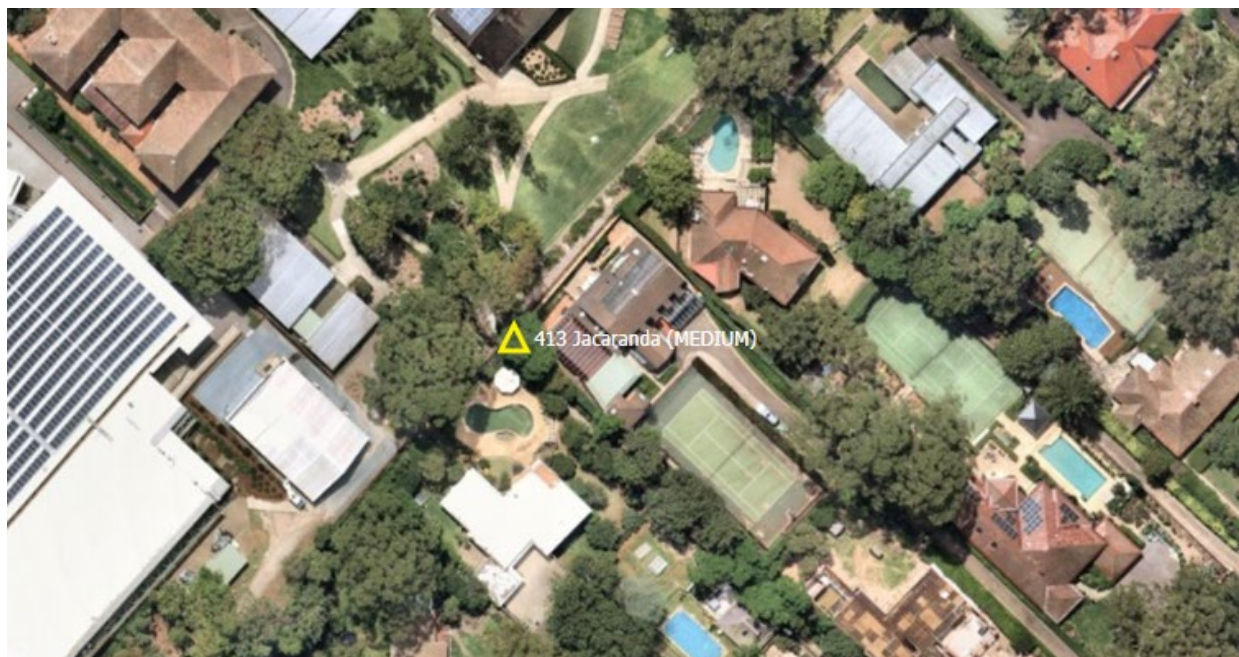
Figure 7. Site map showing tree requiring generic protection measures. (ArborPlan, May 2021).

7.3.1 All retained trees require generic protection measures (Figure 7). Refer to Section 7.5–7.8 for further detail.
