ARBORICULTURAL IMPACT ASSESSMENT

Kristine Marshall (Senior Project Manager)
Taronga Conservation Society Australia (Taronga)

| Project Name | <i>Taronga Wildlife Hospital, Sydney-Nutrition Centre</i> |
| Last saved on | 20 th of December 2021 |

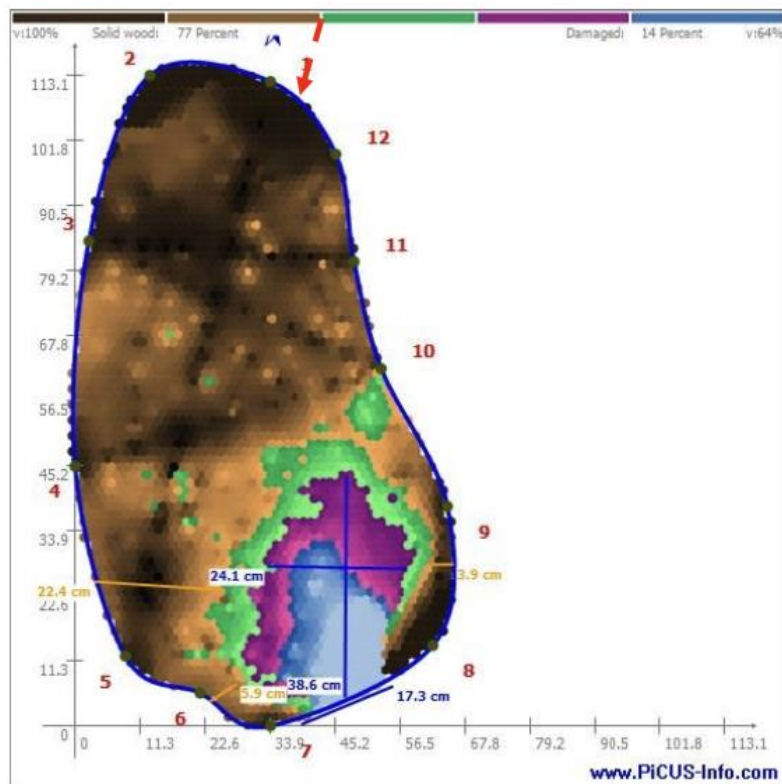
The condition of this tree has been assessed as fair due to a historical wound on the southern side of the trunk. The wound at 1.8m above ground level is an open wound occlusion with a perennial fungal fruiting body consistent with *Phellinus sp. (Phellinus robustus)* a white rot causing fungal pathogen. The site of infection was originally tested in September 2013 by Australian Tree Consultants, Hugh Taylor a leading expert in scientific testing using 'Picus Sonic Tomograph'. Results from the test for the level of decay at the wound site and shown in indicated 77% of the test area was sound wood (brown areas), with 9% consisting of altering wood i.e., wood being altered by the fungus (green area) and 14% of the active fungus and decay (pink & blue areas).

Figure 3 Shows the test Picus test results in September 2013.

The conclusion of the test resulted in the following statement: *“The Picus results showed that 77% of the test site consisted of sound wood with 9% of altering wood and 14% of fungal activity and decay. The fungal pathogen is progressing through the remaining sound wood predominantly in northerly and westerly directions at a slow rate.*

At the time of testing, it was considered that the structural integrity of the trunk at the test location had not been sufficiently compromised by the active fungal pathogen to warrant the trees removal. Future retention of the tree is recommended with further retesting and monitoring’.

‘Based on the results of the Picus test alone, at the time of testing the tree was considered to be structurally sound at the test location and can be considered for future retention. Retesting at the same testing location and height is recommended within two (2) years to ascertain the rate of fungal progression through the remaining sound wood.

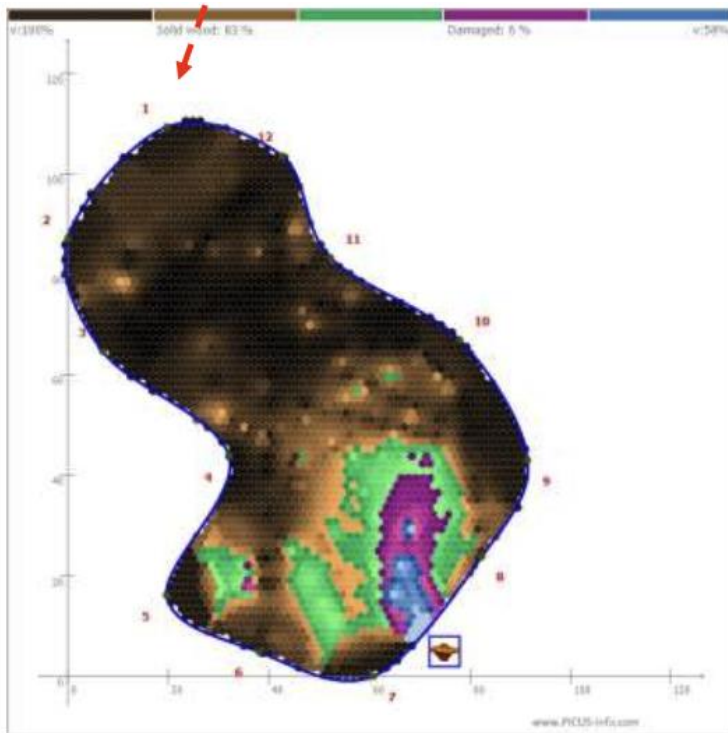
The Picus test in 2016 was undertaken at 2.4 metres above ground level (sensor 1) at the location of a past abrasion wound site. The Picus Tomograph test showed that there is altering wood 11% surrounding a small amount of fungal activity and decay 6% with 83% of sound wood remaining at the site of the test location. In comparison with the test results in 2013 no significant change has occurred with the active decay and sound wood components. The active fungal pathogen is progressing through the sound wood at a slow rate, as shown by the amount of altering wood (green colouration) and has breached the outer trunk between sensors 7 – 8 and a small pocket of decay was detected near sensors 4 – 6.

New incremental wood growth was recorded between all sensors, which is a good indication of sound wood with good levels of nutrient and water uptake which means the tree has good vitality’.

Figure 4 Shows the Picus test in September 2016

The management of the tree should be based on this Picus report as well as any other recent and, or current Arboricultural reports or Visual Tree Assessments. Further testing is recommended within the next five (5) years to ascertain the rate of change in the decay / altering and sound wood components of this tree at the testing height. We do not recommend that

this tree be drilled for any reason unless to validate the Picus test results. This action may breach the natural barrier zones formed as part of the trees response to the fungus and could aid in expediting its effects. If any significant change is noted in the condition of the tree a consulting arborist should be notified as soon as possible’.

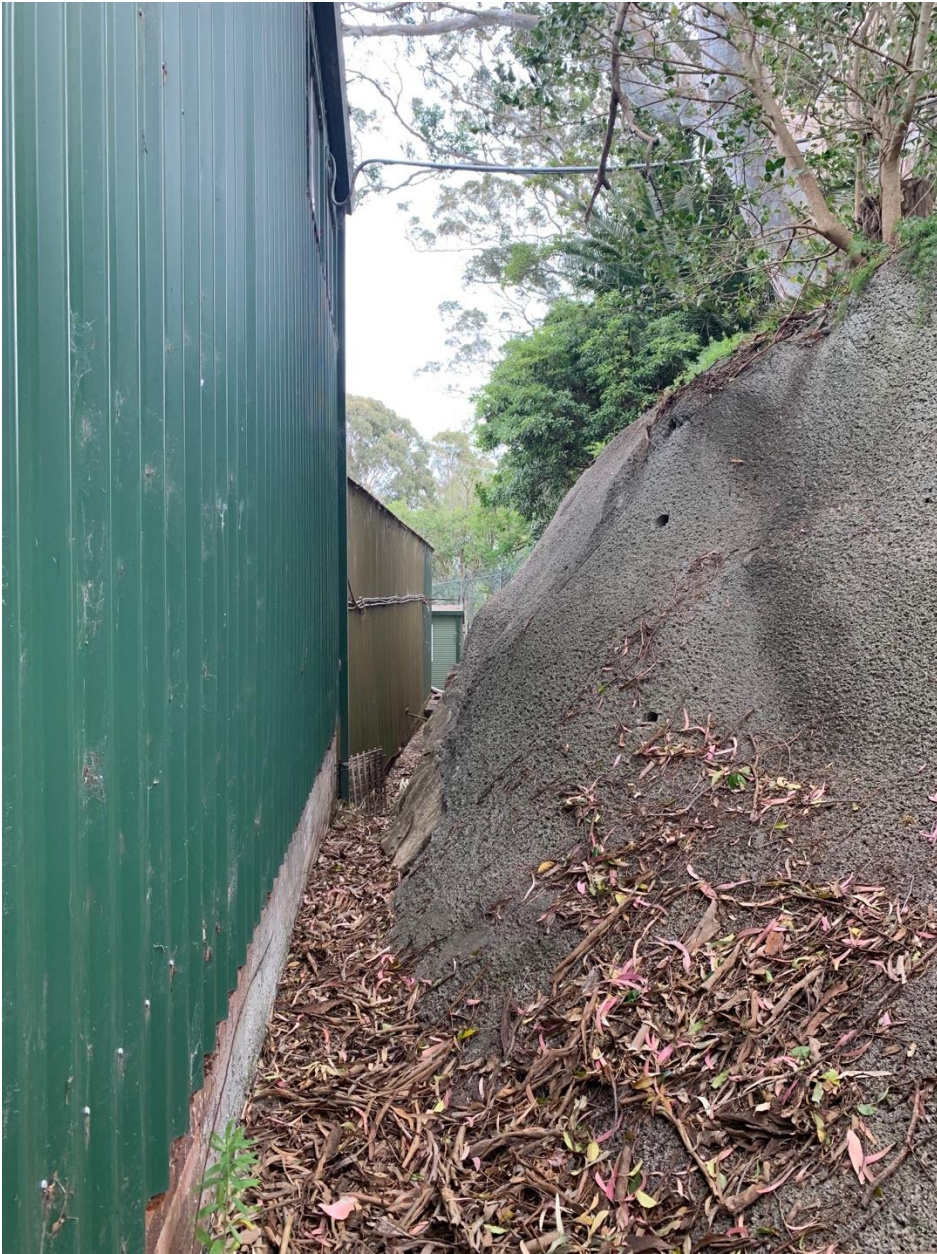
Figure 5 Shows the shotcrete embankment below tree 10.

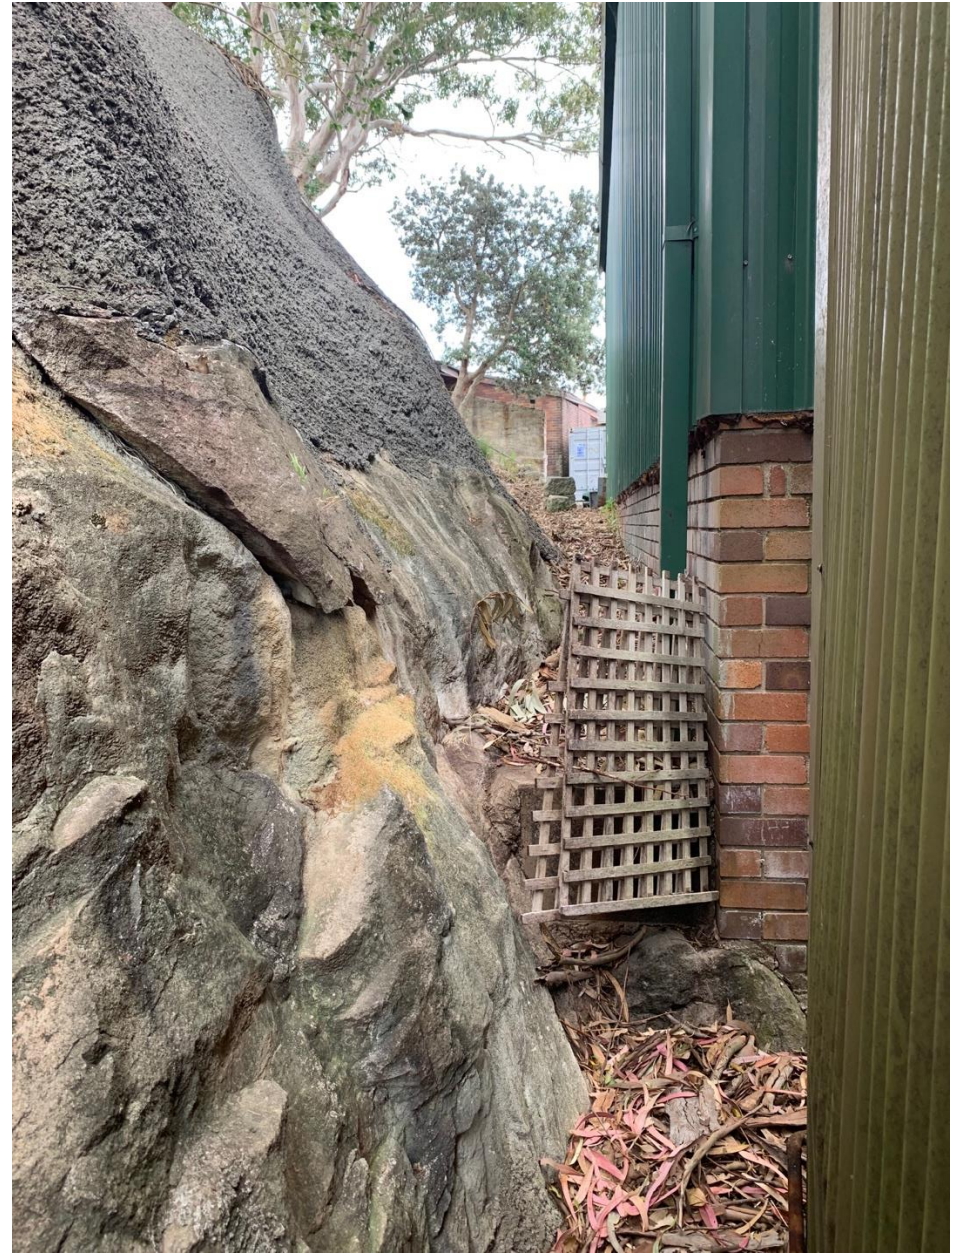
Figure 6 Shows the existing rock shelf.

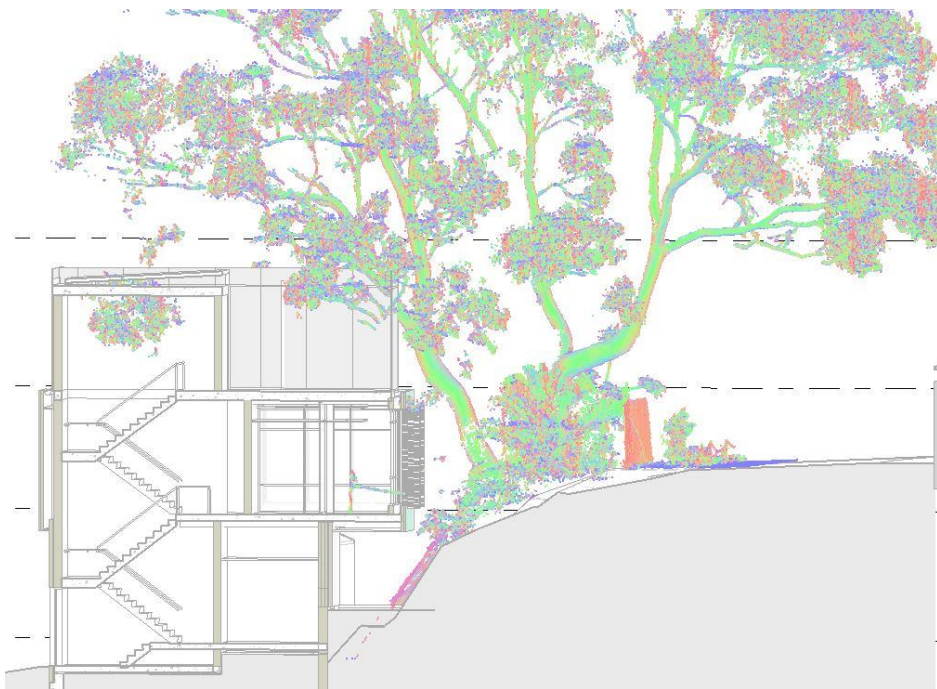
Figure 7 Shows tree 9 and point cloud assessment of branches conflicting with proposed Nutrition Centre

A point cloud survey analysis was conducted to confirm the conflicts of the proposed Nutrition Centre with trees 9, 10, 11 and 14 (Figures 9-10). Based on this detailed assessment, it has been definitely confirmed these trees are not viable for retention given the size, location, type and volume of pruning required to facilitate the proposal.

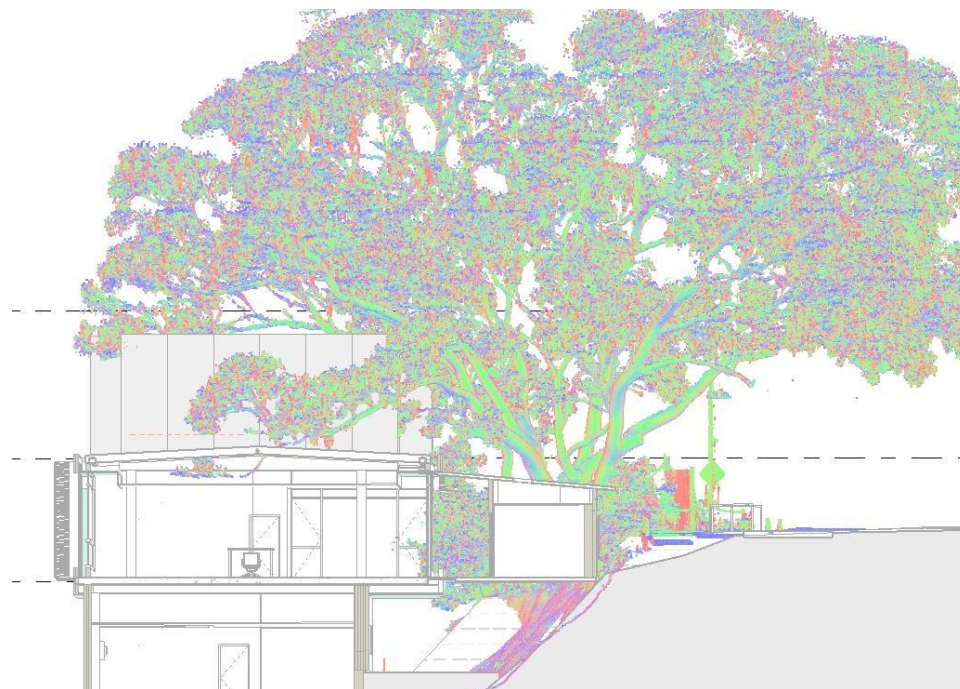
Figure 10 Shows tree 9 and point cloud assessment of branches conflicting with proposed Nutrition Centre
