Report on Geotechnical Investigation

Taronga Wildlife Hospital, Sydney
- Nutrition Centre

Prepared for Taronga Conservation Society Australia

> Project 99931.00 December 2021

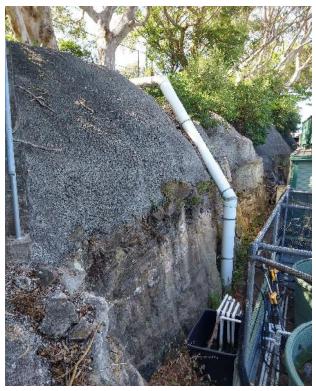
Photo 1 - Towards the north, looking south

An inspection of the existing shotcrete and rockface to the west of the gatehouse was also undertaken. No obvious deflects in the shotcrete were observed. Photographs of the shotcrete are presented in Appendix D.
