Arborist Assessment Report

Department of Education NSW

PROJECT: SSD-21854025 Wee Waa High School

Date of Inspection: 27th August 2021

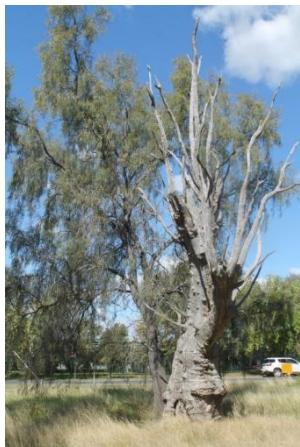
TREE 1 & 1A

- Two (2) significant in sized dead trees (Tree 1 and 46) of indigenous species both contain hollows.
(Ecologist required for further information)

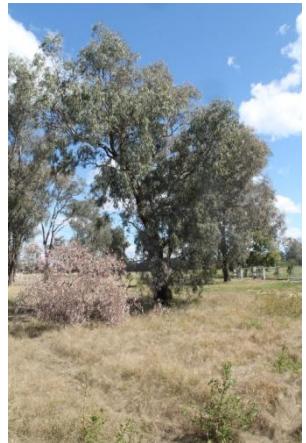
TREE 13

13	Not affected	Eucalyptus <i>microtheca</i> Coolibah	10	40/30	7	Mature good condition but poor form Lowest branch section failed	70	2.8	6.0	D2 Medium	IN build zone REMOVE TREE
14	Not affected	Eucalyptus <i>microtheca</i> Coolibah	10	50/30/ 15	8	Mature good condition, structure good	80	3.0	7.0	A2 HIGH	RETAIN
14A-G	Not affected	Eucalyptus <i>microtheca</i> Coolibah	10	30	5	Mature good condition, structure good	45	2.3	3.6	A2 HIGH	RETAIN
15	Not affected	Eucalyptus <i>microtheca</i> Coolibah	12	35	5	Mature good condition, structure good	40	2.2	4.2	A2 HIGH	RETAIN
15A	Not affected	Eucalyptus <i>microtheca</i> Coolibah	10	40	6	Mature good condition, structure good	40	2.2	4.8	A2 HIGH	RETAIN
16	Not affected	Eucalyptus <i>microtheca</i> Coolibah	10	30/20	5	Mature good condition, structure good	45	2.3	3.6	A2 HIGH	RETAIN
17	Not affected	Eucalyptus <i>microtheca</i> Coolibah	14	70	8	Mature good condition, structure good	85	3.1	8.4	A2 HIGH	RETAIN

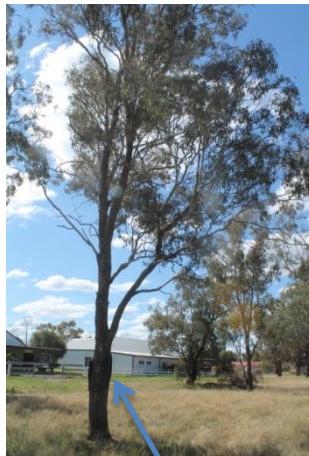
TREE 32A swelling at union

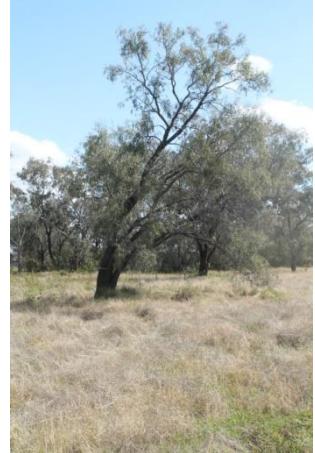
TREE 41

41	Not affected	Geijera parviflora Wilga	8	multi	8	Mature moderate condition poor form borer attack	70	N/A	N/A	D3 MEDIUM	IN build zone REMOVE TREE
42	Not affected In Ag plot	Eucalyptus microtheca Coolibah	10	30x3	8	Mature moderate condition poor form	80	N/A	N/A	A2 HIGH	IN build zone REMOVE TREE
43	In Build Zone	Eucalyptus microtheca Coolibah	10	20x3	5	Mature moderate condition poor form	50	2.4	4.2	A2 N/A	RETAIN
44	In Build Zone	Eucalyptus microtheca Coolibah	10	40	6	Mature good condition, structure good	50	2.4	4.8	A2 N/A	RETAIN
45	Not affected	Eucalyptus microtheca Coolibah	10	30/30	7	Mature moderate condition, inclusion @ base OK	60	2.7	4.2	D3 HIGH	RETAIN
46	Not affected	Eucalyptus microtheca Coolibah	10	70	8	DEAD several small hollows observed. HABITAT TREE	N/A	6.0	N/A	C4 HIGH	RETAIN IF POSSIBLE, if removed condition habitat boxes installed in adjacent trees
47x4	Not affected	Eucalyptus microtheca Coolibah	10	30	6	Semi mature good condition, some damage at base and union	40	2.2	3.6	D3 HIGH	RETAIN

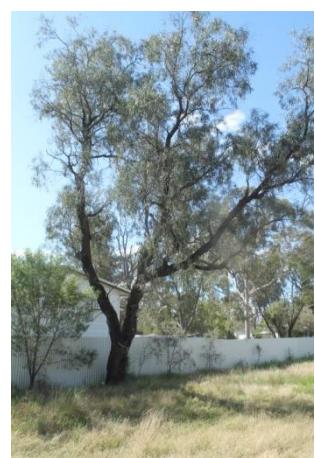
TREE 48

48	Not affected	Geijera parviflora Wilga	12	40/40	8	Mature moderate condition borer attack decay in trunk . Leans to south tree appears to be declining in health & vigour review in 6 months	60	2.6	6.8	D3 Medium	RETAIN review tree status in 6 months' May have implications on construction of security fence panels .
49	Not affected	Eucalyptus microtheca Coolibah	12	40	5	Mature poor condition borer attack , failed section	50	2.4	4.8	D3 HIGH	RETAIN tree is in low usage area
49A	Not	Geijera parviflora	9	30	7	Mature good condition, structure	40	2.2	3.6	D3	RETAIN

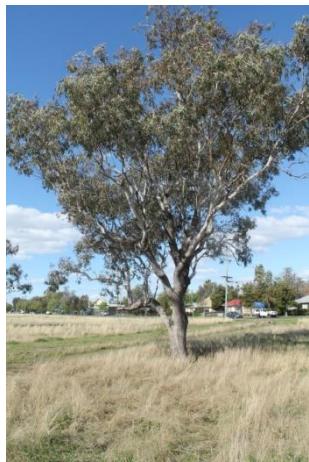
54	Not affected	<i>Eucalyptus microtheca</i> Coolibah	12	60	9	Mature good condition, structure good	85	N/A	N/A	A2 HIGH	IN build zone REMOVE TREE
55	In Build Zone	<i>Eucalyptus microtheca</i> Coolibah	10	60	8	Mature good condition, structure poor, fracture in union West side	80	3.0	7.2	D3 Medium	RETAIN
