Proposed Blessed Carlo College, MOAMA.

Arborist Report

September 2021
(Updated October 2022),
Ref 21/413B.

Trees on (& surrounding) the Site of the Proposed Blessed Carlo College, Lignum & Kiely Roads, Moama.

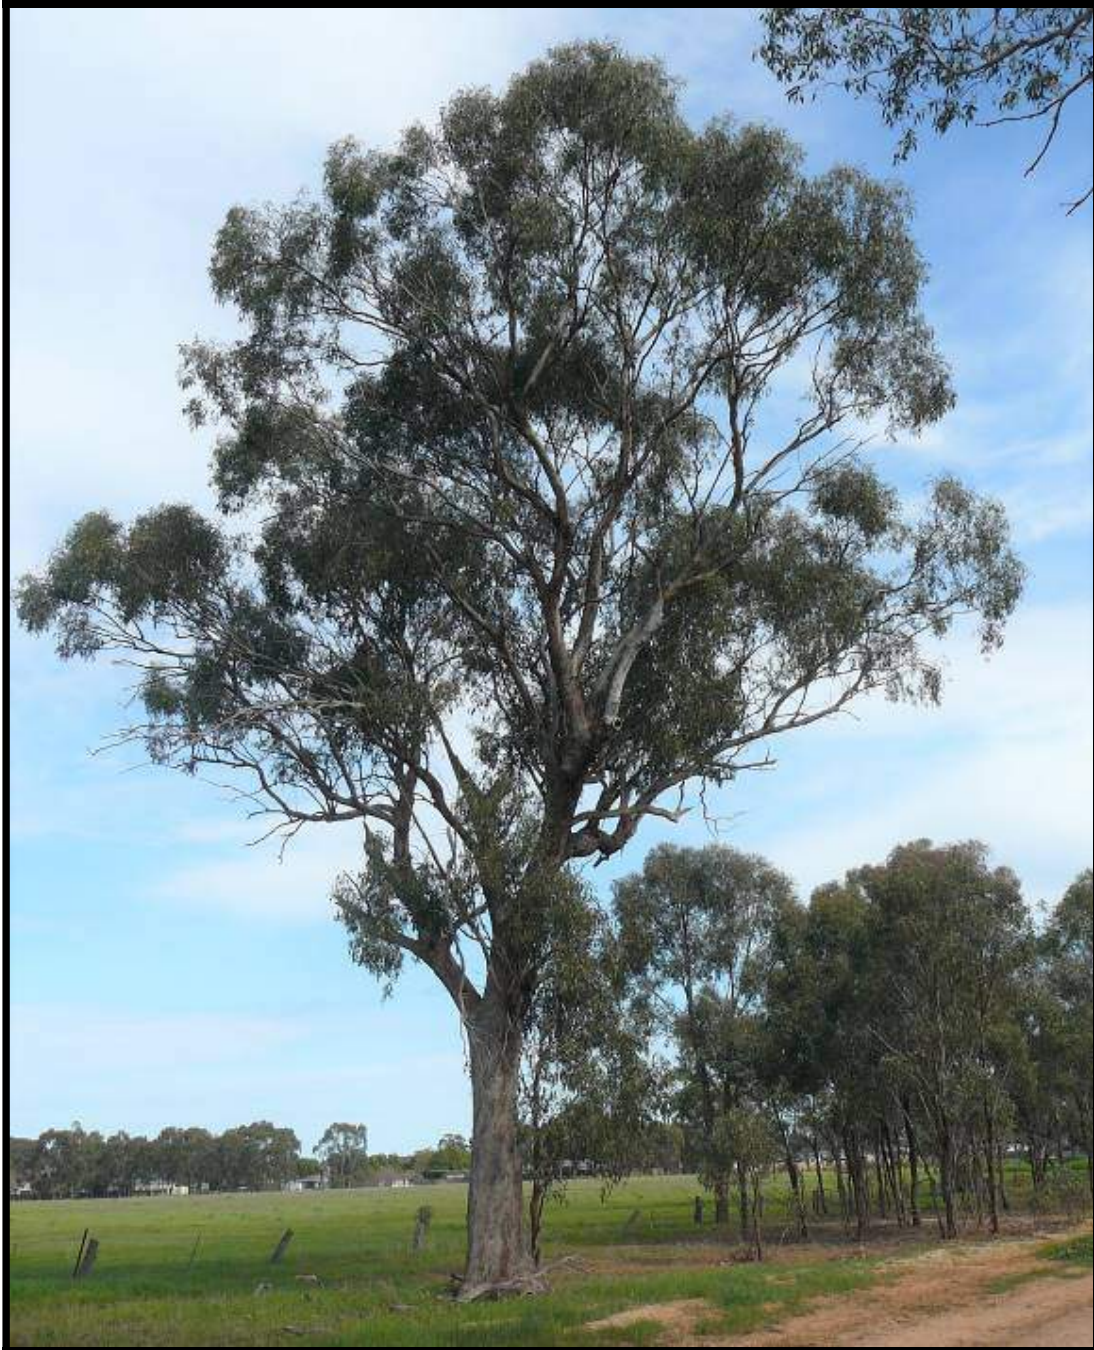
4.1 – Tree No. 1

Exhibit 3 – Tree 1 is a large mature tree in Fair condition. Dead leaders and laterals, up to 250mm in diameter are evident in the tree's crown.

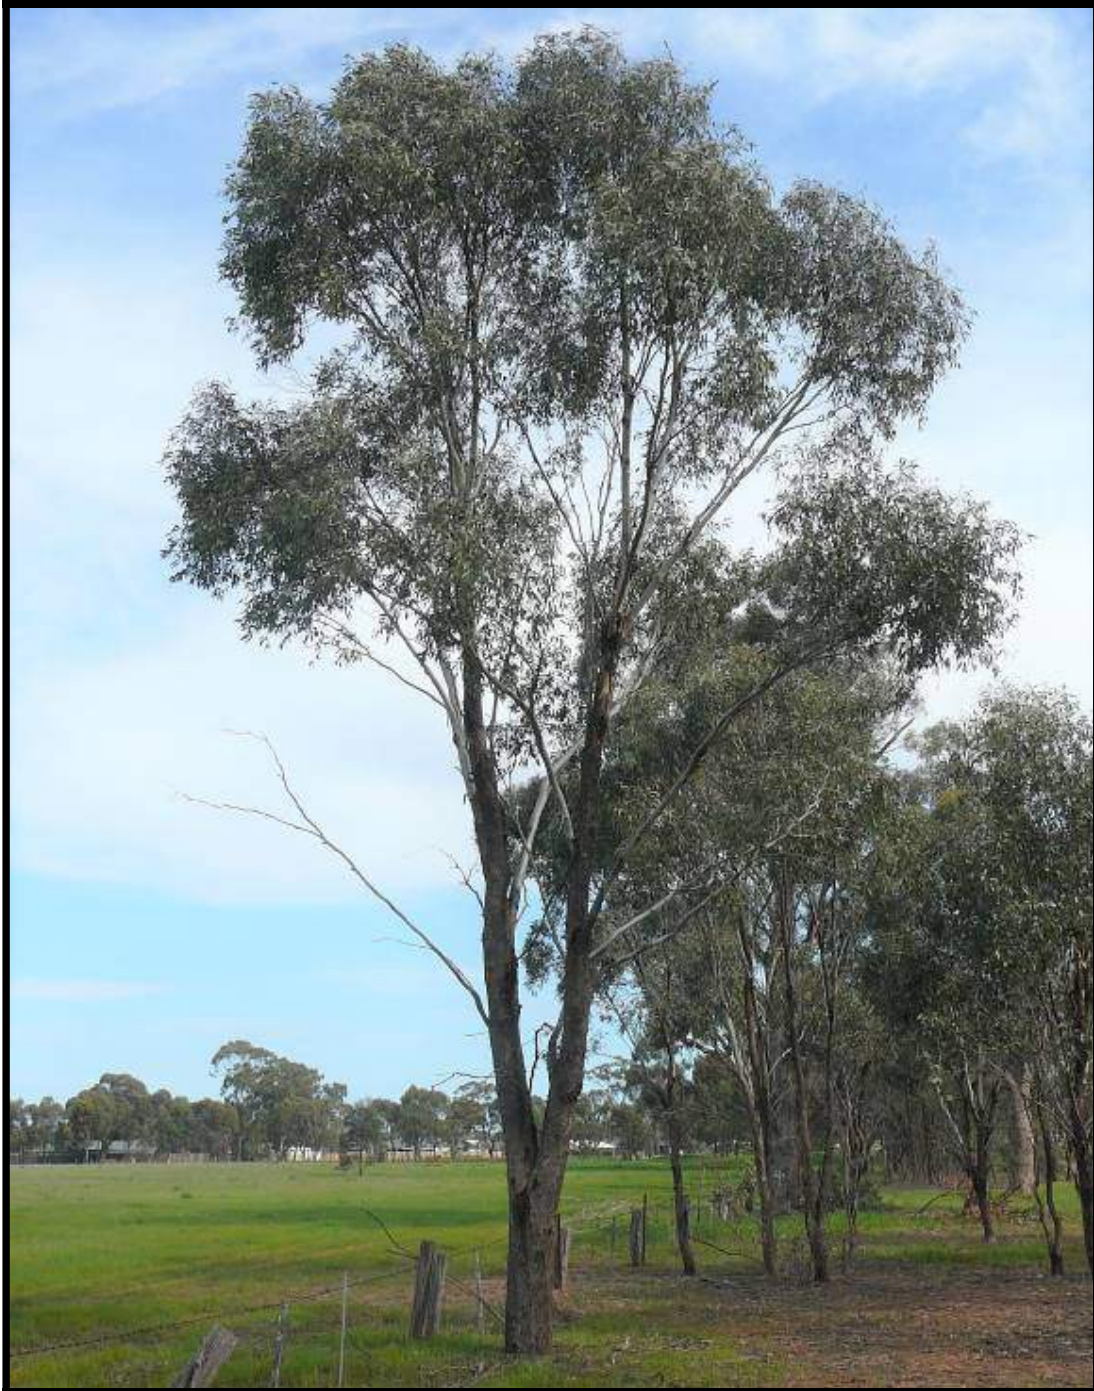
4.2 – Tree No. 2

Exhibit 4 – Tree 2 is a young tree, the stem of which bifurcates approximately 1.5m from the ground (see Exhibit 5). The tree is in good health however this structural fault attributes to its Poor condition rating.

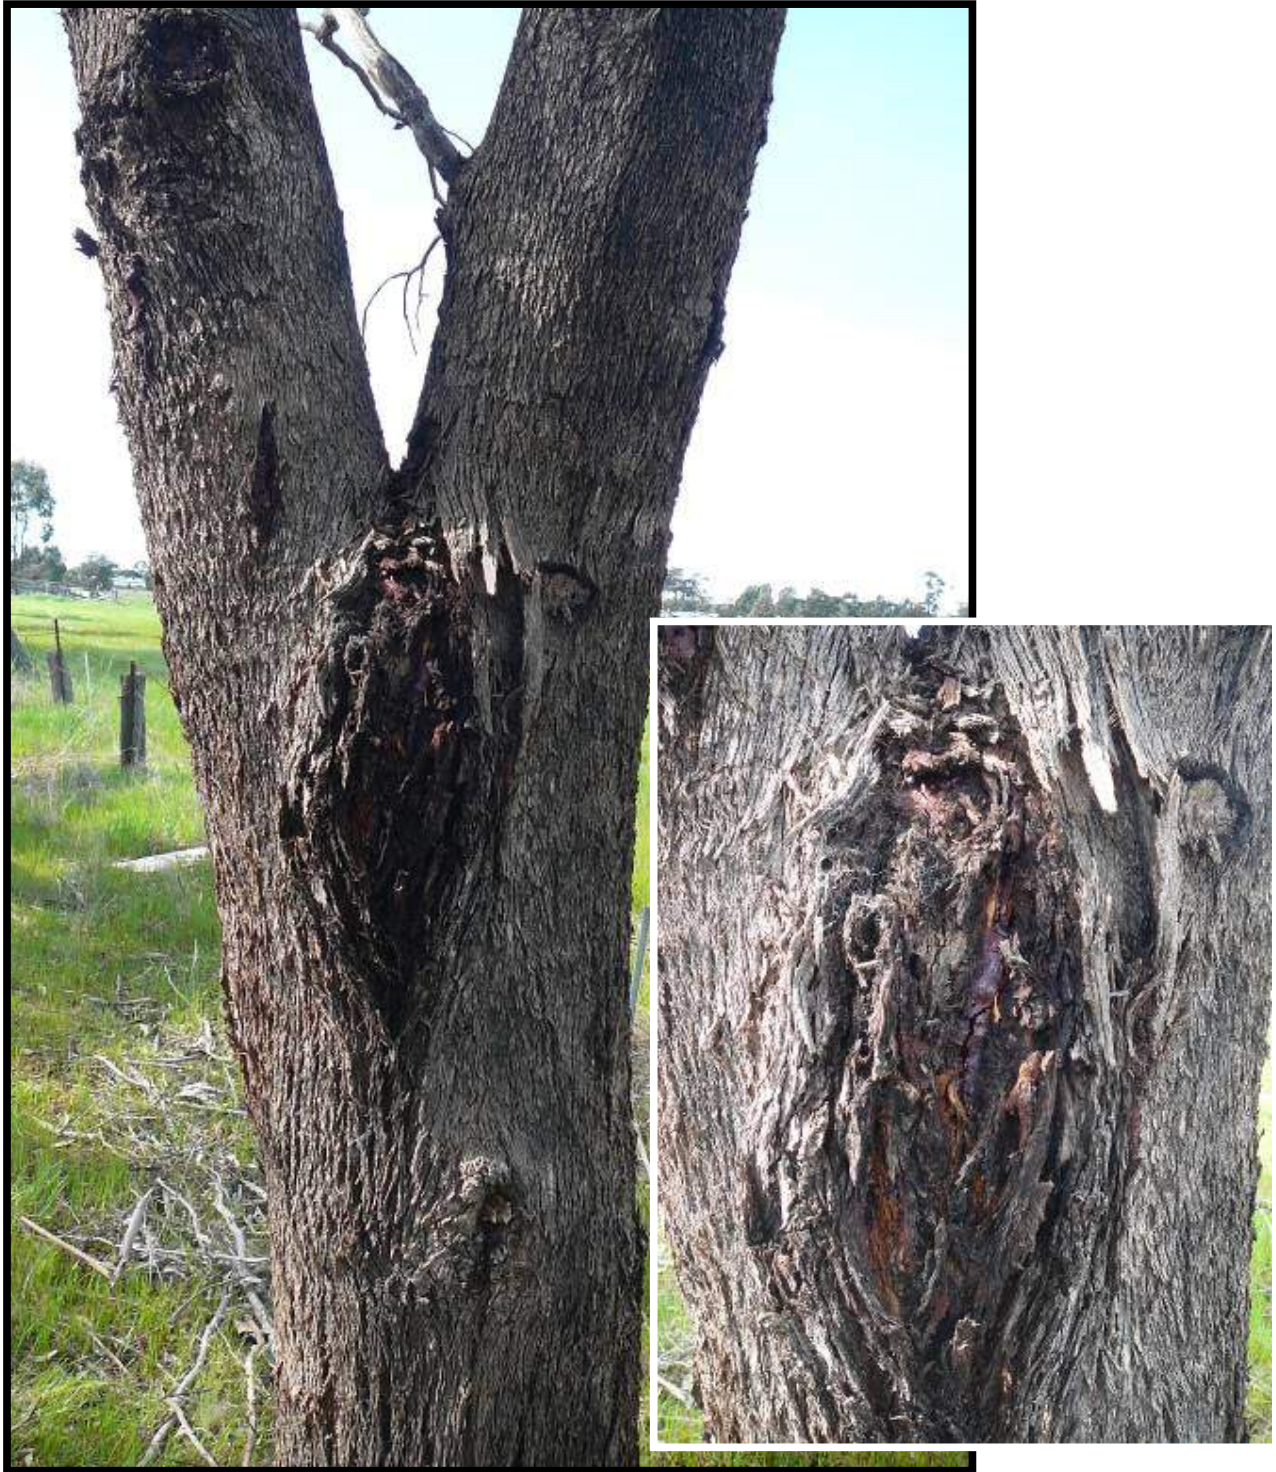
Exhibit 5 – The stem bifurcation on Tree 2. There is an “active” crack at this point (inset) and this junction will eventually fail, causing half the tree’s crown to come down. The tree is not suitable for retention because of this structural fault.

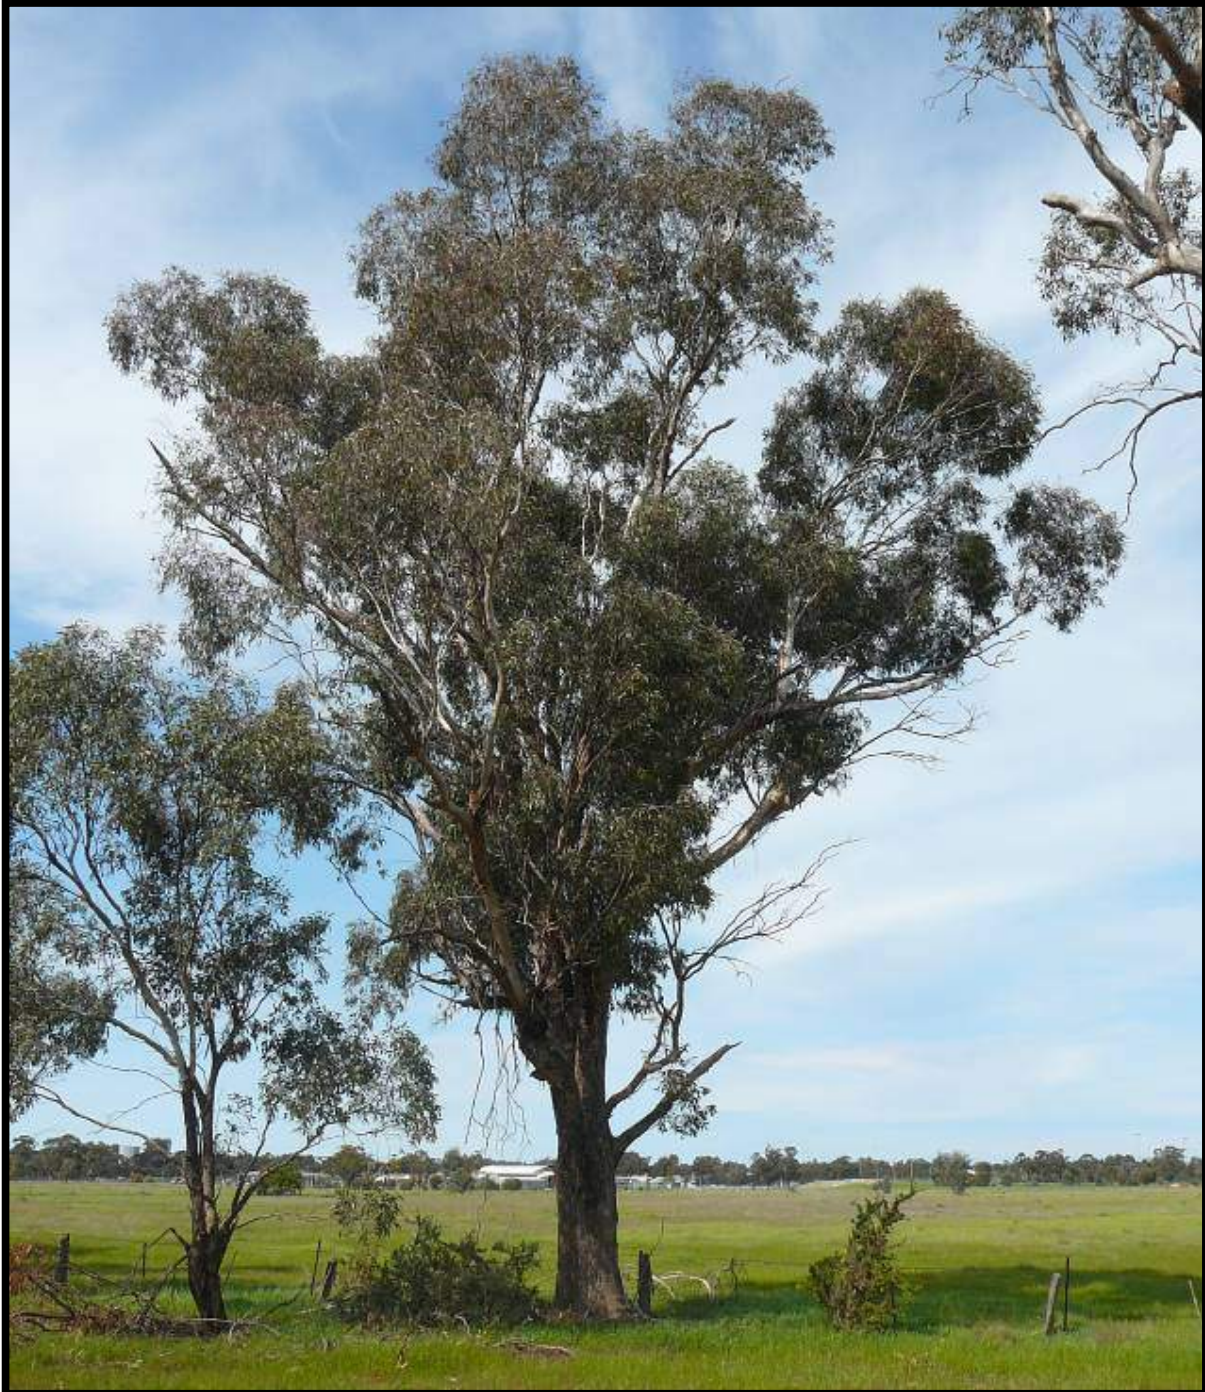
4.3 – Tree No. 3

Exhibit 6 – Tree 3 is in good health. Despite the presence of deadwood (up to 75mm diameter) it exhibits strong vigour and is rated as in Good condition.

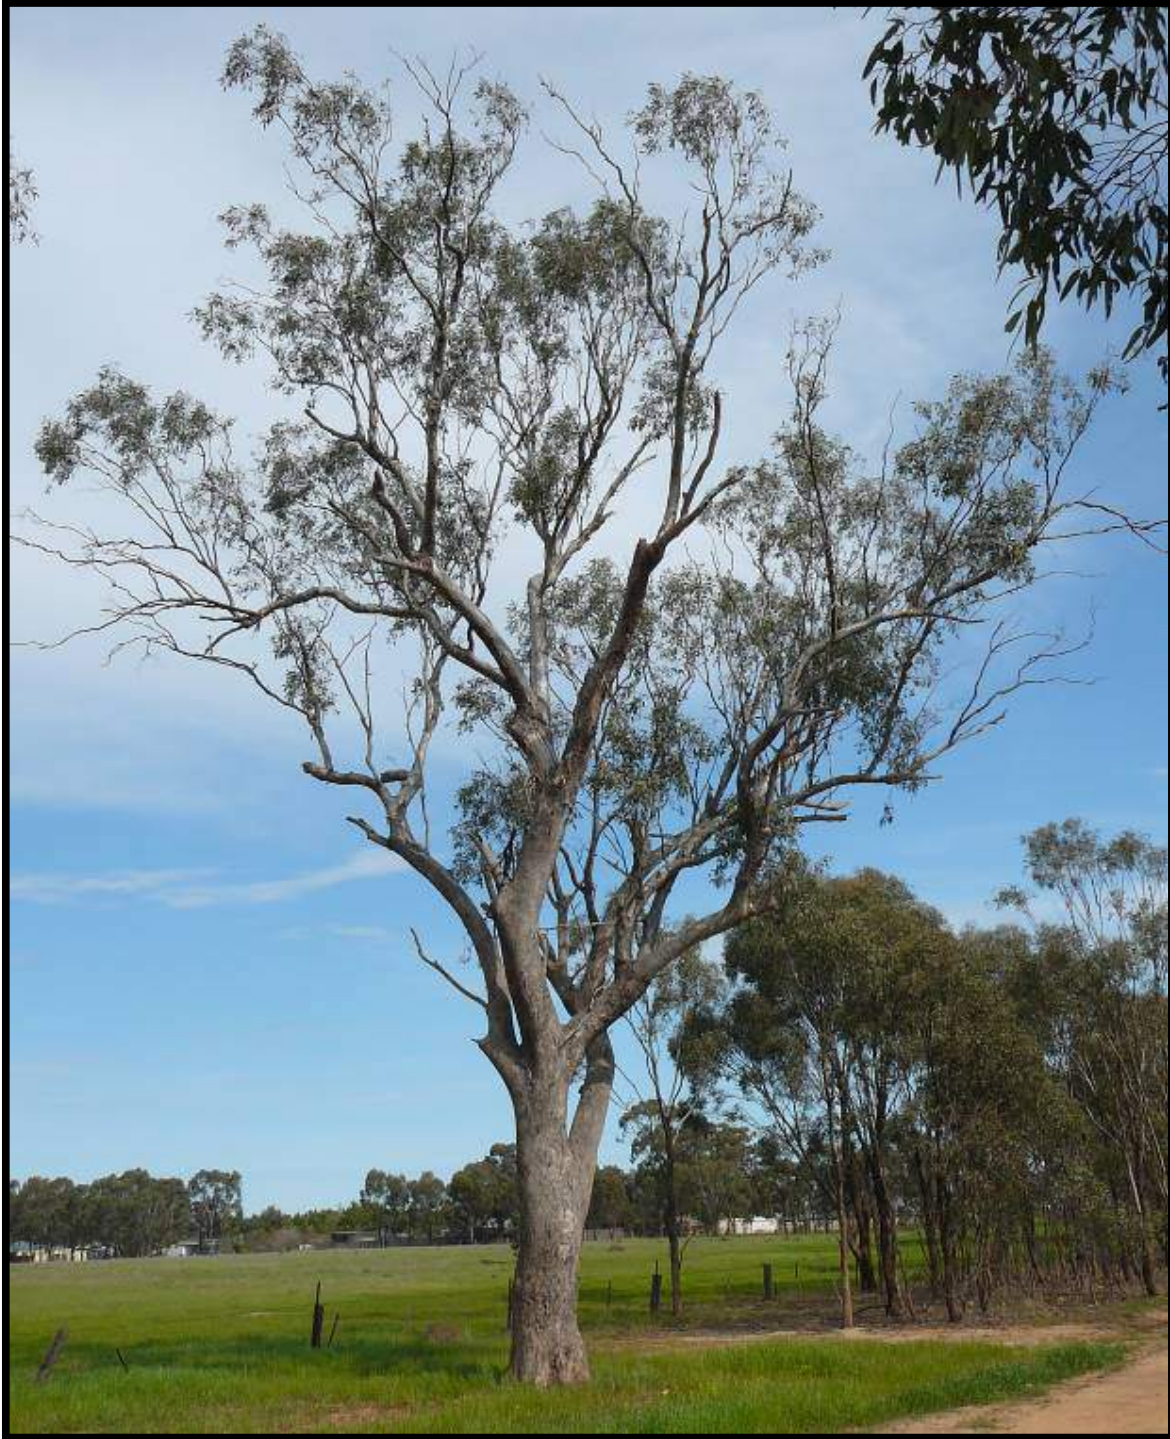
4.4 – Tree No. 4

Exhibit 7 – Tree 4 is a specimen at (or approaching) its “over mature” growth phase, with a sparse crown and small diameter deadwood at the perimeter of its canopy. The tree is rated as in Poor condition because of its declining vigour.

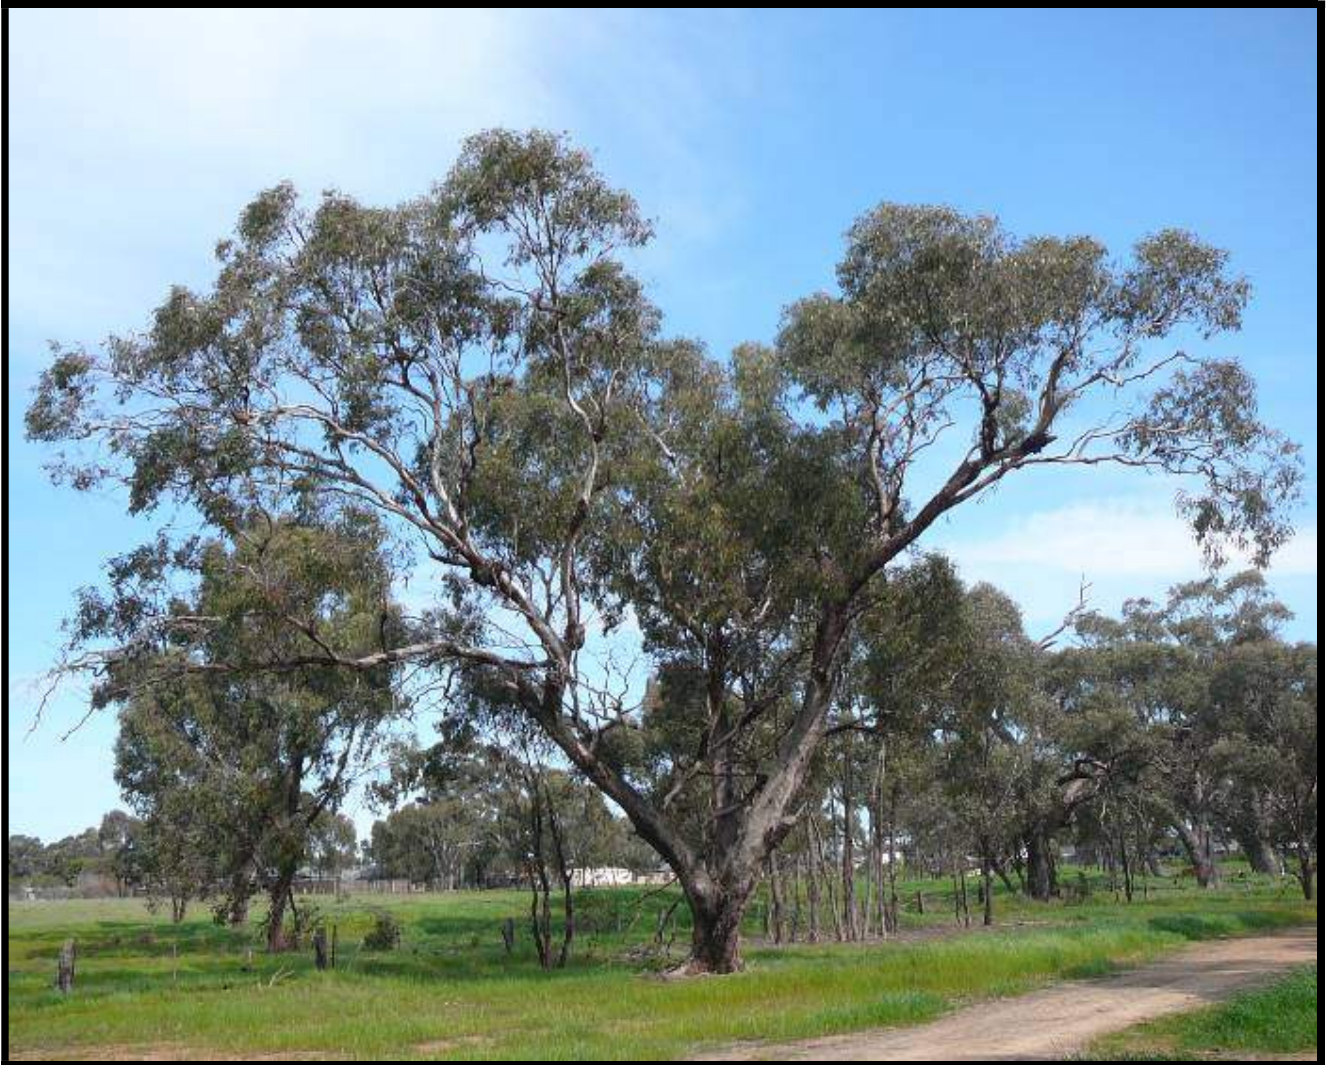
4.5 – Tree No. 5

Exhibit 8 – Tree 5’s “spreading” habit is the result of its branching to form three leaders from about 1.5m. The tree is structurally sound and in reasonable health. There is (small diameter) deadwood and hangers present in the crown and burls evident on some of the lateral branches. Despite of this the tree is still rated as in Good condition.

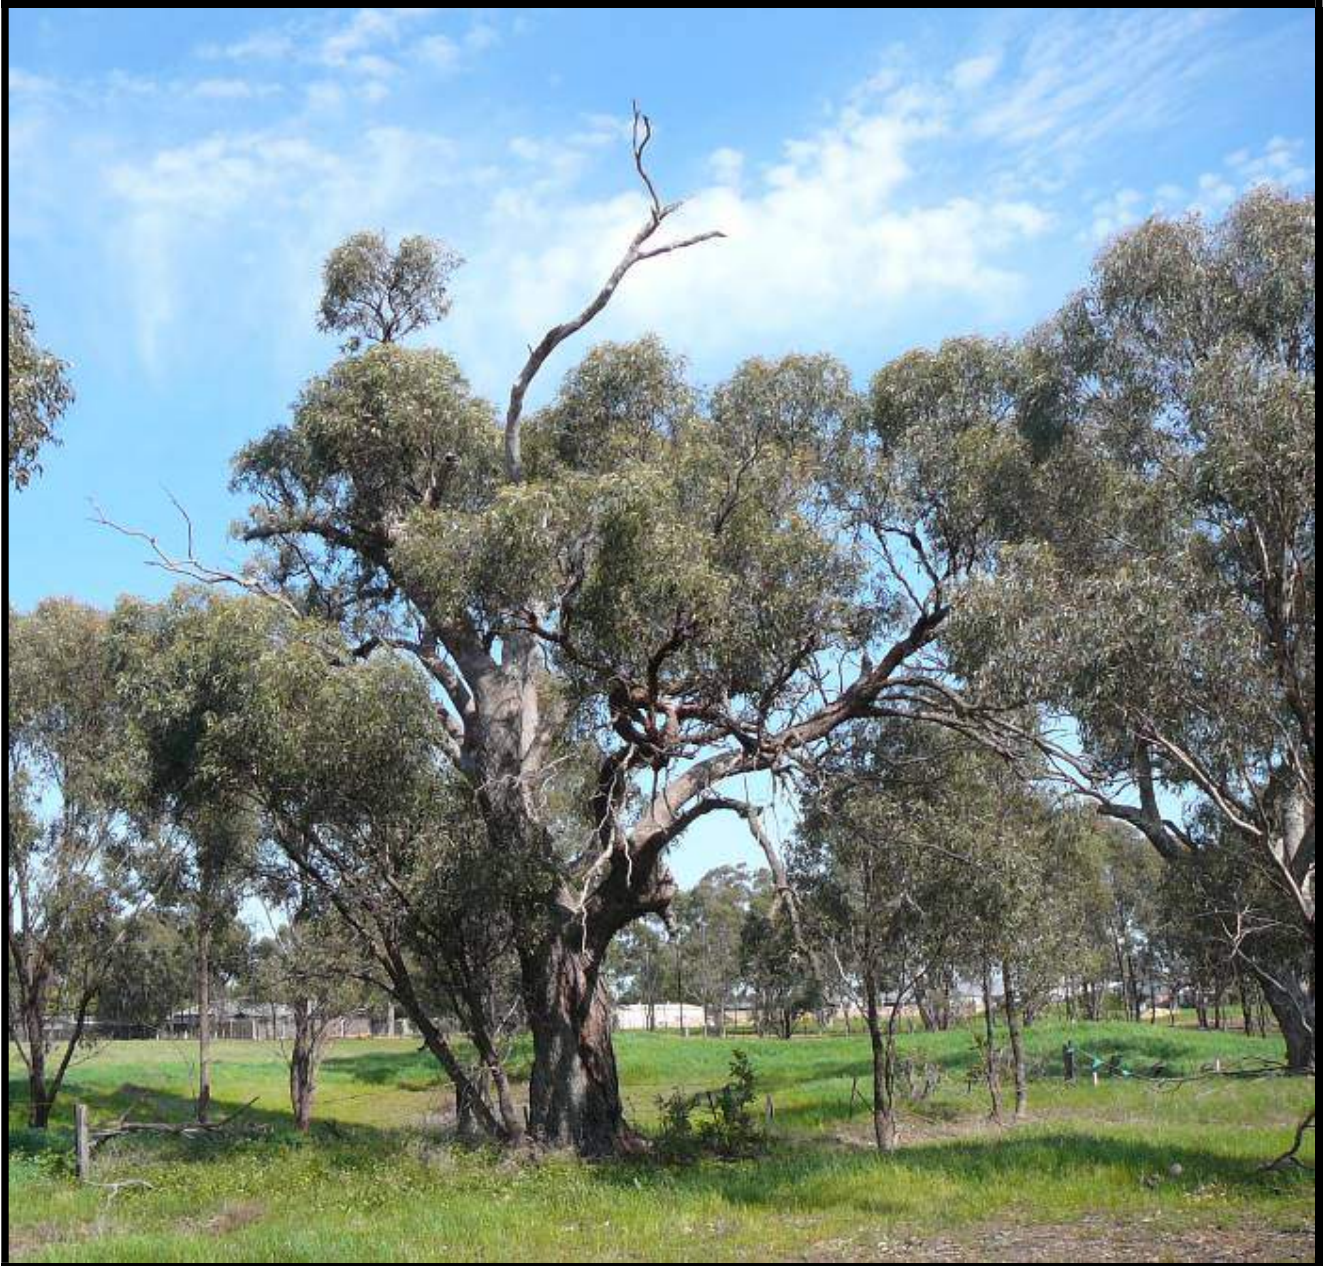
4.6 – Tree No. 6

Exhibit 9 – Tree 6 is a “veteran” specimen that has entered the “retrenchment” phase of its life cycle – the process whereby a tree whose crown is declining forms a smaller, lower crown. The tree’s main leaders are senescent and water shoots are emerging from the base. There are also three or four lesions, some with active decay, on the tree’s barrel. Rated in Fair condition.

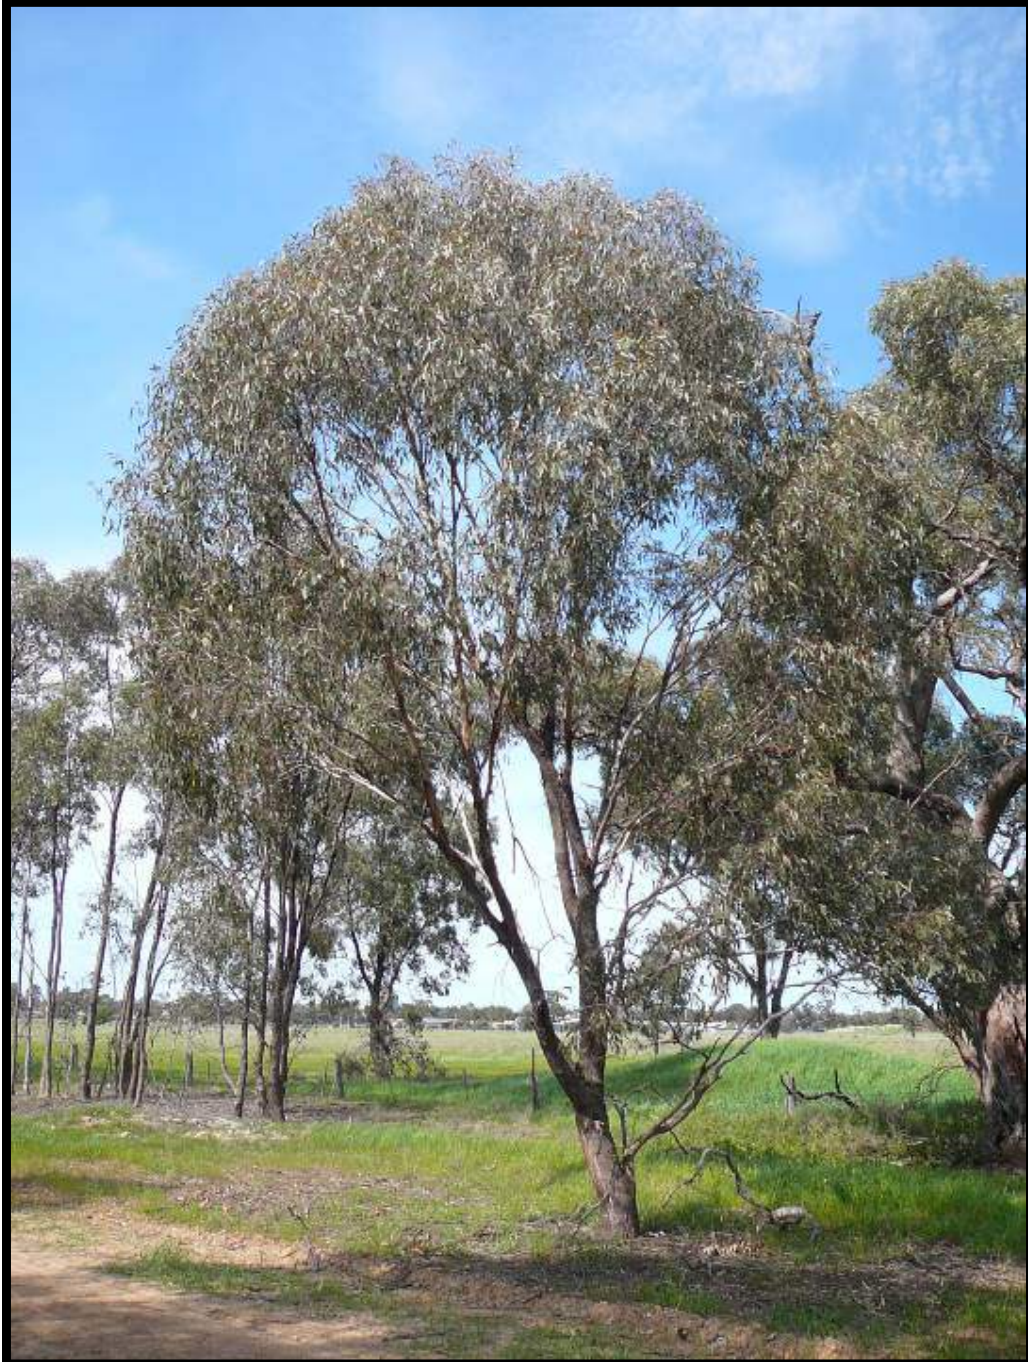
4.7 – Tree No. 7

Exhibit 10 – Tree 7 is a young tree in good health and vigour with no structural faults.
Condition rating Good.

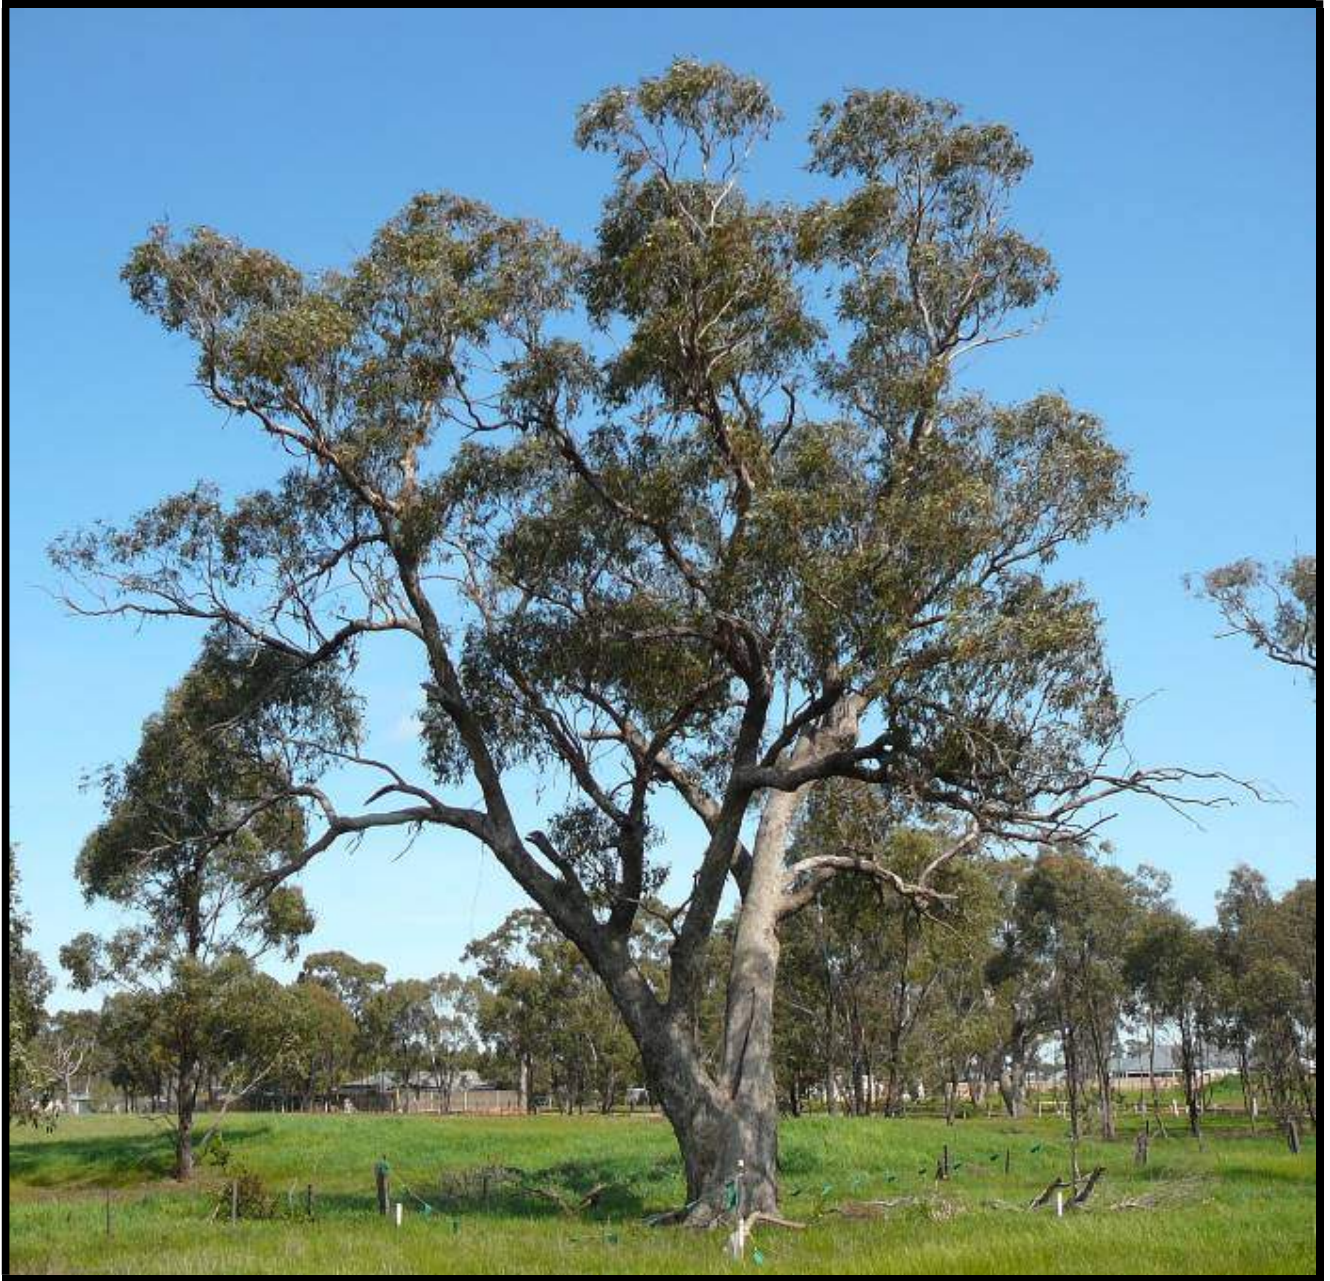
4.8 – Tree No. 8

Exhibit 11 – Tree 8 is a mature tree with impressive stature. The tree's root crown has been partially exposed, most probably by run off from Kiely Road being directed toward the adjacent earth dam. Deadwood is evident in the crown, some of it high up, but it is mostly of < 50mm in diameter. Rated in Fair condition.

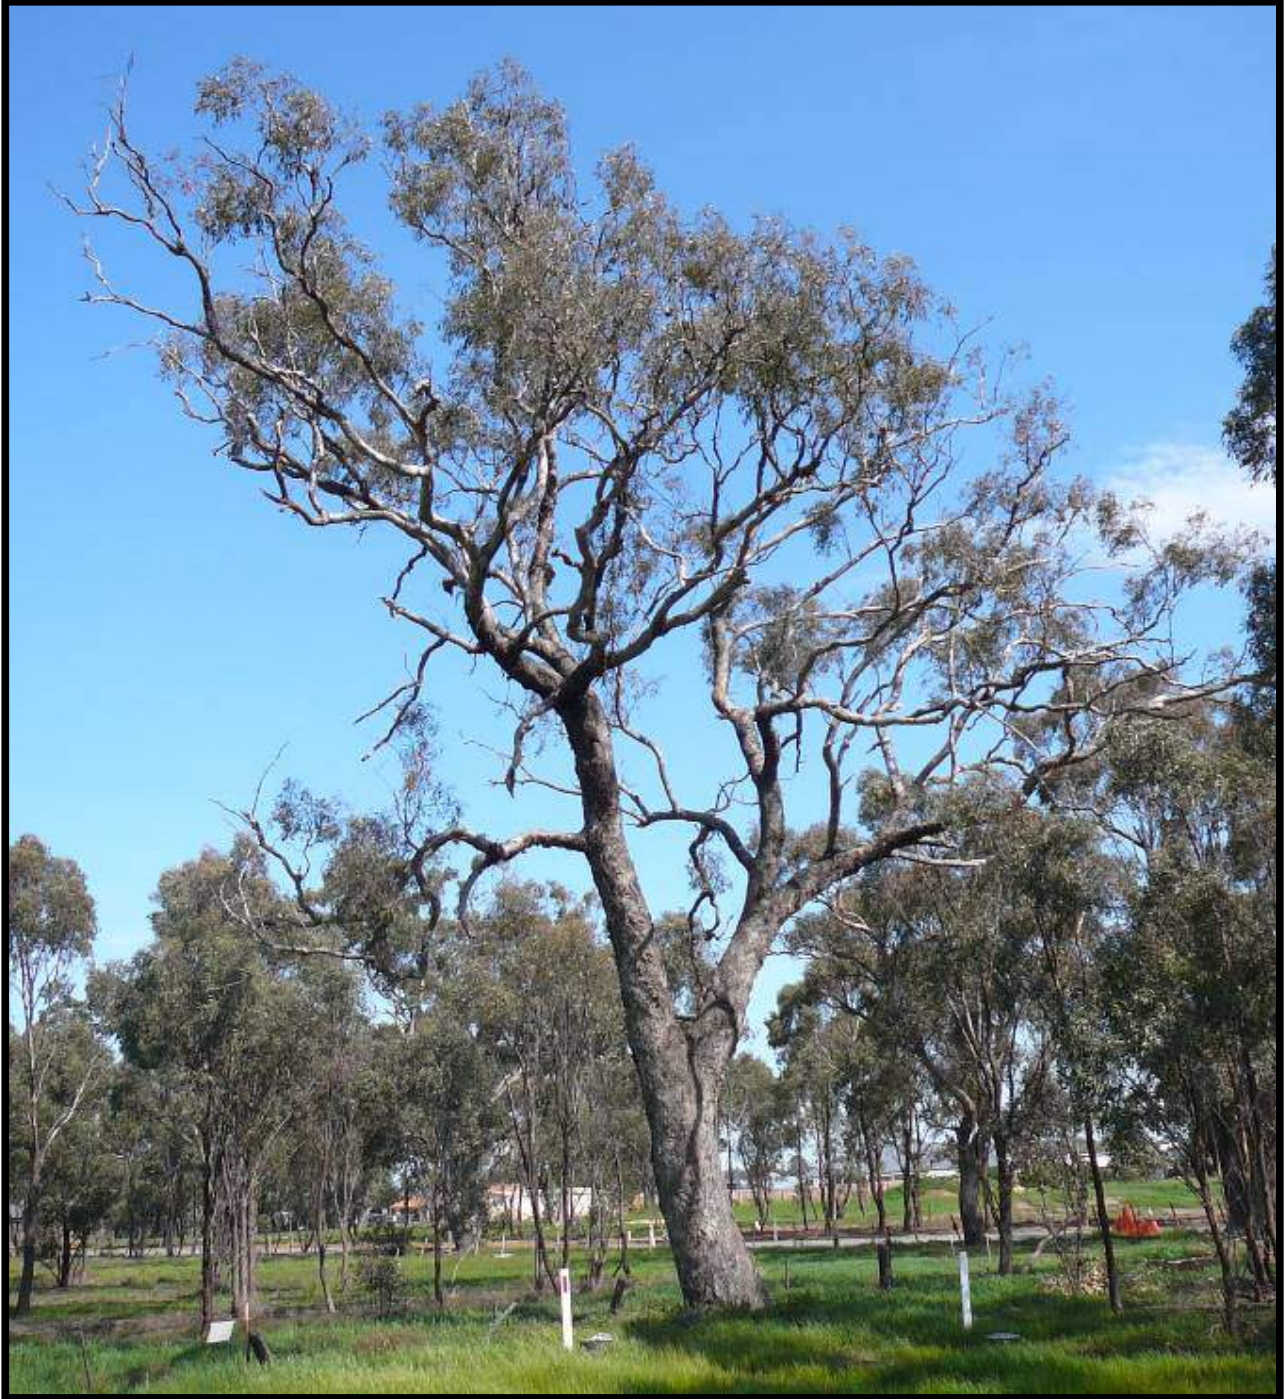
4.9 – Tree No. 11

Exhibit 12 – Tree 11 is another specimen in its “over mature” growth phase, with a sparse crown and small diameter deadwood at the perimeter of its canopy. There is evidence of (recent) trenching to the north-east of the tree’s base. It is rated as in Poor condition because of its declining vigour.

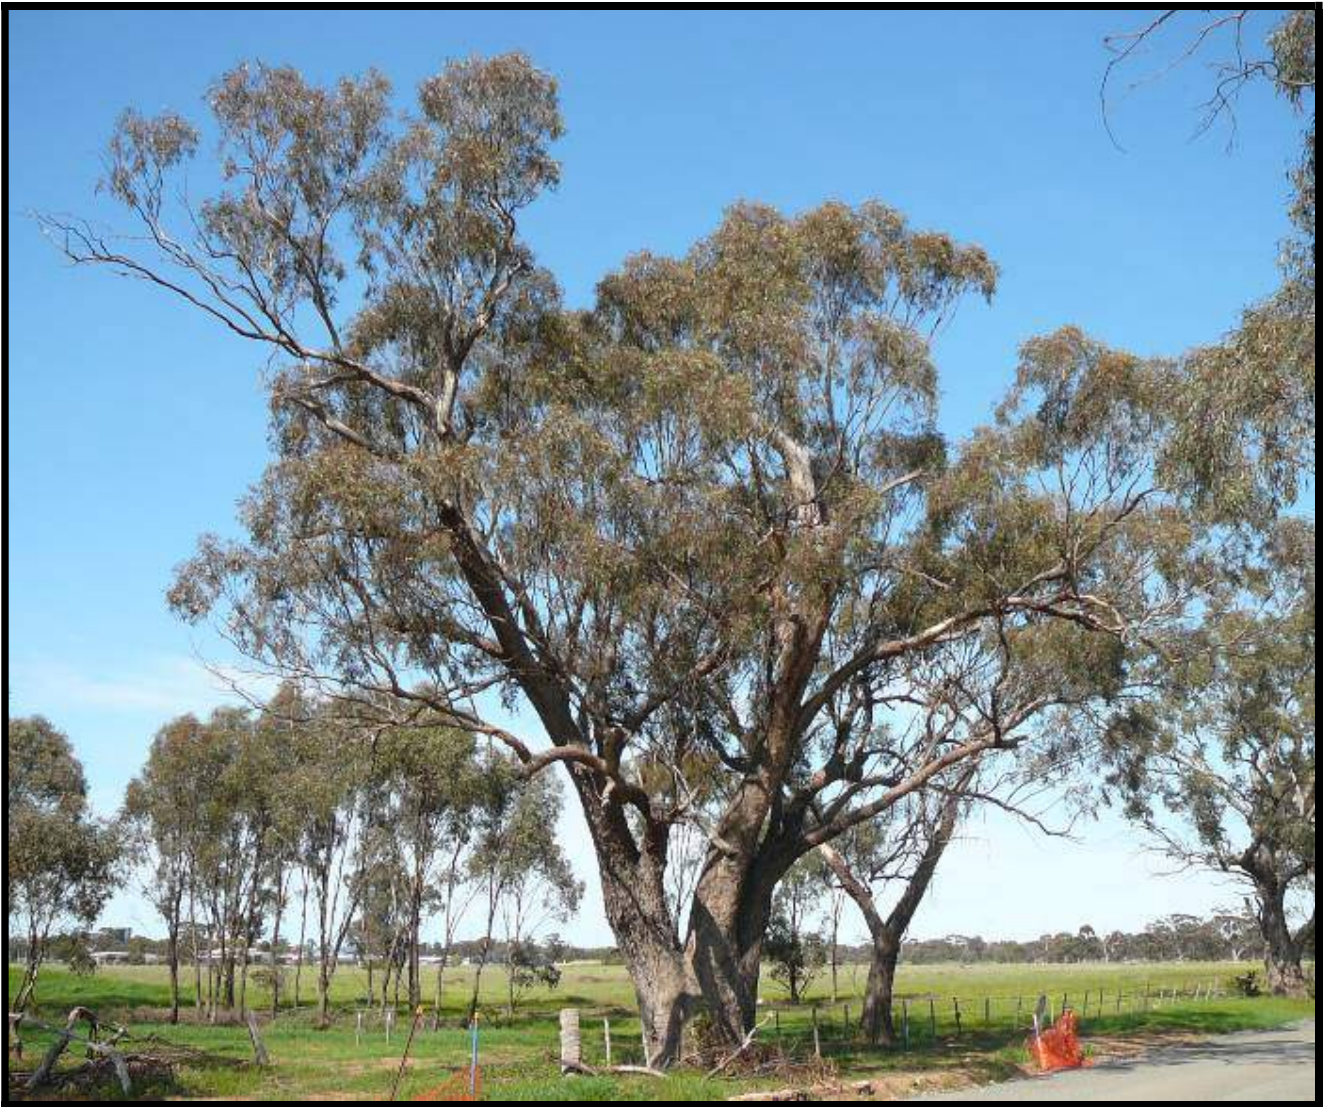
4.10 – Tree No. 12

Exhibit 13 – Tree 12 is massive veteran tree with a stem DBH close to 2 metres. The central and southern leaders of the tree are dead and broken, the start of the “retrenchment” phase. Deadwood up to 300mm in diameter is present in the tree’s crown. Two (small) basal openings are also evident. Recent trenching has also disturbed the tree’s root plate (south of the stem). Tree condition Fair.

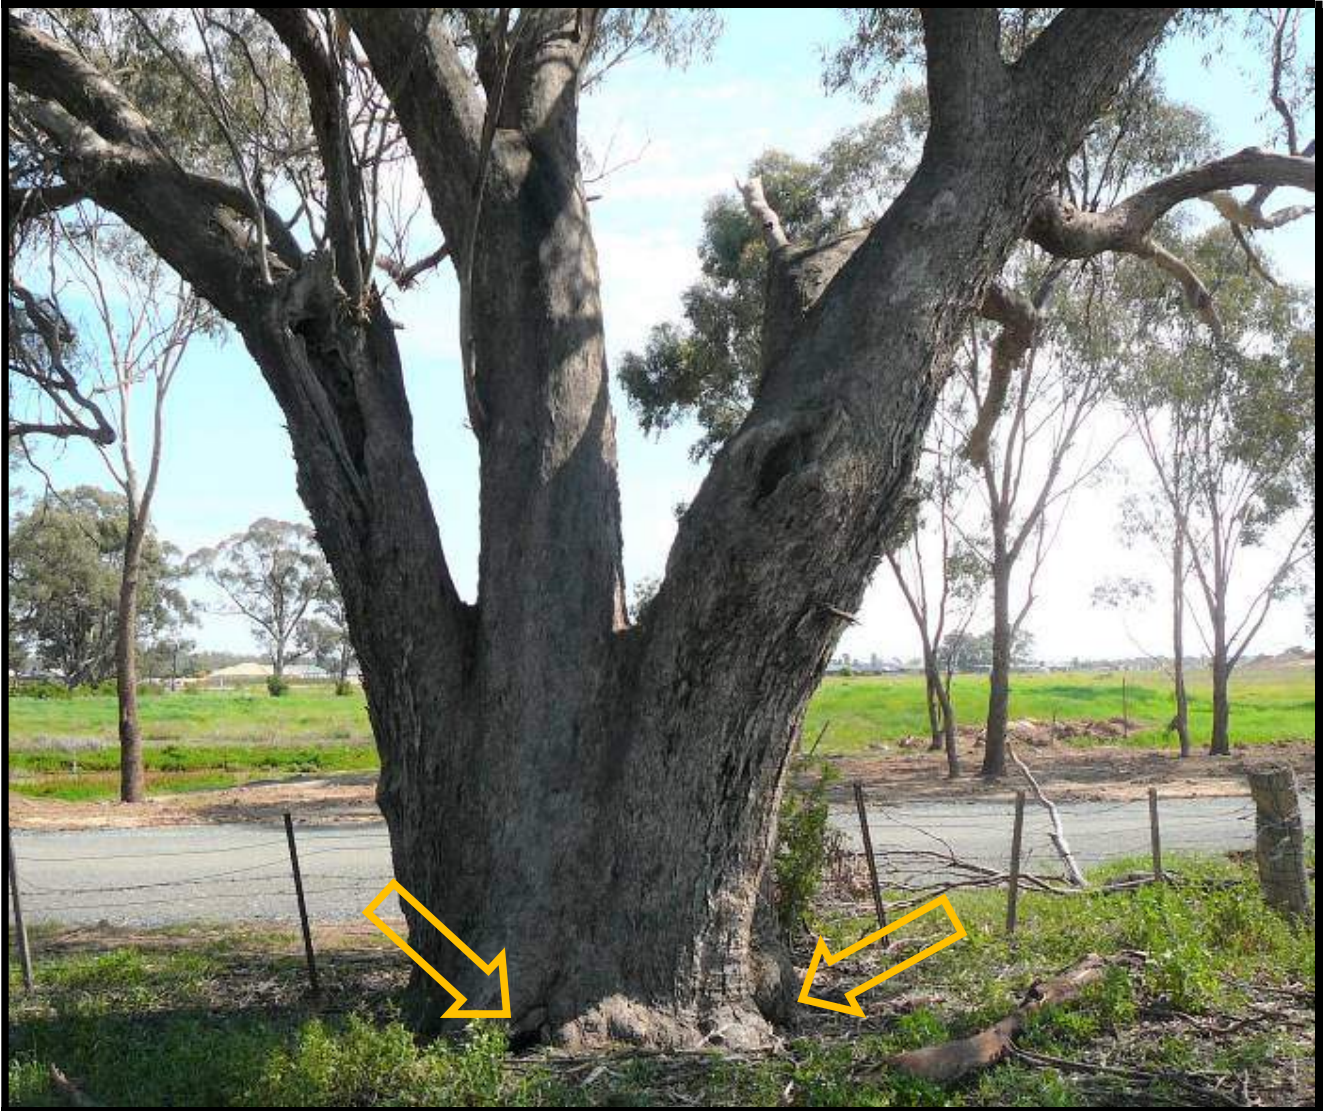
Exhibit 14 – The barrel and three leaders of Tree 12. The basal openings are arrowed.

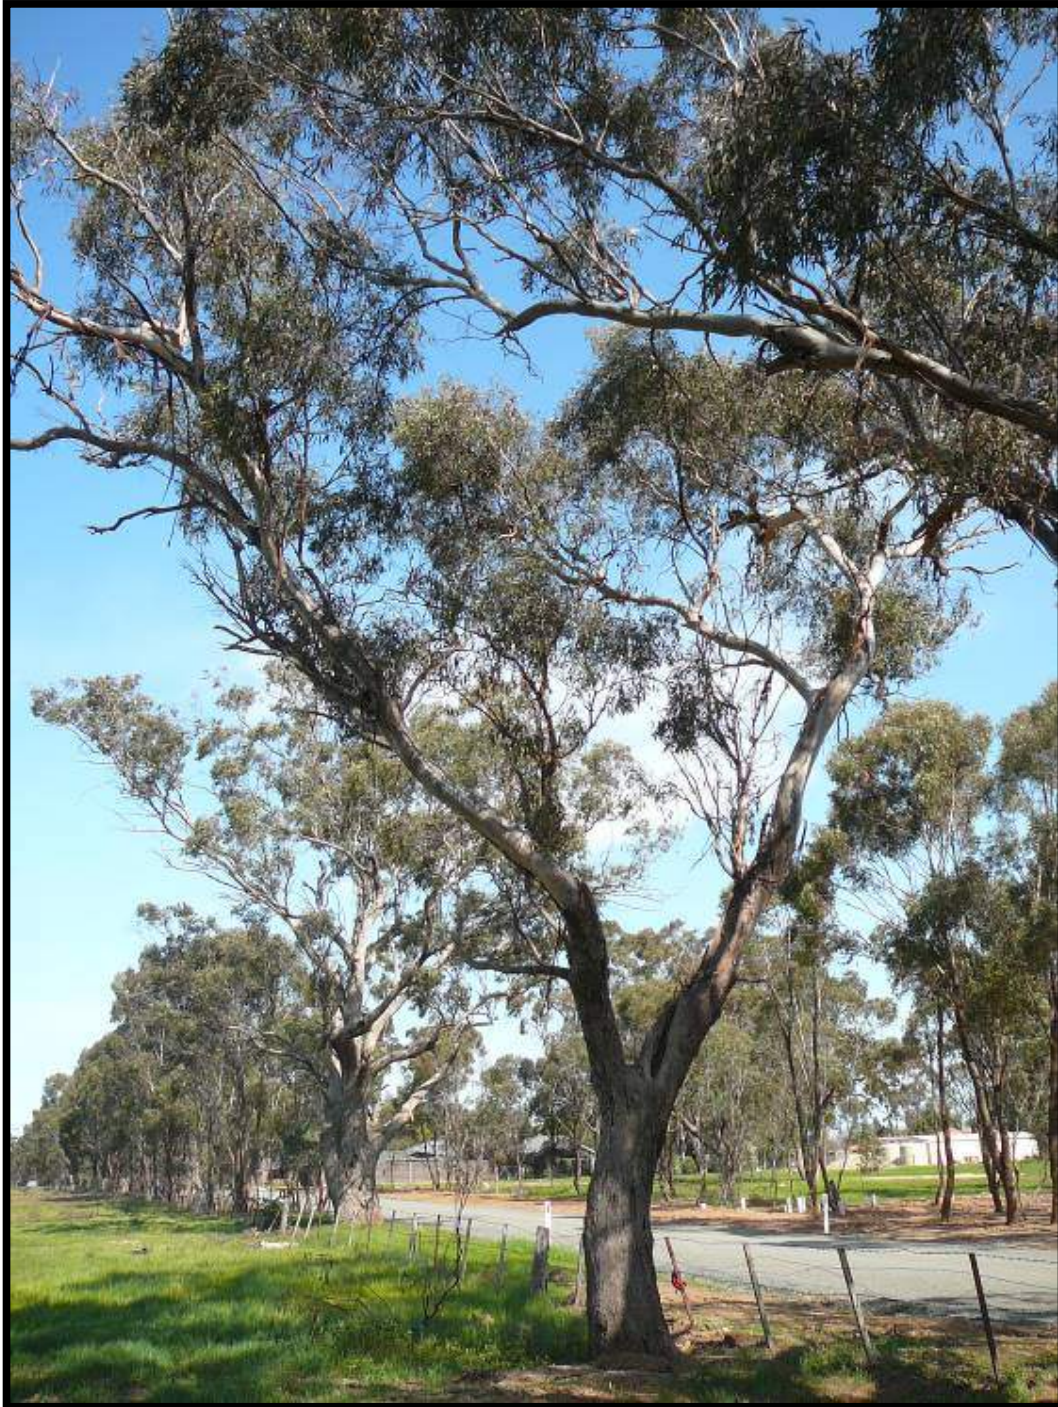
4.11 – Tree No. 13

Exhibit 15 – The form and vigour of Tree 13 has been suppressed by the neighbouring Tree 12. It has a limited crown based on two leaders, one of which (the western) has wounding at the junction. A basal cavity is evident (on the western side) and its root plate has also been disturbed by recent trenching (between Trees 12 and 13). Condition rating Poor.
