Proposed Blessed Carlo College, MOAMA.

Arborist Report

September 2021
(Updated October 2022),
Ref 21/413B.

Trees on (& surrounding) the Site of the Proposed Blessed Carlo College, Lignum & Kiely Roads, Moama.

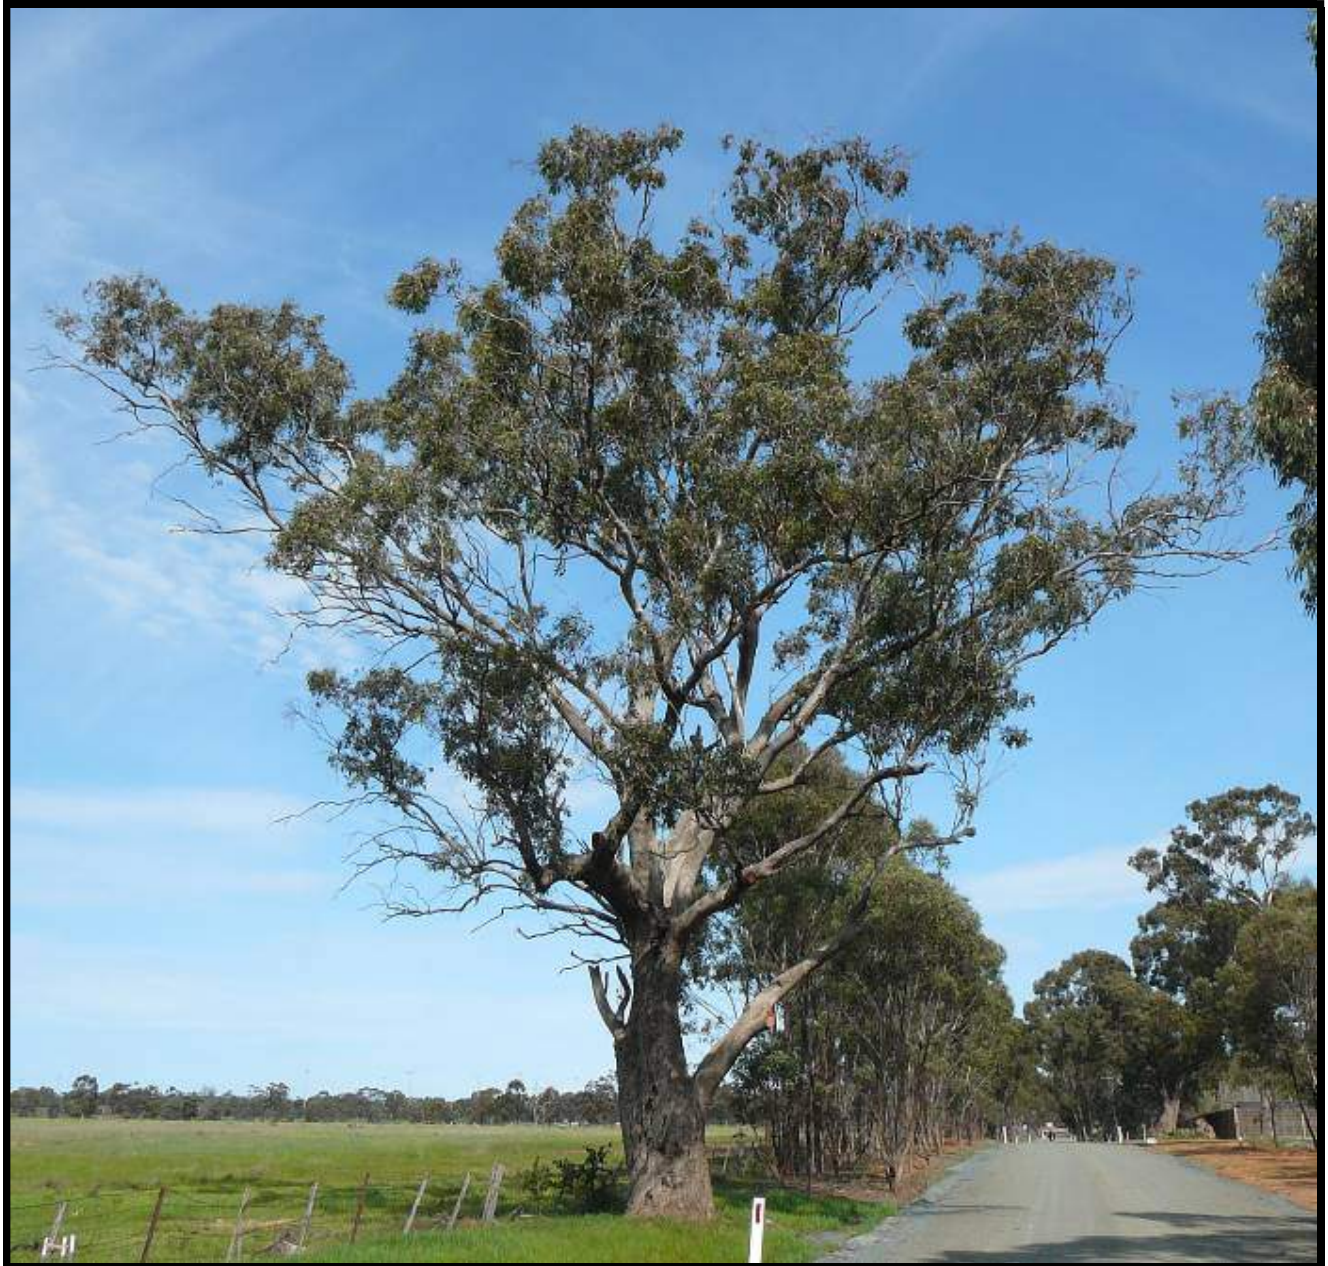
4.12 – Tree No. 14

Exhibit 16 – Tree 14 is another large veteran tree with an impressive stature. There is evidence of limb failures (up to 250mm diameter) and deadwood (to 75mm diameter) in the crown. The tree has been recently pruned (for road corridor clearance) and its (western) root crown has been impacted by roadworks. Rated in Fair condition.

<i>Tree/Stems</i>	<i>No.</i>	<i>Condition</i>	<i>Justification for Removal</i>
14	1	Fair	Within road reserve, in location of proposed bus parking area, to be replace by new landscaping, tree is in fair condition. The tree is one of those described in this report's body as "large veteran tree" and activities that cause people and/or vehicles to congregate in close vicinity to the trees should not be proposed
15	1	Fair	In location of proposed new building, tree is in fair condition, removal to be compensated by additional new tree plantings and landscaping. The tree offers only minimal visual or environmental amenity.
Copse 5	3	Fair	In location of proposed new buildings, stems are in fair condition, removal to be compensated by additional new tree plantings and landscaping. Recently regenerating trees that have seeded from larger mature trees in the vicinity.
Copse 7	5	Poor - Good	In location of proposed new buildings, stems are in poor-good condition, removal to be compensated by additional new tree plantings and landscaping. Recently regenerating trees that have seeded from larger mature trees in the vicinity.

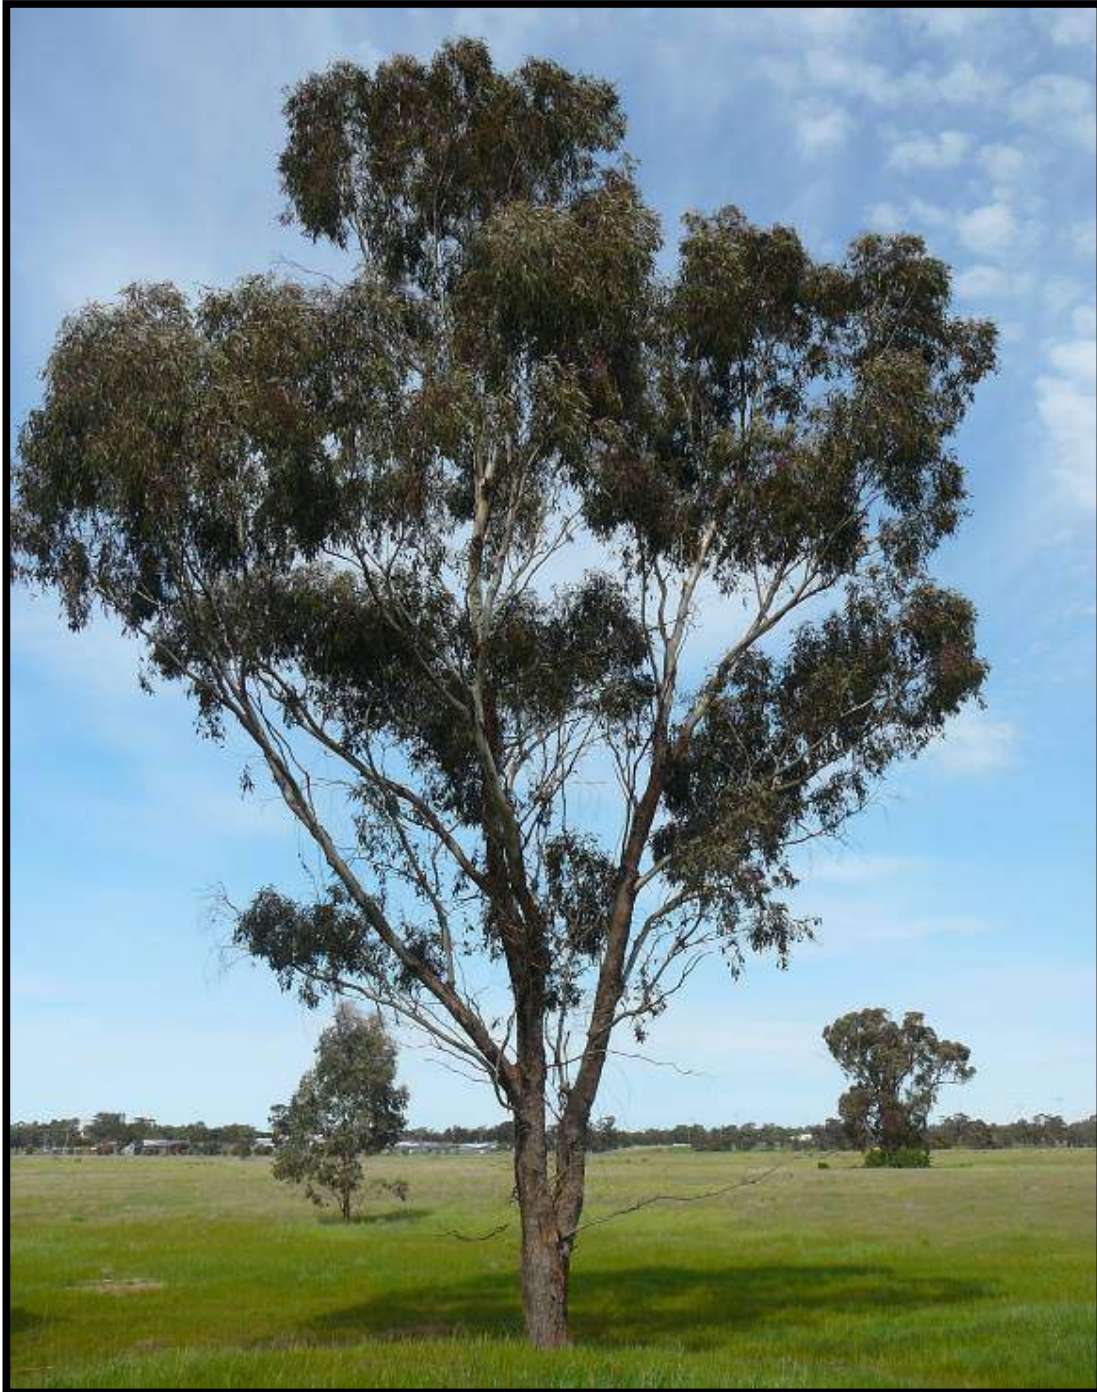
4.13 – Tree No. 15

Exhibit 17 – Tree 15 is a young tree in good health and vigour. Its stem bifurcates at about 1.2m, but the junction appears sound. Condition rating Fair.

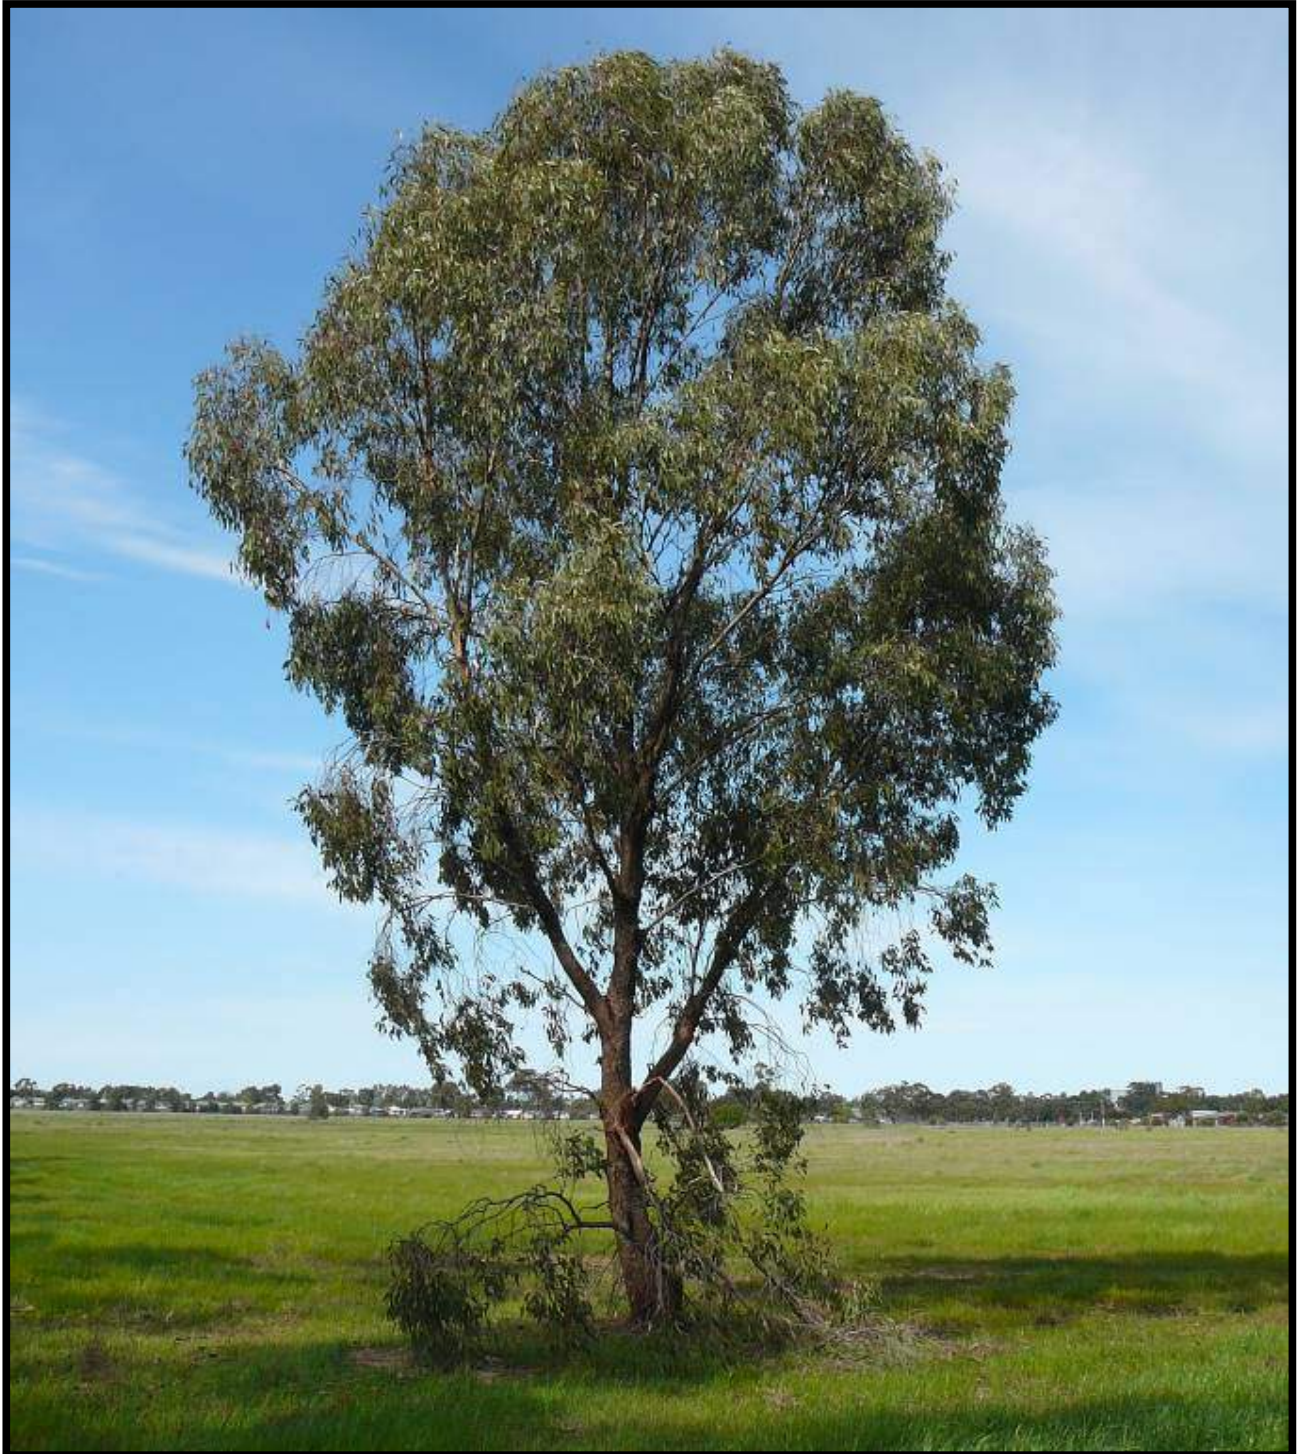
4.14 – Tree No. 16

Exhibit 17 – Tree 16 is another young tree in good health and vigour with no structural faults. Condition rating Good.

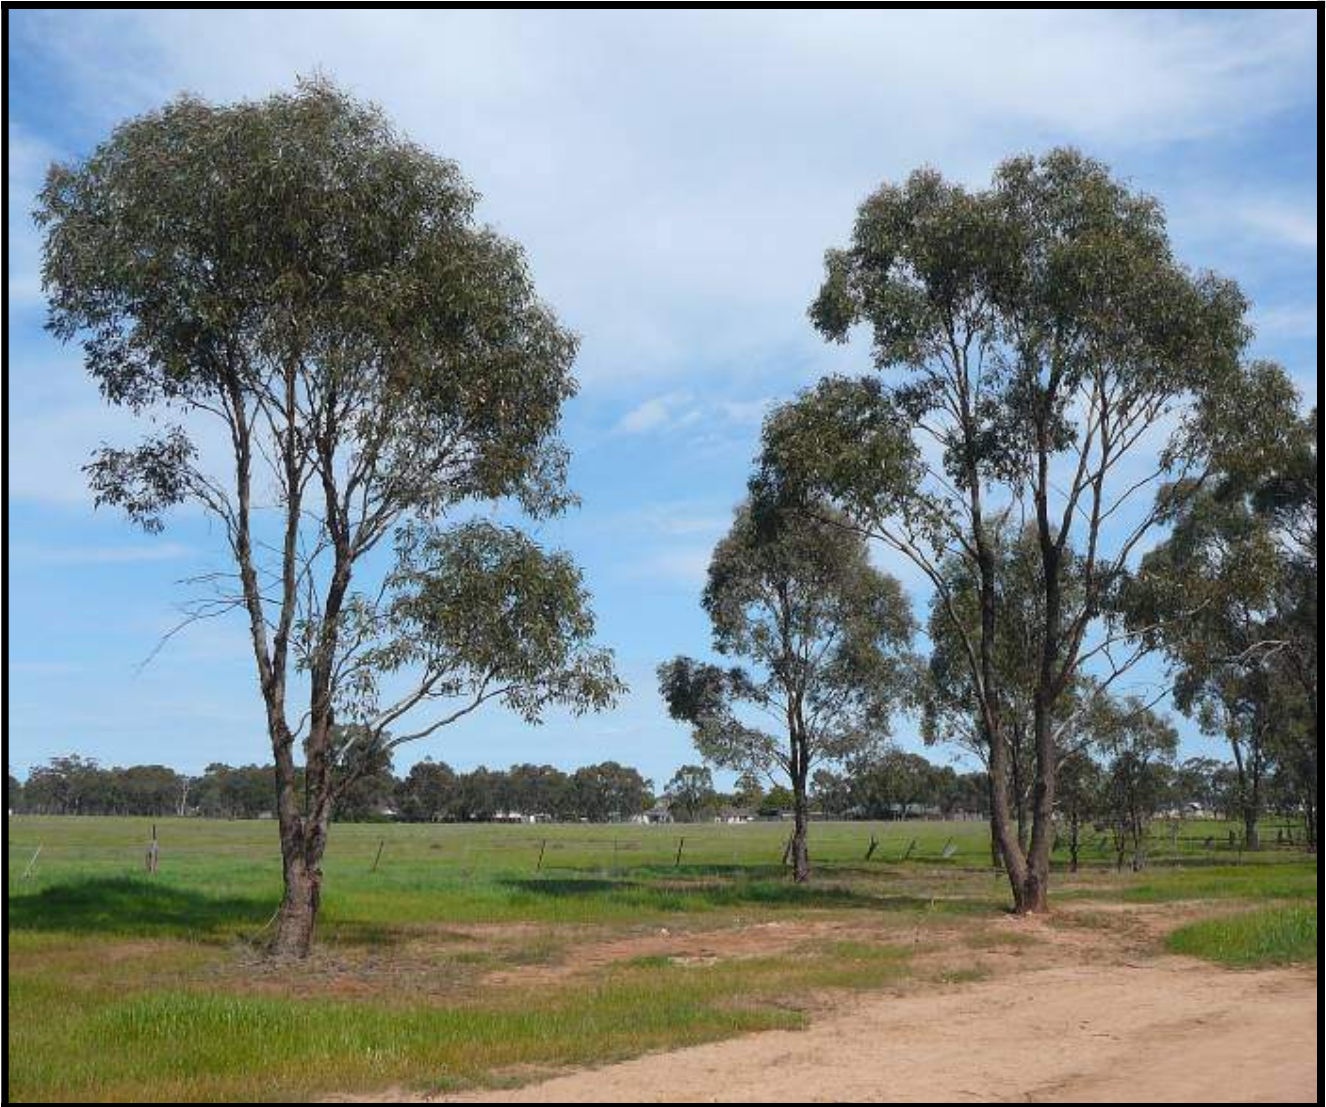
4.15 – Tree Copse 1

Exhibit 18 – Tree Copse 1; on the Kiely Road reserve at the north east end of the development site. Six stems up to 25cm DBH and 12m high.

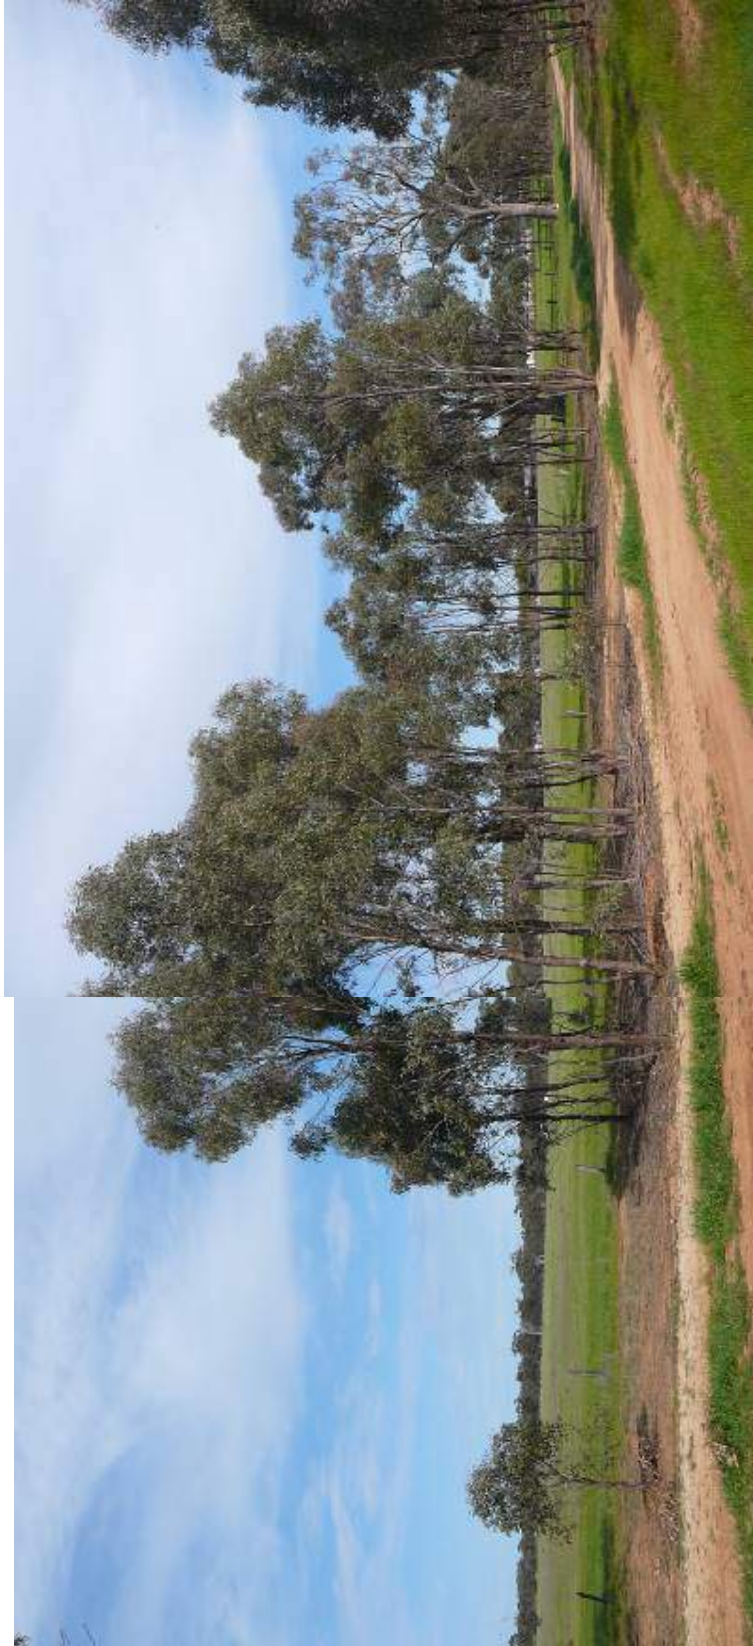
4.16 – Tree Copse 2

Exhibit 19 – Tree Copse 2; also on Kiely Road reserve. Approximately 40 stems, <20cm DBH and 12m high.

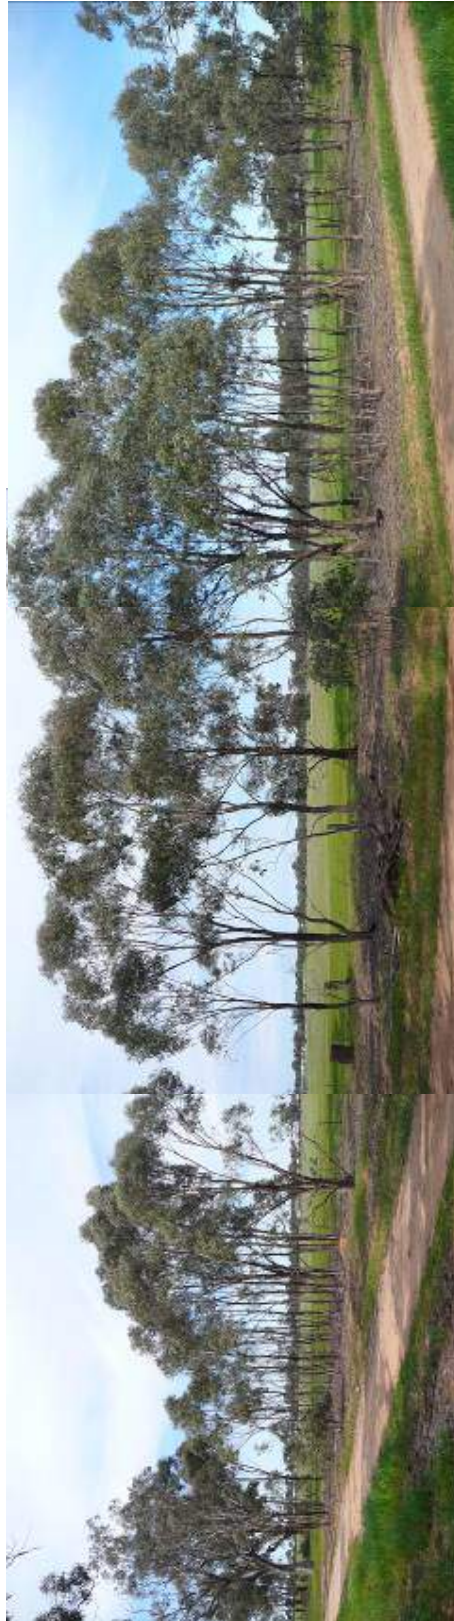
4.17 – Tree Copse 3

Exhibit 20 – Tree Copse 3; Kiely Road reserve. In excess of 100 stems, most <10cm DBH and up to 10m high.

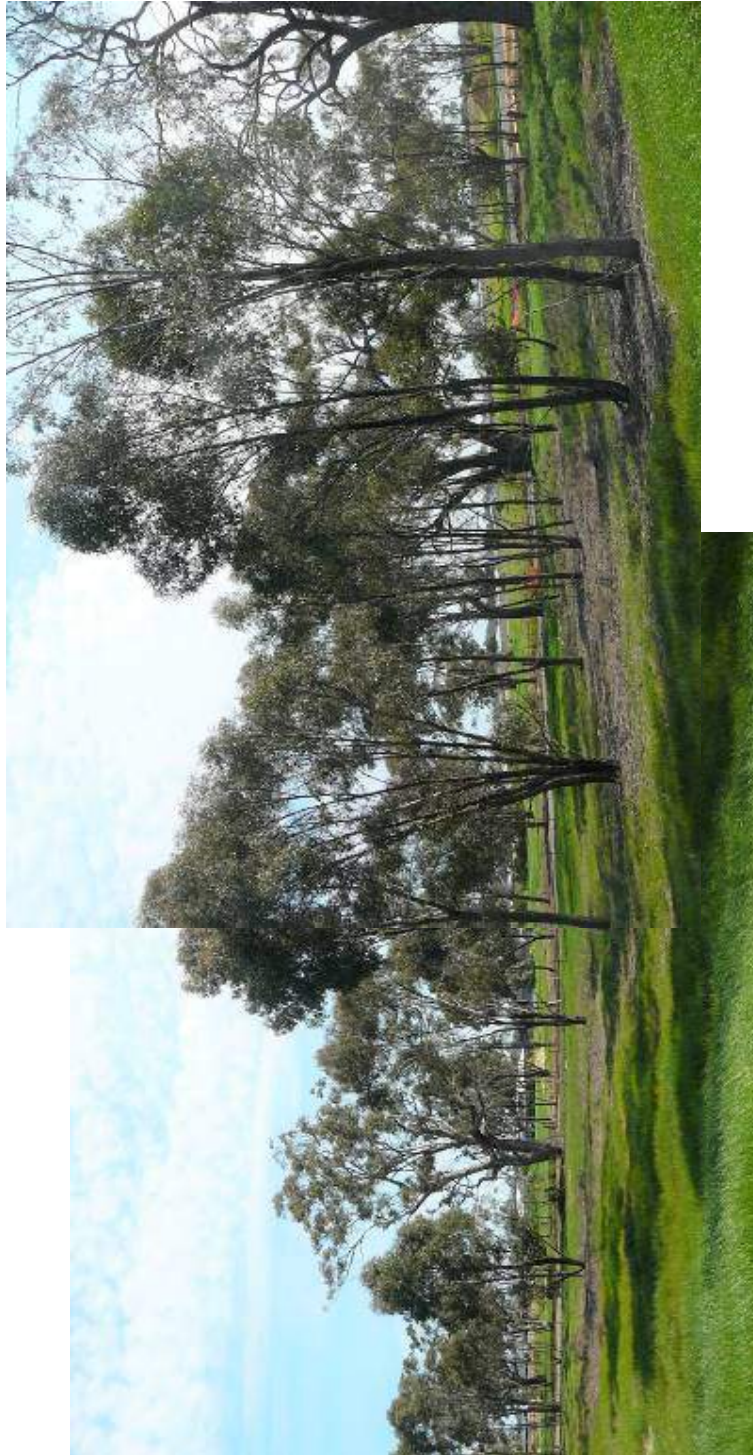
4.18 – Tree Copse 7

Exhibit 21 – Tree copse 7 is in the north-west corner of the property. Approximately 25 stems with DBH up to 25cm (although most <15cm). Some specimens (on south east edge of copse) may warrant retention, should the site's development layout accommodate it.

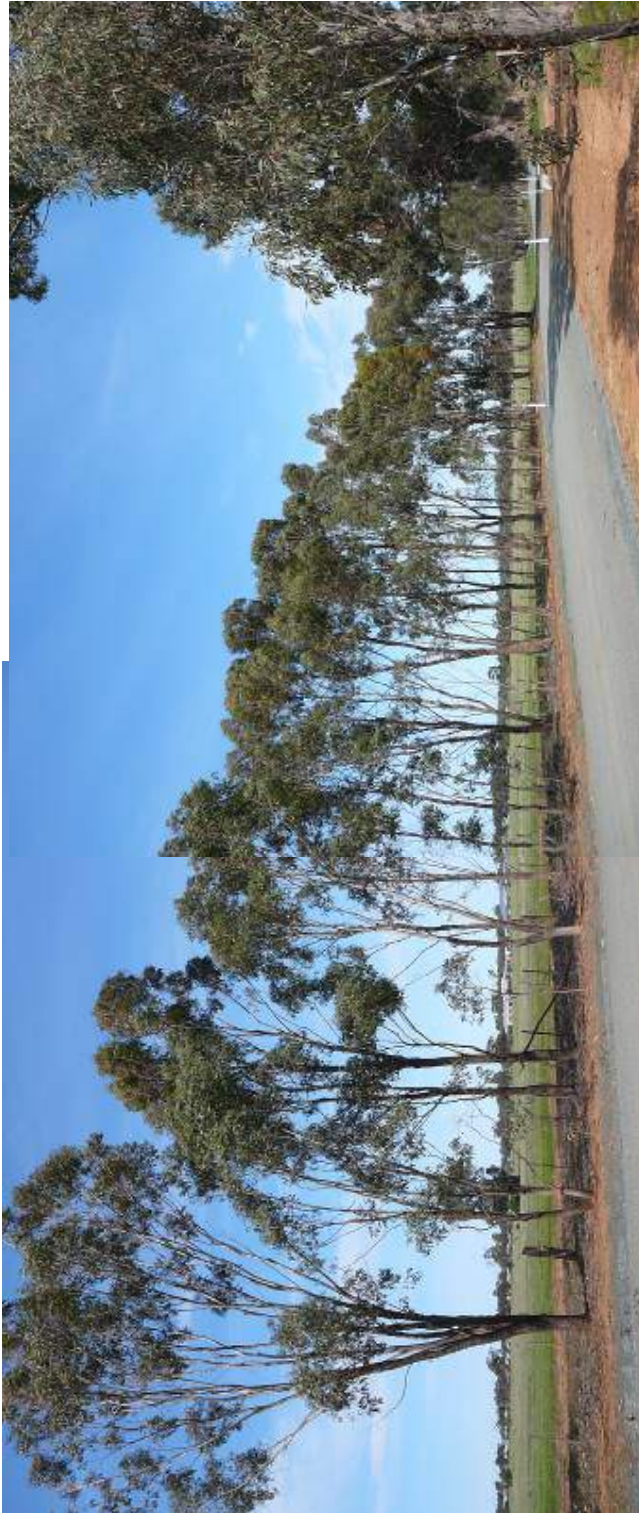
4.19 – Tree Copse 9

Exhibit 22 – Tree Copse 9; Lignum Road reserve at south west end of development site. Approximately 50 stems; largest 25-30cm DBH, most 12cm or less; heights up to 12m.

Copse 8	4	Fair	In location of proposed new buildings, stems are in fair condition, removal to be compensated by additional new tree plantings and landscaping. Recently regenerating trees that have seeded from larger mature trees in the vicinity. Positioned in (& on banks of) earth dam.
Copse 9	35	Poor - Good	Within road reserve, in location of proposed bus parking area and access driveways, stems are in poor-good condition, removal to be compensated by additional new tree plantings and landscaping. Recently regenerating trees that have seeded from larger mature trees in the vicinity.
	49
