Hazardous Materials Survey

268 & 278 Catherine Fields Rd, Catherine Field
NSW

Report No: E25586.E10_Rev0

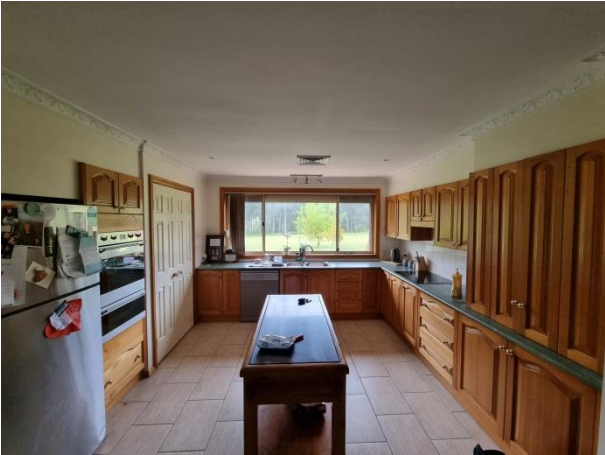
#278 Main Dwelling									
Inaccessible/Limited Access									
Internal, wall and ceiling cavities throughout	Possible hazardous materials	Unknown	-	-	Unknown	Unknown	Unknown	Inspect when access is made available, prior to demolition.	-
Internal, kitchen, walls behind tiles	Assumed to be brick behind tiling, potential for asbestos containing materials	Non-friable	Visual Inspection – Limited access due to floor to ceiling tiling	-	Not determined	Unknown Maintenance only	Priority 4: Negligible Risk Level	Inspect during strip out works and removal of tiles. If suspect material is identified, organise for inspection by a competent environmental consultant to identify if asbestos is present

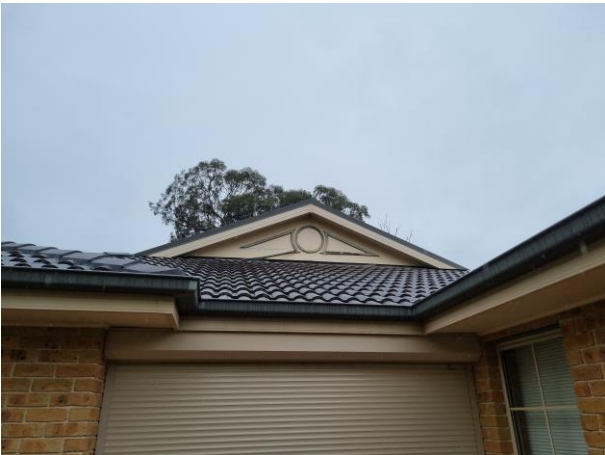
Asbestos									
External, eastern and western gables	Asbestos Cement Sheetting	Non-friable	Inaccessible (height restriction)	-	Approximately 10m²	Good Maintenance Only	NA	NA

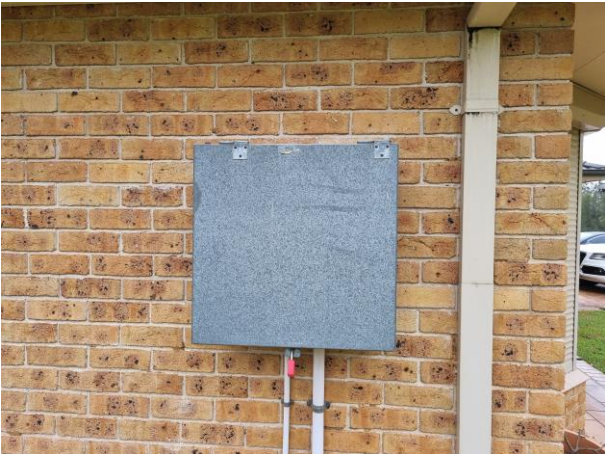
External, northern side	Asbestos Electrical Distribution Board (assumed)	Non-friable	Visual inspection (electrical hazard)	-	1 x board	Unknown Maintenance only	Priority 4 - Negligible Risk Level	Remove during demolition works

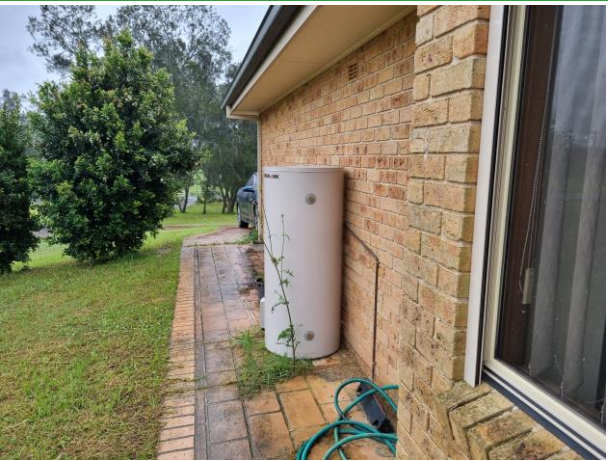
External, southern side, hot water heater	SMF lined insulation (assumed)	Sealed	Visual inspection (inaccessible)	-	1 x unit	Good Maintenance only	Priority 4 - Negligible Risk Level	Remove during demolition works

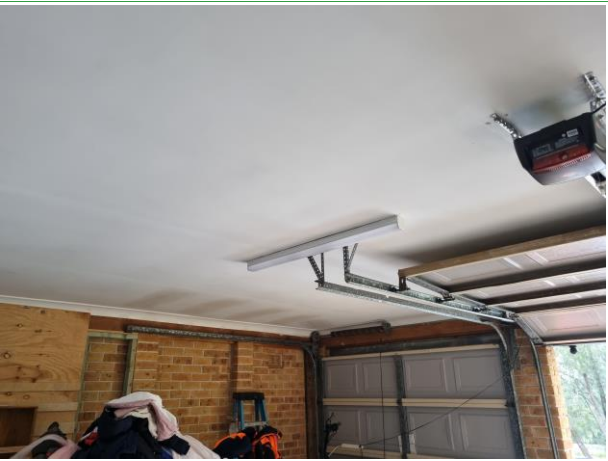
Internal, garage	PCB containing single fluorescent light fitting (assumed)	NA	Visual Inspection (electrical hazard)	-	1 x lighting fixture	Good Maintenance Only	Priority 4 - Negligible Risk Level	Remove prior to demolition works

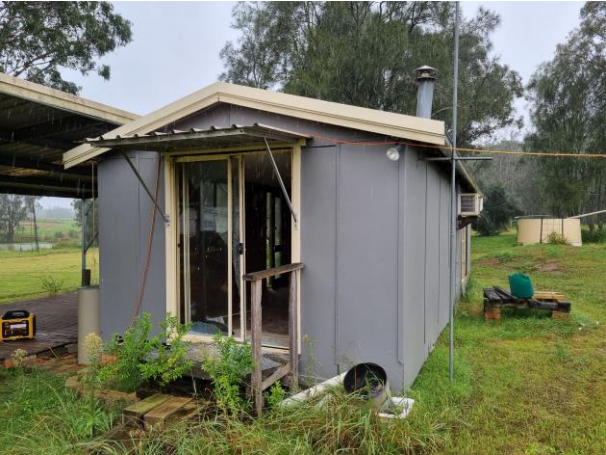
Location	Material Type	Friability	Sample	Analysis Result:	Quantity	Condition and Accessibility	Priority	Recommendations/ Comments	Photograph of material
#278 Detached Cabin									
Inaccessible/Limited Access									
Internal, ceiling, floor and wall cavities throughout	Possible hazardous materials	Unknown	-	-	Unknown	Unknown	Unknown	Inspect when access is made available, prior to demolition.	-
Asbestos									
External, walls and gables	Asbestos Cement Sheeting	Non-friable	Asb-05	Chrysotile Asbestos Detected Organic Fibres Detected	Approximately 80m ²	Fair Maintenance Only	Priority 4 - Negligible Risk Level	Remove prior to demolition works

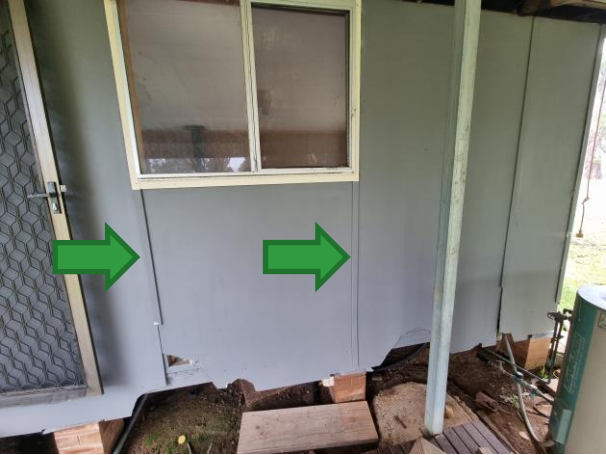
External, walls, edge capping	Asbestos Cement Sheeting	Non-friable	Asb-08	Chrysotile Asbestos Detected Organic Fibres Detected	Not determined	Fair Maintenance Only	Priority 4 - Negligible Risk Level	Remove prior to demolition works

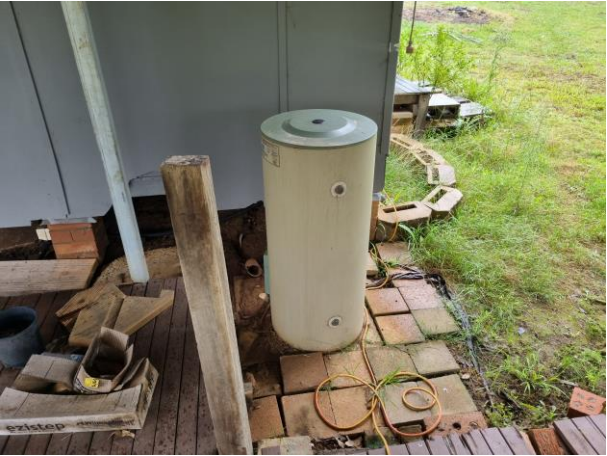
External, northern side, hot water heater	SMF lined insulation (assumed)	Sealed	Visual inspection (inaccessible)	-	1 x unit	Good Maintenance Only	Priority 4 - Negligible Risk Level	Remove prior to demolition works

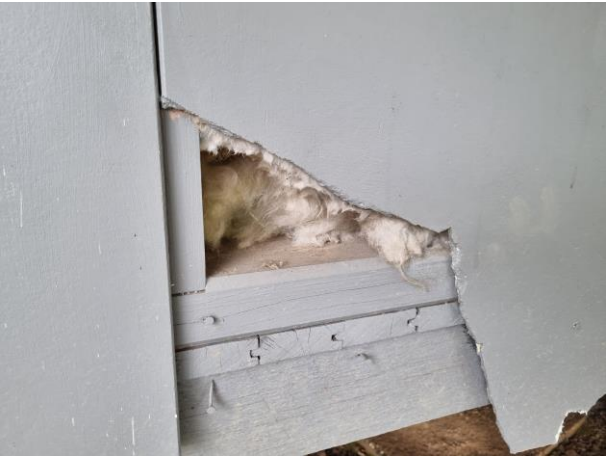
Internal, walls and ceiling	SMF Insulation	Unsealed	Asb-06	No Asbestos Detected SMF Detected	Approximately 80m²	Fair Maintenance Only	Priority 4 - Negligible Risk Level	Remove prior to demolition works

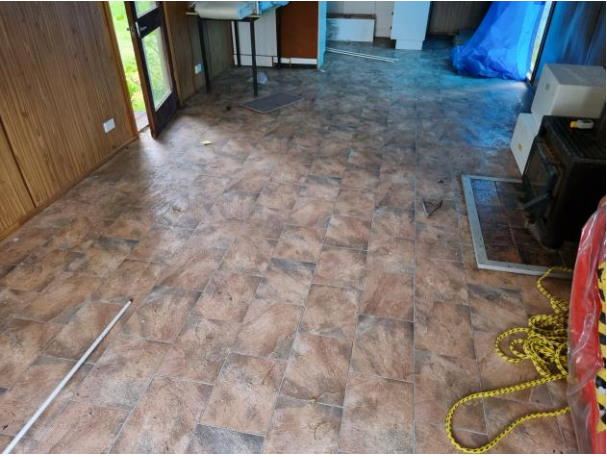
Internal, floor	Beige Vinyl Floor Sheeting	Sealed	Asb-07	No Asbestos Detected SMF Detected	Approximately 40m²	Fair Maintenance Only	Priority 4 - Negligible Risk Level	Remove prior to demolition works

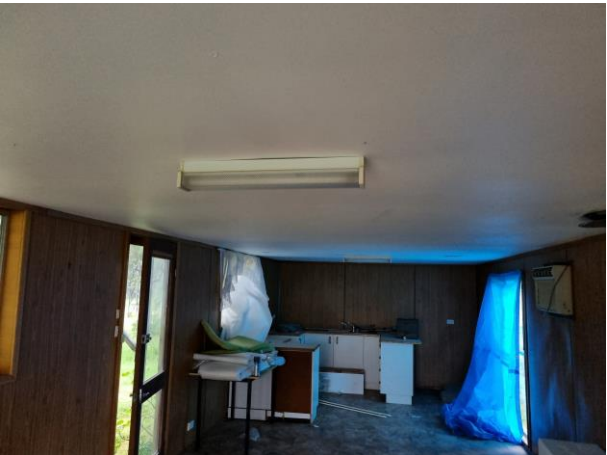
Internal, throughout	PCB containing single tube fluorescent light fitting (assumed)	NA	Visual Inspection (electrical hazard)	-	2 x lighting fixtures	Good Maintenance Only	Priority 4 - Negligible Risk Level	Remove prior to demolition works
----------------------	--	----	---------------------------------------	---	-----------------------	-----------------------	------------------------------------	----------------------------------

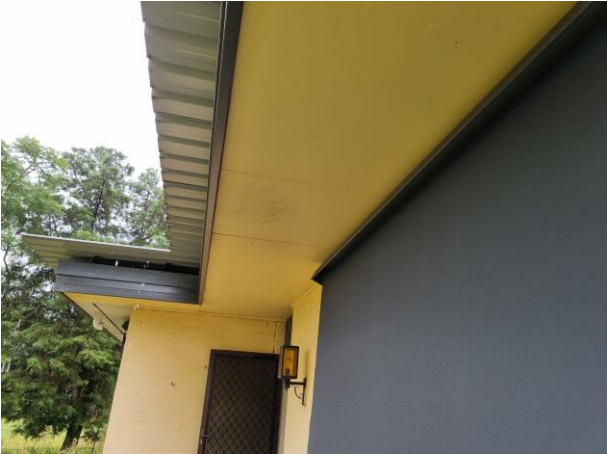
#268 Main Dwelling									
Inaccessible/Limited Access									
Internal, floor, wall and ceiling cavities throughout	Possible hazardous materials	Unknown	-	-	Unknown	Unknown	Unknown	Inspect when access is made available, prior to demolition.	-
Asbestos									
External, eaves	Asbestos Cement Sheeting (assumed)	Non-friable	Visual Inspection (height restriction)	-	Approximately 30m²	Fair Maintenance only	Priority 4 - Negligible Risk Level	Remove prior to demolition works

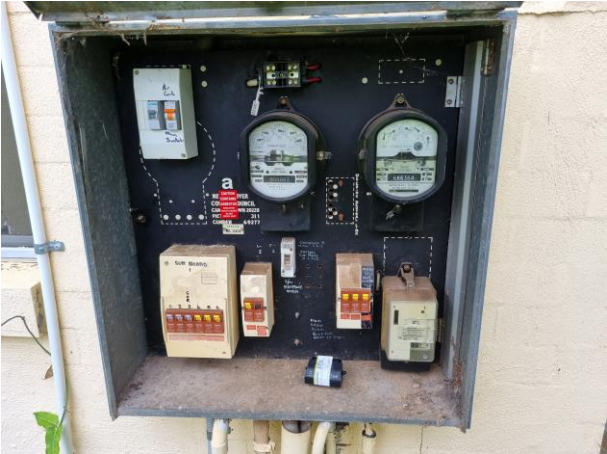
External, southern side	Asbestos Electrical Distribution Board (assumed)	Non-friable	Visual inspection (electrical hazard)	-	1 x board	Unknown Maintenance only	Priority 4 - Negligible Risk Level	Remove during demolition works

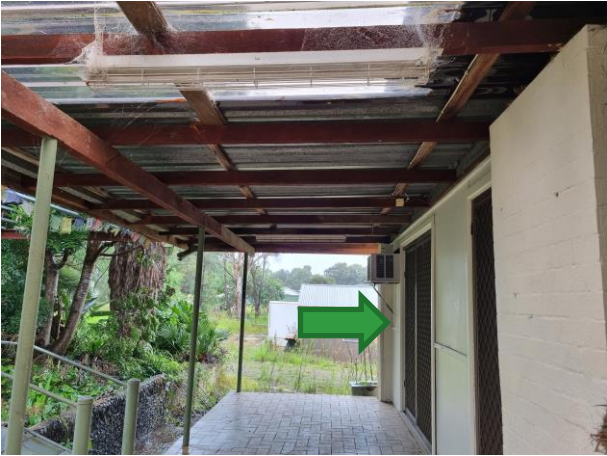
External, eastern side, southern section, wall	Asbestos Cement Sheeting	Non-friable	Asb-13	Chrysotile Asbestos Detected Organic Fibres Detected	Approximately 10m²	Good Maintenance only	Priority 4 - Negligible Risk Level	Remove during demolition works

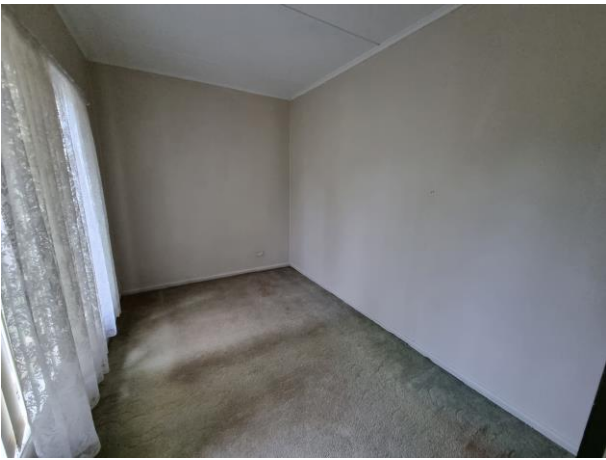
Internal, north-eastern bedroom, walls and ceiling	Asbestos Cement Sheeting	Non-friable	Asb-11	Chrysotile Asbestos Detected Organic Fibres Detected	Approximately 30m ²	Good Maintenance only	Priority 4 - Negligible Risk Level	Remove during demolition works

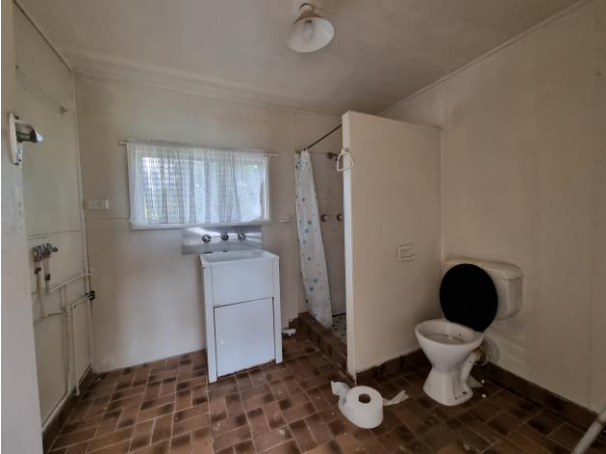
Internal, eastern laundry/bathroom, walls and ceiling	Asbestos Cement Sheeting	Non-friable	Asb-12	Chrysotile Asbestos Detected	Approximately 30m ²	Good Maintenance only	Priority 4 - Negligible Risk Level	Remove during demolition works

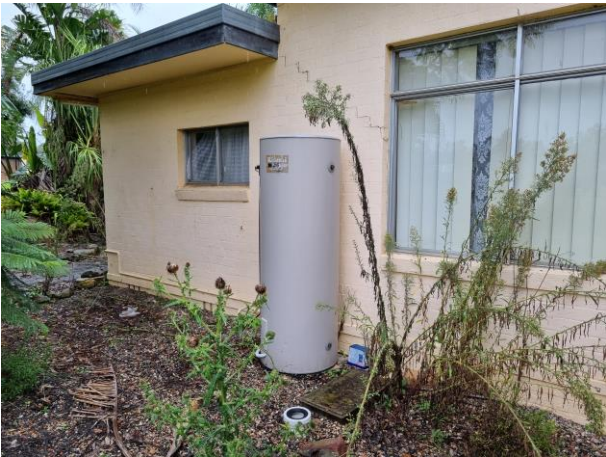
SMF									
External, northern side, hot water heater	SMF lined insulation (assumed)	Sealed	Visual inspection (inaccessible)	-	1 x unit	Good Maintenance only	Priority 4 - Negligible Risk Level	Remove during demolition works

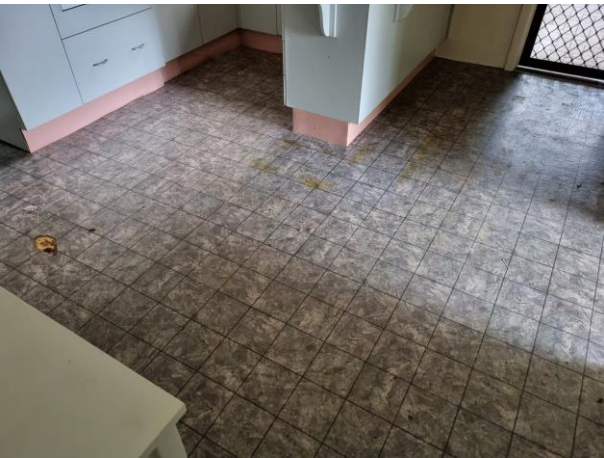
Internal, kitchen, floor, upper layer	Blue Vinyl Floor Sheeting	Sealed	Asb-09	No Asbestos Detected SMF Detected	Approximately 15m ²	Fair Maintenance Only	Priority 4 - Negligible Risk Level	Remove prior to demolition works
---------------------------------------	---------------------------	--------	--------	---	--------------------------------	-----------------------	------------------------------------	---

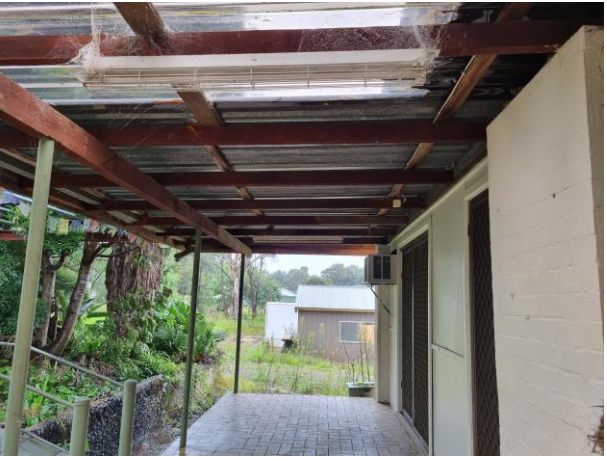
External, eastern awning	PCB containing single tube fluorescent light fitting (assumed)	NA	Visual Inspection (electrical hazard)	-	2 x lighting fixtures	Good Maintenance Only	Priority 4 - Negligible Risk Level	Remove prior to demolition works

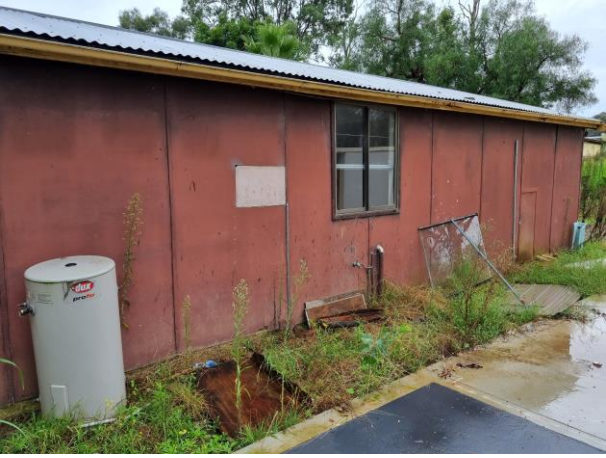
External, southern side, hot water heater	SMF lined insulation (assumed)	Sealed	Visual inspection (inaccessible)	-	1 unit	Good Maintenance only	Priority 4 - Negligible Risk Level	Remove during demolition works

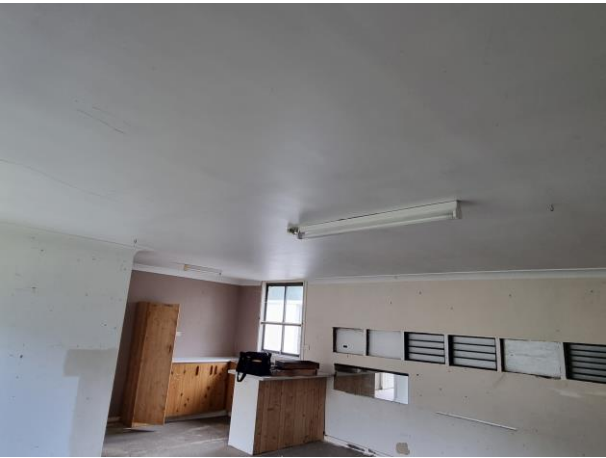
Internal, throughout	PCB containing single tube fluorescent light fitting (assumed)	NA	Visual Inspection (electrical hazard)	-	Not determined	Fair Maintenance Only	Priority 4 - Negligible Risk Level	Remove prior to demolition works

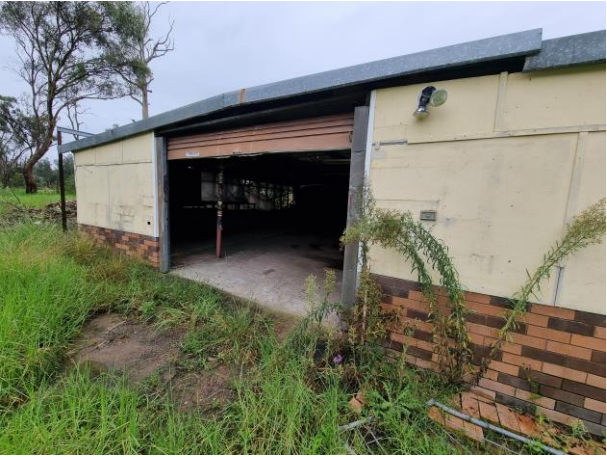
#268 Eastern Detached Shed									
Inaccessible/Limited Access									
Internal, wall and ceiling cavities throughout	Possible hazardous materials	Unknown	-	-	Unknown	Unknown	Unknown	Inspect when access is made available, prior to demolition.	-
Asbestos									
External, western and southern upper walls	Asbestos Cement Sheeting	Non-friable	Asb-16	Chrysotile Asbestos Detected Organic Fibres Detected	Approximately 50m ²	Fair Maintenance only	Priority 4 - Negligible Risk Level	Remove prior to demolition works

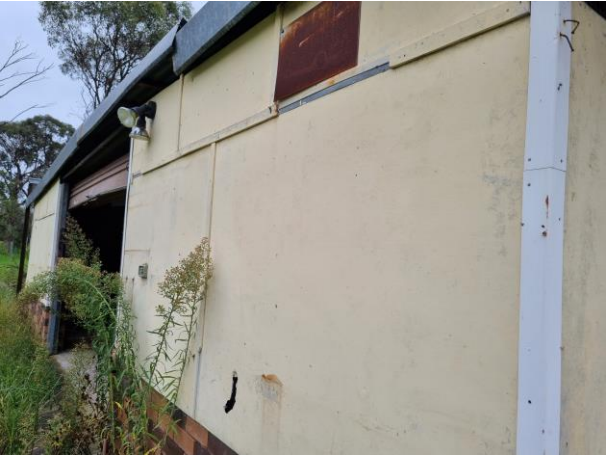
External, western and southern upper walls, edge capping	Asbestos Cement Sheeting	Non-friable	Asb-17	Chrysotile Asbestos Detected Organic Fibres Detected	Approximately 3m ²	Fair Maintenance only	Priority 4 - Negligible Risk Level	Remove prior to demolition works

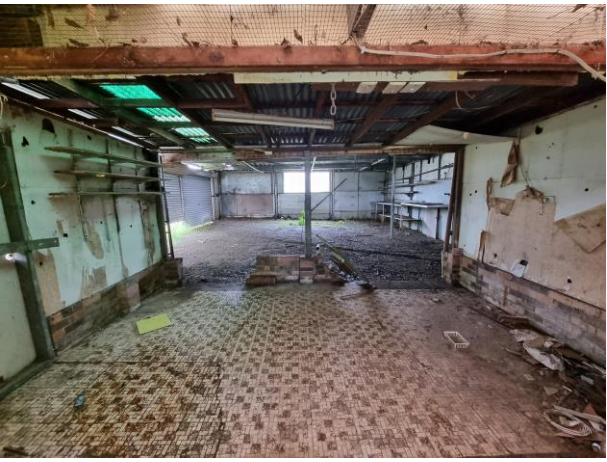
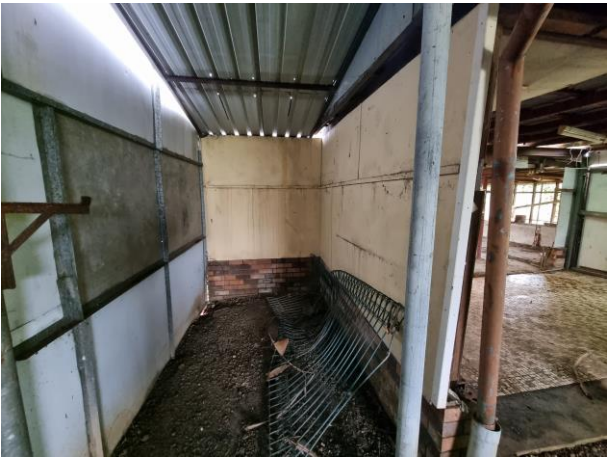
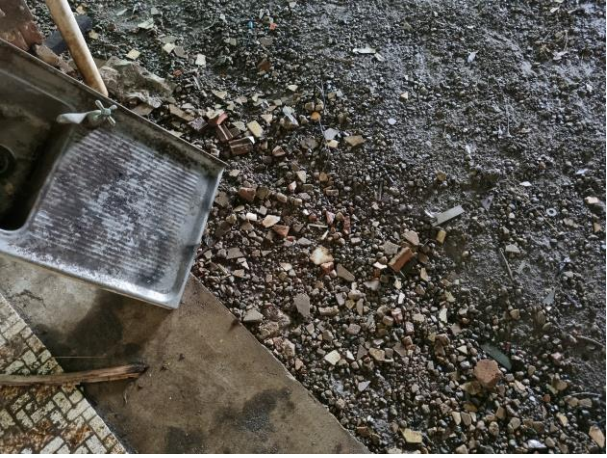
Internal, western, central and eastern rooms, sheeted walls	Asbestos Cement Sheeting (assumed)	Non-friable	Visual Inspection – similar to Asb-16	Chrysotile Asbestos Detected Organic Fibres Detected	Approximately 25m ²	Good Maintenance only	Priority 4 - Negligible Risk Level	Remove prior to demolition works

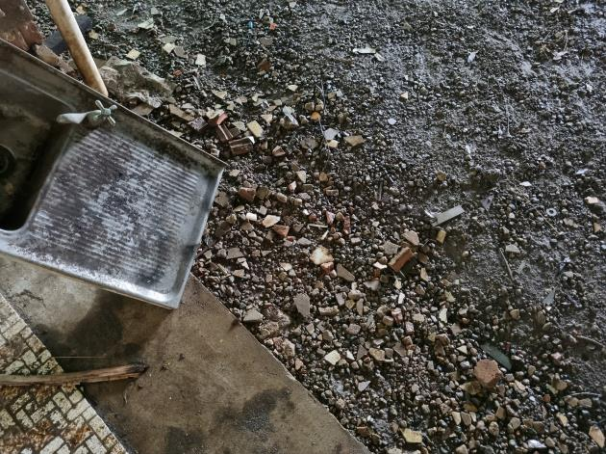
Internal, eastern room, ground surface debris	Asbestos Cement Sheeting Fragments	Non-friable	Asb-18	Chrysotile and Amosite Asbestos Detected	>1m ²	Fair/Poor Maintenance only	Priority 3 – Low Risk under Present Conditions	Remove prior to demolition works
