# **Remediation Validation Report**

42-52 Raymond Avenue, Matraville NSW

Prepared for Perpetual Corporate Trust Limited ATF 42 Matraville Investment Trust November 2021

# **Report Number** J210458 RP#1 Client Perpetual Corporate Trust Limited ATF 42 Matraville Investment Trust Date 16 November 2021 Version v2 Final Prepared by Approved by Lachlan Lewis Victoria Buchanan **Environmental Scientist** National Technical Leader - Contaminated Land 16 November 2021 16 November 2021 EMM Pty Limited (EMM) has prepared this document for the sole use of Perpetual Corporate Trust Limited ATF 42 Matraville Investment Trust

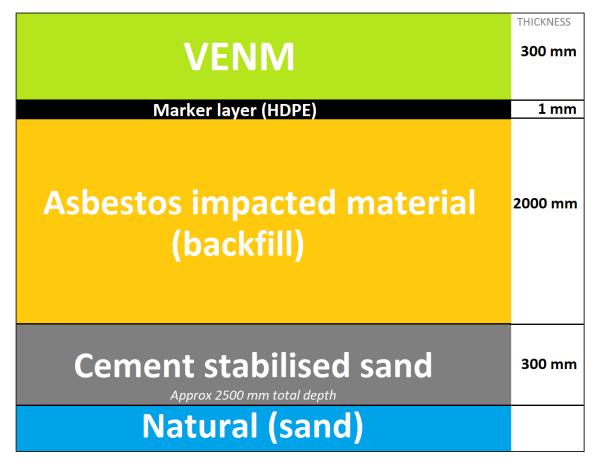
Figure 8.1 Backfill and capping layers – T1 excavation

VENM	THICKNESS
Marker layer (HDPE)	1 mm
Asbestos impacted material (backfill)	900 - 1700 mm
Natural (sand)

Clean fill validated as virgin excavated natural material (VENM) was also used to reinstate the excavations over the backfill material, separated by a high density polyethylene (HDPE) plastic marker layer. The HDPE was perforated to facilitate surface water seepage and infiltration. Compaction was completed by track rolling.
