**Targeted Destructive Hazardous  
Building Materials Assessment  
Clocktower Square  
35 - 55 Harrington Street, The Rocks NSW 2000**

**Essence Project Management Pty Ltd  
September 2022**

**Client No: E0110  
Job No: 107211S**

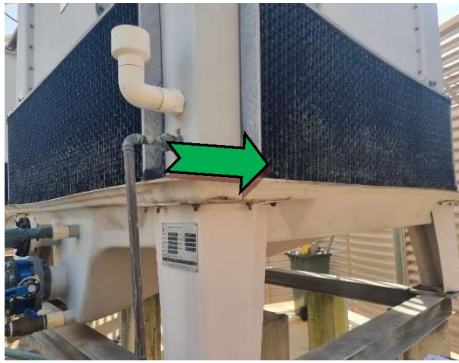
1. Exterior, roof, aqua cooling towers, base of tower, below vents – non asbestos-containing mastic sealant

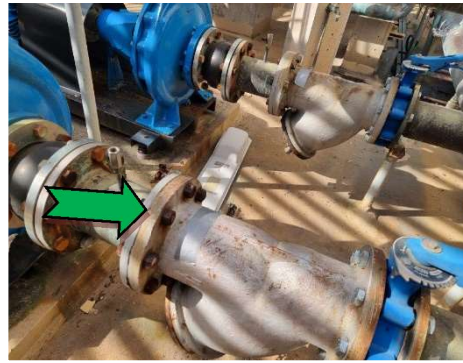
2. Exterior, roof, pumps adjacent aqua cooling tower pipework, flange – non asbestos-containing gasket

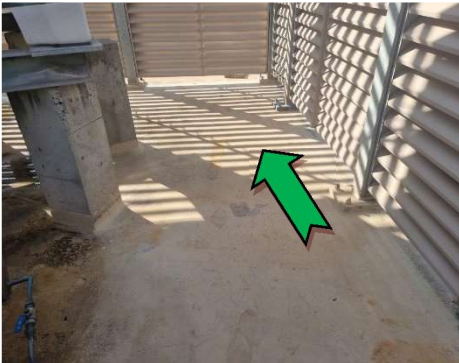
3. Exterior, roof, throughout, flooring – non asbestos-containing waterproofing

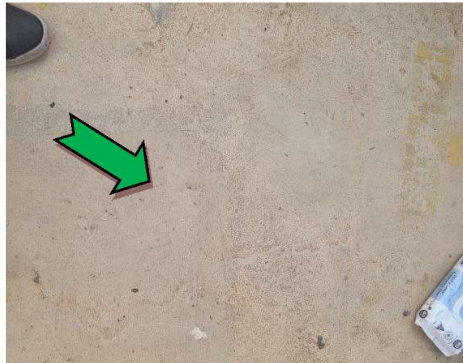
4. Exterior, roof, adjacent fire door, floor – non asbestos-containing screed material

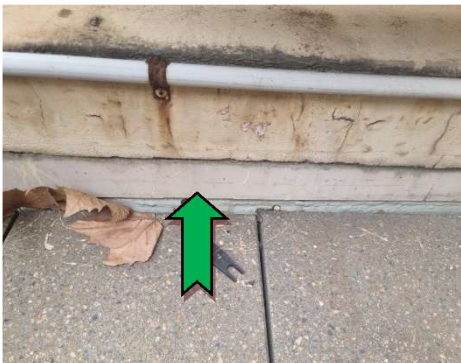
5. Exterior, level 4, balcony, base of perimeter walls – non asbestos-containing bituminous material

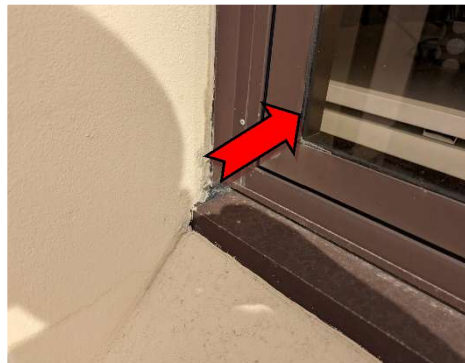
6. Exterior, level 2, eastern elevation, windows– asbestos-containing mastic material

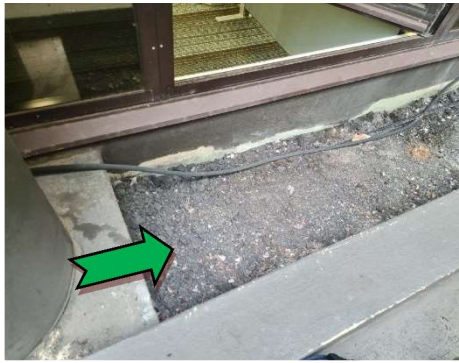
7. Exterior, level 2, courtyard, within garden beds – non asbestos-containing fibre cement debris

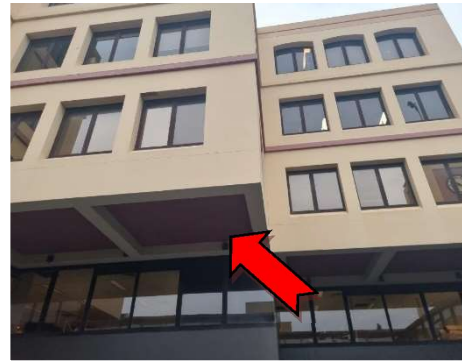
8. Exterior, level 2, courtyard soffit to level 3 offices – assumed asbestos-containing fibre cement sheeting

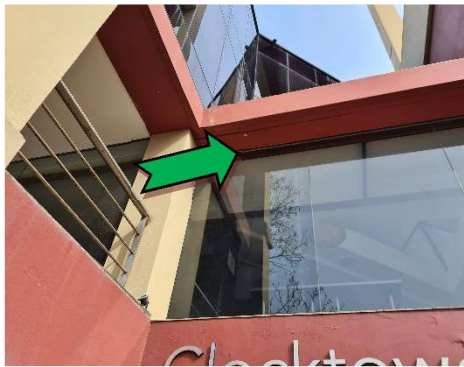
9. Exterior, level 1, north eastern elevation, below Clocktower, eave – non asbestos-containing fibre cement sheet

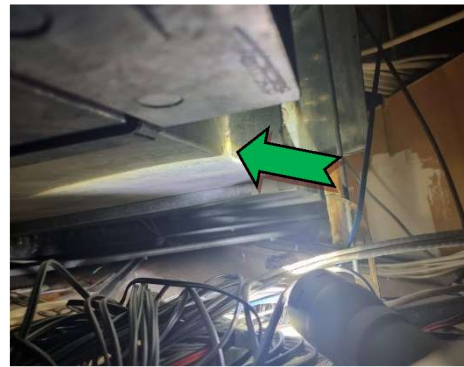
10. Interior, level 6, Orchard Talent Group Tenancy, main foyer, ceiling space, air conditioning ductwork – assumed non asbestos-containing insulation lining

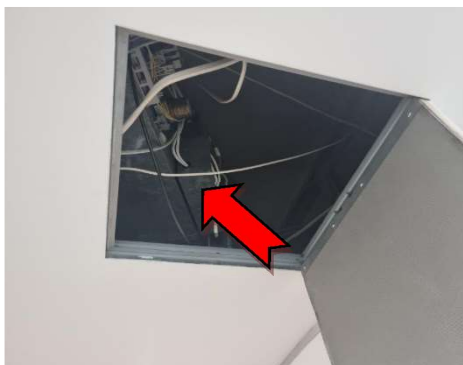
11. Interior, level 6, within ceiling space, air handling unit, heaterbank – assumed asbestos-containing millboard insulation

- Various assumed asbestos-containing materials (e.g. heater banks & lift motor friction pads) should be sampled prior to commencement of demolition works to determine asbestos content. Plant isolation will be required to access these features.

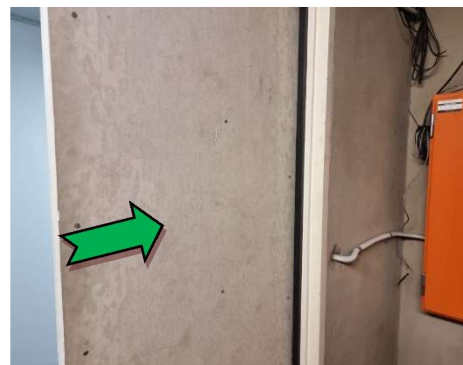
12. Interior, level 6, air handling room, door lining – non asbestos-containing fibre cement sheet

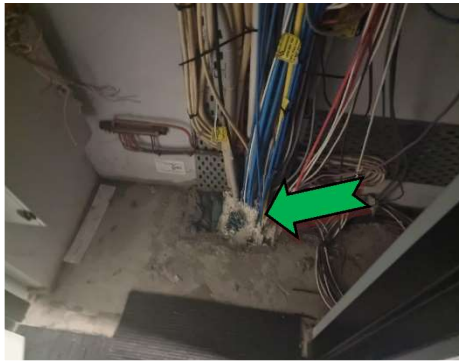
**13.** Interior, level 5, southern riser cupboard, under pipe penetrations – non asbestos-containing mastic material

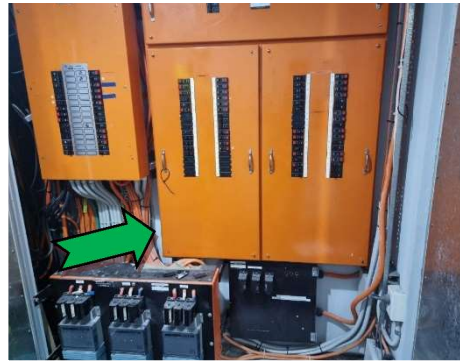
**14.** Interior, level 4, electrical cupboard, electrical distribution board – assumed non asbestos-containing bituminous backing board

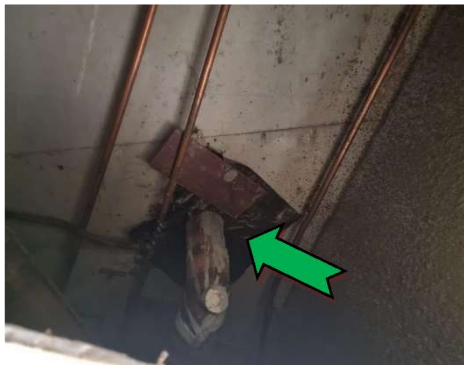
**15.** Interior, level 3, tea room, ceiling space, pipe penetration wrap – non asbestos-containing bituminous material

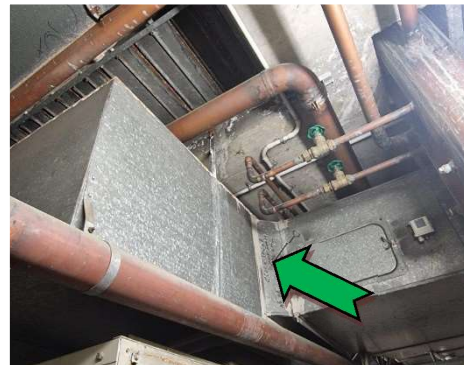
**16.** Interior, level 2, eastern air handling room, ductwork – assumed non asbestos-containing mastic sealant

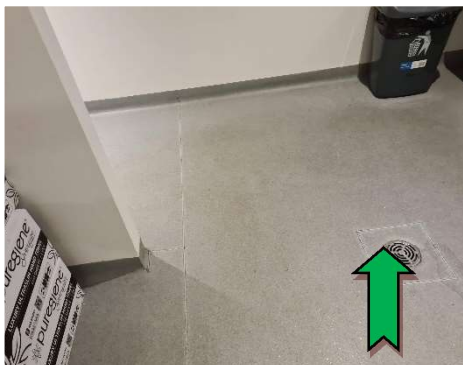
**17.** Interior, level 1, western elevation, Sydney Symphony Orchestra tenancy, bathrooms, floor – assumed non asbestos-containing sheet vinyl

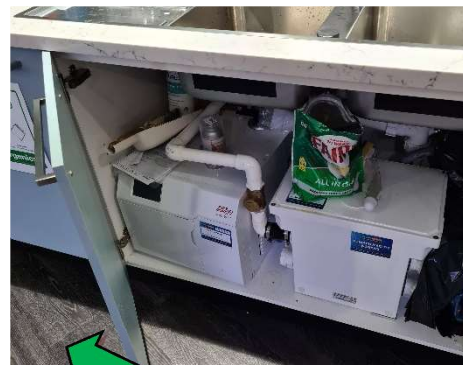
**18.** Interior, south west elevation, Sydney Symphony Orchestra tenancy, kitchenette – non asbestos-containing grey floor coverings

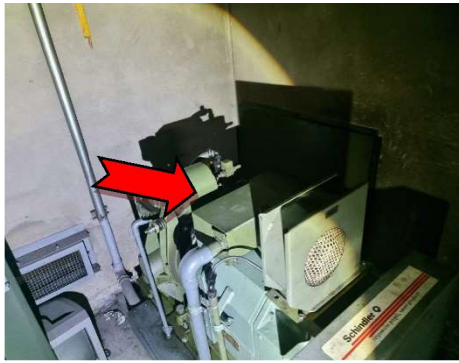
19. Interior, lower B2 level, lift motor room 3, lift motor – assumed asbestos-containing friction pads

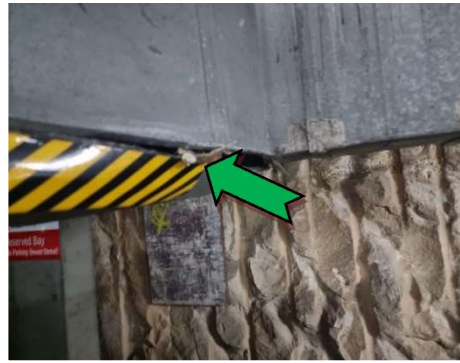
20. Interior, upper B1 level, adjacent carpark entrance, rigid ductwork – non asbestos-containing internal insulation

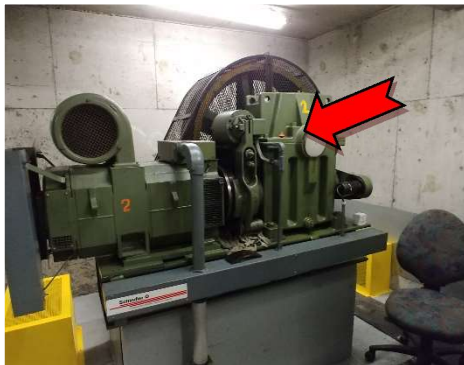
21. Interior, roof level, lift motor room - assumed asbestos-containing friction pads

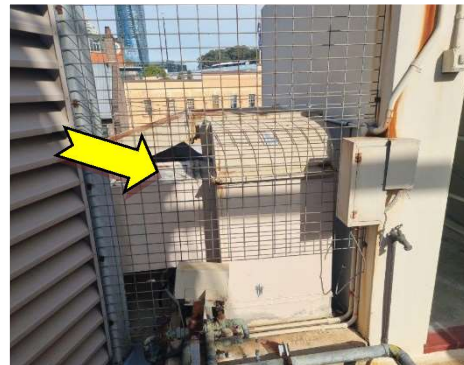
22. Exterior, roof level, throughout, rigid ductwork – suspected SMF-containing internal insulation material

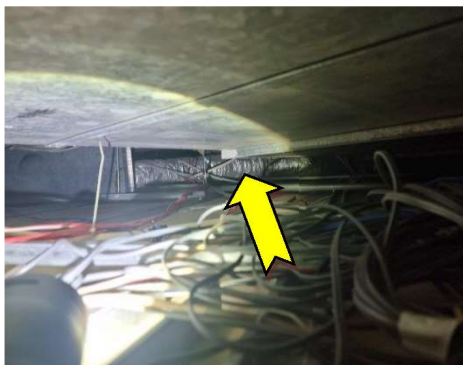
23. Interior, level 6, ceiling space, flexible ductwork – suspected SMF-containing internal insulation material

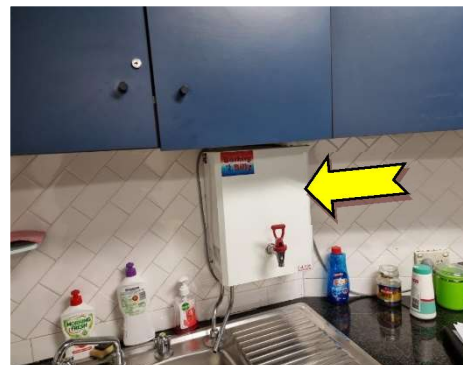
24. Interior, level 6, Harrington Lawyers tenancy, kitchen, hot water boiler – suspected SMF-containing internal insulation

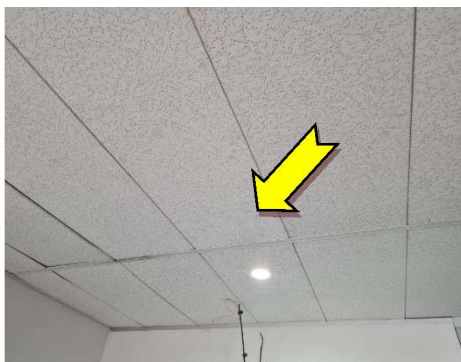
25. Interior, level 5, eastern elevation, throughout Invast Global tenancy, ceiling – suspected SMF-containing compressed ceiling tiles

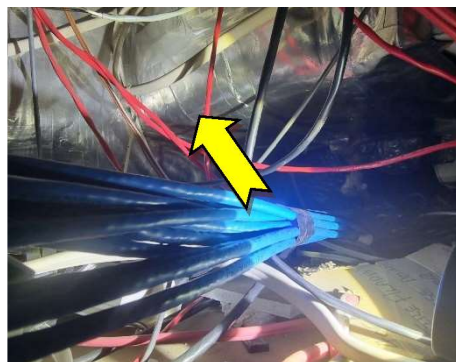
26. Interior, level 5, eastern elevation, Invast Global tenancy, lunchroom, ceiling space, roof – suspected SMF-containing sarking insulation

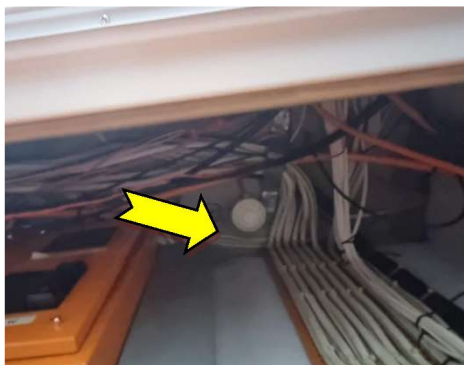
27. Interior, level 4, electrical cupboard, ceiling and floor penetrations, pillow insulation – suspected SMF-containing insulation material

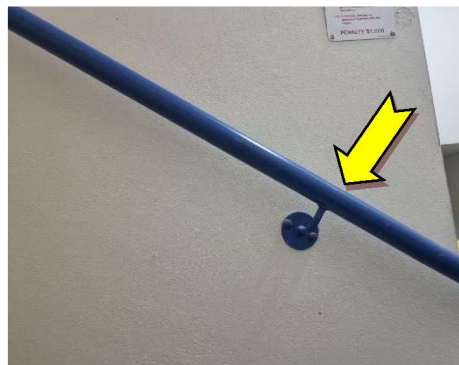
28. Interior, level 2, northern elevation fire stairs, handrail – lead-containing blue upper paint system

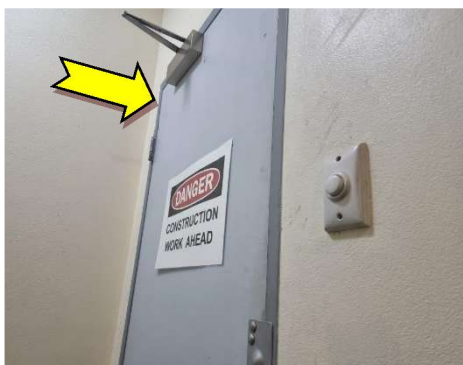
29. Interior, level 2, throughout, fire doors, door frames – lead-containing blue (light) upper paint system

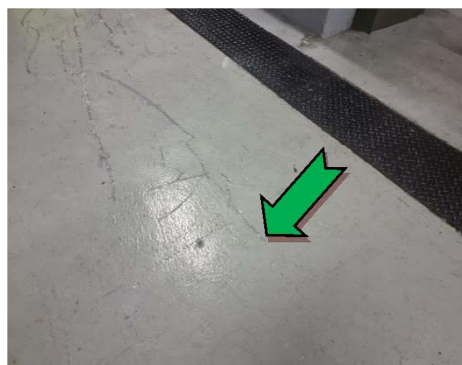
30. Interior, roof level, lift motor room, floor – non lead-containing grey upper paint system

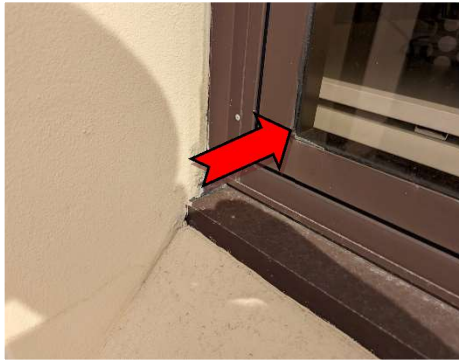
1. Exterior, level 2, eastern elevation, windows – asbestos-containing mastic material

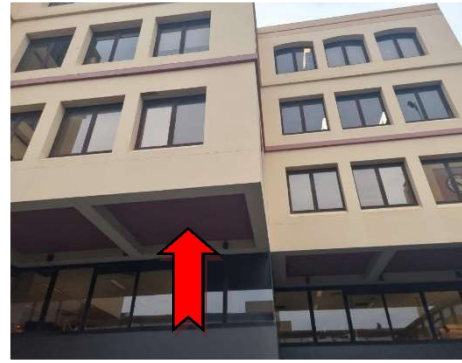
2. Exterior, level 2, courtyard soffit to level 3 offices – assumed asbestos-containing fibre cement sheeting

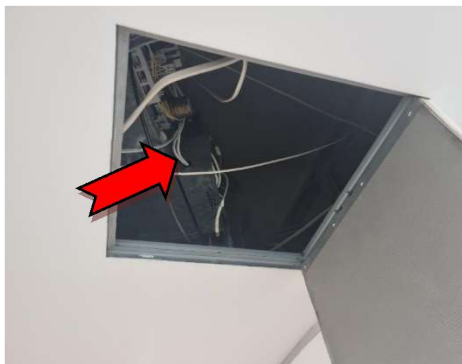
3. Interior, level 6, within ceiling space, air handling unit, heaterbank – assumed asbestos-containing millboard insulation

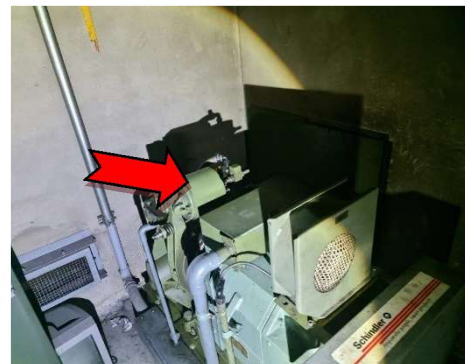
4. Interior, lower B2 level, lift motor room 3, lift motor breaks – assumed asbestos-containing friction pads

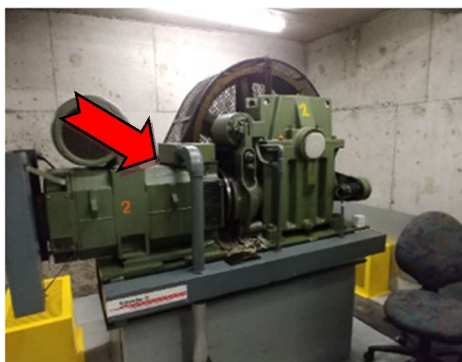
5. Interior, roof level, lift motor room, lift motor breaks – assumed asbestos-containing friction pads

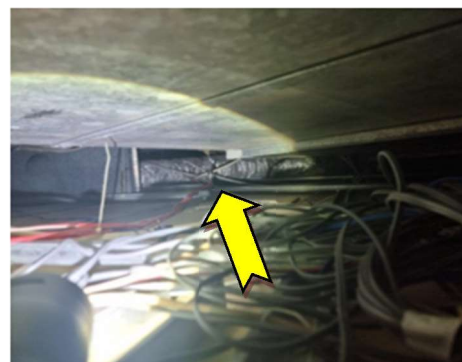
6. Interior, level 6, ceiling space, flexible ductwork – suspected SMF-containing internal insulation material

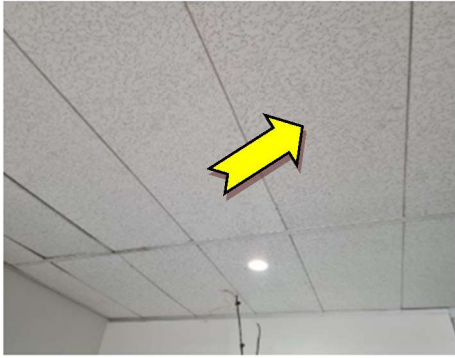
7. Interior, level 5, eastern elevation, throughout Invast Global tenancy, ceiling – suspected SMF-containing compressed ceiling tiles

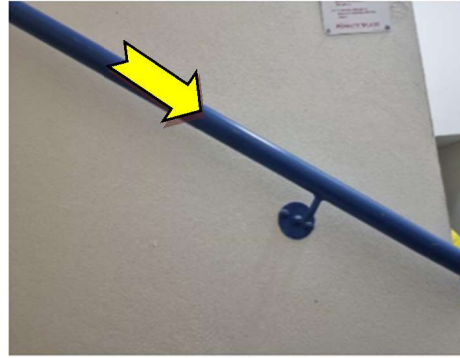
8. Interior, level 2, northern elevation fire stairs, handrail – lead-containing blue upper paint system

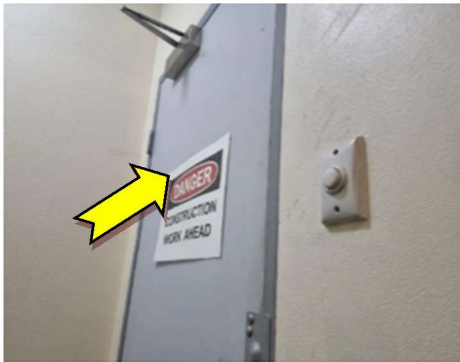
9. Interior, level 2, throughout, fire doors, door frames – lead-containing blue (light) upper paint system
