Manildra – Port Kembla Bulk Liquid Terminal

# Remedial Action Plan

Reference No. 30013038-R02 Prepared for Manildra Group Pty Ltc 27 May 2022

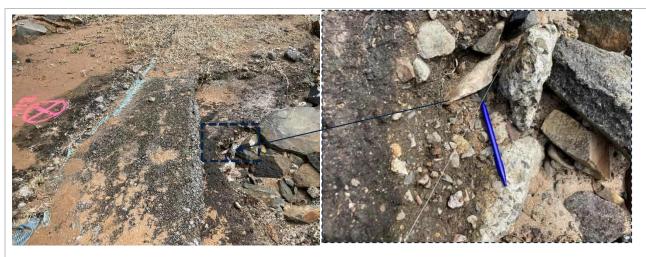
Photo 2-19 Example of ACM fragment observed protruding from eroded embankment wall near BH08 (Chainage 80m)
