Report on  
Geotechnical Investigation

Taronga Wildlife Hospital, Sydney

Project 99931.00  
August 2022

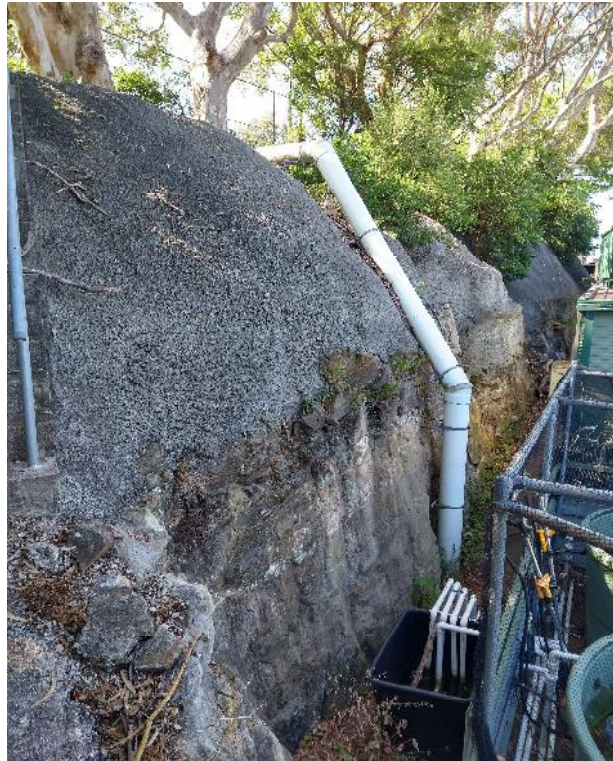
Photo 1 - Towards the north, looking south

An inspection of the existing shotcrete and rockface to the west of the gatehouse was also undertaken. No obvious defects in the shotcrete were observed. Photographs of the shotcrete are presented in Appendix D.
