ADINA CENTRAL, 2 LEE STREET, HAYMARKET - SCHEDULE OF CONSERVATION WORKS (INTERIOR ONLY)

RESULTS OF THE SITE INSPECTION

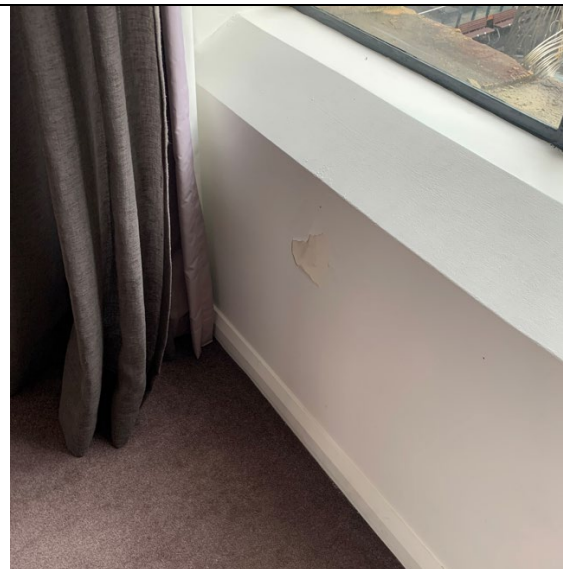
Figure 1 – Minor paint peeling noted in Unit 10 (Level 1)

- Cracking and peeling paint and the minor presence of mould throughout are assumed to be predominantly addressed in conjunction with the removal of all existing internal fit out and subsequent redevelopment of the building internally. Following rectification of any structural issues and external conservation issues, the interior faces of all external walls are to be inspected and paint patched throughout in approved colours as required.

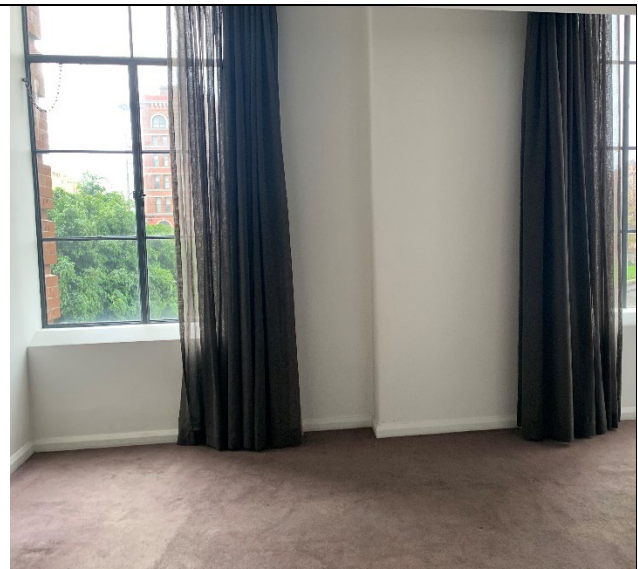
Figure 2 – General condition of original structural fabric as noted in Unit 10 (Level 1).

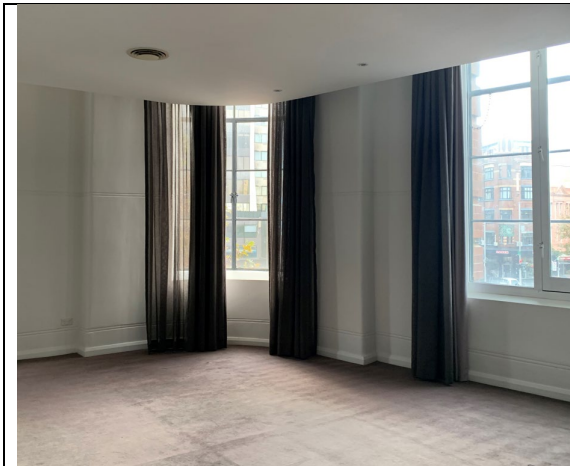
Figure 3 - General condition of original structural fabric as noted in Unit 6 (Level 1).

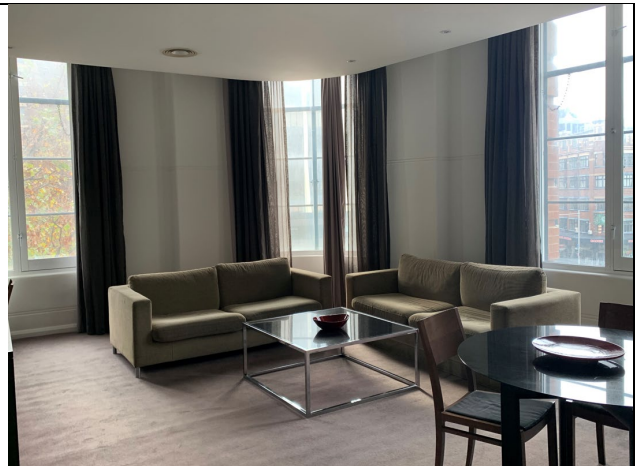
Figure 4 - General condition of original structural fabric as noted in Unit 19 (Level 2).

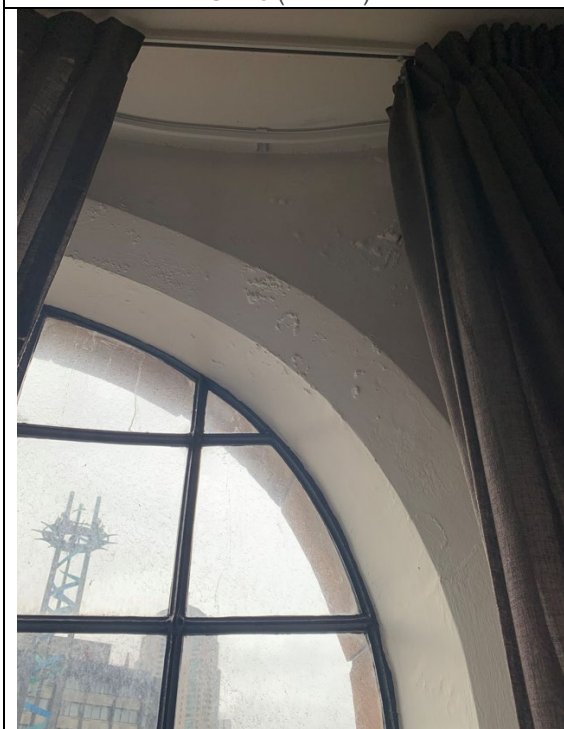
Figure 5 – Detail view to minor paint bubbling to window interior within Unit 38 (Level 3).

- Bubbling paint indicates potential damp near ceiling height at Level 3 as pictured above. Paint to the area to be carefully removed from a minimum area of 2000mm around visible evidence of damp. Where further evidence of damp is in exposed areas remove paint from an additional surrounding 1000mm.HC to inspect with suitably qualified engineer to diagnose cause of damp, extent of damage to plaster and masonry, and appropriate further action. Following completion of all remediation/conservation works to area, allow to refinish in a method agreed with HC TMO.

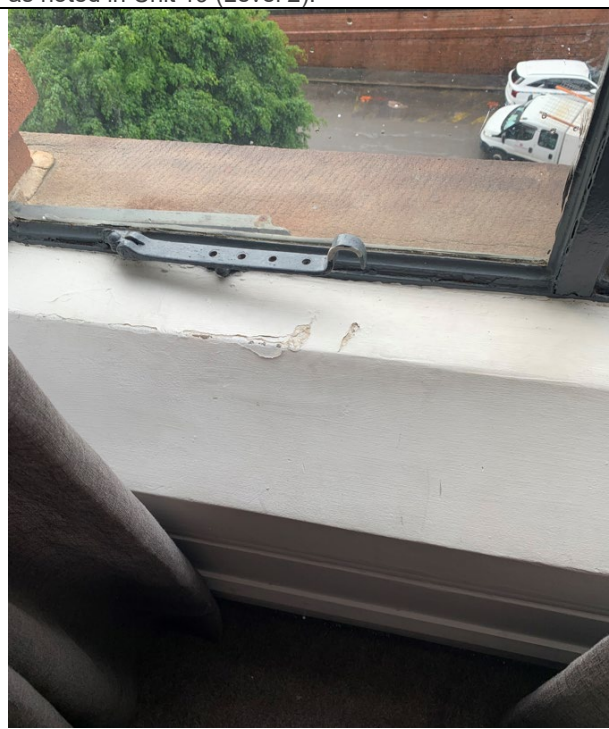
Figure 6 – Detail view to minor paint flaking and peeling to window interior within Unit 42 (Level 3).

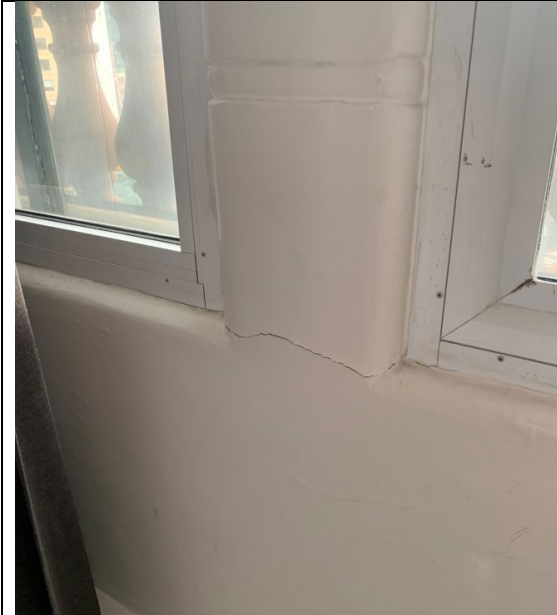
Figure 7 – Detail view to minor paint cracking to original fabric wall in Unit 62 (Level 4).

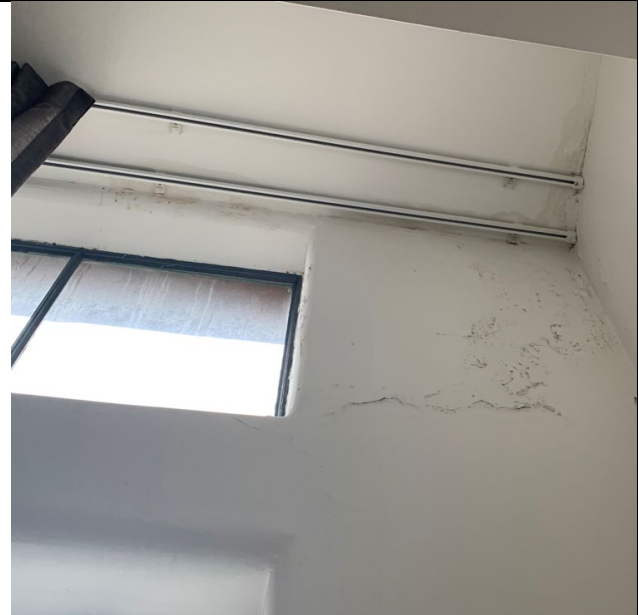
Figure 8 – Detail view to minor water damage and mould within Unit 73 (Level 5).

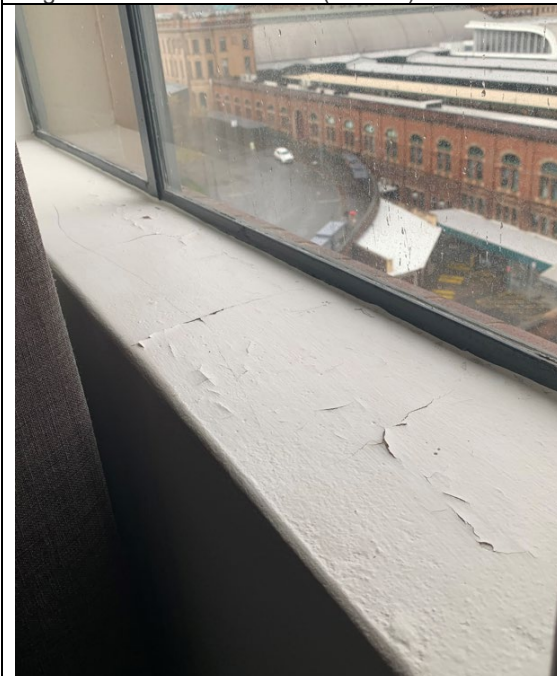
Figure 9 – Detail view to minor paint flaking to window interior within Unit 77 (Level 5).

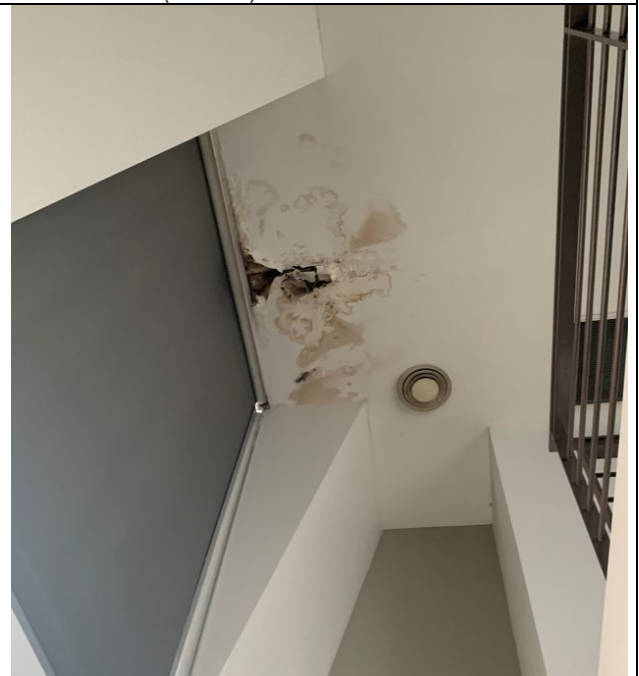
Figure 10 – Detail view to water damage to later addition fabric within Unit 90 (Level 6).
