# HAZARDOUS BUILDING MATERIALS SURVEY REPORT

27 Tiral Street  
Charlestown NSW 2290

SLR Ref No: 610.30773.00000  
Version No: v2.0  
August 2022  
March 2022

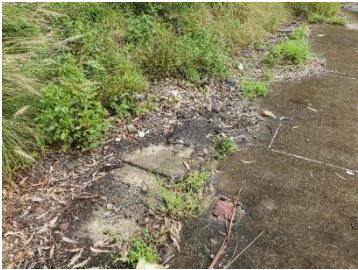
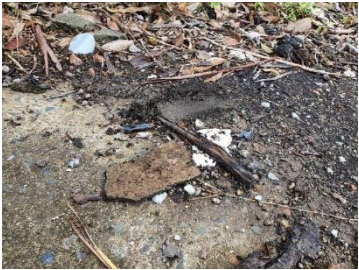
| <b>Location:</b> | 27 Trial Street, External Southern and Western aspects | <b>Material Application</b> | Fibre Cement Debris, Fibrous Cement | <b>Extent:</b> | <1 m <sup>2</sup> | <b>Sample Number</b> | AS01 |
| <b>Main Photo</b> | | <b>Close Up Photo</b> | | <b>Product Type</b> | Asbestos reinforced composites etc. (1) | <b>Material Score</b> | |
| | | | | <b>Condition</b> | Poor (2) | 7 | |
| | | | | <b>Surface Treatment</b> | Unsealed (3) | Risk | |
| | | | | <b>Asbestos Type</b> | Chrysotile (1) | Medium | |

| | | | | <b>Recommendation:</b> | Remove | | |

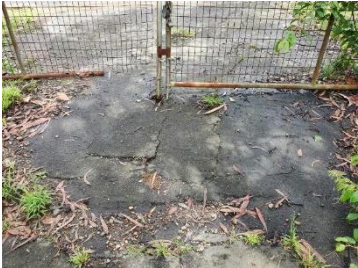
| <b>Location:</b> | 27 Trial Street, External Southern entrance gate | <b>Material Application</b> | Fibre Cement Debris to ground surface, Fibrous Cement | <b>Extent:</b> | <1 m <sup>2</sup> | <b>Sample Number</b> | AS03 |
| <b>Main Photo</b> | | <b>Close Up Photo</b> | | <b>Product Type</b> | Asbestos reinforced composites etc. (1) | <b>Material Score</b> | |
| | | | | <b>Condition</b> | Poor (2) | 7 | |
| | | | | <b>Surface Treatment</b> | Unsealed (3) | Risk | |
| | | | | <b>Asbestos Type</b> | Chrysotile (1) | Medium | |

| | | | | <b>Recommendation:</b> | Remove | | |
