Gruner TH

Hazardous Building Materials Survey

12 Hassall Street,  
Parramatta, NSW

8 October 2021

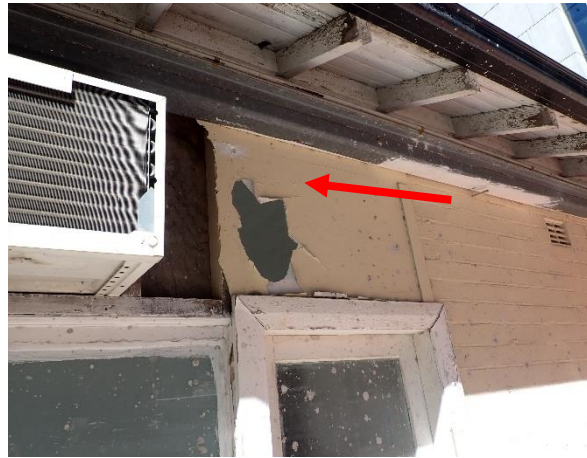
- Asbestos containing fibre cement infill panel (A-01) was identified above the external kitchen door. There was damage observed to the infill panel with debris observed on the adjacent external ground surface and internal floor of the kitchen.

| JBS&G<br>SAMPLE NO. | LOCATION | MATERIAL DESCRIPTION | PHOTO<br>NUMBER | ACCESSIBLE<br>AREA? | FRIABILITY | ANALYTICAL RESULT | MATERIAL<br>CONDITION | APPROX.<br>QUANTITY | ACTION REQUIRED | DATE OF LAST<br>INSPECTION (INCL.<br>COMPANY NAME<br>AND INITIALS) | DATE OF CONTROL<br>ACTION &/OR<br>REMOVAL |
|---|---|---|---|---|---|---|---|---|---|---|---|
| A-01 | External, infill panel<br>above kitchen door | Fibre cement sheeting | 2 | Yes | Non-Friable | <b>Chrysotile Asbestos</b> | Poor | 2 m <sup>2</sup> | Remove prior to demolition. Works<br>to be completed under controlled<br>conditions by Class A or B licensed<br>removal contractor in accordance<br>with SWNSW 2019a | 28/9/2021<br>JBS&G<br>SL | |

Photo 2: Residence – asbestos containing fibre cement infill panel above external kitchen door

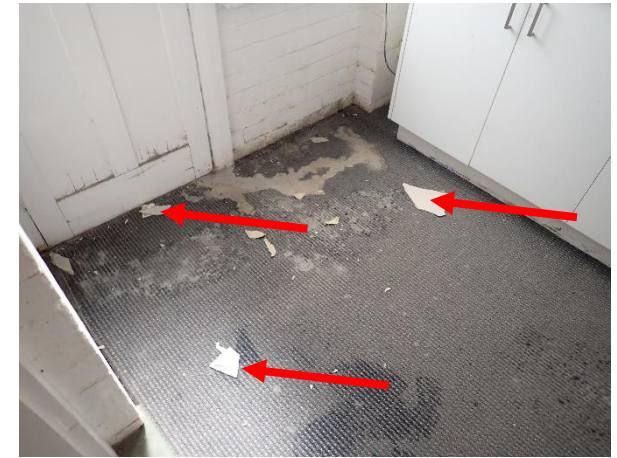
| JBS&G<br>SAMPLE NO. | LOCATION | MATERIAL DESCRIPTION | PHOTO<br>NUMBER | ACCESSIBLE<br>AREA? | FRIABILITY | ANALYTICAL RESULT | MATERIAL<br>CONDITION | APPROX.<br>QUANTITY | ACTION REQUIRED | DATE OF LAST<br>INSPECTION (INCL.<br>COMPANY NAME<br>AND INITIALS) | DATE OF CONTROL<br>ACTION &/OR<br>REMOVAL |
|---|---|---|---|---|---|---|---|---|---|---|---|
| As per<br>A-01- | Kitchen, floor | Fibre cement debris | 3 | Yes | Non-Friable | <b>Assumed Asbestos</b> | Poor | < 1 m <sup>2</sup> | Remove prior to demolition. Works<br>to be completed under controlled<br>conditions by Class A or B licensed<br>removal contractor in accordance<br>with SWNSW 2019a | 28/9/2021<br>JBS&G<br>SL | |

Photo 3: Residence – asbestos containing fibre cement debris on the floor of the kitchen

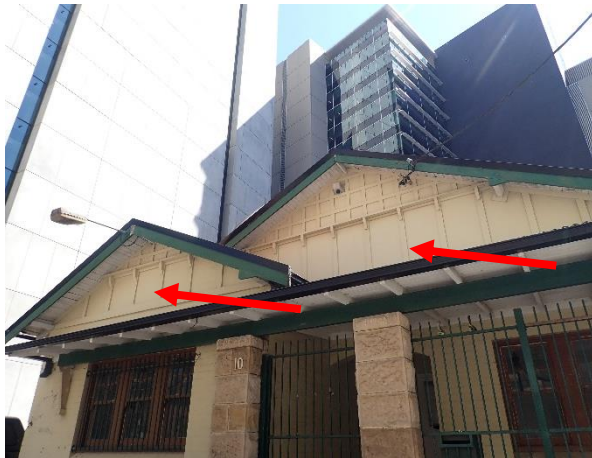
- Non-asbestos containing red vinyl flooring (A-02) was identified to the northwest store room.
- Assumed asbestos containing fibre cement sheeting was identified to the south gable panelling. A sample was unable to be collected due to height safety hazards.

| JBS&G<br>SAMPLE NO. | LOCATION | MATERIAL DESCRIPTION | PHOTO<br>NUMBER | ACCESSIBLE<br>AREA? | FRIABILITY | ANALYTICAL RESULT | MATERIAL<br>CONDITION | APPROX.<br>QUANTITY | ACTION REQUIRED | DATE OF LAST<br>INSPECTION (INCL.<br>COMPANY NAME<br>AND INITIALS) | DATE OF CONTROL<br>ACTION &/OR<br>REMOVAL |
|---|---|---|---|---|---|---|---|---|---|---|---|
| - | External, south gables | Fibre cement sheeting | 4 | Yes | Non-Friable | <b>Assumed Asbestos</b> | Good | 30 m <sup>2</sup> | Remove prior to demolition. Works<br>to be completed under controlled<br>conditions by Class A or B licensed<br>removal contractor in accordance<br>with SWNSW 2019a | 28/9/2021<br>JBS&G<br>SL | |

Photo 4: Residence – assumed asbestos containing fibre cement sheeting to the south gable panels

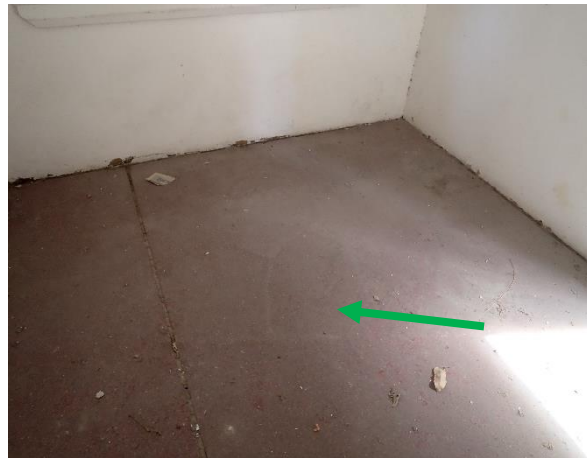
Photo 5: Residence – non-asbestos containing red vinyl flooring to the northwest room

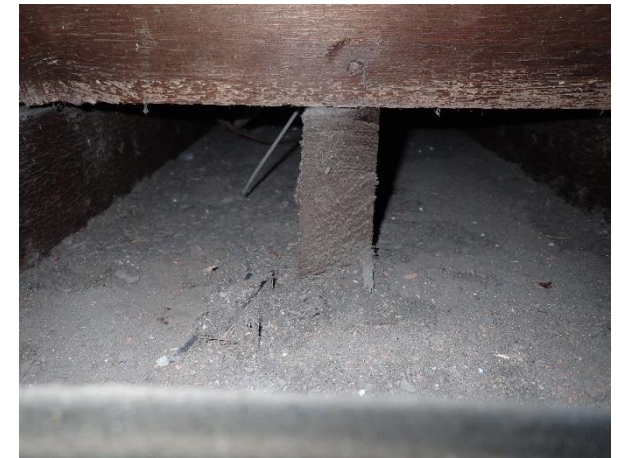
- Elevated lead concentrations within settled dust above the adopted site criteria (LD-01, 1700 mg/kg) was identified within the ceiling cavity. This dust was also found not to contain asbestos.

| JBS&G<br>SAMPLE NO. | LOCATION | MATERIAL DESCRIPTION | PHOTO<br>NUMBER | ACCESSIBLE<br>AREA? | FRIABILITY | ANALYTICAL RESULT | MATERIAL<br>CONDITION | APPROX.<br>QUANTITY | ACTION REQUIRED | DATE OF LAST<br>INSPECTION (INCL.<br>COMPANY NAME<br>AND INITIALS) | DATE OF CONTROL<br>ACTION &/OR<br>REMOVAL |
|---|---|---|---|---|---|---|---|---|---|---|---|
| LD-01 | Ceiling cavity | Settled dust | 6 | Yes | - | <b>1700 mg/kg</b> | Poor | 130 m <sup>2</sup> | Remove prior to demolition by an<br>experience hazardous materials<br>removal contractor in accordance<br>with AS4361.2-2017. | 28/9/2021<br>JBS&G<br>SL | |

Photo 6: Residence – lead containing dust within the ceiling cavity

Elevated levels of lead in dust above the adopted site criteria was identified within the Residence ceiling cavity. A suitably experienced hazardous materials removal contractor should be engaged to

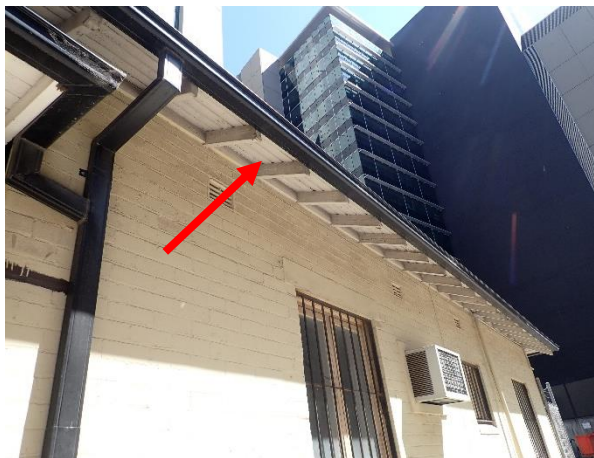
| JBS&G<br>SAMPLE NO. | LOCATION | MATERIAL DESCRIPTION | PHOTO<br>NUMBER | ACCESSIBLE<br>AREA? | FRIABILITY | ANALYTICAL RESULT | MATERIAL<br>CONDITION | APPROX.<br>QUANTITY | ACTION REQUIRED | DATE OF LAST<br>INSPECTION (INCL.<br>COMPANY NAME<br>AND INITIALS) | DATE OF CONTROL<br>ACTION &/OR<br>REMOVAL |
|---|---|---|---|---|---|---|---|---|---|---|---|
| LP-02 | External timber features<br>(eaves, soffits, north<br>kitchen door) | White paint | 7 | Yes | - | <b>Lead Based Paint<br/>(38% w/w)</b> | Poor | 50 m <sup>2</sup> | Remove loose and flaking paint prior<br>to demolition by an experienced<br>hazardous materials removal<br>contractor in accordance with<br>AS4361.2-2017. Remaining paint well<br>adhered to the building materials<br>may be demolished if care is taken<br>not to spread paint flakes to<br>surrounding areas.<br>Alternatively, remove all paint prior<br>to demolition by an experienced<br>hazardous materials removal<br>contractor in accordance with<br>AS4361.2-2017. | 28/9/2021<br>JBS&G<br>SL | |

Photo 7: Residence – lead based white paint to the timber eaves & soffits

The lead based paints, as identified in Hazardous Materials Register (**Appendix A**) should be managed in accordance with the AS4361.2-2017. Where peeling or deteriorated they should be removed under controlled conditions by an experienced contractor prior to demolition. Stable lead based paints adhered to building fabric can be disposed as general solid waste in accordance with NSW EPA 2014 provided care is taken to minimise any potential for paint flakes to be dispersed onto ground surfaces and building and demolition waste is not proposed to be recycled.

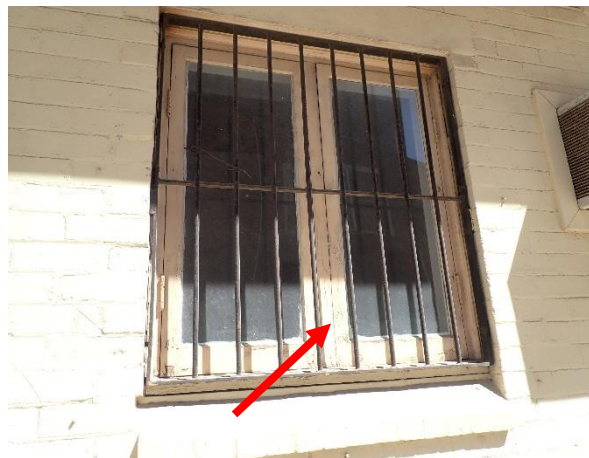
| JBS&G<br>SAMPLE NO. | LOCATION | MATERIAL DESCRIPTION | PHOTO<br>NUMBER | ACCESSIBLE<br>AREA? | FRIABILITY | ANALYTICAL RESULT | MATERIAL<br>CONDITION | APPROX.<br>QUANTITY | ACTION REQUIRED | DATE OF LAST<br>INSPECTION (INCL.<br>COMPANY NAME<br>AND INITIALS) | DATE OF CONTROL<br>ACTION &/OR<br>REMOVAL |
|---|---|---|---|---|---|---|---|---|---|---|---|
| LP-03 | External timber windows | Brown/cream paint | 8 | Yes | - | <b>Lead Based Paint<br/>(14% w/w)</b> | Poor | 20 m <sup>2</sup> | Remove loose and flaking paint prior<br>to demolition by an experienced<br>hazardous materials removal<br>contractor in accordance with<br>AS4361.2-2017. Remaining paint well<br>adhered to the building materials<br>may be demolished if care is taken<br>not to spread paint flakes to<br>surrounding areas.<br>Alternatively, remove all paint prior<br>to demolition by an experienced<br>hazardous materials removal<br>contractor in accordance with<br>AS4361.2-2017. | 28/9/2021<br>JBS&G<br>SL | |

Photo 8: Residence – lead based brown/cream paint to the external timber windows

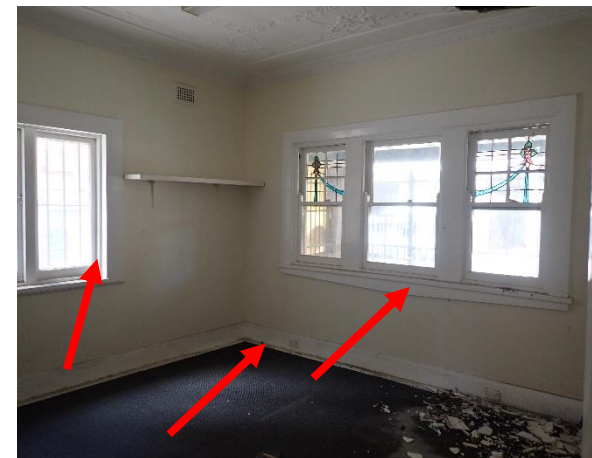
| JBS&G<br>SAMPLE NO. | LOCATION | MATERIAL DESCRIPTION | PHOTO<br>NUMBER | ACCESSIBLE<br>AREA? | FRIABILITY | ANALYTICAL RESULT | MATERIAL<br>CONDITION | APPROX.<br>QUANTITY | ACTION REQUIRED | DATE OF LAST<br>INSPECTION (INCL.<br>COMPANY NAME<br>AND INITIALS) | DATE OF CONTROL<br>ACTION &/OR<br>REMOVAL |
|---|---|---|---|---|---|---|---|---|---|---|---|
| LP-04 | Internal timber features<br>(skirting boards,<br>architraves, doors and<br>windows) | White paint | 9 | Yes | - | <b>Lead Based Paint<br/>(0.17% w/w)</b> | Fair | 100 m <sup>2</sup> | Remove loose and flaking paint prior<br>to demolition by an experienced<br>hazardous materials removal<br>contractor in accordance with<br>AS4361.2-2017. Remaining paint well<br>adhered to the building materials<br>may be demolished if care is taken<br>not to spread paint flakes to<br>surrounding areas.<br>Alternatively, remove all paint prior<br>to demolition by an experienced<br>hazardous materials removal<br>contractor in accordance with<br>AS4361.2-2017. | 28/9/2021<br>JBS&G<br>SL | |

Photo 9: Residence – lead based white paint to the internal timber skirting boards, architraves and windows

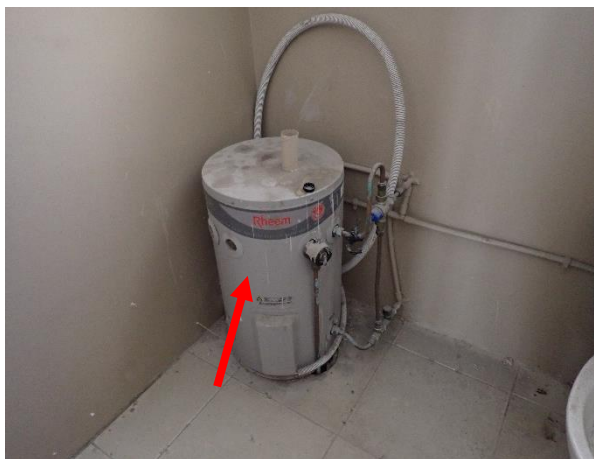
Photo 10: Residence – assumed internal SMF insulation to the hot water system in the bathroom

The identified SMF materials can be removed with the building and demolition waste with care taken not to generate fibres. Appropriate PPE is recommended including the use of P2 respirator as minimum and appropriate removal methodology as outlined in [NOHSC: 1004(1990)] and [NOHSC: 2006(1990)].

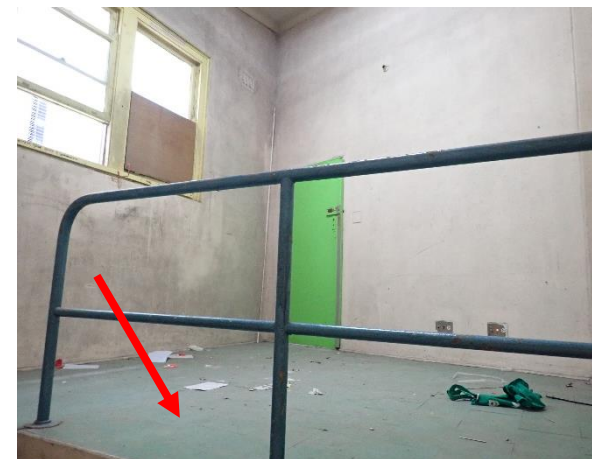
| JBS&G<br>SAMPLE NO. | LOCATION | MATERIAL DESCRIPTION | PHOTO<br>NUMBER | ACCESSIBLE<br>AREA? | FRIABILITY | ANALYTICAL RESULT | MATERIAL<br>CONDITION | APPROX.<br>QUANTITY | ACTION REQUIRED | DATE OF LAST<br>INSPECTION (INCL.<br>COMPANY NAME<br>AND INITIALS) | DATE OF CONTROL<br>ACTION &/OR<br>REMOVAL |
|---|---|---|---|---|---|---|---|---|---|---|---|
| A-04 | Northwest portion,<br>northwest store room<br>adjacent stage, floor | Green vinyl tiles | 12 | Yes | Non-Friable | <b>Chrysotile Asbestos</b> | Fair | 15 m <sup>2</sup> | Remove prior to demolition. Works<br>to be completed under controlled<br>conditions by Class A or B licensed<br>removal contractor in accordance<br>with SWNSW 2019a | 28/9/2021<br>JBS&G<br>SL | |

Photo 12: PCYC – asbestos containing green vinyl floor tiles to the northwest store room in the northwest portion

- A Class A or B licensed asbestos removalist shall be engaged to remove all asbestos containing materials as identified in the Hazardous Materials Register (**Appendix A**). Removal of non-friable asbestos materials shall be undertaken in accordance with the *Work Health and Safety Act (2011)*, *Work Health and Safety Regulation (2017)* and *SWNSW 2019a*. An asbestos removal control plan is to be developed by the engaged licensed asbestos removalist prior to the removal works outlining the specific control measures necessary to minimise any risk from exposure to asbestos.

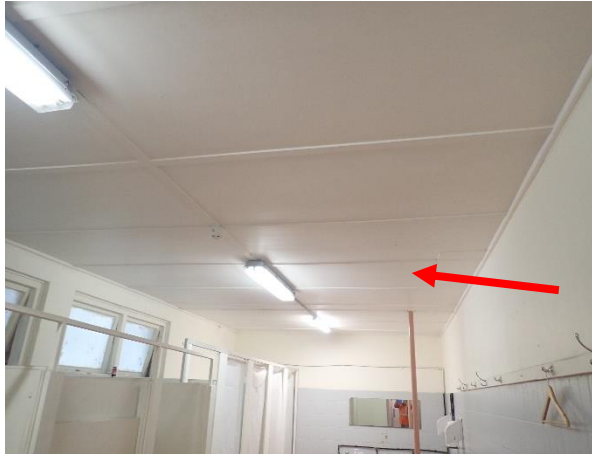
| JBS&G<br>SAMPLE NO. | LOCATION | MATERIAL DESCRIPTION | PHOTO<br>NUMBER | ACCESSIBLE<br>AREA? | FRIABILITY | ANALYTICAL RESULT | MATERIAL<br>CONDITION | APPROX.<br>QUANTITY | ACTION REQUIRED | DATE OF LAST<br>INSPECTION (INCL.<br>COMPANY NAME<br>AND INITIALS) | DATE OF CONTROL<br>ACTION &/OR<br>REMOVAL |
|---|---|---|---|---|---|---|---|---|---|---|---|
| A-06 | Northeast portion, male<br>toilets and change room,<br>ceiling | Fibre cement sheeting | 13 | Yes | Non-Friable | <b>Chrysotile Asbestos</b> | Good | 50 m <sup>2</sup> | Remove prior to demolition. Works<br>to be completed under controlled<br>conditions by Class A or B licensed<br>removal contractor in accordance<br>with SWNSW 2019a | 28/9/2021<br>JBS&G<br>SL | |

Photo 13: PCYC – asbestos containing fibre cement sheeting to the ceiling of the male toilets in the northeast portion

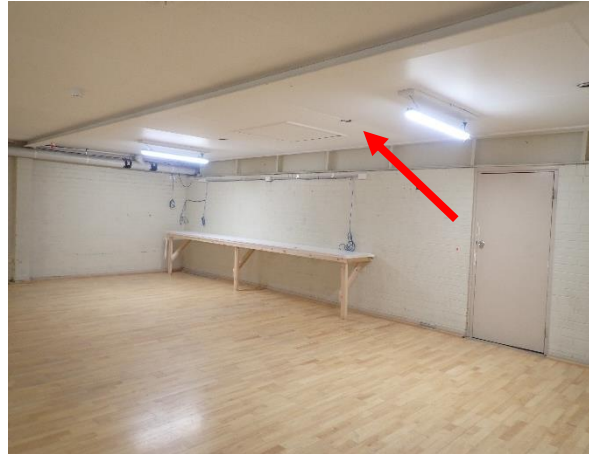
| JBS&G<br>SAMPLE NO. | LOCATION | MATERIAL DESCRIPTION | PHOTO<br>NUMBER | ACCESSIBLE<br>AREA? | FRIABILITY | ANALYTICAL RESULT | MATERIAL<br>CONDITION | APPROX.<br>QUANTITY | ACTION REQUIRED | DATE OF LAST<br>INSPECTION (INCL.<br>COMPANY NAME<br>AND INITIALS) | DATE OF CONTROL<br>ACTION &/OR<br>REMOVAL |
|---|---|---|---|---|---|---|---|---|---|---|---|
| A-08 | Northeast portion,<br>offices, ceiling | Fibre cement sheeting | 14 | Yes | Non-Friable | <b>Chrysotile Asbestos</b> | Good | 100 m <sup>2</sup> | Remove prior to demolition. Works<br>to be completed under controlled<br>conditions by Class A or B licensed<br>removal contractor in accordance<br>with SWNSW 2019a | 28/9/2021<br>JBS&G<br>SL | |

Photo 14: PCYC – asbestos containing fibre cement sheeting to the offices in the northeast portion

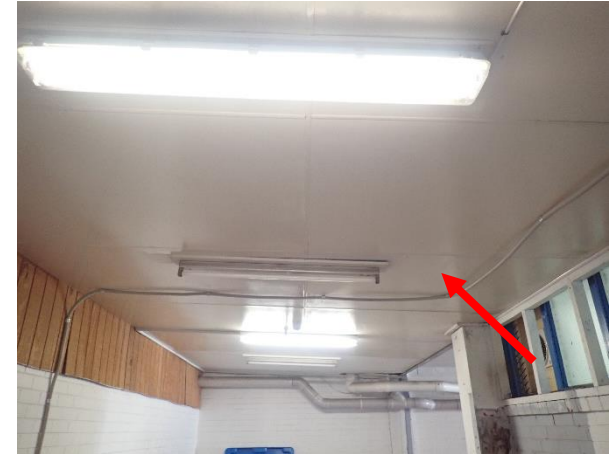
| JBS&G<br>SAMPLE NO. | LOCATION | MATERIAL DESCRIPTION | PHOTO<br>NUMBER | ACCESSIBLE<br>AREA? | FRIABILITY | ANALYTICAL RESULT | MATERIAL<br>CONDITION | APPROX.<br>QUANTITY | ACTION REQUIRED | DATE OF LAST<br>INSPECTION (INCL.<br>COMPANY NAME<br>AND INITIALS) | DATE OF CONTROL<br>ACTION &/OR<br>REMOVAL |
|---|---|---|---|---|---|---|---|---|---|---|---|
| A-09 | Garage, north ceiling | Fibre cement sheeting | 15 | Yes | Non-Friable | <b>Chrysotile Asbestos</b> | Fair | 20 m <sup>2</sup> | Remove prior to demolition. Works<br>to be completed under controlled<br>conditions by Class A or B licensed<br>removal contractor in accordance<br>with SWNSW 2019a | 28/9/2021<br>JBS&G<br>SL | |

Photo 15: PCYC – asbestos containing fibre cement sheeting to the north ceiling of the garage

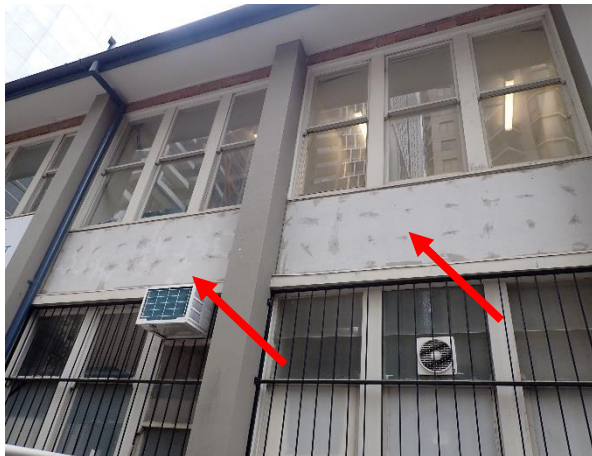
- Assumed asbestos containing fibre cement sheeting was identified to the southern spandrel panels, however, a representative sample was unable to be collected due to height safety hazards.

| JBS&G<br>SAMPLE NO. | LOCATION | MATERIAL DESCRIPTION | PHOTO<br>NUMBER | ACCESSIBLE<br>AREA? | FRIABILITY | ANALYTICAL RESULT | MATERIAL<br>CONDITION | APPROX.<br>QUANTITY | ACTION REQUIRED | DATE OF LAST<br>INSPECTION (INCL.<br>COMPANY NAME<br>AND INITIALS) | DATE OF CONTROL<br>ACTION &/OR<br>REMOVAL |
|---|---|---|---|---|---|---|---|---|---|---|---|
| - | External, south aspect,<br>spandrel panels | Fibre cement sheeting | 16 | Yes | Non-Friable | <b>Assumed Asbestos</b> | Fair | 20 m <sup>2</sup> | Remove prior to demolition. Works<br>to be completed under controlled<br>conditions by Class A or B licensed<br>removal contractor in accordance<br>with SWNSW 2019a | 28/9/2021<br>JBS&G<br>SL | |

Photo 16: PCYC – assumed asbestos containing fibre cement sheeting to the south spandrel panels

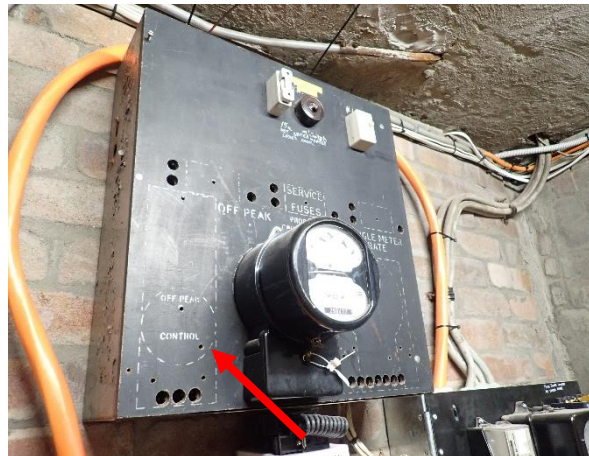
| JBS&G<br>SAMPLE NO. | LOCATION | MATERIAL DESCRIPTION | PHOTO<br>NUMBER | ACCESSIBLE<br>AREA? | FRIABILITY | ANALYTICAL RESULT | MATERIAL<br>CONDITION | APPROX.<br>QUANTITY | ACTION REQUIRED | DATE OF LAST<br>INSPECTION (INCL.<br>COMPANY NAME<br>AND INITIALS) | DATE OF CONTROL<br>ACTION &/OR<br>REMOVAL |
|---|---|---|---|---|---|---|---|---|---|---|---|
| - | Southern portion,<br>electrical room | Electrical backing boards<br>(x3) | 17 | Yes | Non-Friable | <b>Assumed Asbestos</b> | Fair | 3 m <sup>2</sup> | Remove prior to demolition. Works<br>to be completed under controlled<br>conditions by Class A or B licensed<br>removal contractor in accordance<br>with SWNSW 2019a | 28/9/2021<br>JBS&G<br>SL | |

Photo 17: PCYC – assumed asbestos containing electrical backing boards within the south portion electrical room

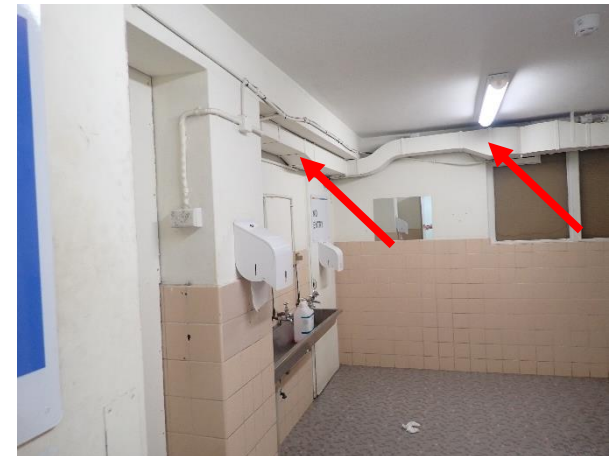
| JBS&G<br>SAMPLE NO. | LOCATION | MATERIAL DESCRIPTION | PHOTO<br>NUMBER | ACCESSIBLE<br>AREA? | FRIABILITY | ANALYTICAL RESULT | MATERIAL<br>CONDITION | APPROX.<br>QUANTITY | ACTION REQUIRED | DATE OF LAST<br>INSPECTION (INCL.<br>COMPANY NAME<br>AND INITIALS) | DATE OF CONTROL<br>ACTION &/OR<br>REMOVAL |
|---|---|---|---|---|---|---|---|---|---|---|---|
| - | Southern portion, air<br>conditioning ducting | Mastic | 18 | Yes | Non-Friable | <b>Assumed Asbestos</b> | Unknown | Unknown | Remove prior to demolition. Works<br>to be completed under controlled<br>conditions by Class A or B licensed<br>removal contractor in accordance<br>with SWNSW 2019a | 28/9/2021<br>JBS&G<br>SL | |

Photo 18: PCYC – assumed asbestos containing mastic to the air conditioning ducting within the south portion

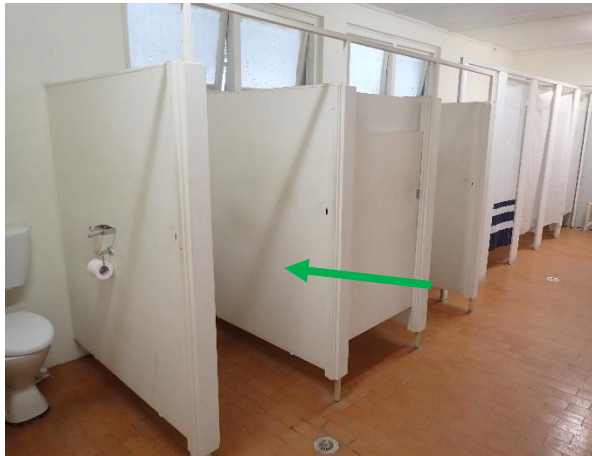
Photo 19: PCYC – non-asbestos containing compressed fibre cement cubicle partitions to the northeast male toilets

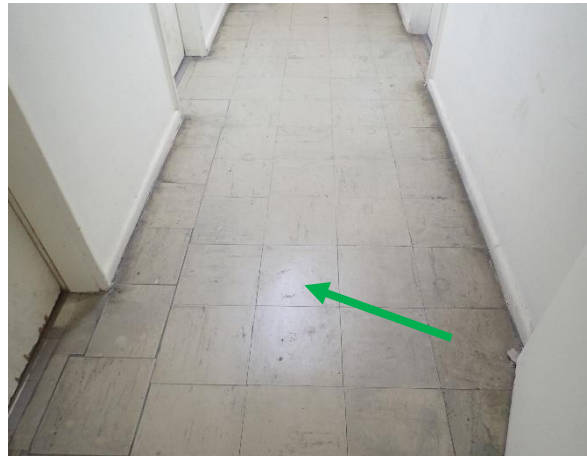
Photo 20: PCYC – non-asbestos containing white vinyl floor tiles to the amenities corridor in the south portion

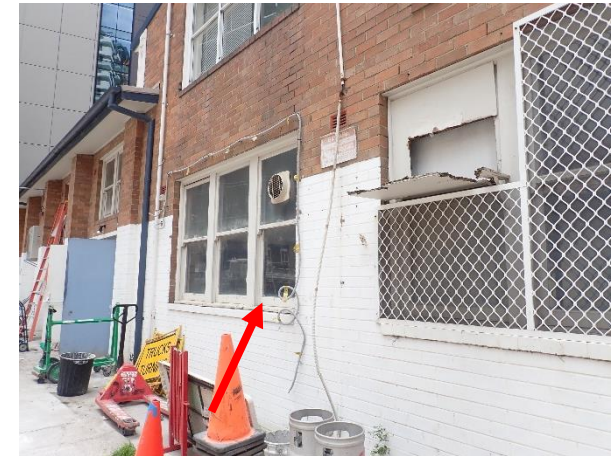
- Air conditioning ducting was observed throughout the southern portion and is assumed to contain asbestos containing mastics.
- Lead based cream paint (LP-06, 0.18% w/w) was identified to the external timber windows.

| JBS&G<br>SAMPLE NO. | LOCATION | MATERIAL DESCRIPTION | PHOTO<br>NUMBER | ACCESSIBLE<br>AREA? | FRIABILITY | ANALYTICAL RESULT | MATERIAL<br>CONDITION | APPROX.<br>QUANTITY | ACTION REQUIRED | DATE OF LAST<br>INSPECTION (INCL.<br>COMPANY NAME<br>AND INITIALS) | DATE OF CONTROL<br>ACTION &/OR<br>REMOVAL |
|---|---|---|---|---|---|---|---|---|---|---|---|
| LP-06 | External timber windows | Cream paint | 21 | Yes | - | <b>Lead Based Paint<br/>(0.18% w/w)</b> | Fair | 50 m <sup>2</sup> | Remove loose and flaking paint prior to demolition by an experienced hazardous materials removal contractor in accordance with AS4361.2-2017. Remaining paint well adhered to the building materials may be demolished if care is taken not to spread paint flakes to surrounding areas. Alternatively, remove all paint prior to demolition by an experienced hazardous materials removal contractor in accordance with AS4361.2-2017. | 28/9/2021<br>JBS&G<br>SL | |

Photo 21: PCYC – lead based cream paint to the external timber windows

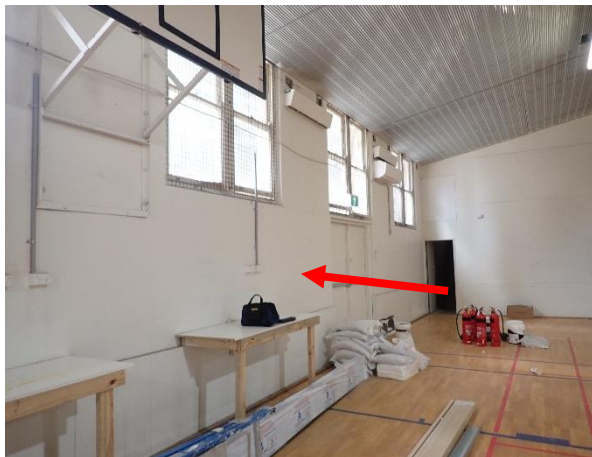
| JBS&G<br>SAMPLE NO. | LOCATION | MATERIAL DESCRIPTION | PHOTO<br>NUMBER | ACCESSIBLE<br>AREA? | FRIABILITY | ANALYTICAL RESULT | MATERIAL<br>CONDITION | APPROX.<br>QUANTITY | ACTION REQUIRED | DATE OF LAST<br>INSPECTION (INCL.<br>COMPANY NAME<br>AND INITIALS) | DATE OF CONTROL<br>ACTION &/OR<br>REMOVAL |
|---|---|---|---|---|---|---|---|---|---|---|---|
| LP-08 | Internal cement<br>rendered masonry walls | White paint | 22 | Yes | - | <b>Lead Based Paint<br/>(0.83% w/w)</b> | Fair | 300 m <sup>2</sup> | Remove loose and flaking paint prior to demolition by an experienced hazardous materials removal contractor in accordance with AS4361.2-2017. Remaining paint well adhered to the building materials may be demolished if care is taken not to spread paint flakes to surrounding areas. Alternatively, remove all paint prior to demolition by an experienced hazardous materials removal contractor in accordance with AS4361.2-2017. | 28/9/2021<br>JBS&G<br>SL | |

Photo 22: PCYC – lead based white paint to the internal cement rendered masonry walls

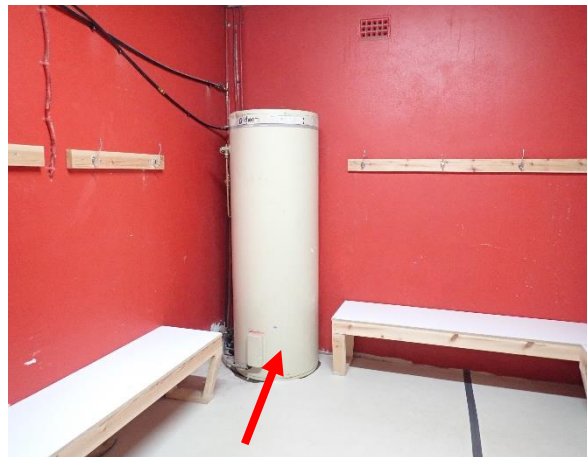
Photo 23: PCYC – assumed internal SMF insulation to the hot water system in the male change room

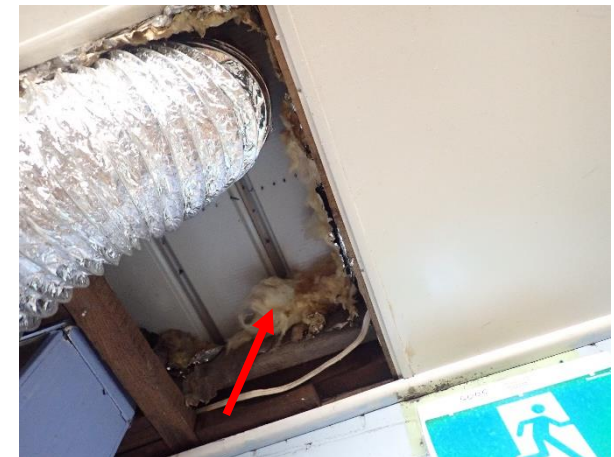
Photo 24: PCYC – assumed SMF insulation within the north ceiling cavity of the garage
