REPORT FOR GOODMAN PROPERTY
HAZARDOUS MATERIALS ASSESSMENT

AU130 1-3 Burrows Road, Alexandria NSW 2015

Our Ref: J008683-AU130

24 JANUARY 2022

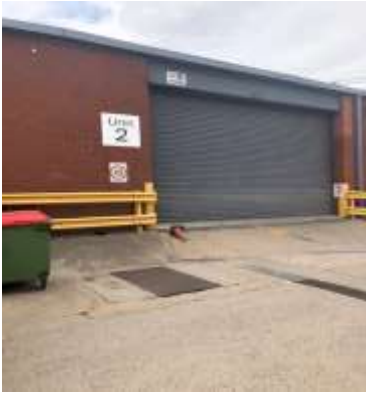
| Location | Photo | Photo |
|--|--|---|
| <p>Photo 1: Unit 2 Exterior</p> | <p>Photo 2 Unit 2-Showing white paint line-clean this level and below, 1 metre out on floor-before clean</p> | <p>Photo 3 Unit 2-Showing white paint line-clean this level and below, 1 metre out on floor-after clean</p> |

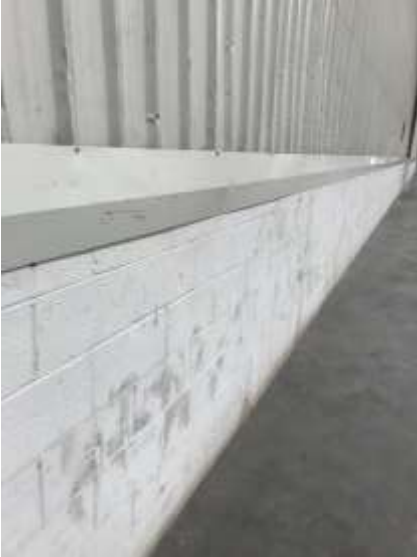
| Location | Photo | Photo |
|--|--|---|
| <p>Photo 4 Post clean</p> | <p>Photo 5: Unit 2 Showing typical column with typical interferences-clean 2 meters and below, 1 metre out on floor-before clean</p> | <p>Photo 6: Unit 2 Showing typical column with typical interferences-clean 2 meters and below, 1 metre out on floor-after clean</p> |

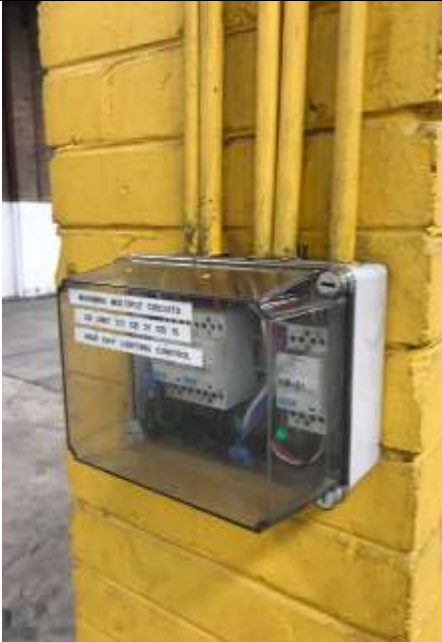
| Location | Photo | Photo |
|---|--|---|
| <p>Photo 7: Unit 2 Showing typical column with typical interferences -after clean</p> | <p>Photo 8: Unit 2 1 metre out on floor-after clean</p> | <p>Photo 9: Unit 2 Location of swab LD2</p> |

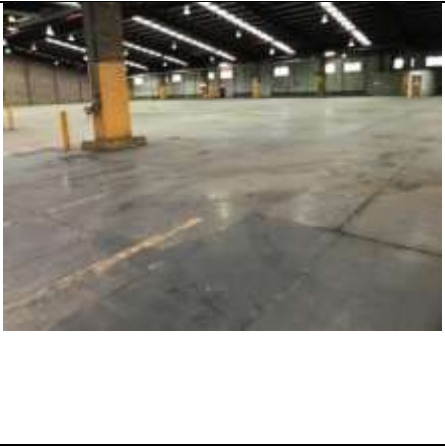
| Location | Photo | Photo |
|---|--|---|
| <p>Photo 10: Unit 3 Exterior</p> | <p>Photo 11: Unit 3 Showing typical columns and perimeter walls with typical interferences-clean 2 meters and below, 1 metre out on floor-before clean</p> | <p>Photo 12: Unit 3 Showing typical columns and perimeter walls with typical interferences-clean 2 meters and below, 1 metre out on floor-after clean</p> |

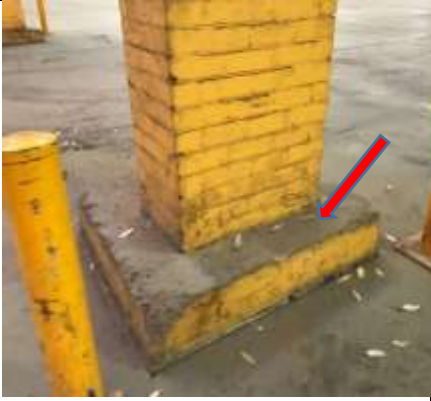
| Location | Photo | Photo |
|---|--|---|
| <p>Photo 13: Unit 3 Showing typical column -clean 2 meters and below, 1 metre out on floor</p> | <p>Photo 15: Unit 3 Showing typical interferences- surfaces clean 2 m and below-after clean</p> | <p>Photo 16: Unit 3 Office floor - clean 2 rooms per site visit-floor, window ledges only-before clean</p> |

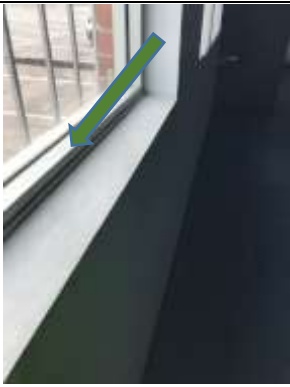
| Location | Photo | Photo |
|---|--|---|
| <p>Photo 17: Unit 3 Office floor - clean 2 rooms per site visit-floor, window ledges only-after clean</p> | <p>Photo 18: Unit 3 Level 1 - topside of beam/pipes before clean</p> | <p>Photo 19: Unit 3 Level 1 - topside of beam/pipes after clean</p> |

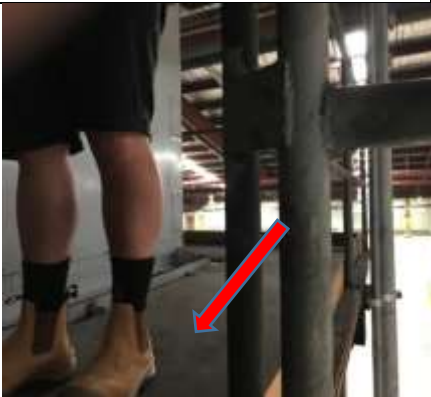
| Location | Photo | Photo |
|---|--|---|
| <p>Photo 17: Unit 3 Upper levels: typical equipment requiring surface cleaning- as far as reasonably practicable-before clean</p> | <p>Photo 18: Unit 3 Upper levels: typical equipment requiring surface cleaning- as far as reasonably practicable-after clean</p> | <p>Photo 19: Unit 3 Upper levels: typical equipment requiring surface cleaning- as far as reasonably practicable-before clean</p> |

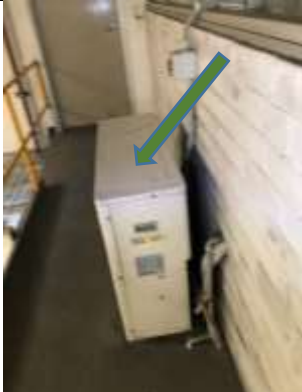
| Location | Photo | Photo |
|--|---|--|
| <p>Photo 20: Unit 3 Upper levels: typical equipment requiring surface cleaning- as far as reasonably practicable-after clean</p> | <p>Photo 21: Unit 3 Upper levels: typical equipment requiring surface cleaning- as far as reasonably practicable-before clean</p> | <p>Photo 22: Unit 3 Upper levels: typical equipment requiring surface cleaning- as far as reasonably practicable-after clean</p> |

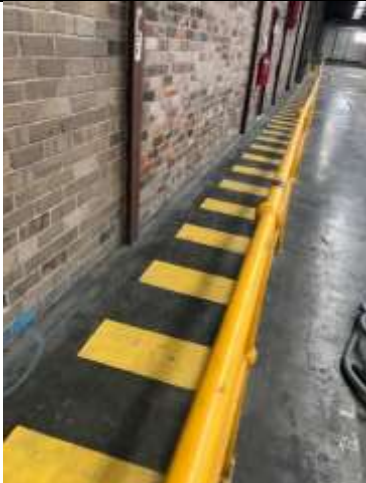
| Location | Photo | Photo |
|--|---|--|
| <p>Photo 23-Unit 3 perimeters after clean</p> | <p>Photo 24-Unit 3 columns after clean</p> | <p>Photo 23-Unit 3 LD1 sample</p> |
