Health Infrastructure NSW  
Hazardous Building Materials Survey  
Shoalhaven Community Pre-School and  
Nowra Recreation Park  
Shoalhaven Street, Nowra NSW

2 May 2022

62585/144,950 (Rev A)

JBS&G Australia Pty Ltd

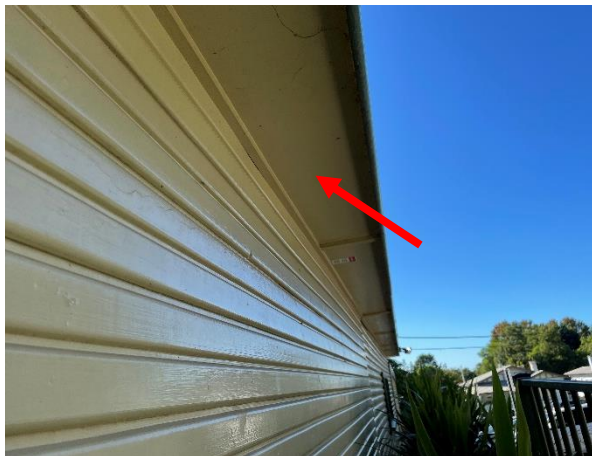
| JBS&G<br>SAMPLE NO. | LOCATION | MATERIAL DESCRIPTION | PHOTO<br>NUMBER | ACCESSIBLE<br>AREA? | FRIABILITY | ANALYTICAL RESULT | MATERIAL<br>CONDITION | APPROX.<br>QUANTITY | ACTION REQUIRED | DATE OF LAST<br>INSPECTION (INCL.<br>COMPANY NAME<br>AND INITIALS) | DATE OF CONTROL<br>ACTION &/OR<br>REMOVAL |
|---|---|---|---|---|---|---|---|---|---|---|---|
| A01 | Storage Shed, north, east and south aspect, eaves | Fibre cement sheeting | 4 | Yes | Non-Friable | <b>Chrysotile Asbestos</b> | Good | 20 m <sup>2</sup> | Remove prior to demolition. Works to be completed under controlled conditions by Class A or B licensed removal contractor in accordance with SWNSW 2019a | 11/4/2022<br>JBS&G<br>SL & RS | |

Photo 4: Storage Shed – asbestos containing fibre cement sheeting to the eaves

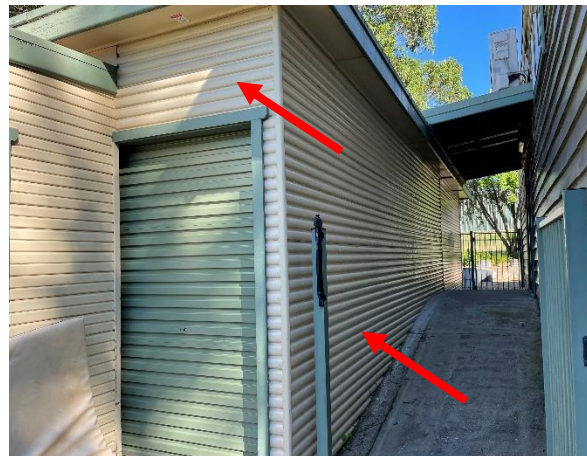
| JBS&G<br>SAMPLE NO. | LOCATION | MATERIAL DESCRIPTION | PHOTO<br>NUMBER | ACCESSIBLE<br>AREA? | FRIABILITY | ANALYTICAL RESULT | MATERIAL<br>CONDITION | APPROX.<br>QUANTITY | ACTION REQUIRED | DATE OF LAST<br>INSPECTION (INCL.<br>COMPANY NAME<br>AND INITIALS) | DATE OF CONTROL<br>ACTION &/OR<br>REMOVAL |
|---|---|---|---|---|---|---|---|---|---|---|---|
| A02 | Storage Shed, eastern half, north, east and south external wall cladding | Fibre cement sheeting | 5 | Yes | Non-Friable | <b>Chrysotile and Crocidolite Asbestos</b> | Good | 35 m <sup>2</sup> | Remove prior to demolition. Works to be completed under controlled conditions by Class A or B licensed removal contractor in accordance with SWNSW 2019a | 11/4/2022<br>JBS&G<br>SL & RS | |

Photo 5: Storage Shed – asbestos containing fibre cement sheeting to the external cladding

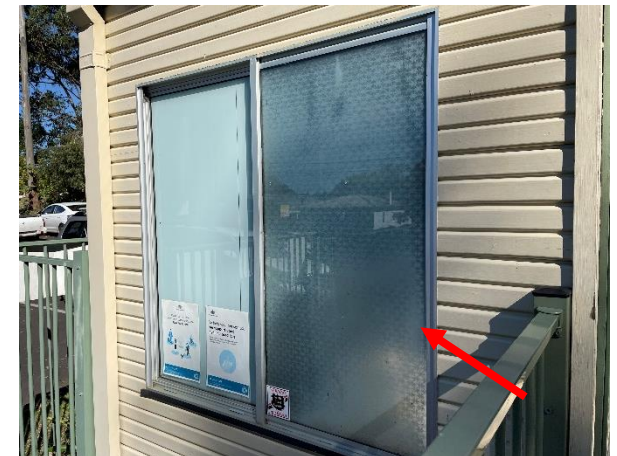
| JBS&G<br>SAMPLE NO. | LOCATION | MATERIAL DESCRIPTION | PHOTO<br>NUMBER | ACCESSIBLE<br>AREA? | FRIABILITY | ANALYTICAL RESULT | MATERIAL<br>CONDITION | APPROX.<br>QUANTITY | ACTION REQUIRED | DATE OF LAST<br>INSPECTION (INCL.<br>COMPANY NAME<br>AND INITIALS) | DATE OF CONTROL<br>ACTION &/OR<br>REMOVAL |
|---|---|---|---|---|---|---|---|---|---|---|---|
| A03 | Storage Shed, toilet window | Mastic sealant | 6 | Yes | Non-Friable | <b>Chrysotile Asbestos</b> | Good | 1 m <sup>2</sup> | Remove prior to demolition. Works to be completed under controlled conditions by Class A or B licensed removal contractor in accordance with SWNSW 2019a | 11/4/2022<br>JBS&G<br>SL & RS | |

Photo 6: Storage Shed – asbestos containing mastic sealant to the toilet window

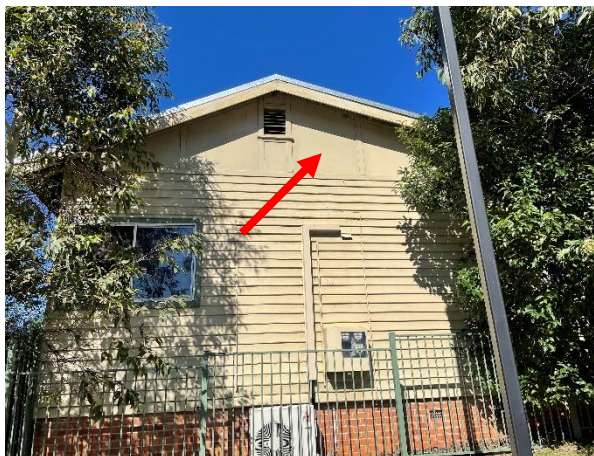
| JBS&G<br>SAMPLE NO. | LOCATION | MATERIAL DESCRIPTION | PHOTO<br>NUMBER | ACCESSIBLE<br>AREA? | FRIABILITY | ANALYTICAL RESULT | MATERIAL<br>CONDITION | APPROX.<br>QUANTITY | ACTION REQUIRED | DATE OF LAST<br>INSPECTION (INCL.<br>COMPANY NAME<br>AND INITIALS) | DATE OF CONTROL<br>ACTION &/OR<br>REMOVAL |
|---|---|---|---|---|---|---|---|---|---|---|---|
| - | Main Building, north gable | Fibre cement sheeting | 7 | Yes | Non-Friable | <b>Assumed Asbestos</b> | Good | 15 m <sup>2</sup> | Remove prior to demolition. Works to be completed under controlled conditions by Class A or B licensed removal contractor in accordance with SWNSW 2019a | 11/4/2022<br>JBS&G<br>SL & RS | |

Photo 7: Main Building – assumed asbestos containing fibre cement sheeting to the north gable

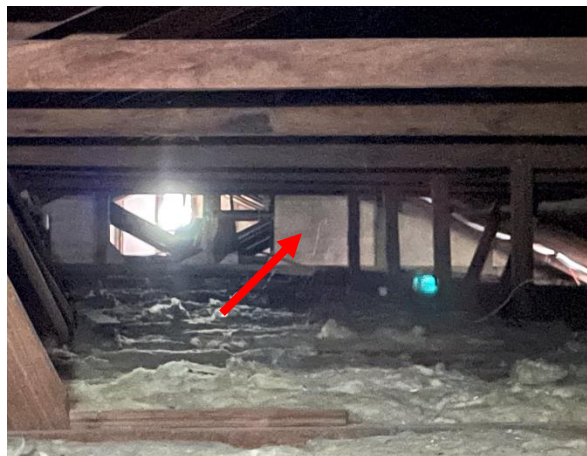
| JBS&G<br>SAMPLE NO. | LOCATION | MATERIAL DESCRIPTION | PHOTO<br>NUMBER | ACCESSIBLE<br>AREA? | FRIABILITY | ANALYTICAL RESULT | MATERIAL<br>CONDITION | APPROX.<br>QUANTITY | ACTION REQUIRED | DATE OF LAST<br>INSPECTION (INCL.<br>COMPANY NAME<br>AND INITIALS) | DATE OF CONTROL<br>ACTION &/OR<br>REMOVAL |
|---|---|---|---|---|---|---|---|---|---|---|---|
| - | Main Building, ceiling cavity, northern portion, gable wall | Fibre cement sheeting | 8 | No | Non-Friable | <b>Assumed Asbestos</b> | Poor | 15 m <sup>2</sup> | Remove prior to demolition. Works to be completed under controlled conditions by Class A or B licensed removal contractor in accordance with SWNSW 2019a | 11/4/2022<br>JBS&G<br>SL & RS | |

Photo 8: Main Building – assumed asbestos containing fibre cement sheeting to the gable wall within the ceiling cavity

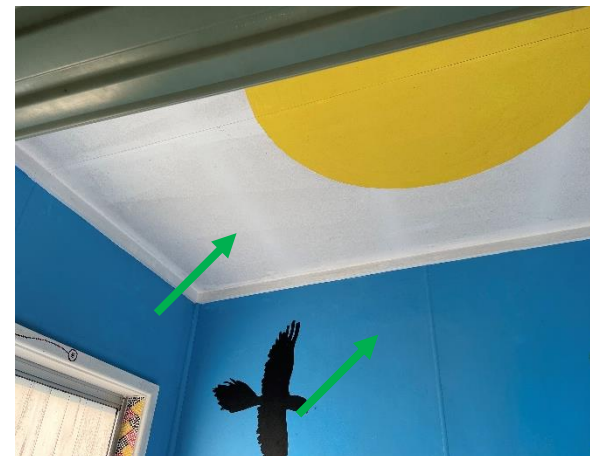
Photo 9: Storage Shed – non-asbestos containing fibre cement sheeting to the internal walls and ceiling of the toilet

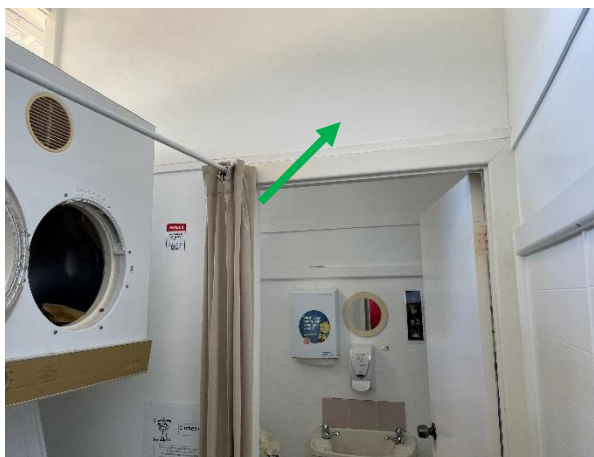
Photo 10: Main Building – non-asbestos containing fibre cement sheeting to the laundry partition wall

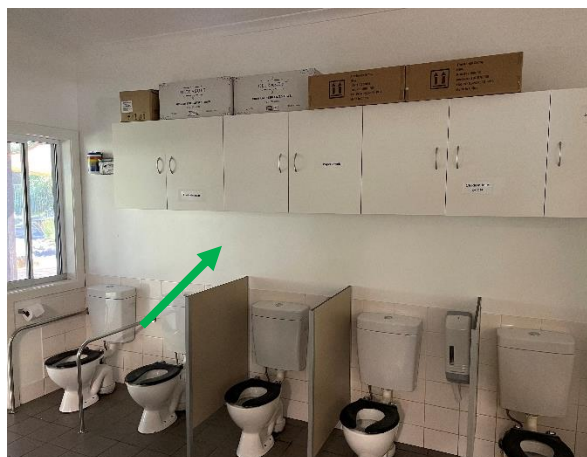
Photo 11: Main Building – non-asbestos containing fibre cement sheeting to the north wall of the toilets

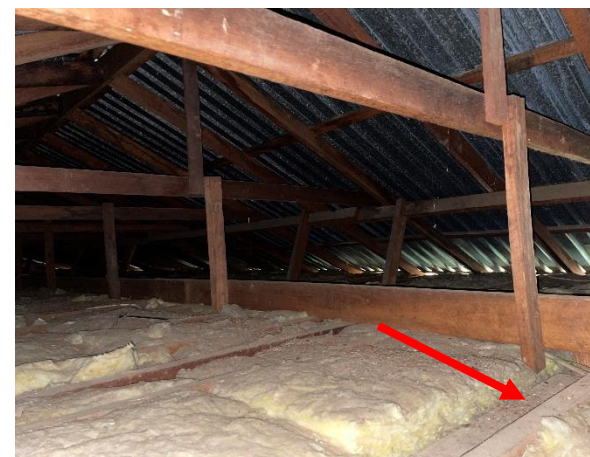
- Elevated lead concentrations within settled dust above the adopted site criteria (LD01, 860 mg/kg) was identified within the ceiling cavity. This dust was also found not to contain asbestos (AD01).

| JBS&G<br>SAMPLE NO. | LOCATION | MATERIAL DESCRIPTION | PHOTO<br>NUMBER | ACCESSIBLE<br>AREA? | FRIABILITY | ANALYTICAL RESULT | MATERIAL<br>CONDITION | APPROX.<br>QUANTITY | ACTION REQUIRED | DATE OF LAST<br>INSPECTION (INCL.<br>COMPANY NAME<br>AND INITIALS) | DATE OF CONTROL<br>ACTION &/OR<br>REMOVAL |
|---|---|---|---|---|---|---|---|---|---|---|---|
| LD01 | Main Building, ceiling<br>cavity | Settled dust | 12 | Yes | - | 860 mg/kg | Poor | 375 m <sup>2</sup> | Remove prior to demolition by an<br>experienced hazardous materials<br>removal contractor in accordance<br>with AS4361.2-2017. | 11/4/2022<br>JBS&G<br>SL & RS | |

Photo 12: Main Building – lead containing dust throughout the ceiling cavity

Elevated levels of lead in dust above the adopted site criteria were identified at the site. A suitably experienced hazardous materials removal contractor should be engaged to remove the lead containing dust in accordance with the AS4361.2-2017 prior to the commencement of any demolition or refurbishment works.

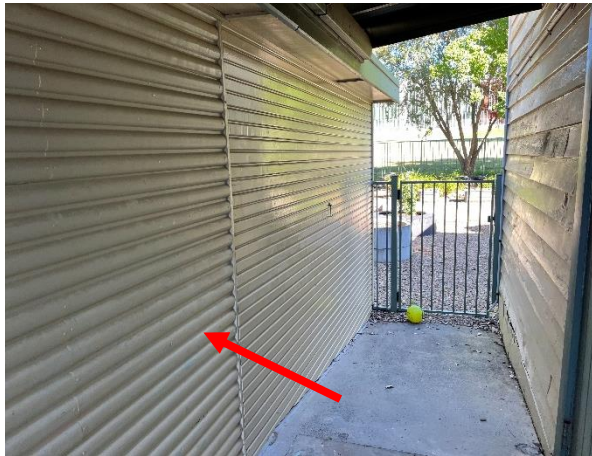
| JBS&G<br>SAMPLE NO. | LOCATION | MATERIAL DESCRIPTION | PHOTO<br>NUMBER | ACCESSIBLE<br>AREA? | FRIABILITY | ANALYTICAL RESULT | MATERIAL<br>CONDITION | APPROX.<br>QUANTITY | ACTION REQUIRED | DATE OF LAST<br>INSPECTION (INCL.<br>COMPANY NAME<br>AND INITIALS) | DATE OF CONTROL<br>ACTION &/OR<br>REMOVAL |
|---|---|---|---|---|---|---|---|---|---|---|---|
| L01 | Storage Shed, external<br>cladding | Cream paint | 13 | Yes | - | 0.16% w/w | Fair | 200 m <sup>2</sup> | Remove loose and flaking paint prior<br>to demolition by an experienced<br>hazardous materials removal<br>contractor in accordance with<br>AS4361.2-2017. Remaining paint well<br>adhered to the building materials<br>may be demolished if care is taken<br>not to spread paint flakes to<br>surrounding areas.<br>Alternatively, remove all paint prior<br>to demolition by an experienced<br>hazardous materials removal<br>contractor in accordance with<br>AS4361.2-2017. | 11/4/2022<br>JBS&G<br>SL & RS | |

Photo 13: Storage Shed – lead based cream paint to the external cladding

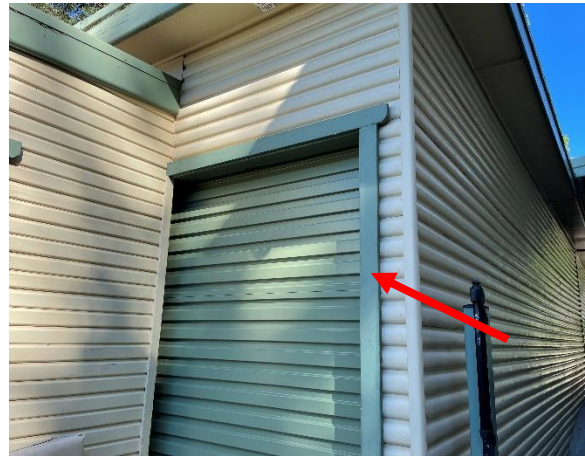
| JBS&G<br>SAMPLE NO. | LOCATION | MATERIAL DESCRIPTION | PHOTO<br>NUMBER | ACCESSIBLE<br>AREA? | FRIABILITY | ANALYTICAL RESULT | MATERIAL<br>CONDITION | APPROX.<br>QUANTITY | ACTION REQUIRED | DATE OF LAST<br>INSPECTION (INCL.<br>COMPANY NAME<br>AND INITIALS) | DATE OF CONTROL<br>ACTION &/OR<br>REMOVAL |
|---|---|---|---|---|---|---|---|---|---|---|---|
| L02 | Storage Shed, external<br>timber fascia, door<br>jambs and roller doors | Green paint | 14 | Yes | - | 0.13% w/w | Fair | | Remove loose and flaking paint prior<br>to demolition by an experienced<br>hazardous materials removal<br>contractor in accordance with<br>AS4361.2-2017. Remaining paint well<br>adhered to the building materials<br>may be demolished if care is taken<br>not to spread paint flakes to<br>surrounding areas.<br>Alternatively, remove all paint prior<br>to demolition by an experienced<br>hazardous materials removal<br>contractor in accordance with<br>AS4361.2-2017. | 11/4/2022<br>JBS&G<br>SL & RS | |

Photo 14: Storage Shed – lead based green paint to the external fascia, door jambs and roller doors

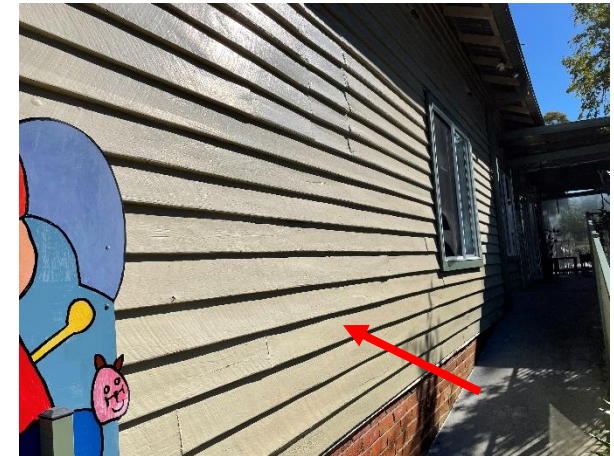
| JBS&G<br>SAMPLE NO. | LOCATION | MATERIAL DESCRIPTION | PHOTO<br>NUMBER | ACCESSIBLE<br>AREA? | FRIABILITY | ANALYTICAL RESULT | MATERIAL<br>CONDITION | APPROX.<br>QUANTITY | ACTION REQUIRED | DATE OF LAST<br>INSPECTION (INCL.<br>COMPANY NAME<br>AND INITIALS) | DATE OF CONTROL<br>ACTION &/OR<br>REMOVAL |
|---|---|---|---|---|---|---|---|---|---|---|---|
| L03 | Main Building, external<br>timber cladding and<br>fascia | Cream paint | 15 | Yes | - | 0.13% w/w | Fair | | Remove loose and flaking paint prior to demolition by an experienced hazardous materials removal contractor in accordance with AS4361.2-2017. Remaining paint well adhered to the building materials may be demolished if care is taken not to spread paint flakes to surrounding areas. Alternatively, remove all paint prior to demolition by an experienced hazardous materials removal contractor in accordance with AS4361.2-2017. | 11/4/2022<br>JBS&G<br>SL & RS | |

Photo 15: Main Building – lead based cream paint to the external cladding and fascia

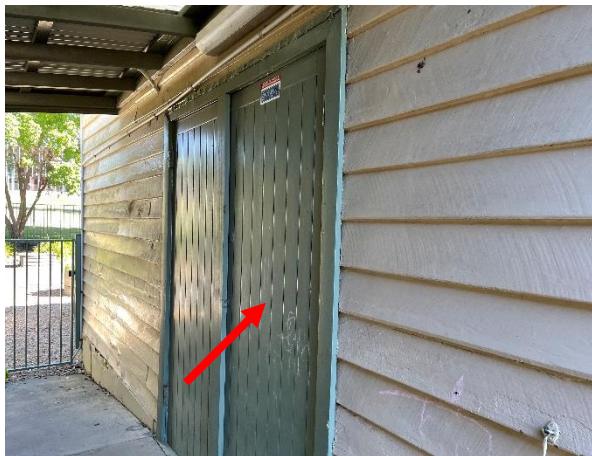
| JBS&G<br>SAMPLE NO. | LOCATION | MATERIAL DESCRIPTION | PHOTO<br>NUMBER | ACCESSIBLE<br>AREA? | FRIABILITY | ANALYTICAL RESULT | MATERIAL<br>CONDITION | APPROX.<br>QUANTITY | ACTION REQUIRED | DATE OF LAST<br>INSPECTION (INCL.<br>COMPANY NAME<br>AND INITIALS) | DATE OF CONTROL<br>ACTION &/OR<br>REMOVAL |
|---|---|---|---|---|---|---|---|---|---|---|---|
| L04 | Main Building, external<br>timber doors, jambs and<br>trim | Green paint | 16 | Yes | - | 1.7% w/w | Fair | | Remove loose and flaking paint prior to demolition by an experienced hazardous materials removal contractor in accordance with AS4361.2-2017. Remaining paint well adhered to the building materials may be demolished if care is taken not to spread paint flakes to surrounding areas. Alternatively, remove all paint prior to demolition by an experienced hazardous materials removal contractor in accordance with AS4361.2-2017. | 11/4/2022<br>JBS&G<br>SL & RS | |

Photo 16: Main Building – lead based green paint to the external timber doors, jambs and trim

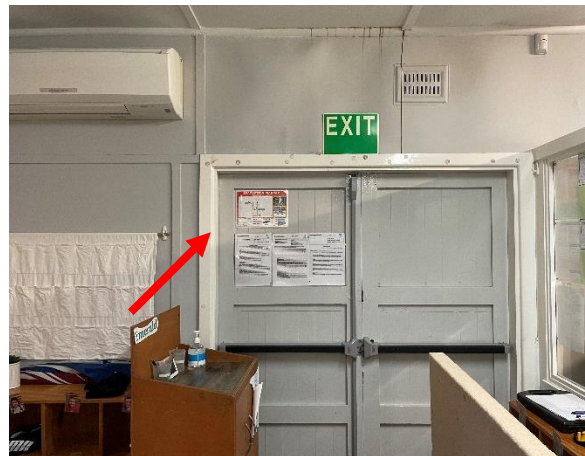
| JBS&G<br>SAMPLE NO. | LOCATION | MATERIAL DESCRIPTION | PHOTO<br>NUMBER | ACCESSIBLE<br>AREA? | FRIABILITY | ANALYTICAL RESULT | MATERIAL<br>CONDITION | APPROX.<br>QUANTITY | ACTION REQUIRED | DATE OF LAST<br>INSPECTION (INCL.<br>COMPANY NAME<br>AND INITIALS) | DATE OF CONTROL<br>ACTION &/OR<br>REMOVAL |
|---|---|---|---|---|---|---|---|---|---|---|---|
| L05 | Main Building, internal<br>timber architraves and<br>skirting boards | White/cream paint | 17 | Yes | - | 2.9% w/w | Good | | Remove loose and flaking paint prior to demolition by an experienced hazardous materials removal contractor in accordance with AS4361.2-2017. Remaining paint well adhered to the building materials may be demolished if care is taken not to spread paint flakes to surrounding areas. Alternatively, remove all paint prior to demolition by an experienced hazardous materials removal contractor in accordance with AS4361.2-2017. | 11/4/2022<br>JBS&G<br>SL & RS | |

Photo 17: Main Building – lead based white/cream paint to the internal timber architraves and skirting boards

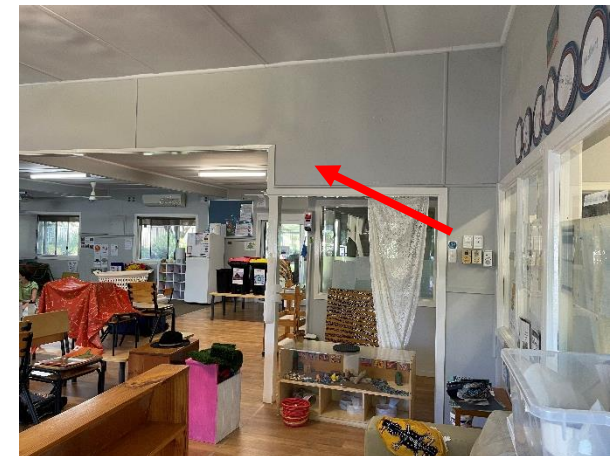
| JBS&G<br>SAMPLE NO. | LOCATION | MATERIAL DESCRIPTION | PHOTO<br>NUMBER | ACCESSIBLE<br>AREA? | FRIABILITY | ANALYTICAL RESULT | MATERIAL<br>CONDITION | APPROX.<br>QUANTITY | ACTION REQUIRED | DATE OF LAST<br>INSPECTION (INCL.<br>COMPANY NAME<br>AND INITIALS) | DATE OF CONTROL<br>ACTION &/OR<br>REMOVAL |
|---|---|---|---|---|---|---|---|---|---|---|---|
| L06 | Main Building, Emerald Room, walls | Grey paint | 18 | Yes | - | 0.37% w/w | Good | | Remove loose and flaking paint prior to demolition by an experienced hazardous materials removal contractor in accordance with AS4361.2-2017. Remaining paint well adhered to the building materials may be demolished if care is taken not to spread paint flakes to surrounding areas. Alternatively, remove all paint prior to demolition by an experienced hazardous materials removal contractor in accordance with AS4361.2-2017. | 11/4/2022<br>JBS&G<br>SL & RS | |

Photo 18: Main Building – lead based grey paint to the internal walls throughout the Emerald Room

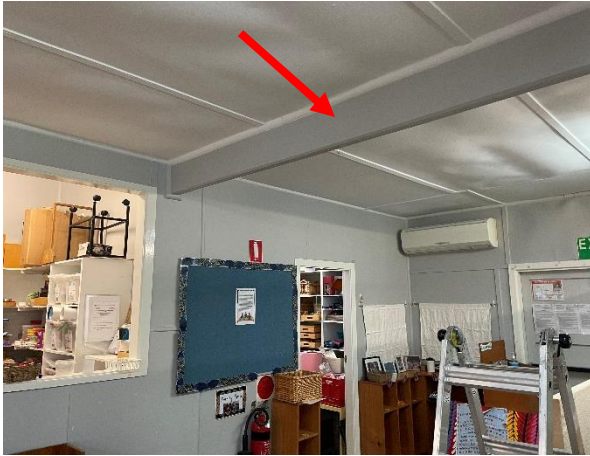
| JBS&G<br>SAMPLE NO. | LOCATION | MATERIAL DESCRIPTION | PHOTO<br>NUMBER | ACCESSIBLE<br>AREA? | FRIABILITY | ANALYTICAL RESULT | MATERIAL<br>CONDITION | APPROX.<br>QUANTITY | ACTION REQUIRED | DATE OF LAST<br>INSPECTION (INCL.<br>COMPANY NAME<br>AND INITIALS) | DATE OF CONTROL<br>ACTION &/OR<br>REMOVAL |
|---|---|---|---|---|---|---|---|---|---|---|---|
| XRF | Main Building, Emerald Room, ceiling beams | Grey paint | 19 | Yes | - | > 5.00 mg/cm <sup>2</sup> | Good | | Remove loose and flaking paint prior to demolition by an experienced hazardous materials removal contractor in accordance with AS4361.2-2017. Remaining paint well adhered to the building materials may be demolished if care is taken not to spread paint flakes to surrounding areas. Alternatively, remove all paint prior to demolition by an experienced hazardous materials removal contractor in accordance with AS4361.2-2017. | 11/4/2022<br>JBS&G<br>SL & RS | |

Photo 19: Main Building – assumed lead based green paint to the timber ceiling beams within the Emerald Room

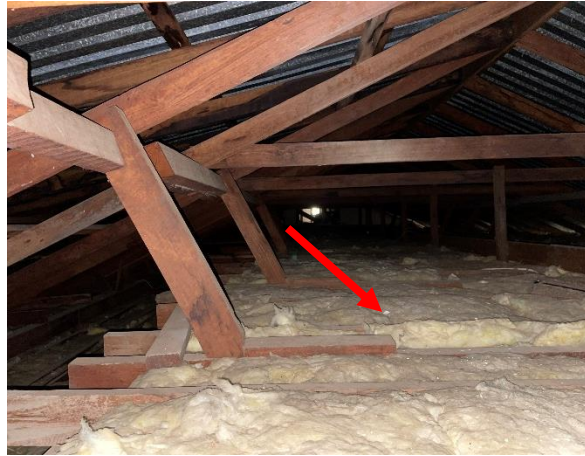
Photo 20: Main Building – Assumed SMF insulation batts throughout the ceiling cavity

The synthetic mineral fibres encountered during this inspection were generally contained and deemed to be low risk. These SMF materials can be removed with the building and demolition waste with care taken not to generate fibres. Appropriate PPE is recommended including the use of P2 respirator as minimum and appropriate removal methodology as outlined in [NOHSC: 1004(1990)] and [NOHSC: 2006(1990)].

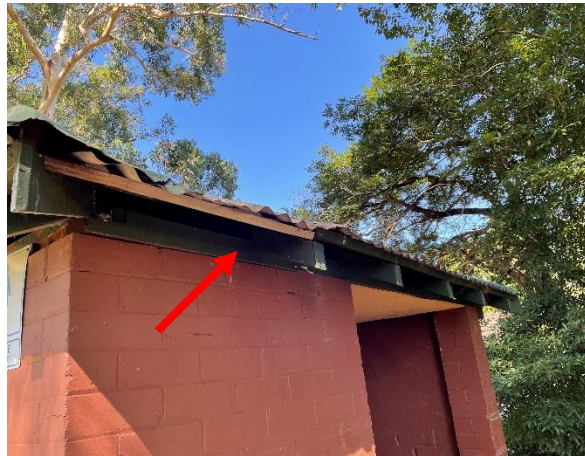
| JBS&G<br>SAMPLE NO. | LOCATION | MATERIAL DESCRIPTION | PHOTO<br>NUMBER | ACCESSIBLE<br>AREA? | FRIABILITY | ANALYTICAL RESULT | MATERIAL<br>CONDITION | APPROX.<br>QUANTITY | ACTION REQUIRED | DATE OF LAST<br>INSPECTION (INCL.<br>COMPANY NAME<br>AND INITIALS) | DATE OF CONTROL<br>ACTION &/OR<br>REMOVAL |
|---|---|---|---|---|---|---|---|---|---|---|---|
| L09 | Male and Female Toilets,<br>timber fascia, doors and<br>trim | Green paint | 23 | Yes | - | 0.16% w/w | Fair | 200 m <sup>2</sup> | Remove loose and flaking paint prior<br>to demolition by an experienced<br>hazardous materials removal<br>contractor in accordance with<br>AS4361.2-2017. Remaining paint well<br>adhered to the building materials<br>may be demolished if care is taken<br>not to spread paint flakes to<br>surrounding areas.<br>Alternatively, remove all paint prior<br>to demolition by an experienced<br>hazardous materials removal<br>contractor in accordance with<br>AS4361.2-2017. | 11/4/2022<br>JBS&G<br>SL & RS | |

Photo 23: Male/Female Toilets – lead based green paint to the external timber fascia, doors and trim

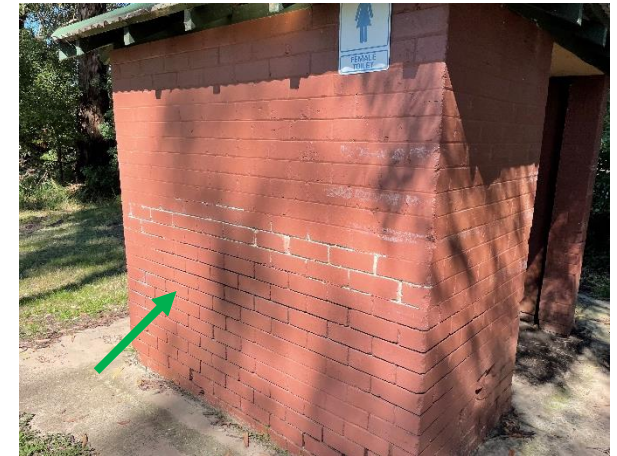
Photo 24: Male/Female Toilets – non-lead based red/brown paint to the external walls
