# **42 BOOREA ST, LIDCOMBE, NSW 2141**

## **HAZARDOUS BUILDING MATERIALS REPORT**

JUNE 2021

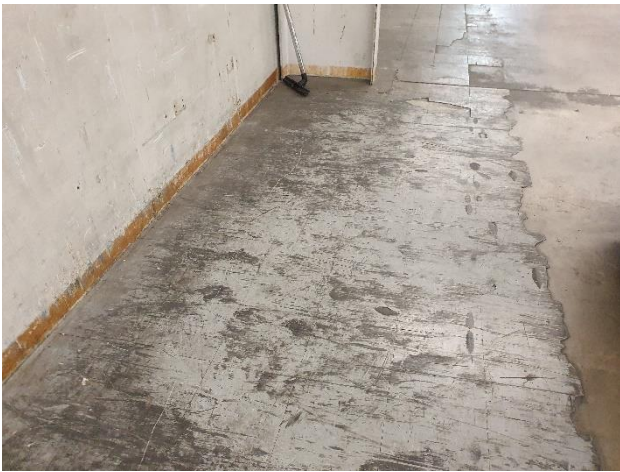
**Photo 1:** Internal, Main warehouse, vinyl floor tiling.

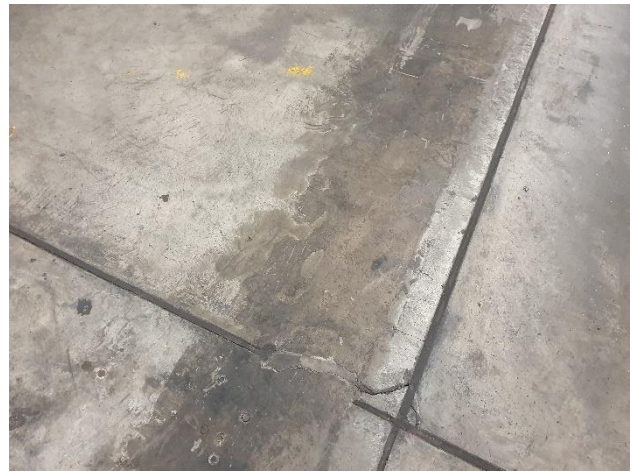
**Photo 2:** Internal, Main warehouse, slab expansion joint.

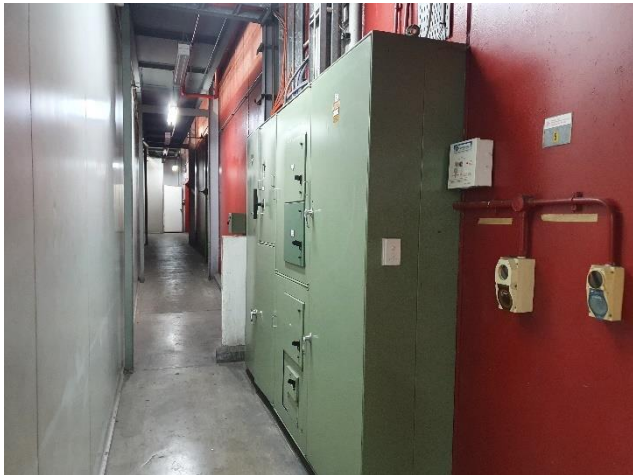
**Photo 3:** Internal, Main building, south east elevation, electrical cupboards.

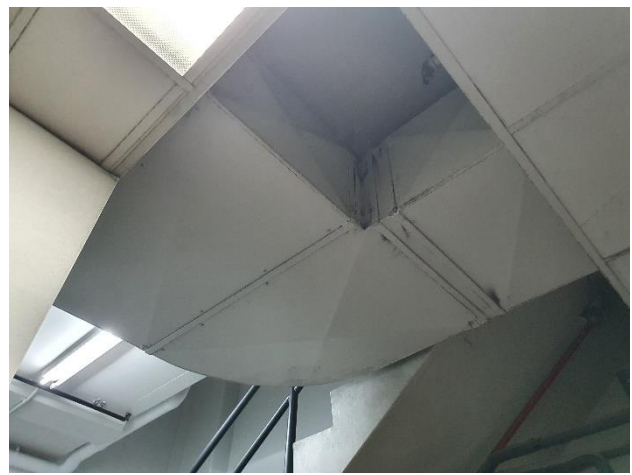
**Photo 4:** Main building, East office/store, ac ducting joints presumed positive for asbestos.

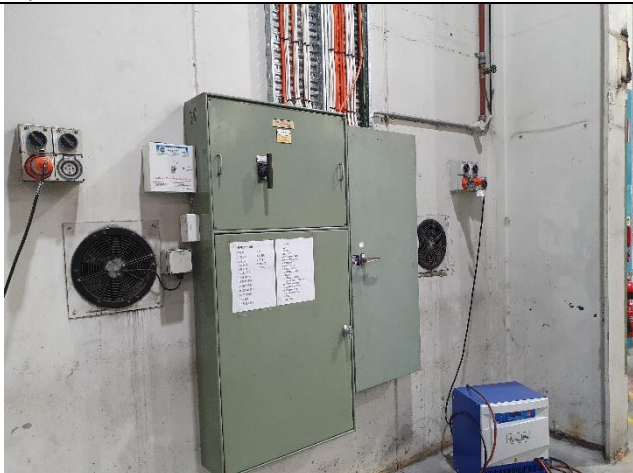
Main Bld	G	Interior	Main warehouse, eastern wall northern end	Resinous board	Electrical distribution board	Visual Identification	Presumed positive	3m2	5	NF	5	E	L	Inaccessible due to electrical hazard. Confirm status prior to demolition or refurbishment works. Maintain in current condition if to remain in-situ. Remove under controlled non-friable asbestos removal conditions prior to refurbishment or demolition works by a Class A (friable) or Class B (non-friable) licensed asbestos removal contractor.		
Main Bld	1	Interior	Main warehouse, central section west wall mezzanine	Electrical distribution board and fuses	Electrical distribution cabinet bank	Visual Identification	Presumed positive	25m2	8	nf	5	E	L	Inaccessible due to electrical hazard. Confirm status prior to demolition or refurbishment works. Maintain in current condition if to remain in-situ. Remove under controlled non-friable asbestos removal conditions prior to refurbishment or demolition works by a Class A (friable) or Class B (non-friable) licensed asbestos removal contractor.

**Photo 5:** Main warehouse, electrical distribution board

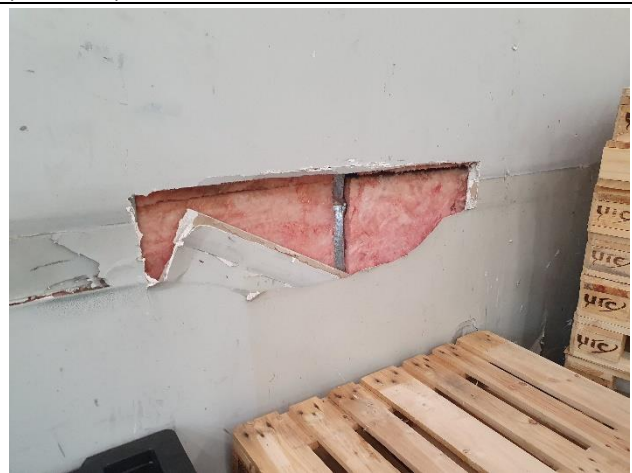
**Photo 6:** Eastern customs area, SMF wall insulation

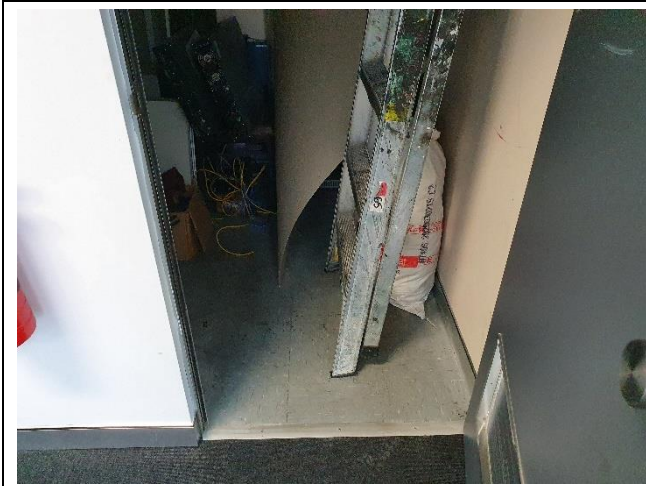
**Photo 7:** Main reception area, electrical storeroom, vinyl floor tiles

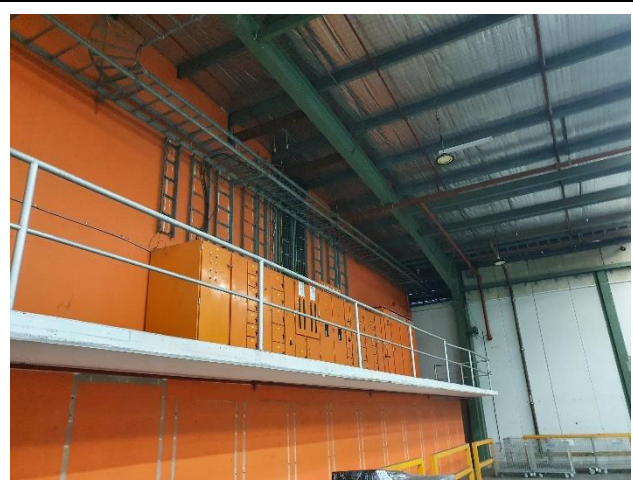
**Photo 8:** Central ware house, West wall mezzanine, electrical distribution cabinet bank

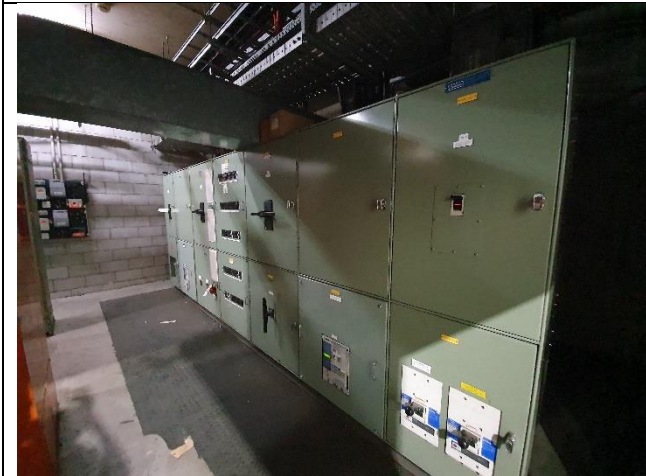
Main Bld	G	Internal	South Eastern warehouse, electrical switch room	Electrical distribution banks x 4	Switchroom electrical cupboards	Visual Identification	Presumed positive	30m2	9	NF	5	E	L	Inaccessible due to electrical hazard. Confirm status prior to demolition or refurbishment works. Maintain in current condition if to remain in-situ. Remove under controlled non-friable asbestos removal conditions prior to refurbishment or demolition works by a Class A (friable) or Class B (non-friable) licensed asbestos removal contractor.		
Main Bld	G	Internal	South Eastern warehouse, electrical switch room	Electrical distribution boards x 2	Switchroom electrical backing boards	Visual Identification	Presumed positive	2m2	9	NF	5	E	L	Inaccessible due to electrical hazard. Confirm status prior to demolition or refurbishment works. Maintain in current condition if to remain in-situ. Remove under controlled non-friable asbestos removal conditions prior to refurbishment or demolition works by a Class A (friable) or Class B (non-friable) licensed asbestos removal contractor.

**Photo 9:** South east warehouse, electrical room room, electrical distribution banks

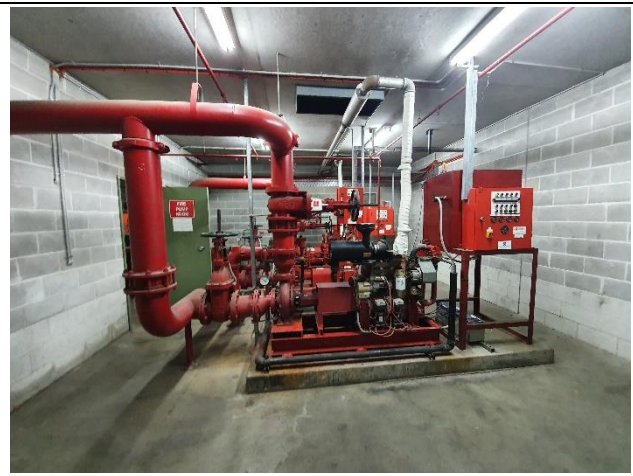
**Photo 10:** South east warehouse, pumphoom piping

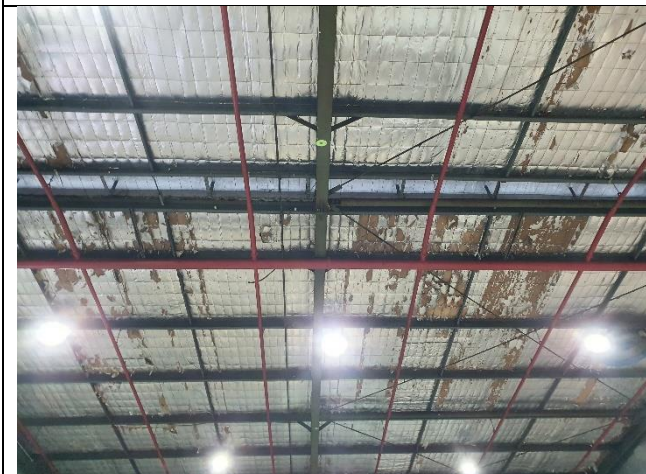
**Photo 11:** Representative photo of ceiling sarking, green support beams and red fire suppression system to docks.

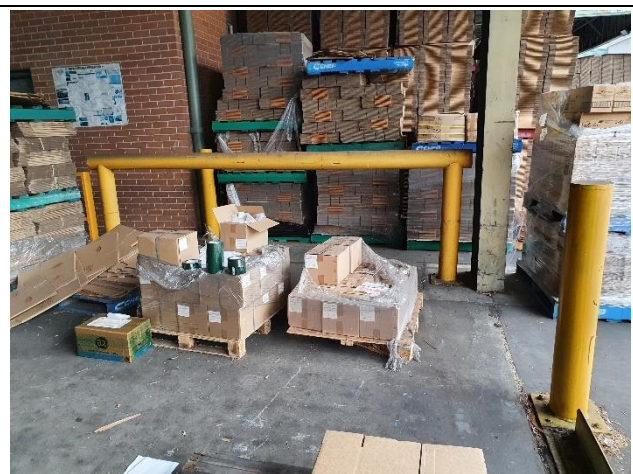
**Photo 12:** South loading dock, adjacent dock office, yellow painted guard rails.
