PRELIMINARY SITE INVESTIGATION AT 505 WILSON STREET EVELEIGH TRANSPORT FOR NSW

29 JULY 2022
122040_VAR1
VERSION 1

Preliminary site investigation at 505 Wilson Street, Eveleigh, NSW

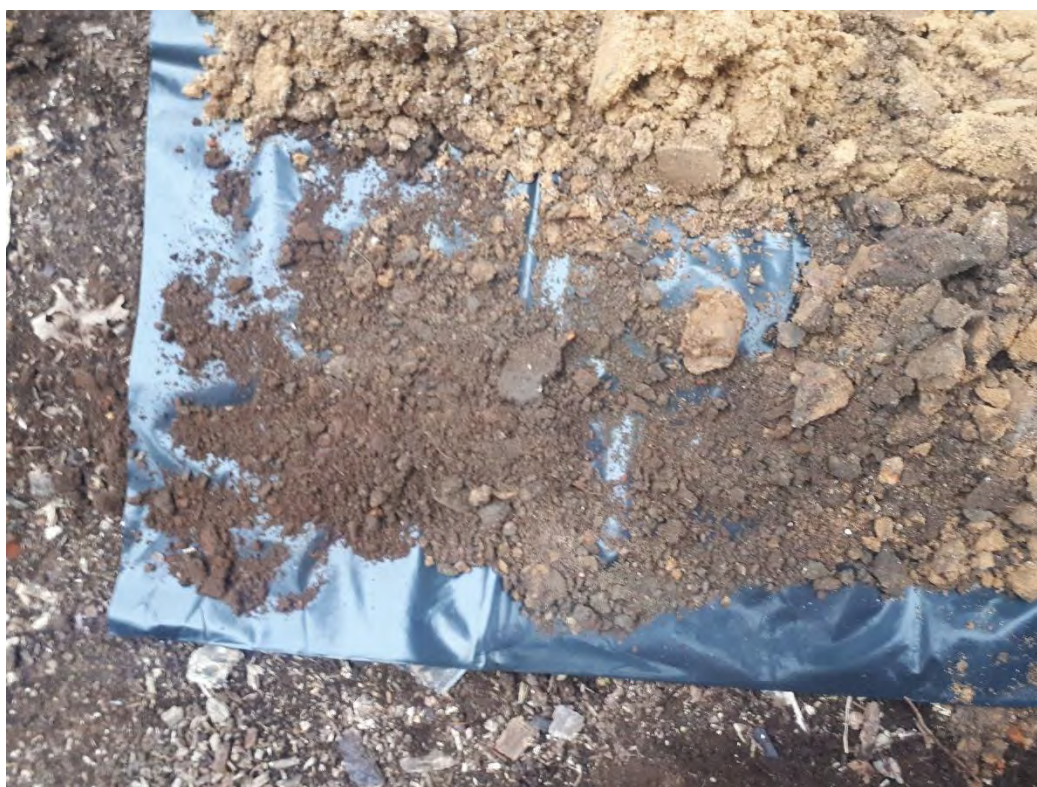
Photo Plate 7: Partially Augured BH2

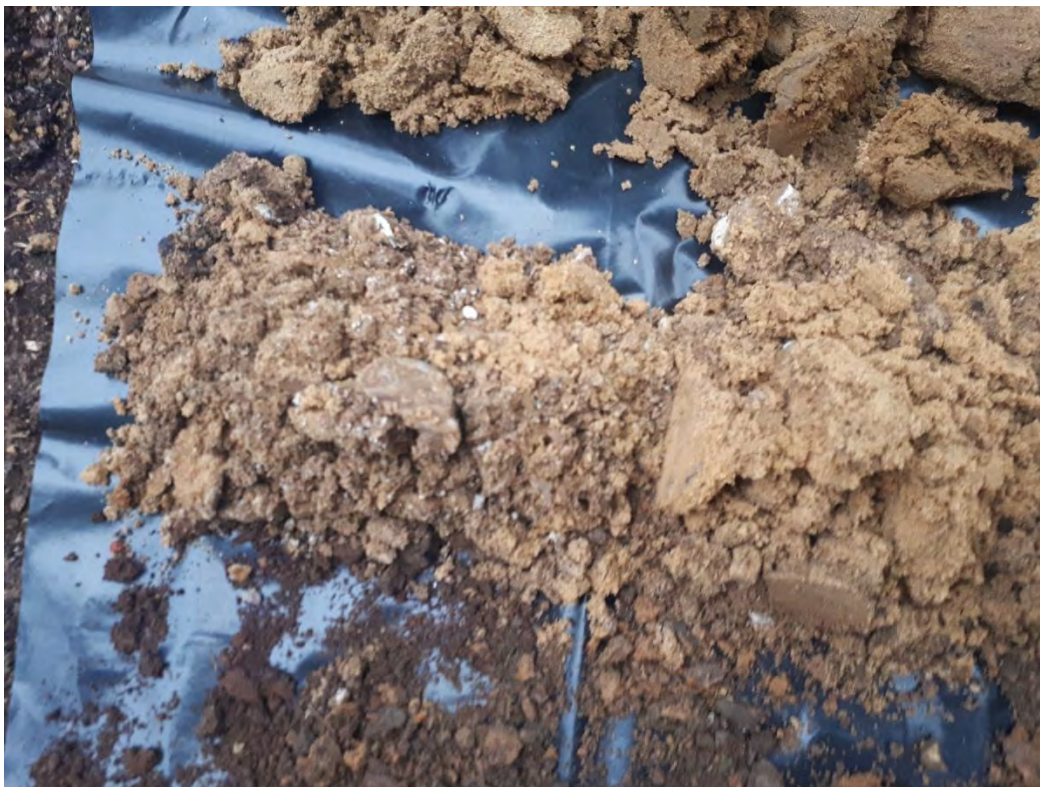
Photo Plate 8: Representative varying fill material observed at BH1

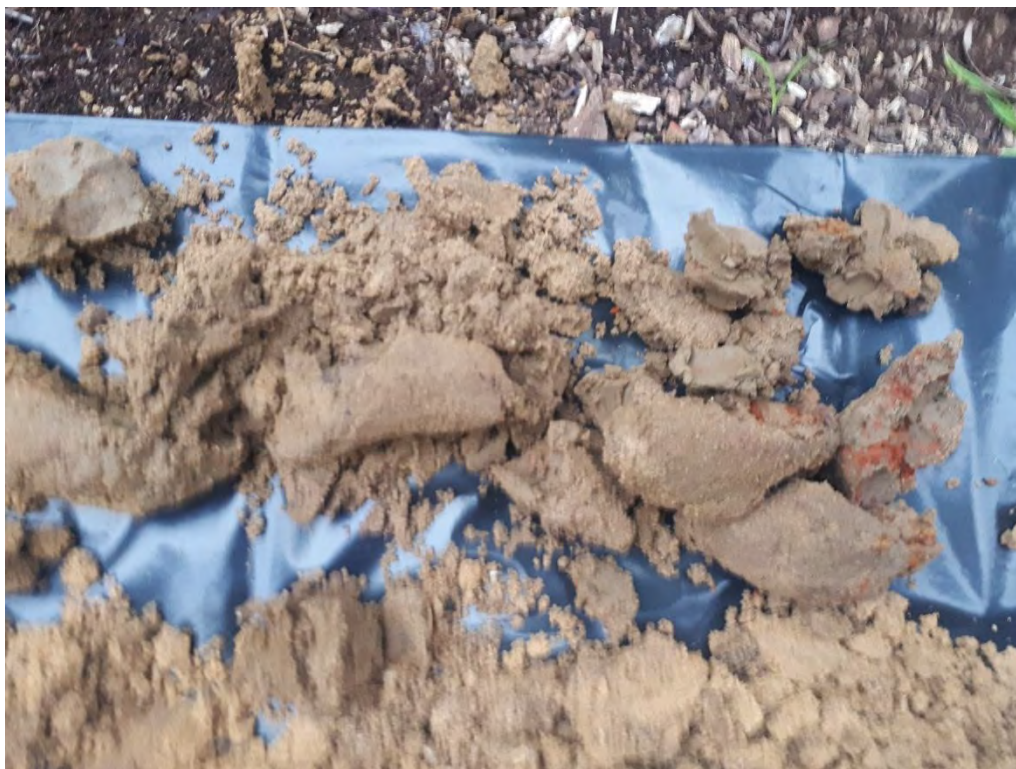
Photo Plate 9: Representative varying fill material observed at BH1

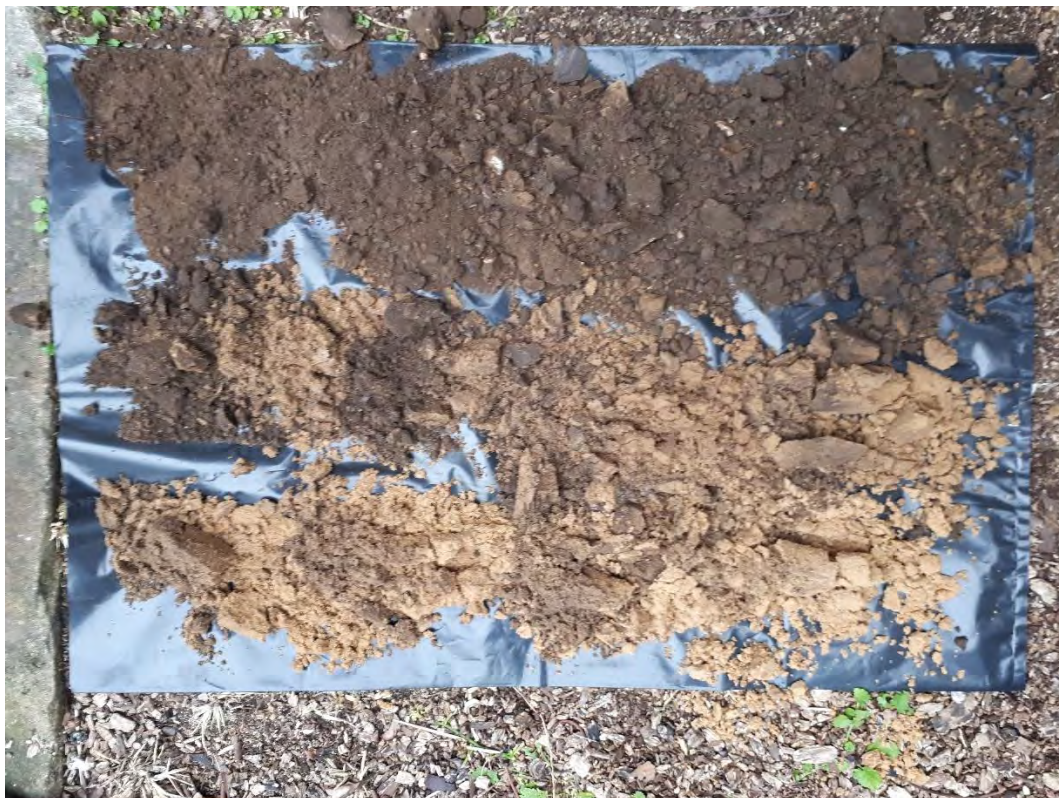
Photo Plate 10: Representative natural material found beyond 0.7mBGL at BH1

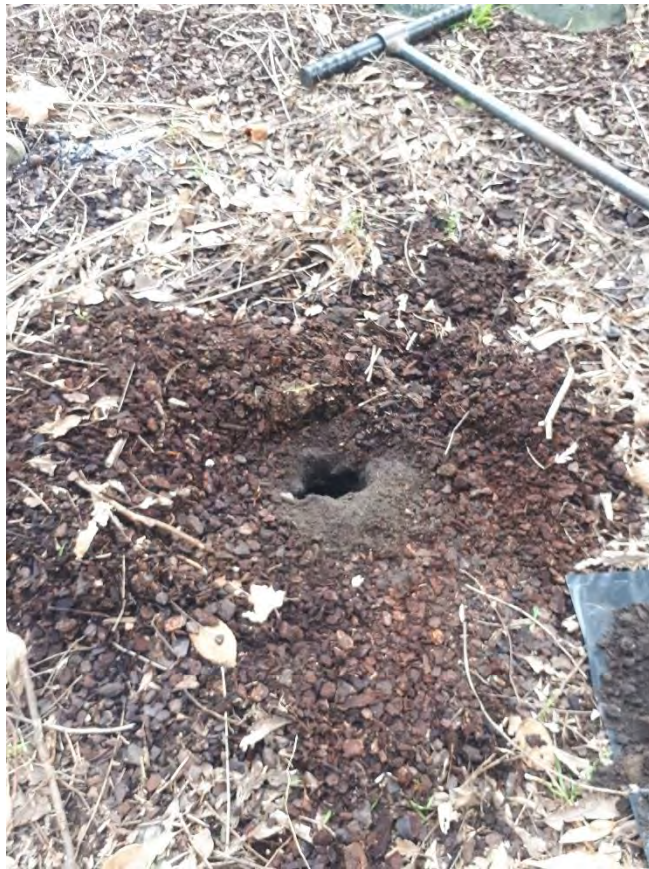
Photo Plate 12: Representative material of BH3

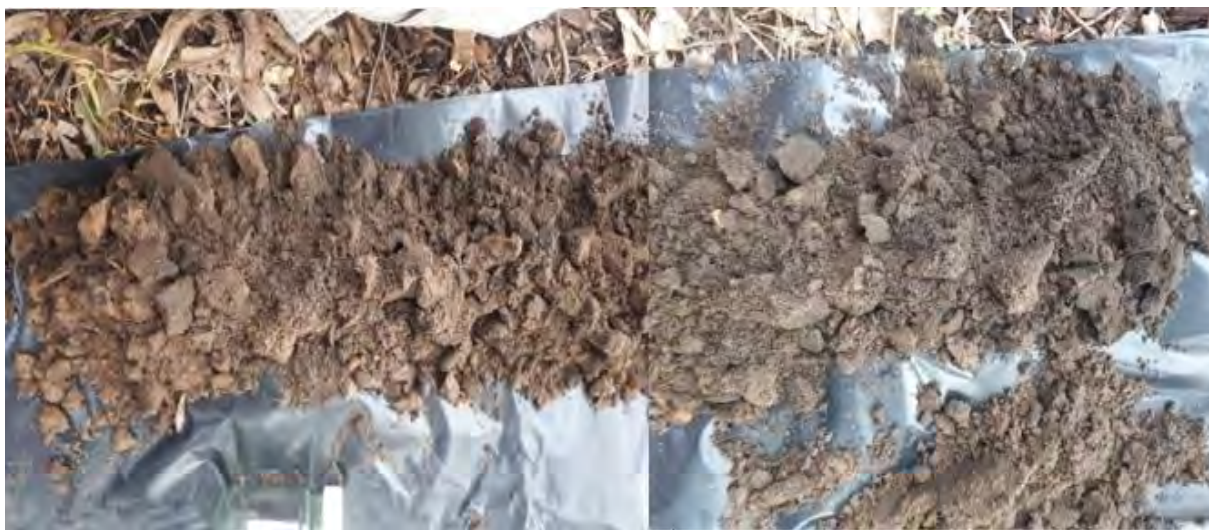
Photo Plate 13: Augured hole from BH4. Dry leaf and mulch coverage observed.
