Pre-Refurbishment Hazardous Materials Survey Report

505 Wilson Street, North Eveleigh NSW

22.0624.00|V2F| Date: 27/07/2022

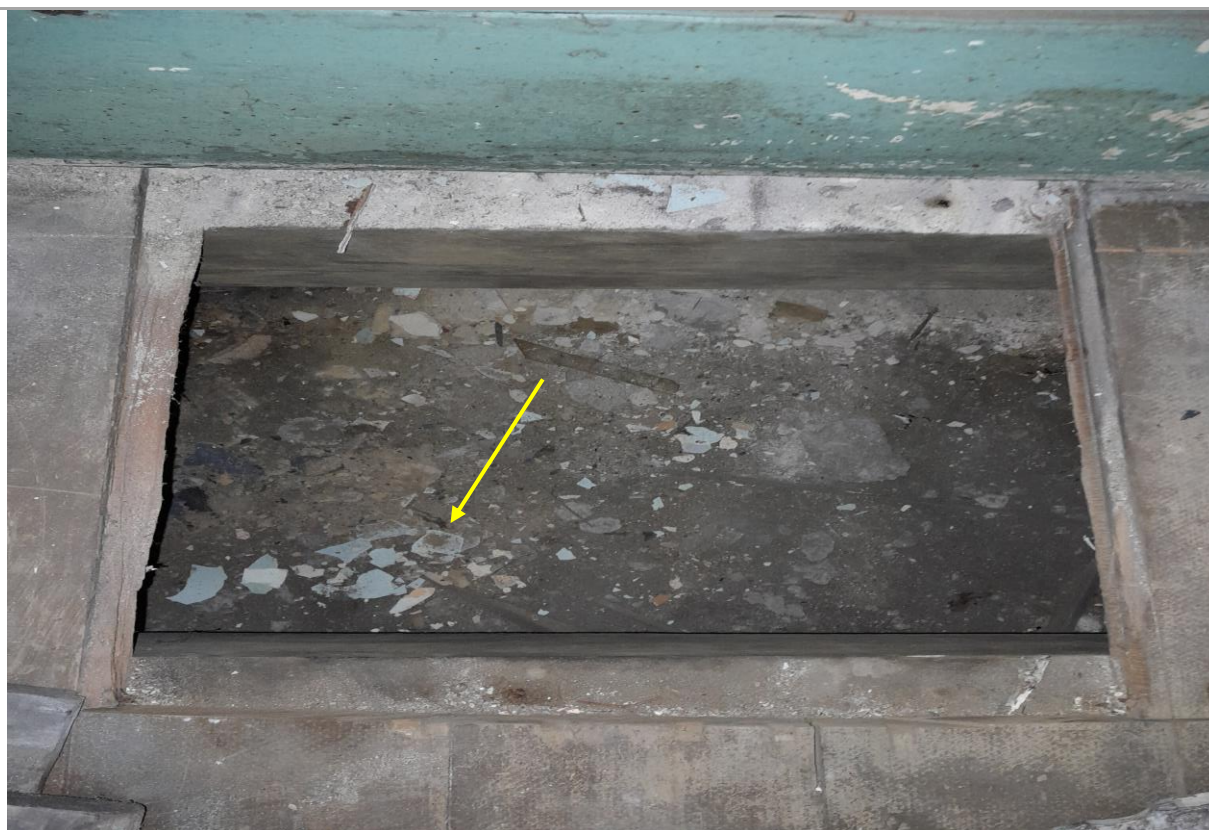
Photograph 1. Interior, subfloor – lead containing dust as observed on [04.07.2022].

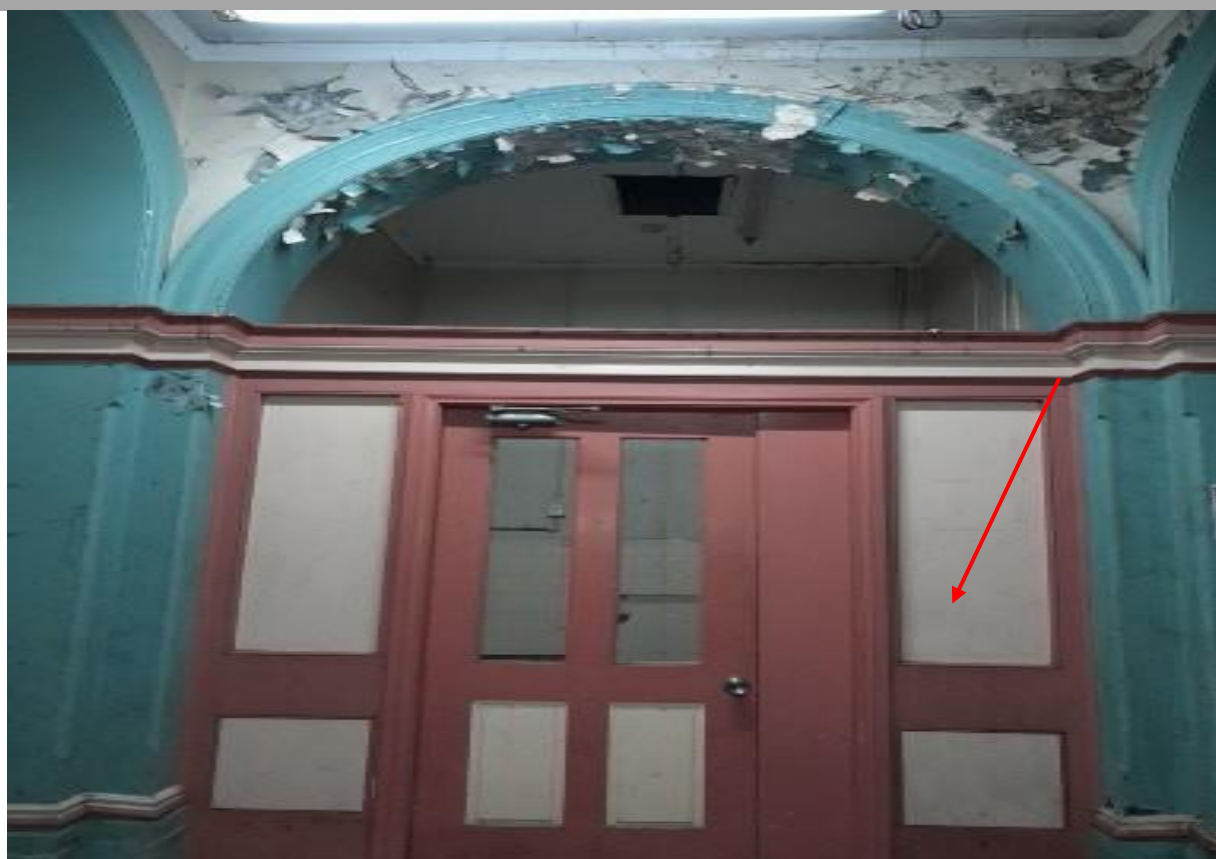
Photograph 2. Interior, level 1, north room kitchenette – asbestos containing wall lining as observed on [04.07.2022].

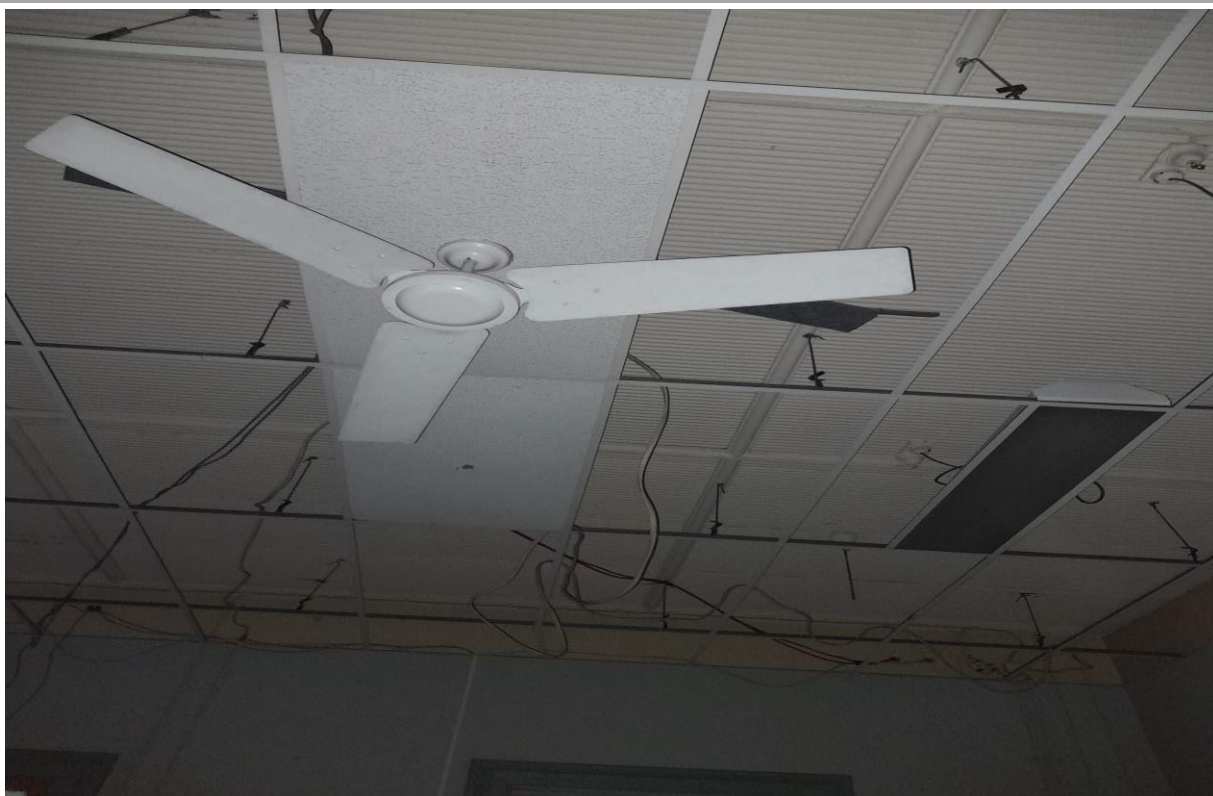
Photograph 3. Interior, throughout SMF ceiling tiles as observed on [04.07.2022].

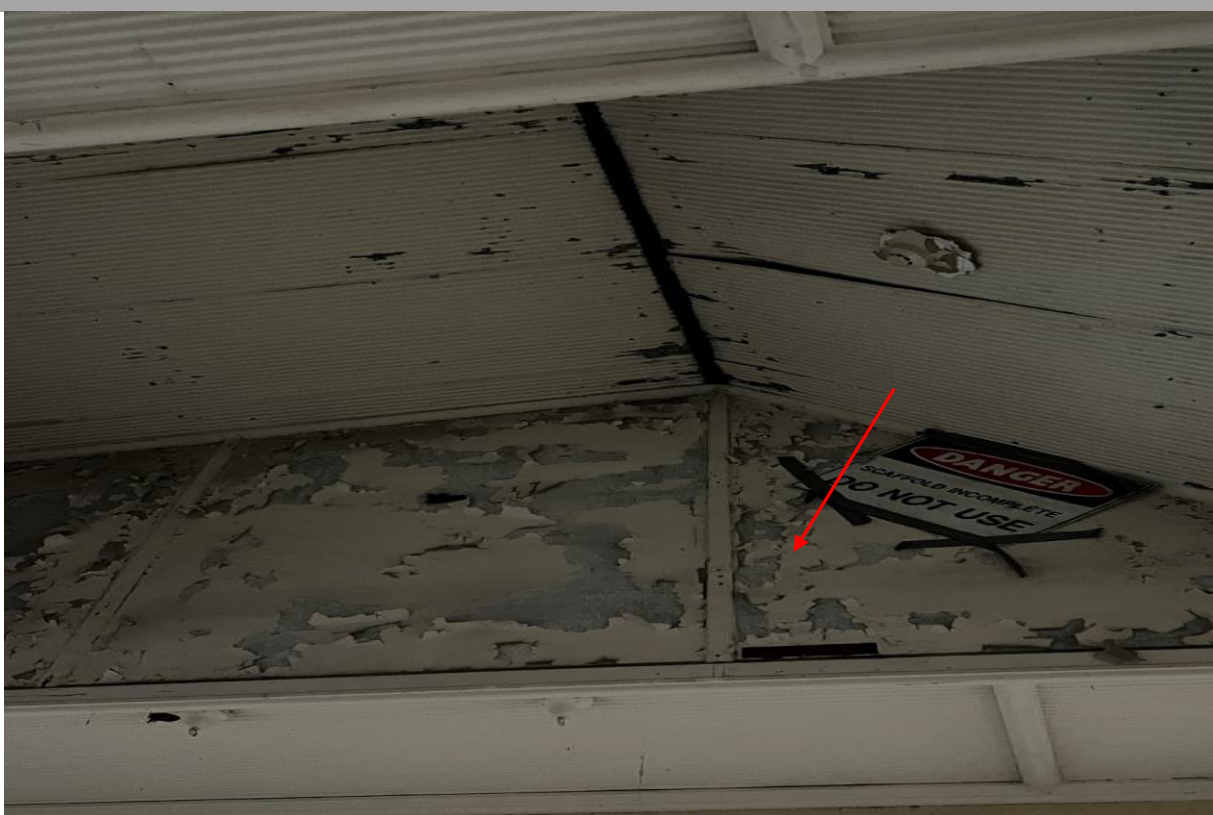
Location	Material	Risk score	Recommendation
Chief Mechanical Engineers Building interior, level 1 21 High level wall lining	FC wall lining	Medium	Remove or label and enclose/encapsulate in line with the Asbestos Management Plan (AMP) by a Class A or B licensed asbestos removal contractor or remove prior to refurbishment or demolition.
Chief Mechanical Engineers Building interior, level 1 Northern room (kitchenette) High level wall lining	FC wall lining	Medium	Remove or label and enclose/encapsulate in line with the Asbestos Management Plan (AMP) by a Class A or B licensed asbestos removal contractor or remove prior to refurbishment or demolition.
Chief Mechanical Engineers Building exterior Throughout exterior Presume eaves lining	Eaves	Low	Label the item in line with the Asbestos Management Plan (AMP) and the SafeWork NSW Code of Practice: How to Manage and Control Asbestos in the Workplace (2019). Reinspect periodically. Maintain in current condition if to remain in situ, otherwise remove before refurbishment or demolition following the SafeWork NSW Code of Practice: How to Safely Remove Asbestos (2019);

Photograph 4. Interior, level 1, room 21 – high level asbestos containing wall lining as observed on [04.07.2022].

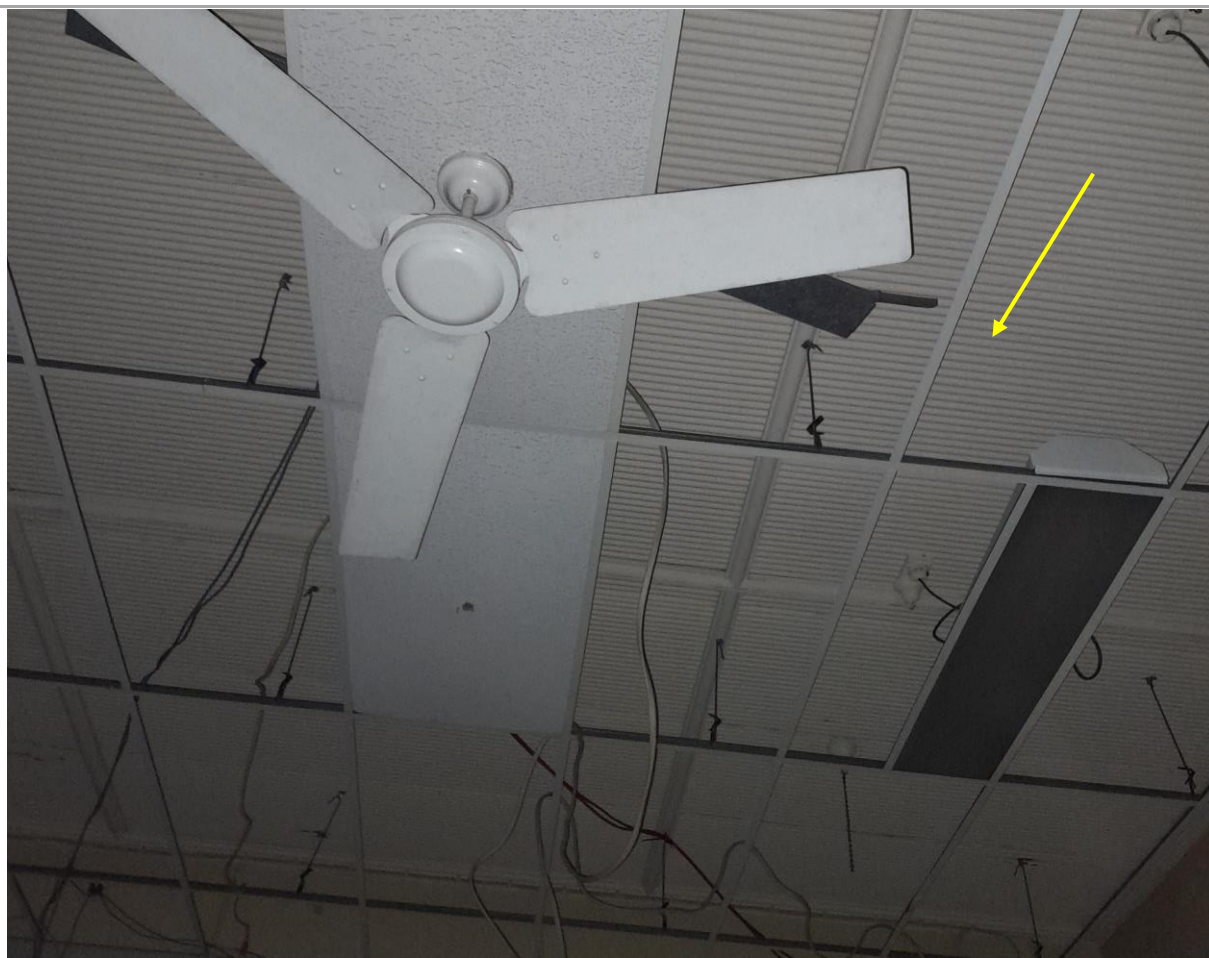
Photograph 5. Interior of the room, Lead paint system to second ceiling lining as observed on [04.07.2022].

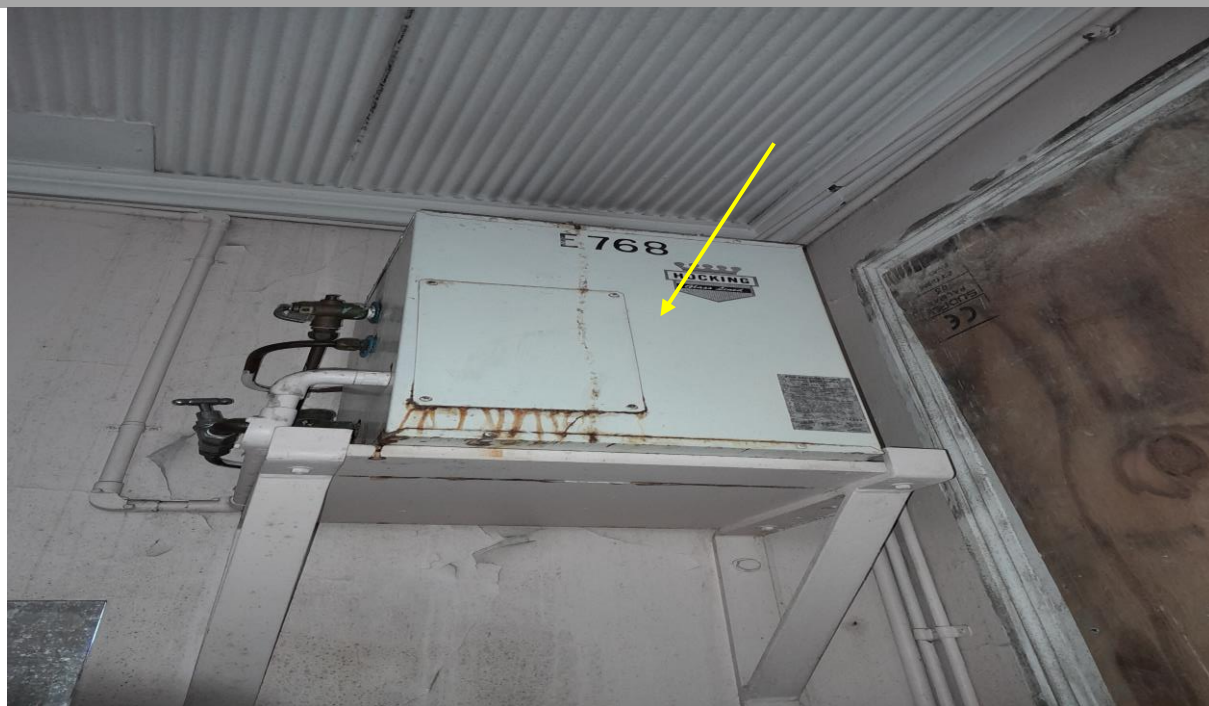
Photograph 6. Interior, level 1, ladies' toilet – Presumed SMF containing water heater as observed on [04.07.2022].

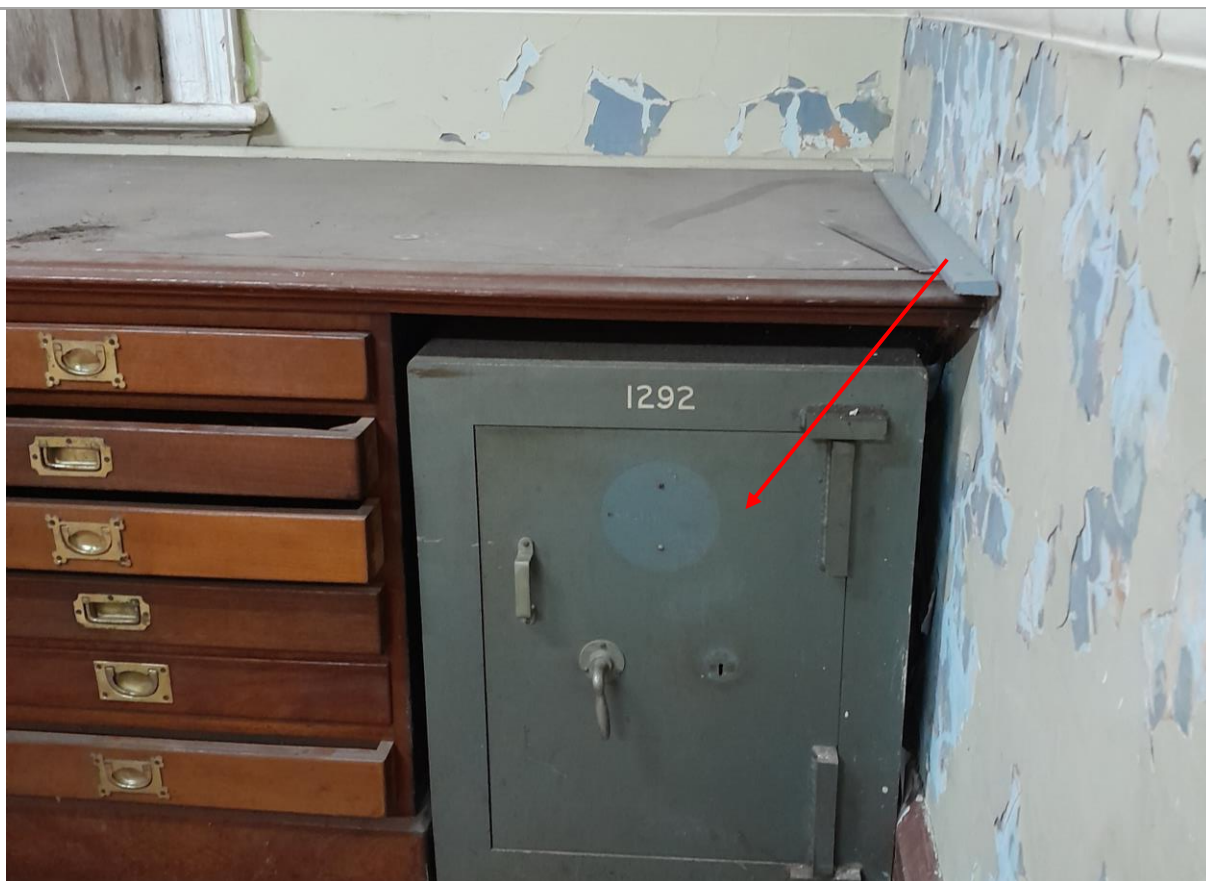
Photograph 7. Interior, ground floor, room 1 – Presumed asbestos containing internal insulation to safe as observed on [04.07.2022].

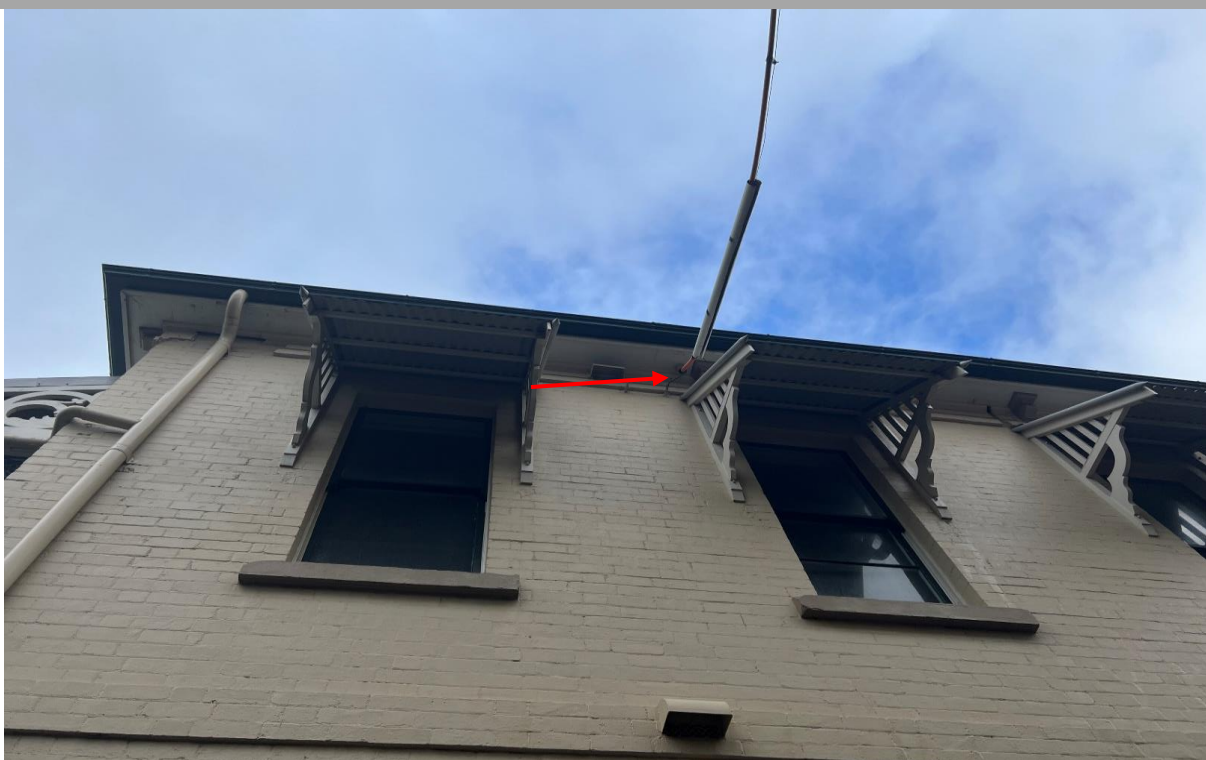
Chief Mechanical Engineers Building Exterior Western exterior FC flue pipe Presume high level FC flue	FC flue pipe	Low	Label the item in line with the Asbestos Management Plan (AMP) and the SafeWork NSW Code of Practice: How to Manage and Control Asbestos in the Workplace (2019). Reinspect periodically. Maintain in current condition if to remain in situ, otherwise remove before refurbishment or demolition following the SafeWork NSW Code of Practice: How to Safely Remove Asbestos (2019);
Chief Mechanical Engineers Building exterior Roof Presume High level panels to roofline	FC panels	Low	Label the item in line with the Asbestos Management Plan (AMP) and the SafeWork NSW Code of Practice: How to Manage and Control Asbestos in the Workplace (2019). Reinspect periodically. Maintain in current condition if to remain in situ, otherwise remove before refurbishment or demolition following the SafeWork NSW Code of Practice: How to Safely Remove Asbestos (2019);

Photograph 8. Western exterior - presume asbestos containing high level flue as observed on [04.07.2022].

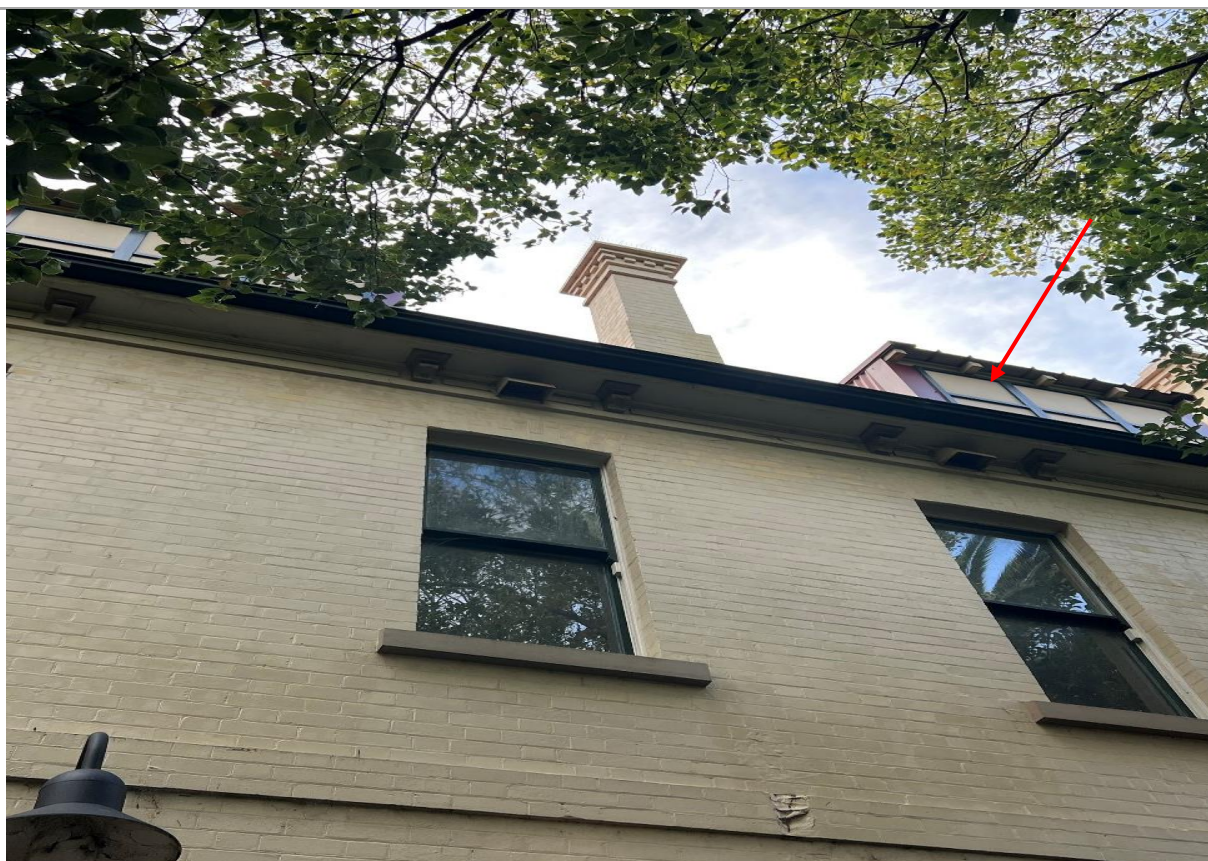
Chief Mechanical Engineers Building exterior Roof High level panels to roofline	FC panels	Low	Label the item in line with the Asbestos Management Plan (AMP) and the SafeWork NSW Code of Practice: How to Manage and Control Asbestos in the Workplace (2019). Reinspect periodically. Maintain in current condition if to remain in situ, otherwise remove before refurbishment or demolition following the SafeWork NSW Code of Practice: How to Safely Remove Asbestos (2019);
Chief Mechanical Engineers Building interior, level 1 21 High level wall lining	FC wall lining	Medium	Remove or label and enclose/encapsulate in line with the Asbestos Management Plan (AMP) by a Class A or B licensed asbestos removal contractor or remove prior to refurbishment or demolition.
Chief Mechanical Engineers Building interior, level 1 Northern room (kitchenette) High level wall lining	FC wall lining	Medium	Remove or label and enclose/encapsulate in line with the Asbestos Management Plan (AMP) by a Class A or B licensed asbestos removal contractor or remove prior to refurbishment or demolition.

Photograph 9. Exterior – presume high level panels to roofline as observed on [04.07.2022].

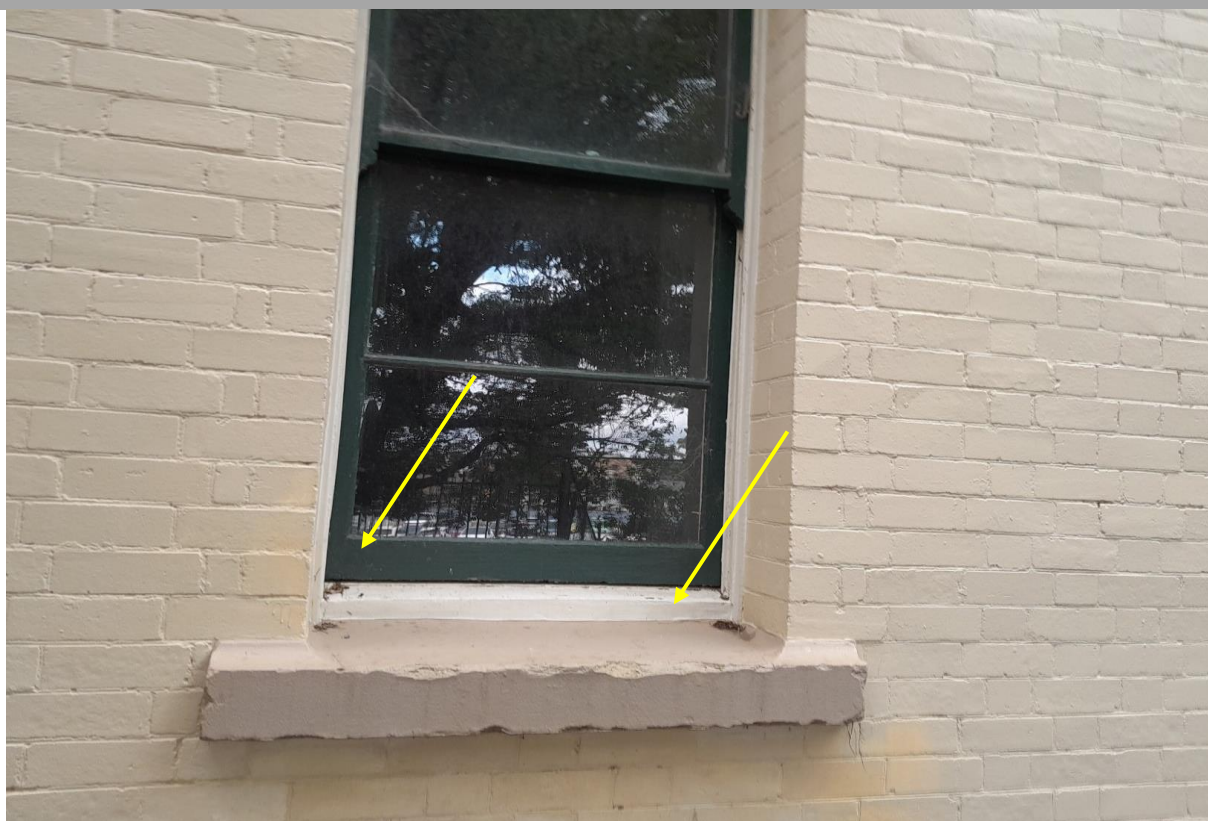
21.07.2022	Chief Mechanical Engineers Building exterior	Throughout exterior	Window frames surround	White lead paint system	60	sq. m	Pb1	10	47320 mg/kg	Fair	Medium	It is recommended to remove flaking areas and stabilize the paint system by overpaint using a lead-free product prior to refurbishment or demolition.	Prior to refurbishment

21.07.2022	Chief Mechanical Engineers Building exterior	Throughout exterior	Window frame	Green lead paint system	80	Linear m	Pb4	10	14685 mg/kg	Fair	Medium	It is recommended to remove flaking areas and stabilize the paint system by overpaint using a lead-free product prior to refurbishment or demolition.	Prior to refurbishment

Photograph 10. Exterior, window frames – Lead containing paint systems to window frame and window frame surround as observed on [21.07.2022].

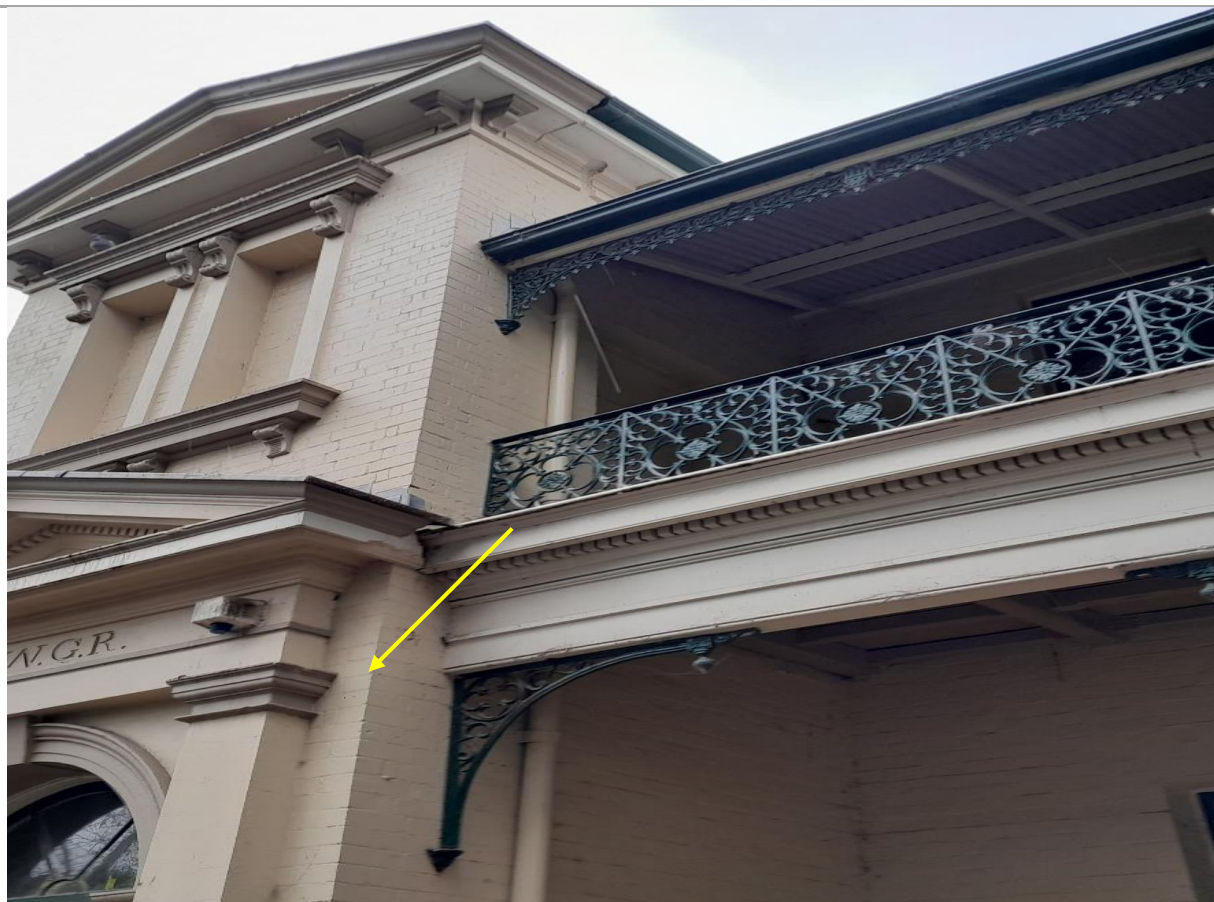
21.07.2022	Chief Mechanical Engineers Building exterior	Throughout exterior	Walls and metal rain water goods	Beige lead paint system	400	sq. m	Pb2	11	80850 mg/kg	Fair	Medium	It is recommended to remove flaking areas and stabilize the paint system by overpaint using a lead-free product prior to refurbishment or demolition.	Prior to refurbishment

Photograph 11. Exterior, walls – Lead containing beige paint system as observed on [21.07.2022].

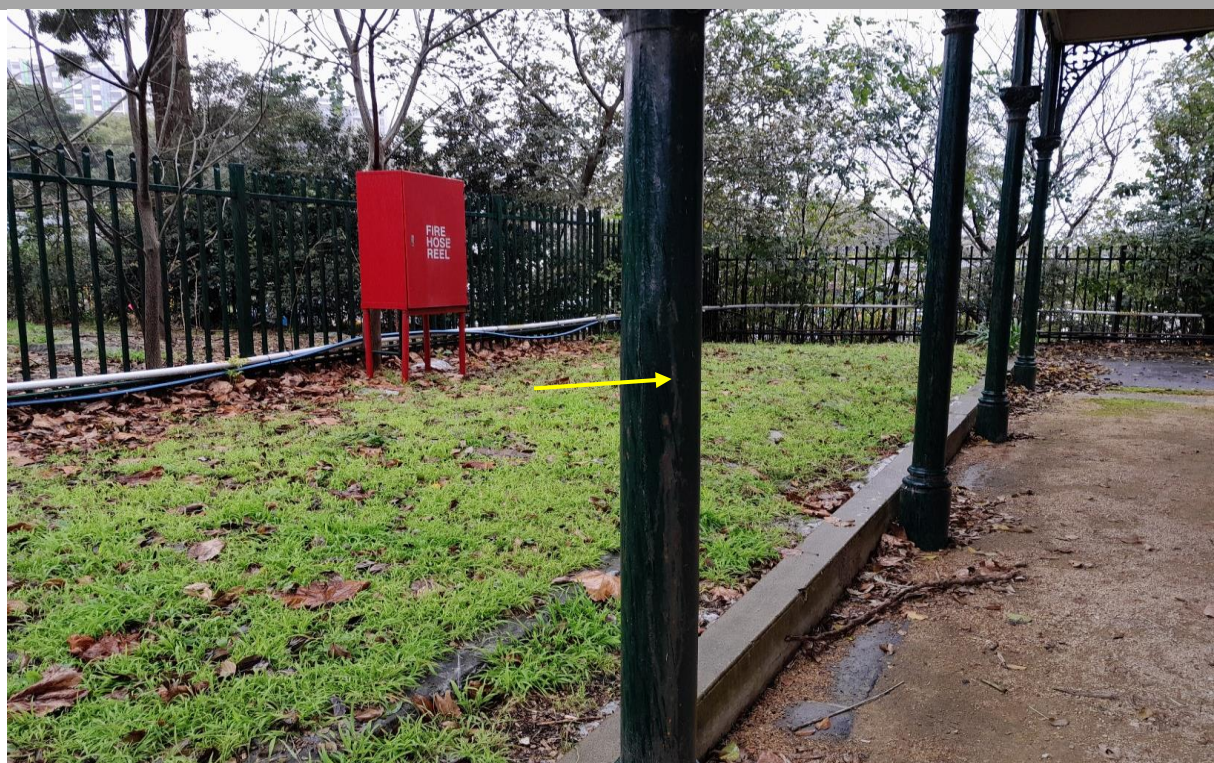
21.07.2022	Chief Mechanical Engineers Building exterior	Throughout exterior	Metal support poles to awning	Green lead paint system	40	Linear m	Pb3	12	8895 mg/kg	Fair	Medium	It is recommended to remove flaking areas and stabilize the paint system by overpaint using a lead-free product prior to refurbishment or demolition.	Prior to refurbishment

Photograph 12. Exterior, support poles – lead containing green paint system as observed on [21.07.2022].

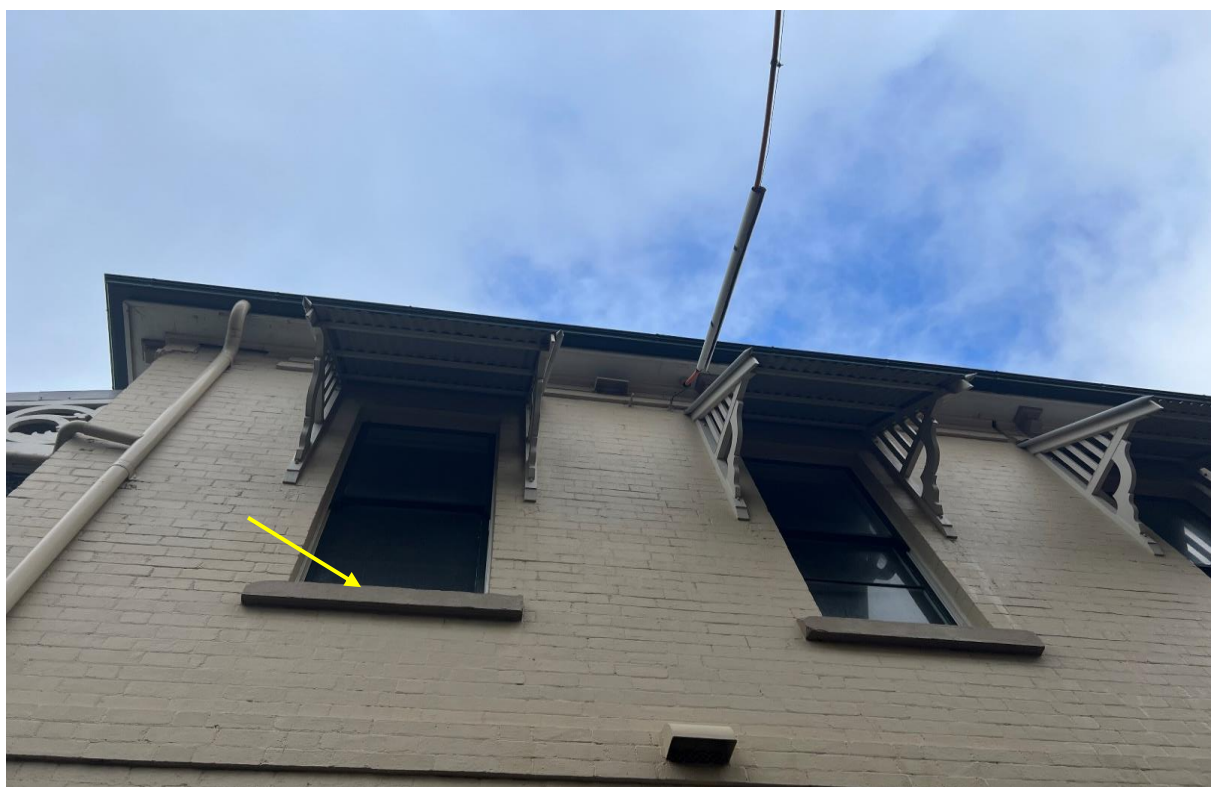
Photograph 13. Exterior, windowsills – lead containing paint as observed on [21.07.2022].

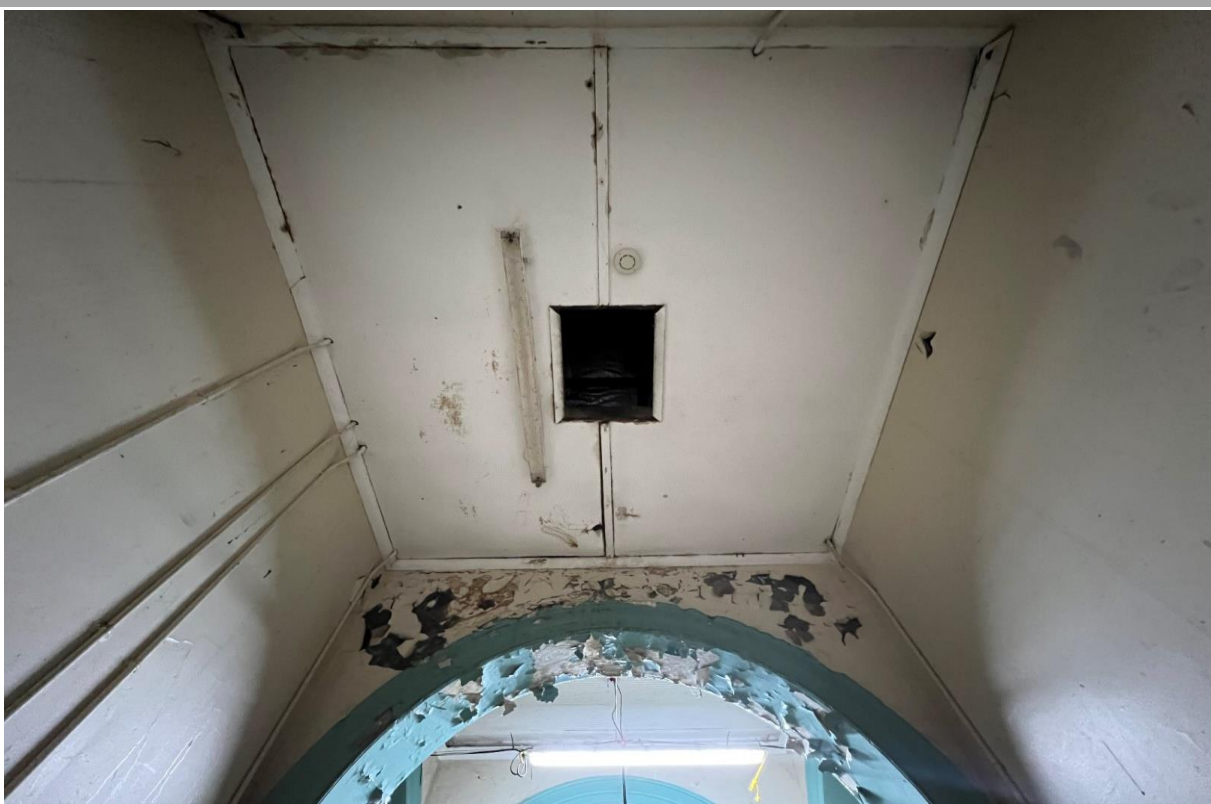
Photograph 14. Interior, level 1, north room kitchenette – no access within ceiling void due to unsafe access as observed on [04.07.2022].

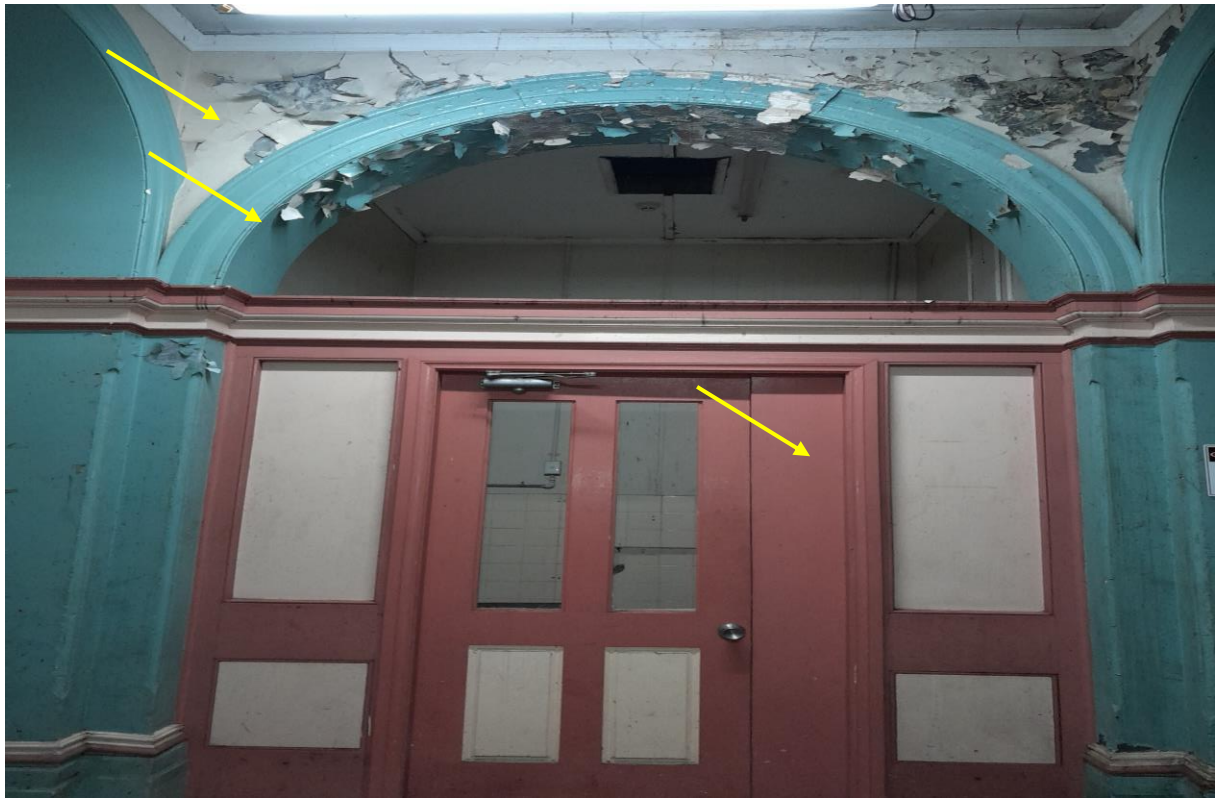
Photograph 15. Interior, level 1 hallway pink, turquoise and beige lead paint systems as observed on [04.07.2022].
