8 July 2022

**Transport for NSW**  
680 George Street  
Sydney NSW 2000

**Environmental cleaning summary letter at 505 Wilson Street, Eveleigh, NSW.**

122040L01V01

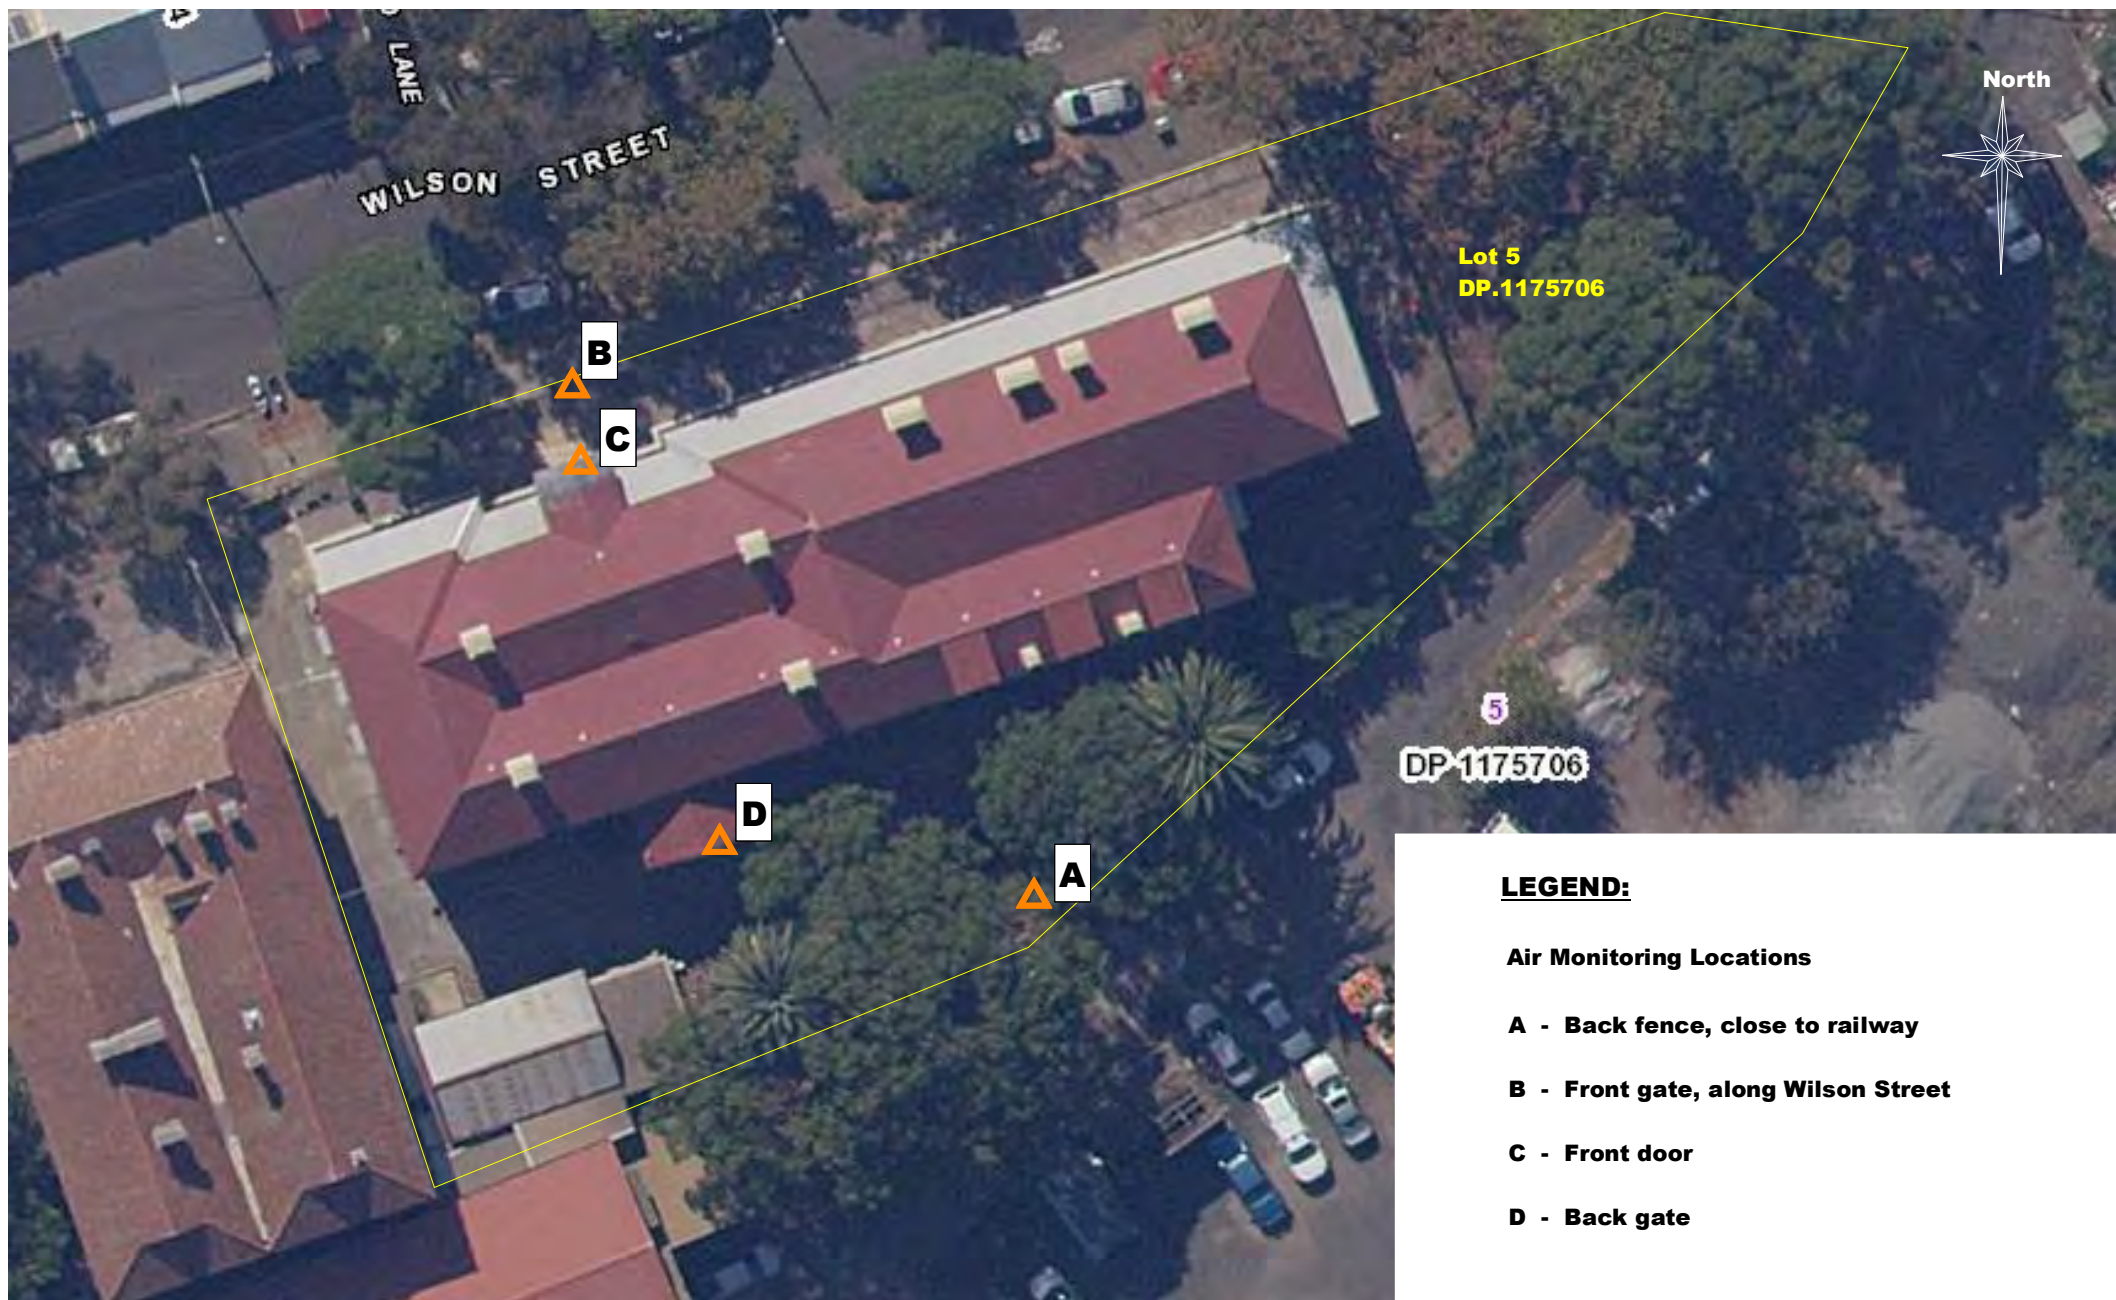
**Figure 2**

Air monitoring results reported during the remediation works did not exceed outlined criteria of 0.15 mg/m<sup>3</sup> set out in *Adopted National exposure standards for atmospheric contaminants in the occupational environment (NOHSC:1003(1995))*. Therefore, works conducted did not present an actual risk to onsite construction workers / contractors and offsite neighbouring residents and general public.

Air monitoring results reported < 0.01 fibres/ml during the excavations therefore works conducted did not present an actual risk to onsite construction workers / contractors and offsite neighbouring residents and general public.

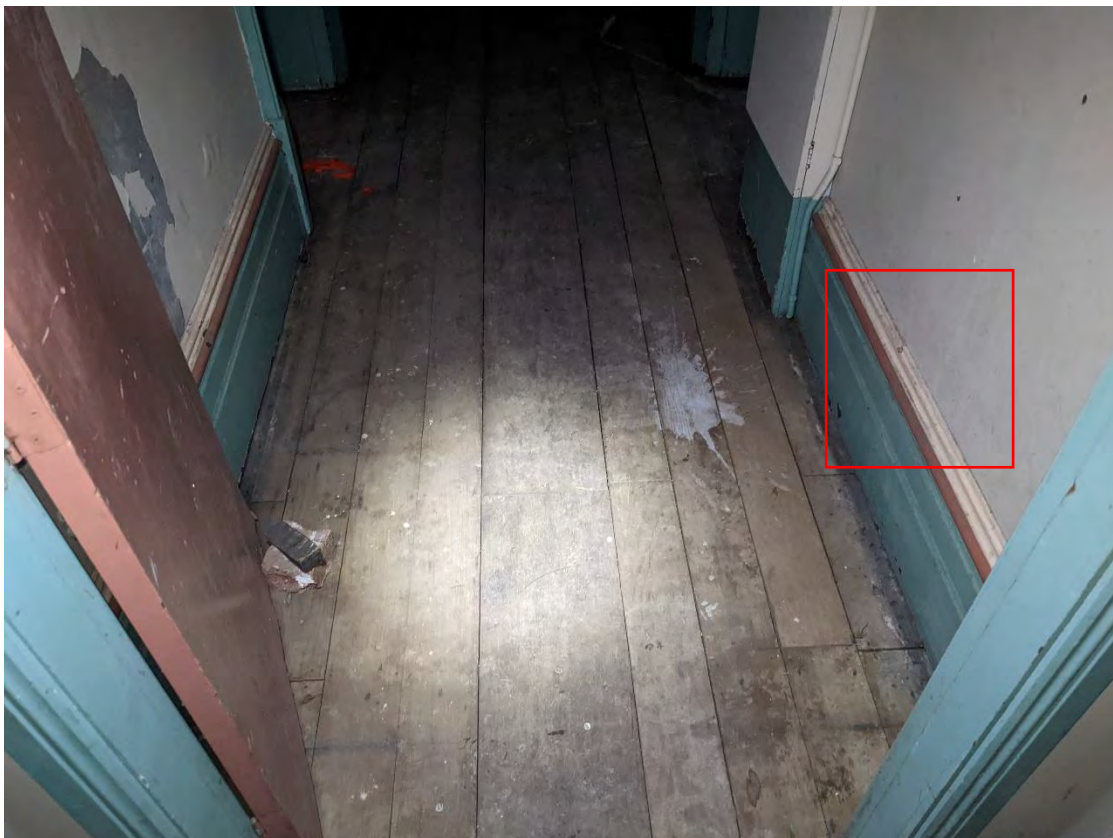
Sampling Date	Sample ID	Laboratory Reference ES2216027 / Sample No	Result (ug/swab) <sup>3</sup>
5 May 2022	US_S3	Wall and skirting boards / upstairs	189 <sup>1</sup>
	US_S5	Cabinet surface (roof facing) / upstairs	73.4
	US_F6	Plywood floor covering / upstairs	269 <sup>2</sup>
	US_F7	Plywood floor covering / upstairs	378 <sup>2</sup>
	STR_S1	Handrail / staircase	374 <sup>1</sup>
	STR_S2	Handrail / staircase	92.1 <sup>1</sup>
	STR_S3	Handrail / staircase	72.1 <sup>1</sup>
	DS_A1_F1	Floorboards / downstairs	734
	DS_A2_S2	Doorknob / downstairs	775
	DS_A3_S3	Power plug / downstairs	156
	DS_A5_S5	Doorframe / downstairs	65.1 <sup>1</sup>
	DS_A7_S7	Doorknob / downstairs	58
	DS_A10_S10	Doorknob / downstairs	244
	DS_A11_S11	Ledge (roof facing) / downstairs	130
	DS_A14_S14	Cabinet surface (roof facing) / downstairs	1260
	DS_H1_F1	Floorboards / downstairs	783
	DS_H1_S2	Keypad for alarm / downstairs	240
	DS_H3_F5	Floorboards / downstairs	2050 <sup>2</sup>

**Photo Plate 1: Sample location at US\_S3. Refer to F11 on Attachment B. Red box denotes swab location.**

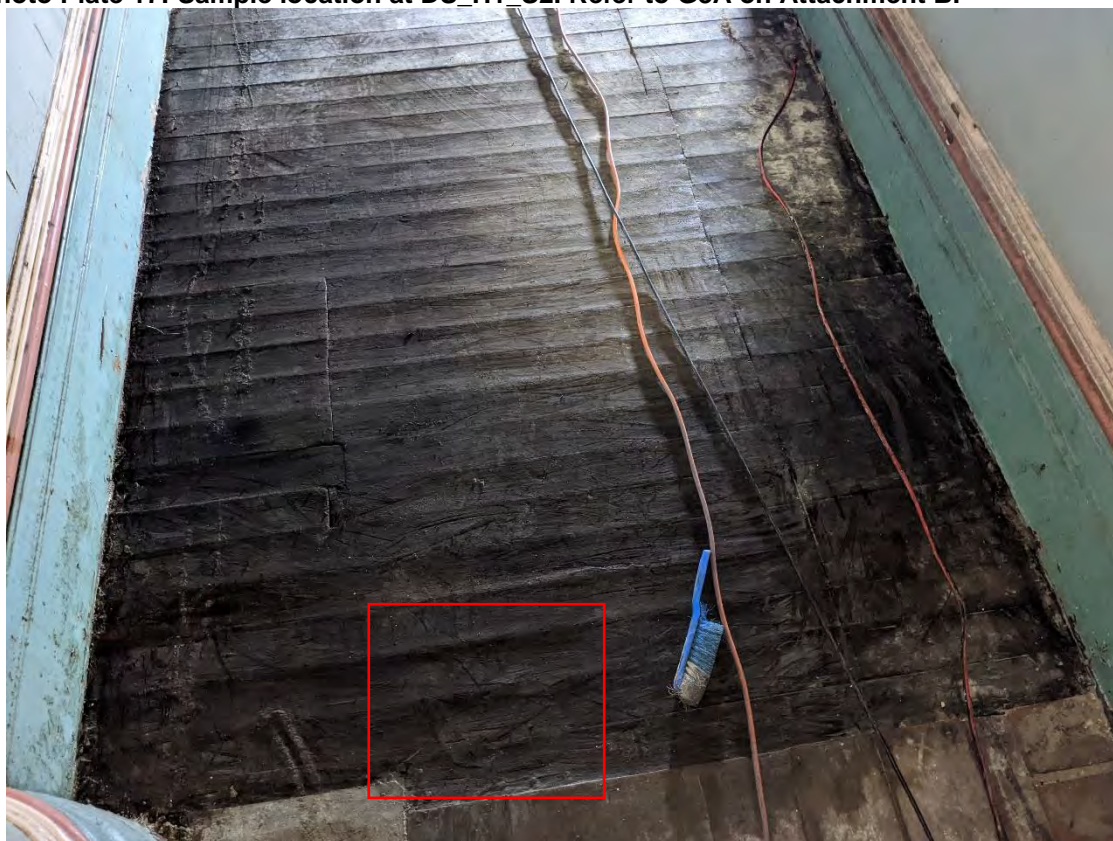
**Photo Plate 18: Sample location at DS\_H3\_F5. Refer to G24 on Attachment B.**

1. Degraded lead paint contained within swab area
2. Ingrained lead paints contained within moist plywood floor coverings
3. Swab results have been covered to mg/kg to compare with relevant guidelines. Results are indicative to guide decision making

Reported lead results are below the adopted threshold of 1500 mg/kg under HIL D – commercial / industrial exposure scenario (NEPM 2013) with the exception of DS\_H3\_F5 (2,050 mg/kg).

- Lead paint and dust remains within the building, this risk can only be fully mitigated through the removal of all wall and ceiling coverings which contain lead paint, removal of all paint from door and window frames or sealing with new paint and stripping and revarnishing of timber floor or covering with new floor finishes.
- Due to the poor condition of the building and presence of flaking paint on walls and ceilings has led to the accumulation of lead paint over time post cleaning.
- The risk of respirable asbestos fibres within the buildings has been deemed low.
- No renovation works should be undertaken until all lead-based paint has been stripped and removed from the building.
- Visiting the building should be avoided if entry to the site should be required full PPE including boot coveralls, P2 mask are required and touching any surfaces during their occupancy should be avoided.

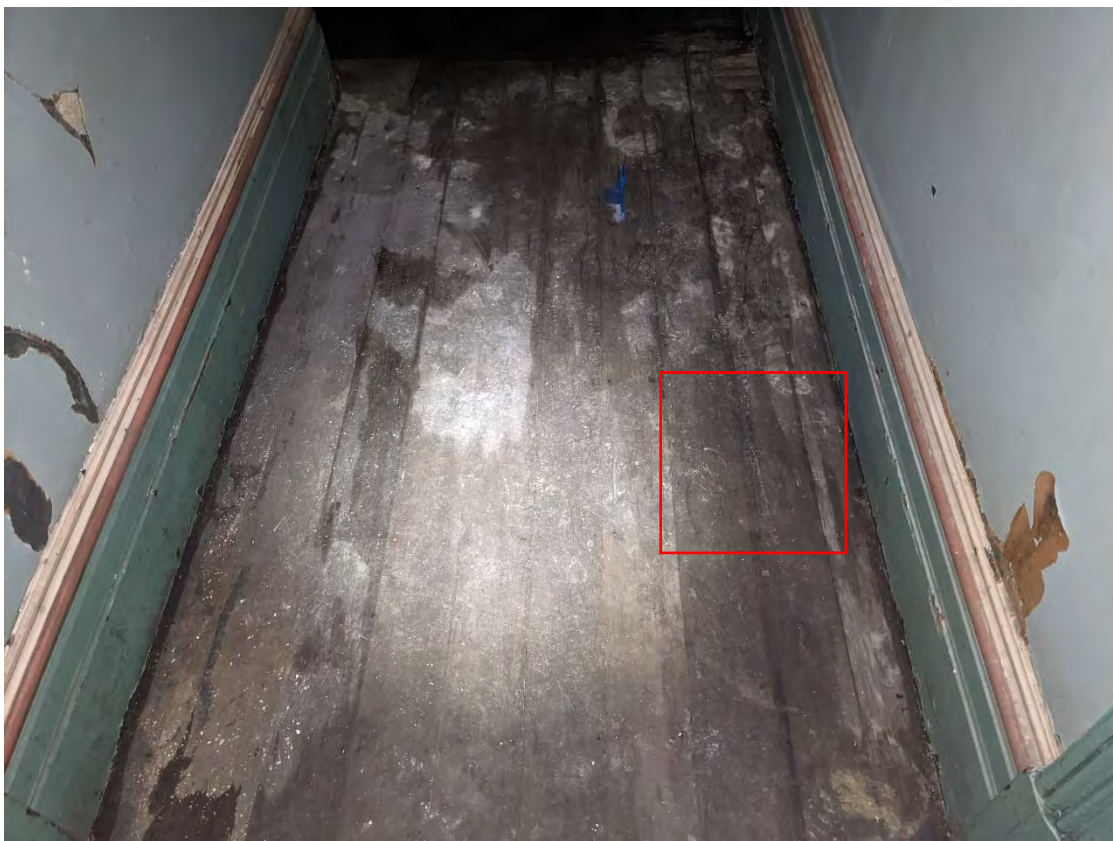
**Photo Plate 19: Sample location at DS H3 F6. Refer to G24 on Attachment B.**

DS_H3_F6	Floorboards / downstairs	860
	DS_H3_S7	Interior windowsill / downstairs	1470 <sup>1</sup>
	DS_H4_F10	Plywood floor covering / downstairs	347
	DS_H5_S12	Switch board (roof facing) / downstairs	541
