## 9. Inventory Sheets

This chapter includes the inventory sheets for each room within the CME Building. Each datasheet includes:

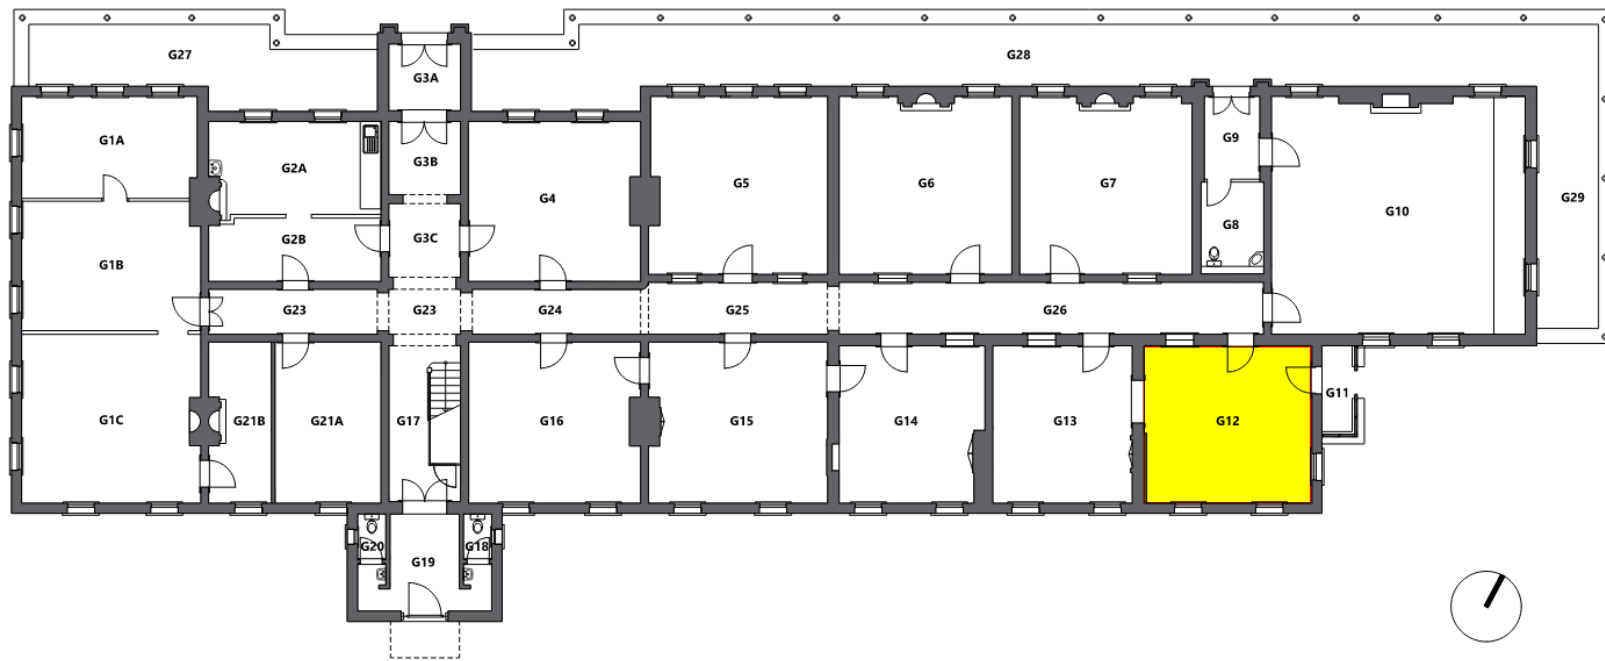
CME Building – Room G12		
Fabric	Current Condition	Description and Recommendation
Floor	Very Poor	<p><b>Description:</b> Large missing sections of floorboards infilled with water damaged yellow tongue particleboard, narrow hardwood floorboards to the rest with water damage. Masonry infill threshold between rooms G12 and G13.</p> <p><b>Recommendation:</b> All floors on ground floor will need to be temporarily removed to facilitate subfloor works, including installation of concealed services. It is intended to salvage as much as possible of the remnant floorboards for reuse in accordance with Section 3.1.4. Floors in the <i>Physical Condition and Schedule of Conservation Works</i> methodology for floor works. Salvaged flooring from the entire building should collated and graded for condition from best to worst before being re-laid at the completion of subfloor works. Priority should be given to the rooms in key view lines and of most significance to have the floorboards in the best condition as per section 3.1 - 6 General recommendations in the <i>Physical Condition and Schedule of Conservation Works</i></p> <p>The threshold should be dressed and maintained or replaced with a more suitable finish. It should remain as an interpretive feature as evidence of the wall that was originally there.</p> <p><b>Grading of Significance:</b> High</p>

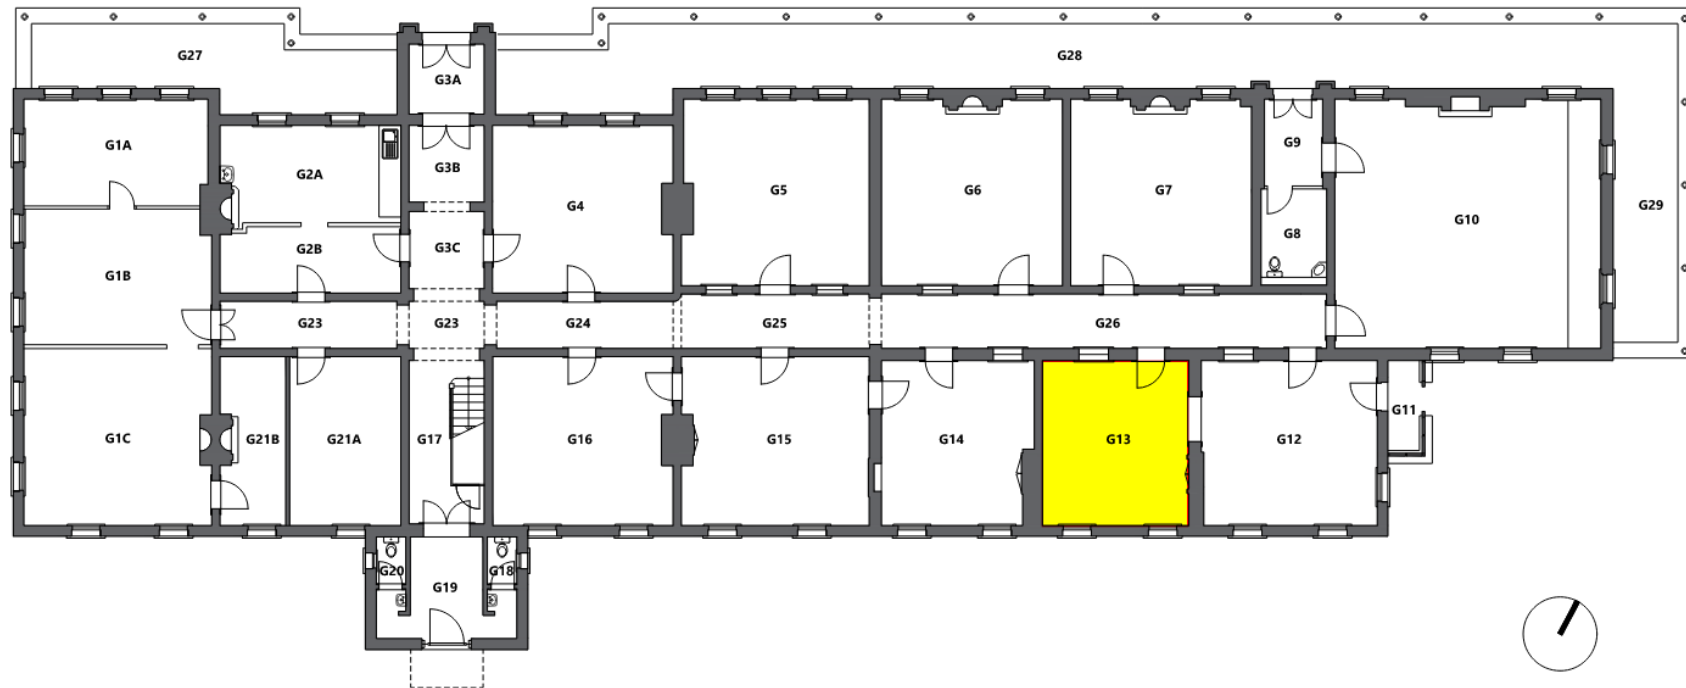
CME Building – Room G13		
Fabric	Current Condition	Description and Recommendation
Floor	Poor	<p><b>Description:</b> Narrow hardwood floorboards with water damage. Several damaged boards and infill repairs. Masonry infill threshold between rooms G12 and G13.</p> <p><b>Recommendation:</b> All floors on ground floor will need to be temporarily removed to facilitate subfloor works, including installation of concealed services. It is intended to salvage as much as possible of the remnant floorboards for reuse in accordance with Section 3.1.4. Floors in the <i>Physical Condition and Schedule of Conservation Works</i> methodology for floor works. Salvaged flooring from the entire building should collated and graded for condition from best to worst before being re-laid at the completion of subfloor works. Priority should be given to the rooms in key view lines and of most significance to have the floorboards in the best condition as per section 3.1 - 6 General recommendations in the <i>Physical Condition and Schedule of Conservation Works</i></p> <p>The threshold should be dressed and maintained or replaced with a more suitable finish. It should remain as an interpretive feature as evidence of the wall that was originally there.</p> <p><b>Grading of Significance: High</b></p>

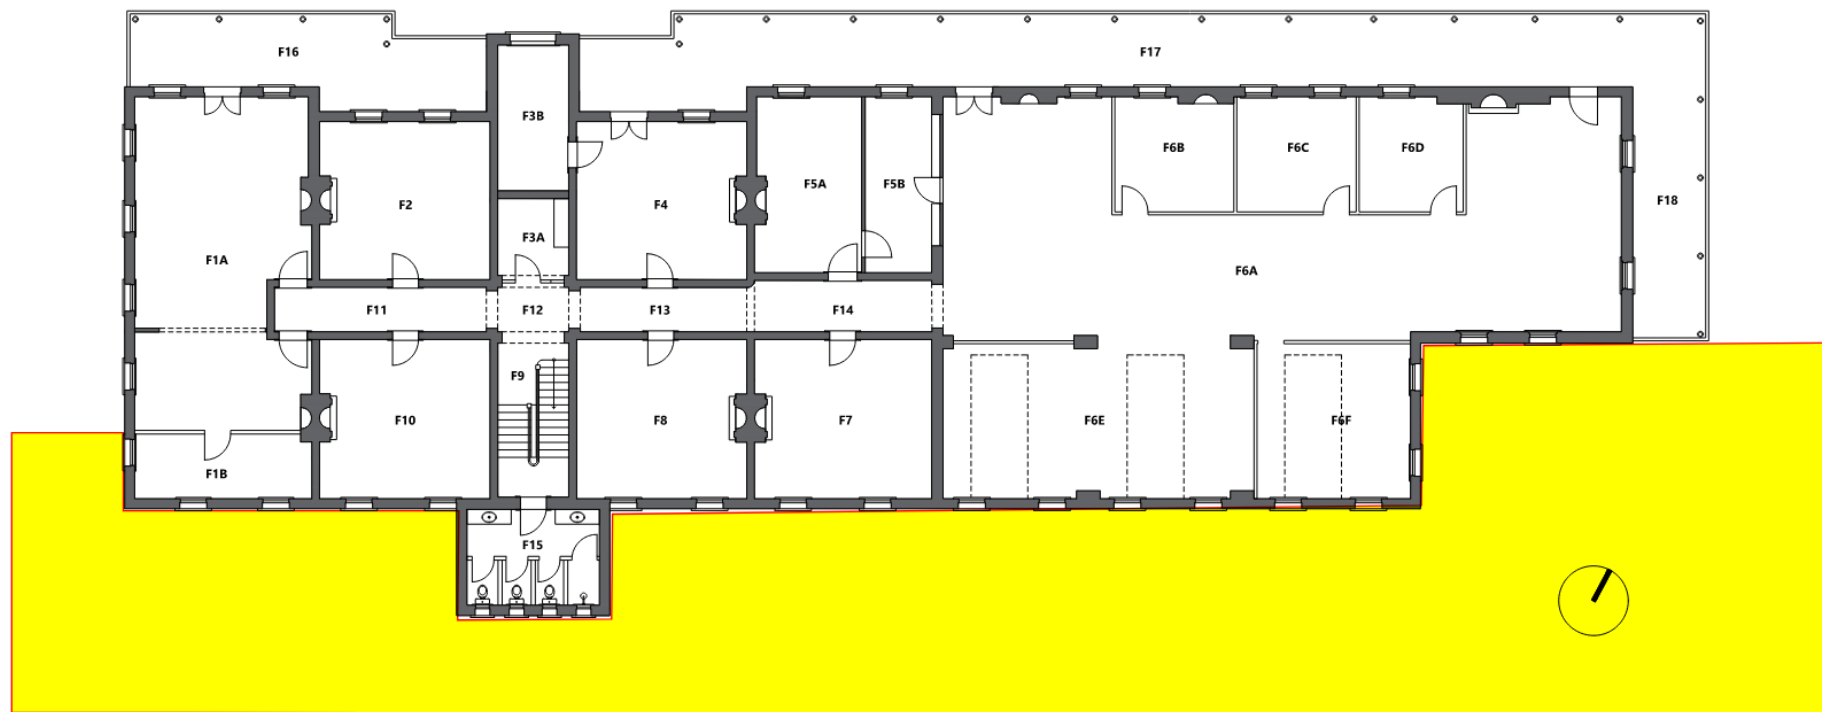
CME Building – External South Elevation		
Fabric	Current Condition	Description and Recommendation
Floor	Poor	<p><b>Description:</b> Poor condition asphalt. With brick dams around the subfloor ventilation grills. The area is poorly graded and not compliant with access requirements. Various drainage pits in poor condition.</p> <p><b>Recommendation:</b> Area to be regraded and asphalt reinstated. All levels to be amended to suit compliance. See Landscape Plans for further details.</p> <p><b>Grading of Significance:</b> Neutral</p>
Walls	Fair	<p><b>Description:</b> External Paint finish brick walls. Gooseneck style lights are located in various locations at high level. All high level brick vents have a metal shroud protecting them from the weather.</p> <p><b>Recommendation:</b> Repair and prep spot repairs and repoint wall as necessary. Prepare existing paint for overcoating and repaint. See also section 3.1.3 Painted Surfaces in the <i>Physical Condition and Schedule of Conservation Works</i> report for further treatment recommendations.</p> <p><b>Grading of Significance:</b> High</p>

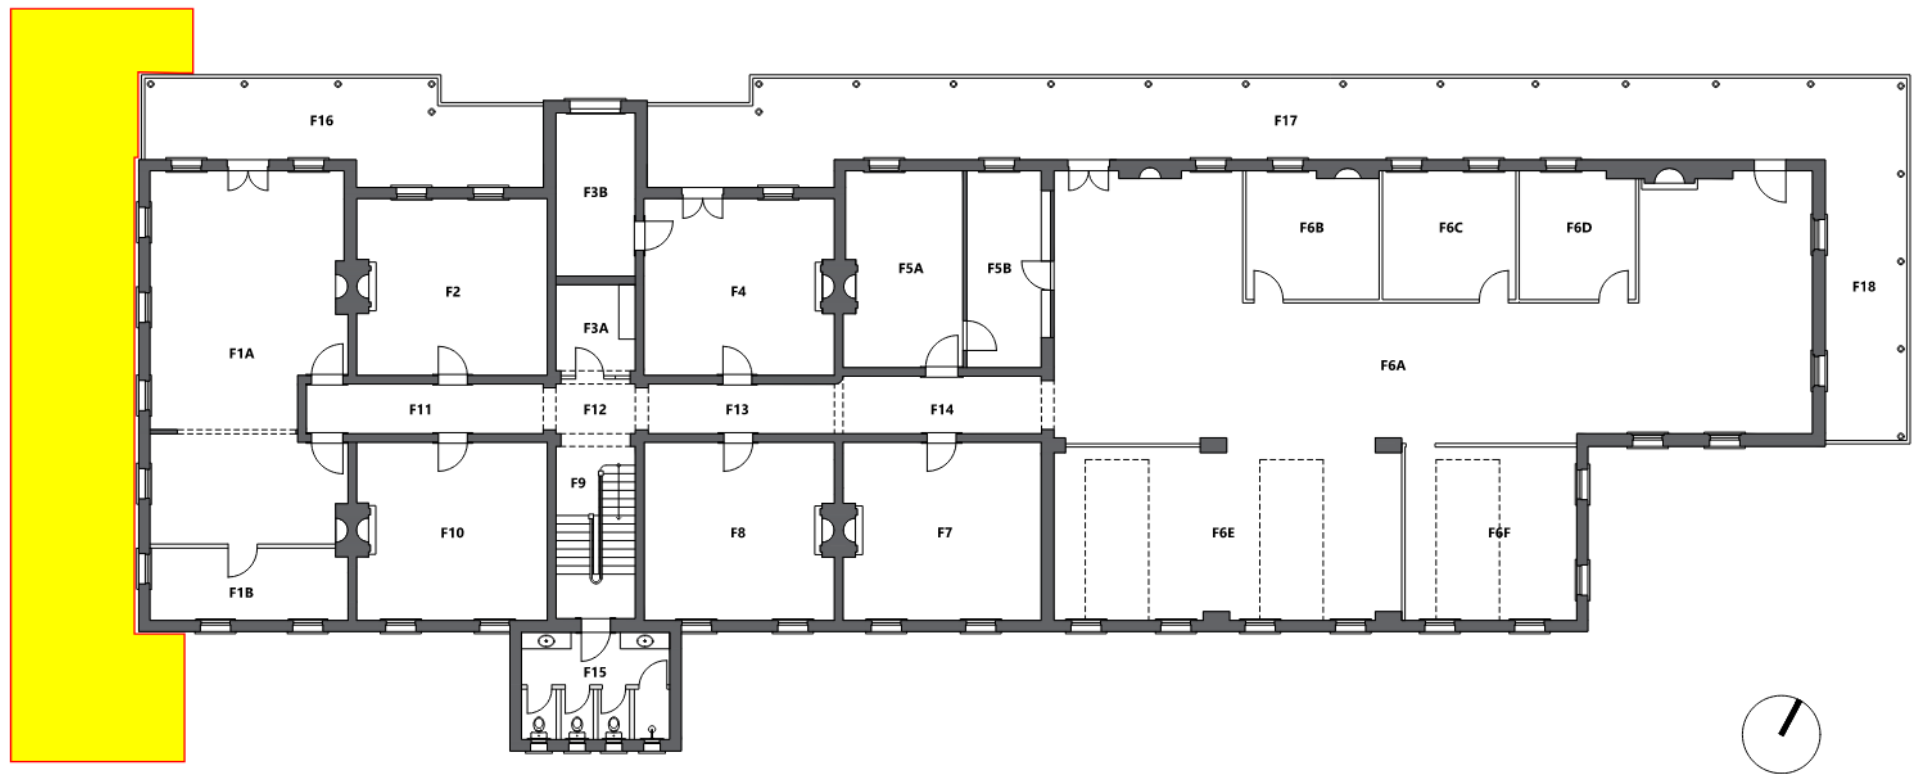
CME Building – External West Elevation		
Fabric	Current Condition	Description and Recommendation
Floor	Poor	<p><b>Description:</b> Poor condition asphalt. With brick dams around some of the the subfloor ventilation grills. The area is poorly graded and not compliant with access requirements to the Veranda.</p> <p><b>Recommendation:</b> Area to be regraded and asphalt reinstated. All levels to be amended to suit compliance. See Landscape Plans for further details.</p> <p><b>Grading of Significance:</b> Neutral</p>
Walls	Fair	<p><b>Description:</b> External Paint finish brick walls. Gooseneck style lights are located in various locations at high level. All high level brick vents have a metal shroud protecting them from the weather.</p> <p><b>Recommendation:</b> Repair and prep spot repairs and repoint wall as necessary. Prepare existing paint for overcoating and repaint. See also section 3.1.3 Painted Surfaces in the <i>Physical Condition and Schedule of Conservation Works</i> report for further treatment recommendations.</p> <p><b>Grading of Significance:</b> High</p>

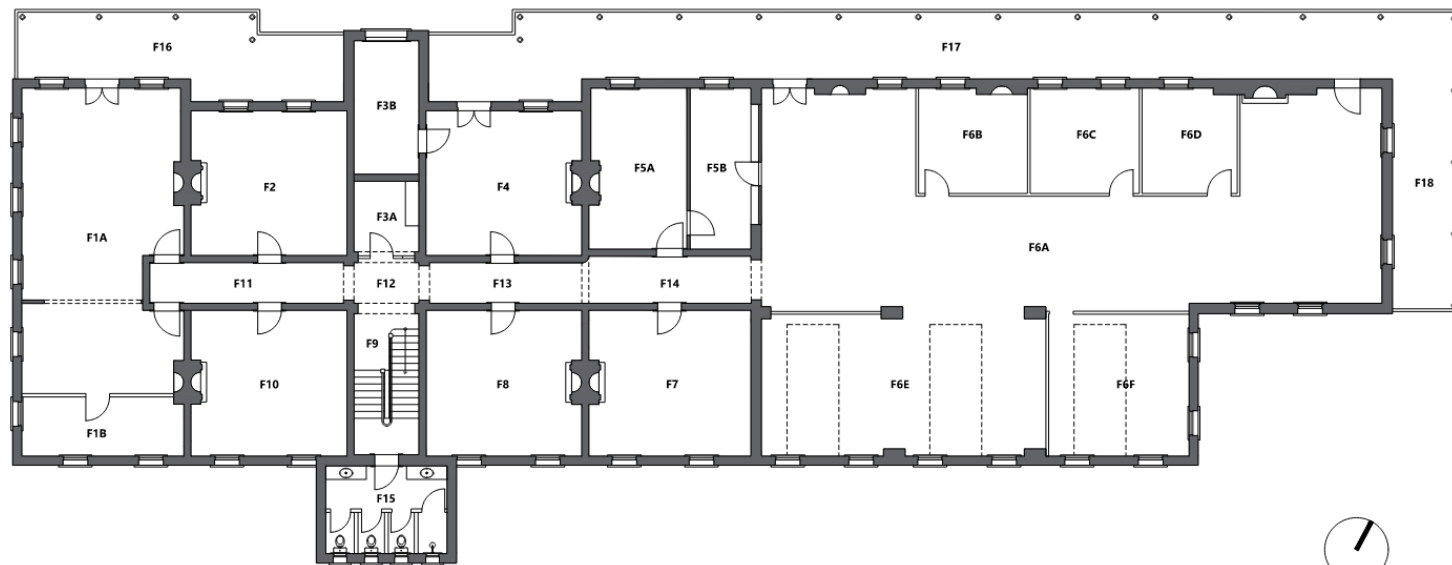
CME Building – Front Fence		
Fabric	Current Condition	Description and Recommendation
Metal Fence	Poor	<p><b>Description:</b> Poor condition metal fence, rusty in places. At the western end at the driveway, a large pair of gates with inoperable openers swing inwards into the site. At the eastern end, a single gate provides access from the Wilson street footpath via some concrete stairs.</p> <p><b>Recommendation:</b> Fence to be removed and replaced. See Landscape Plans for further details.</p> <p><b>Grading of Significance:</b> Intrusive</p>
Retaining Wall	Poor	<p><b>Description:</b> Concrete sleeper retaining wall with vertical railway iron retaining posts. Evidence of concrete cancer and is leaning towards the street. Damaged in places.</p> <p><b>Recommendation:</b> Remove and replace retaining wall. See Landscape Plans for further details.</p> <p><b>Grading of Significance:</b> Intrusive</p>
