## **NEW PRIMARY SCHOOL AT GREGORY HILLS**

**GREGORY HILLS, NSW**

## **DEVELOPMENT PROPOSAL ARBORICULTURAL IMPACT ASSESSMENT REPORT**

*Ref No- 9622*

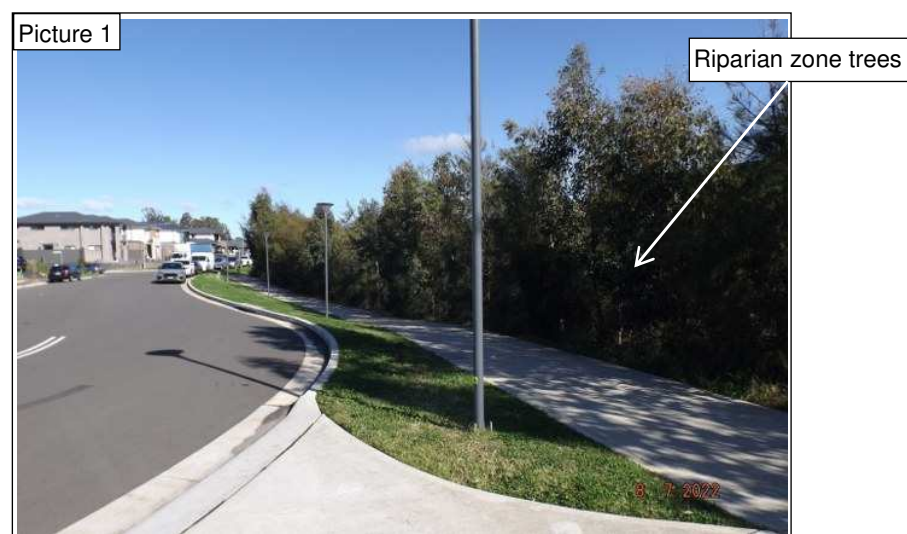
### 1.1 Riparian zone southwest(SW) of 'the site'

- 1.1.1 The riparian zone contains recently planted young native specimen trees. All trees are closely grouped, are at or less than 6m in height containing basal stem diameters between 100 & 150mm(Ø). The Structural Root Zone (SRZ) radius being a development activity exclusion zone is calculated at 1.5m, with the radial Tree Protection Zone (TPZ) 2m from the centre of individual trees. The trees are viable trees and capable of further. Based on site observations the existing footpath provides a suitable ground protection barrier. Should development occur adjacent these trees further arborist advice and tree protection fencing is recommended to be installed under the guidance and certification of appointed project arborist.

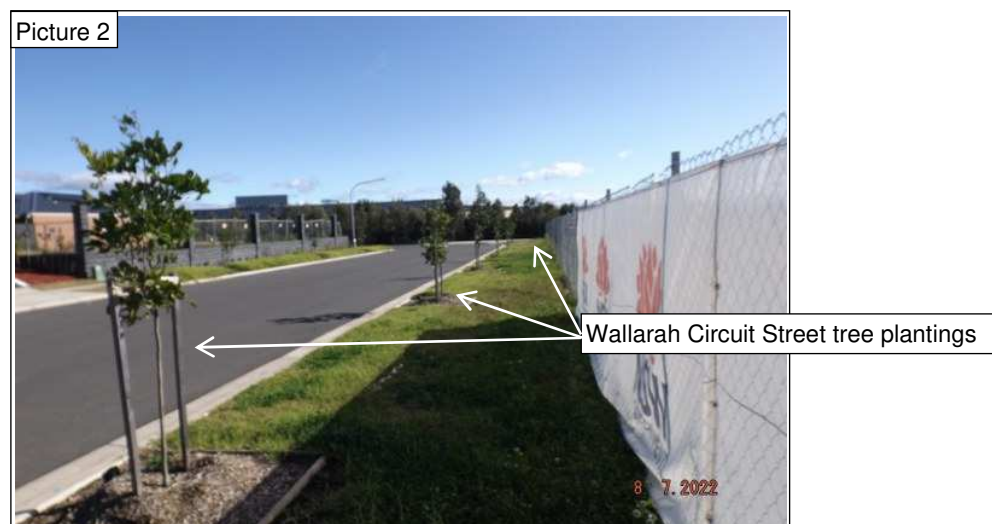
### 1.2 Wallarah Circuit Street tree plantings

- 1.2.1 The Street tree plantings consist of Tuckeroo trees (*Cupaniopsis anacardioides*). They not established trees being very young plantings having basal diameters <50mm(Ø). The trees are likely to grow to provide the desired canopy cover for street tree plantings with risk of slip hazards on public pathways or hard surfaces during seed fall.

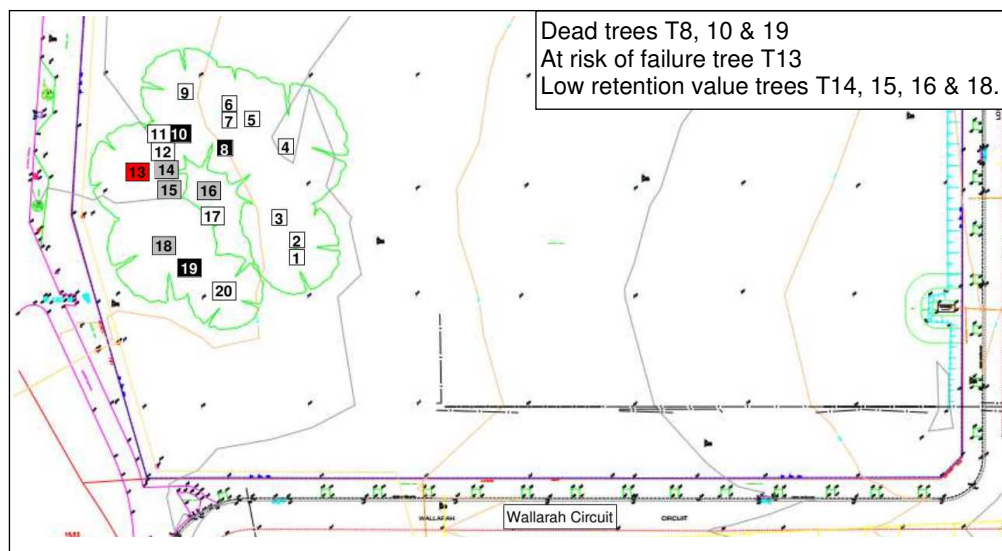
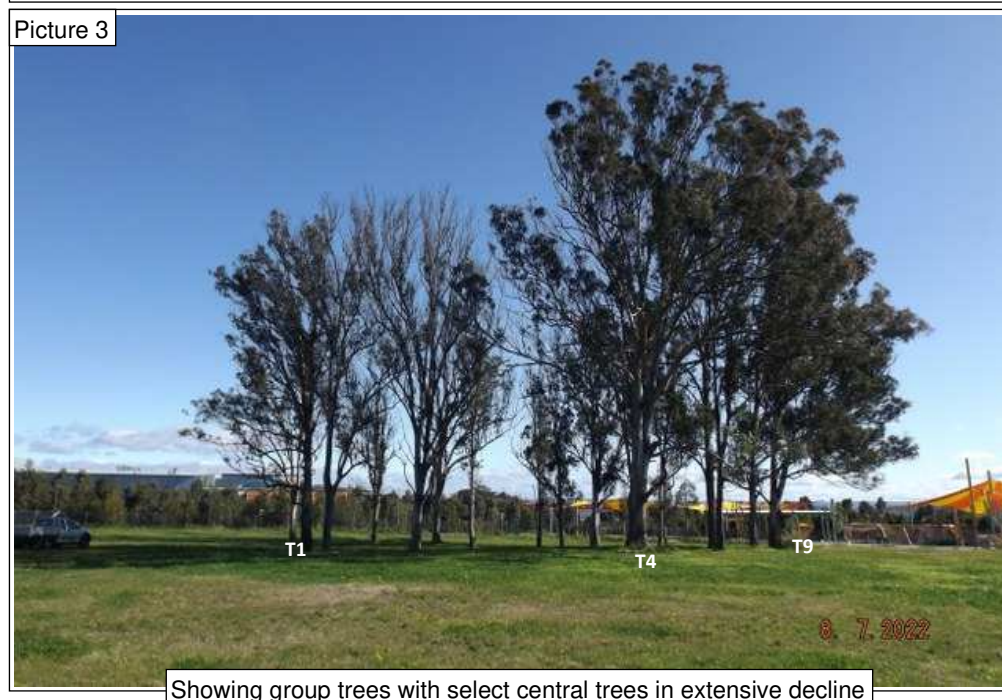
Figure 1, tree retention value site plan

- 1.4.2 Dead trees: Dead or near dead trees are identified as trees:
- T8, 10 & 19.
- The trees are likely to stand dead within the assessment period where during this time large limb drop can be expected. Whole tree collapse is also likely at some stage as the anchoring root zone degrades in its support function. The trees are therefore considered at risk of failure trees where person(s) or structures should be limited or prevented within a tree or tree part fall range.

- 1.4.3 High risk of failure tree(s): One (1) tree T13 has been assessed as a structurally defective tree and highly likely to fail. The tree contains a deep open cavity and unsound surrounding wood on three (3) sides of the lower trunk. The tree is weight loaded to the west(W) by mass canopy weight and branch extension where should the tree fail contact within the adjacent neighbouring playground is highly likely. Given estimated tree height of 22m the target area is determined at 24.2m where the target zone of at or near 7m within the adjoining property will be affected by tree fall in the westerly direction.

1.4.5 Remaining trees 1, 2, 3, 4, 5, 6, 7, 9, 11, 12, 17 & 20 are considered somewhat viable trees without change in existing site conditions or modification within their Tree Protection Zone (TPZ) radiuses as indicated within the SRZ & TPZ distance column of Appendix- F.

- The tree has been identified for removal to eliminate associated risks and consequence of injury or damages in the event of failure.

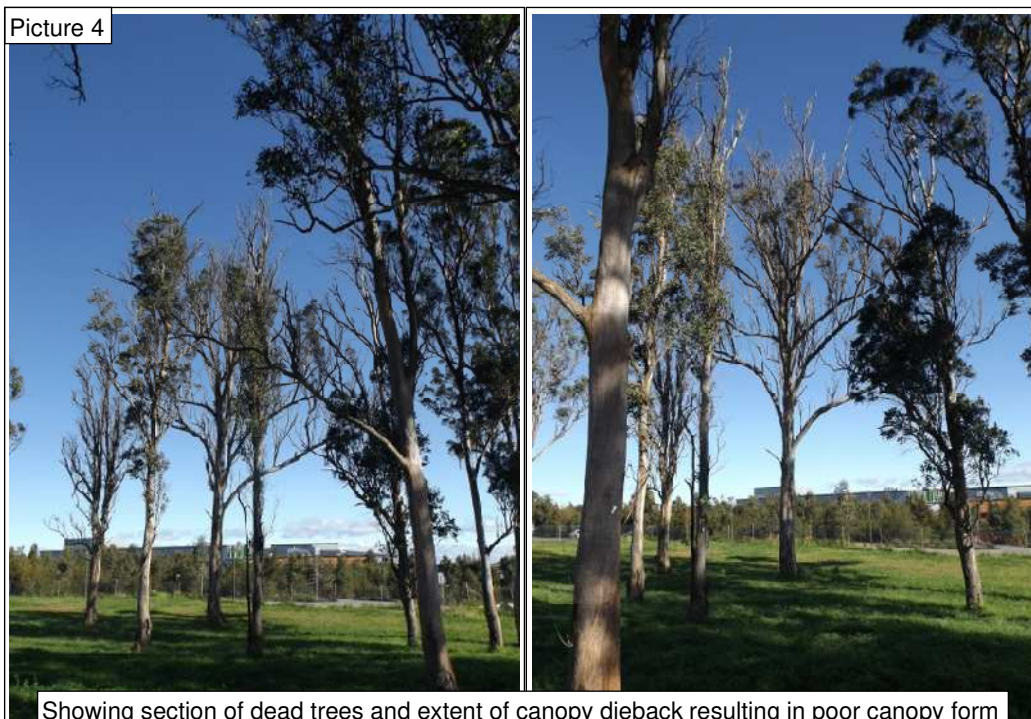
- 1.5.2 Given that trees 8, 10 & 19 are dead trees that will likely fail at some stage the consequence of failure is likely to be low or negligible as no person or structures are within the site. Design should therefore be mindful of placing person or structures at risk within a dead tree fall range or target area being tree height + 10%. The trees have been recommended for removal to accommodate the development proposal.

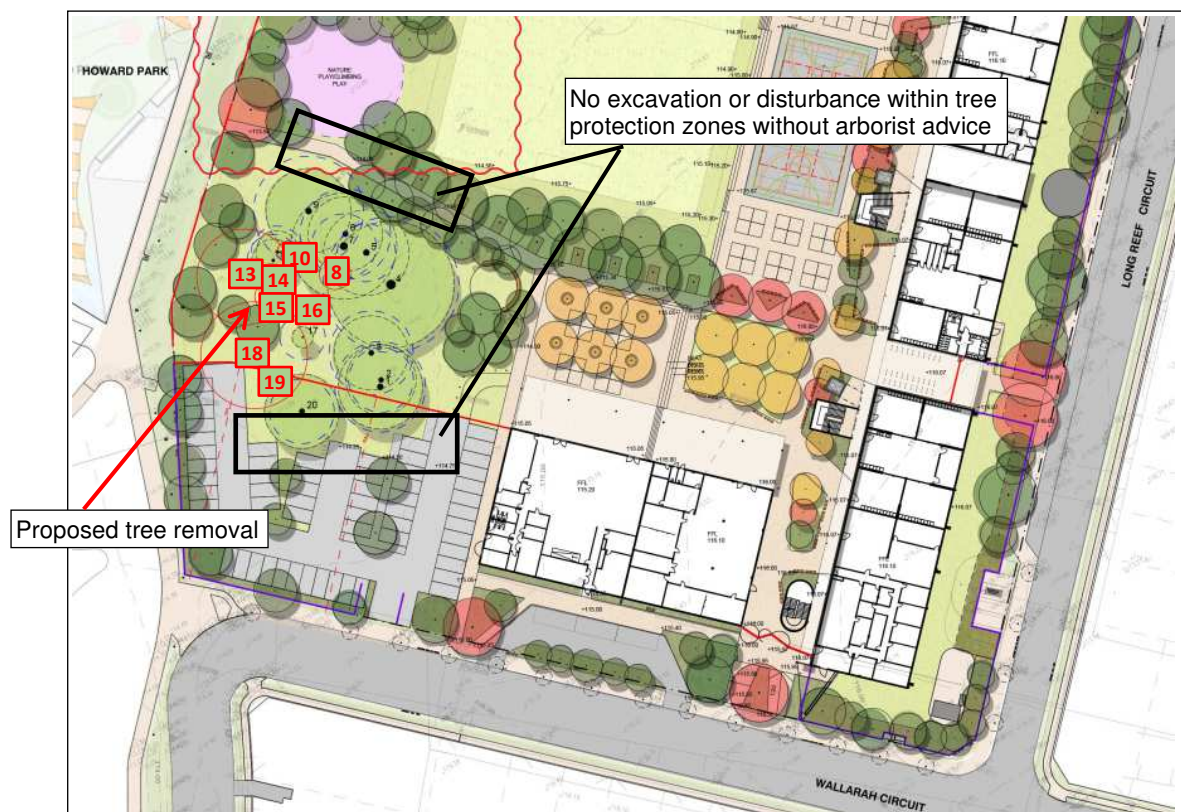
Figure 2, showing proposed development footprint & tree removal plan

The identified development impacts and/or design requirements have been detailed within Appendix- F.
