# TREE SURVEY

## MONITORING & CERTIFICATION

**Airtrunk Data Centre**  
**51 Huntingwood Drive, Huntingwood**  
**Inspection 9**

**13 November 2025**

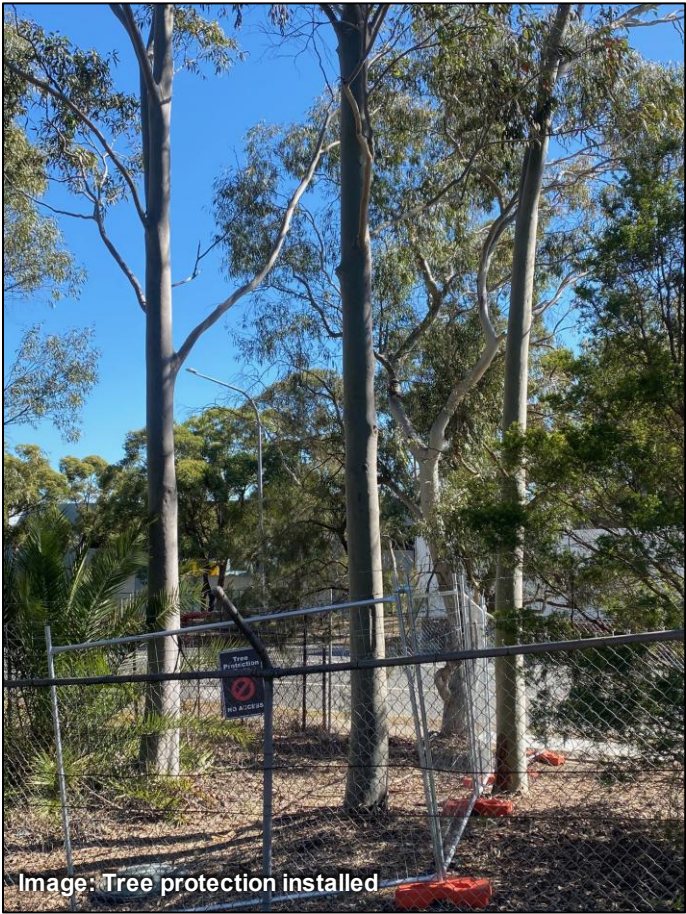
Image: Tree protection installed

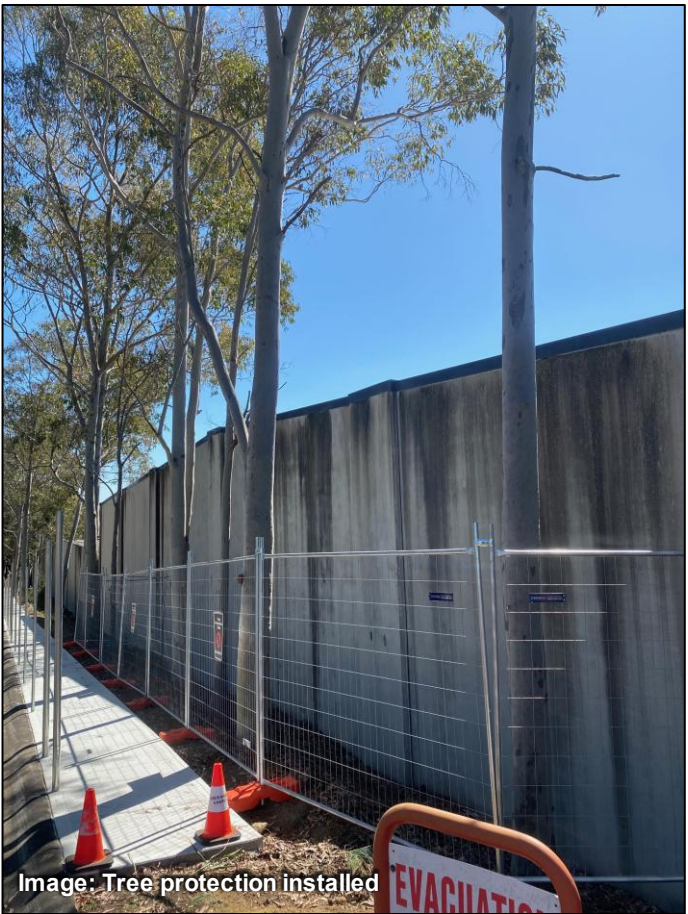
Image: Tree protection installed

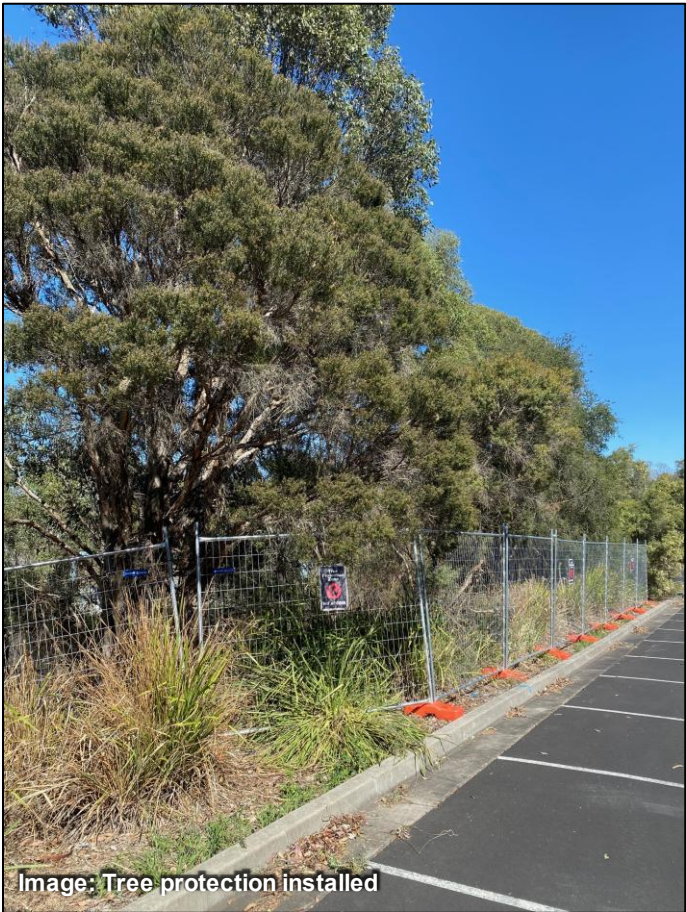
Image: Tree protection installed

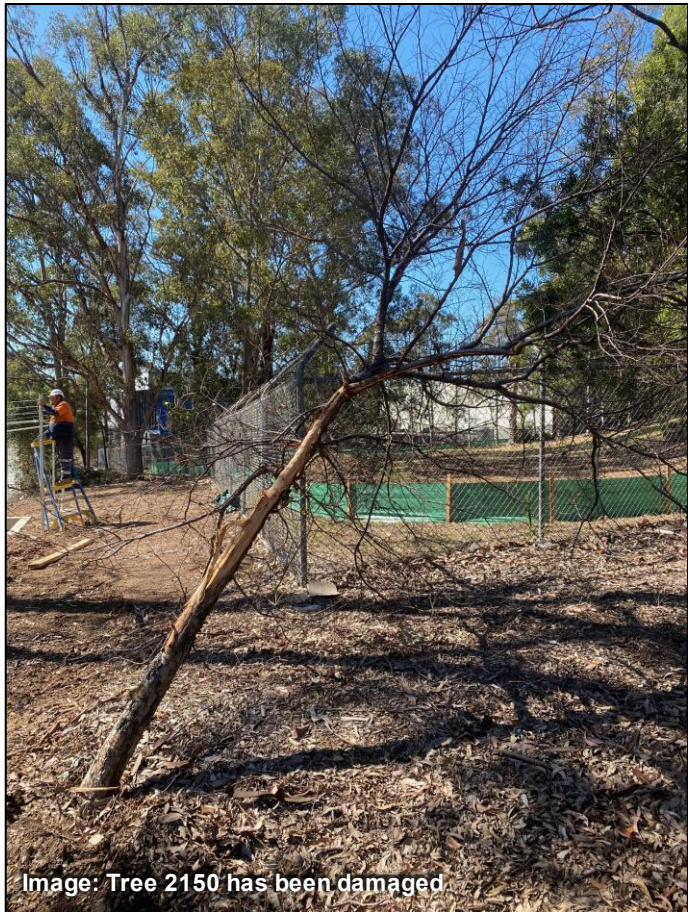
- 75% of the tree protection fencing has been installed in accordance with the approved tree protection plan.
- Tree protection has not yet been installed around Trees 1, 2, 164, 165, 166, 935, 2208, 2212, 2213, 2214, 2215, 2216, 2217, 2218, 2219, 2220, 2281.
- Tree 2150 was damaged by construction activities. This tree is small, non-native, and recommended for removal (previously proposed to be retained).

Image: Tree 2150 has been damaged

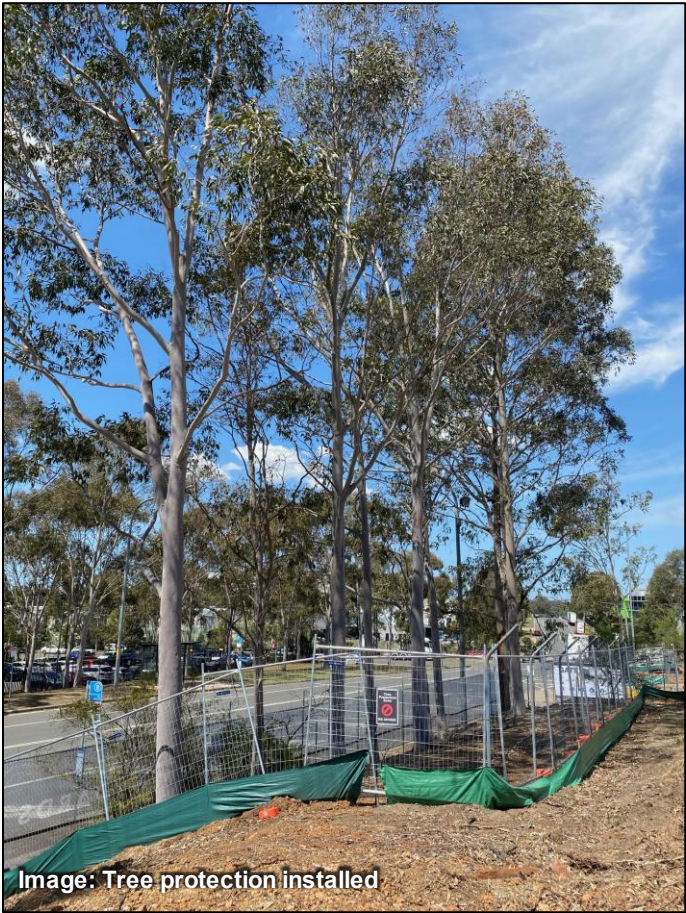
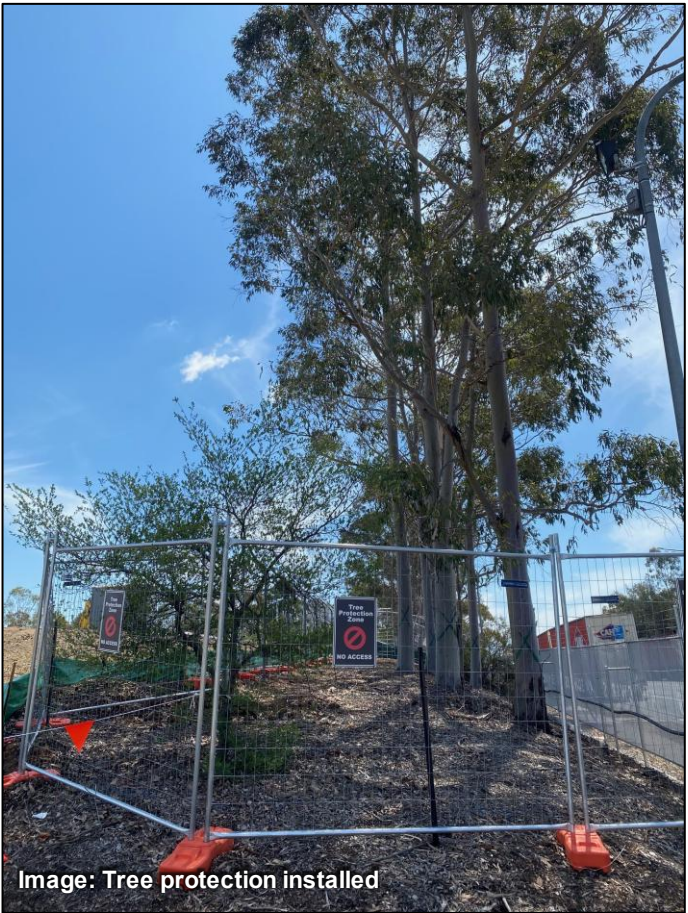
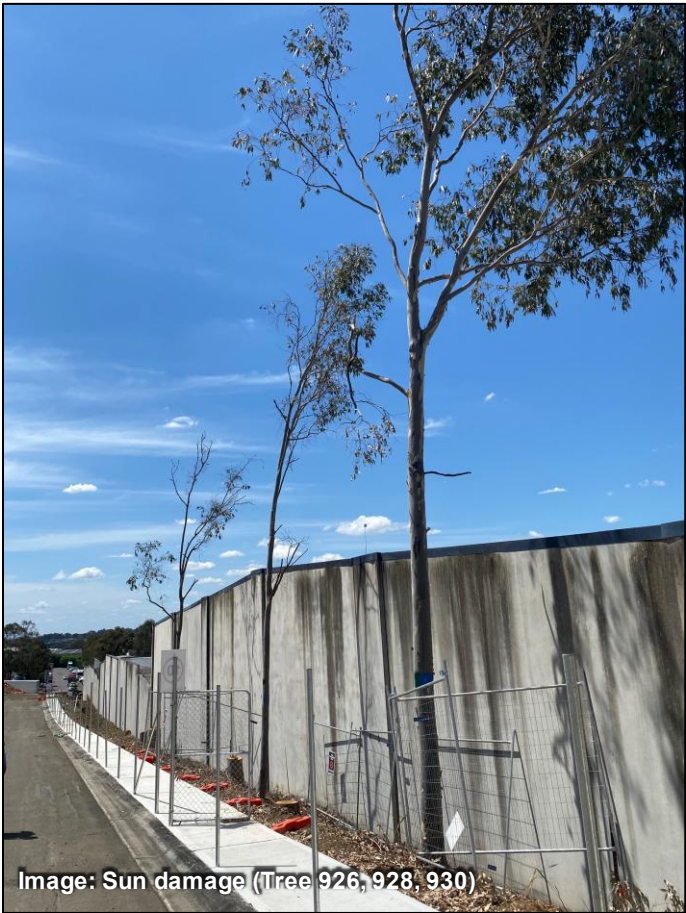
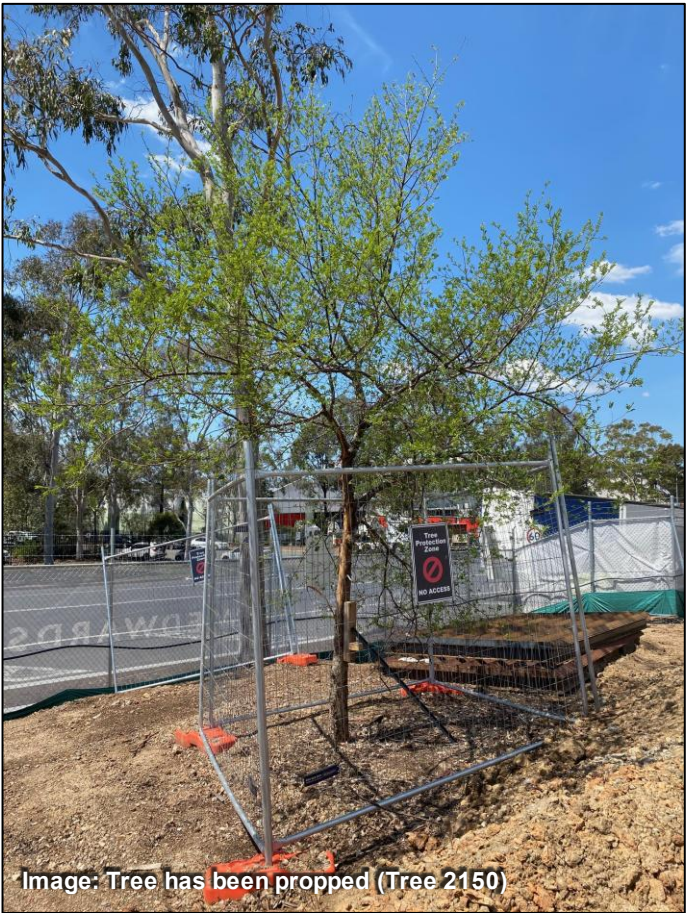
- All tree protection fencing has been installed in accordance with the approved tree protection plan.
- Tree 2150 was damaged by construction activities. This tree has been propped up in the ground and re-established.
- Trees 926, 928, and 930 have been affected by the removal of larger adjacent shade trees. The increased sun exposure has caused canopy dieback and premature leaf drop.

- Monitor the health and condition of Tree 2150.
- Supply additional water (irrigation) to Trees 926, 928 and 930. Monitor health and condition at the next inspection.
- Inspection of all retained trees should be carried out within 12 weeks.

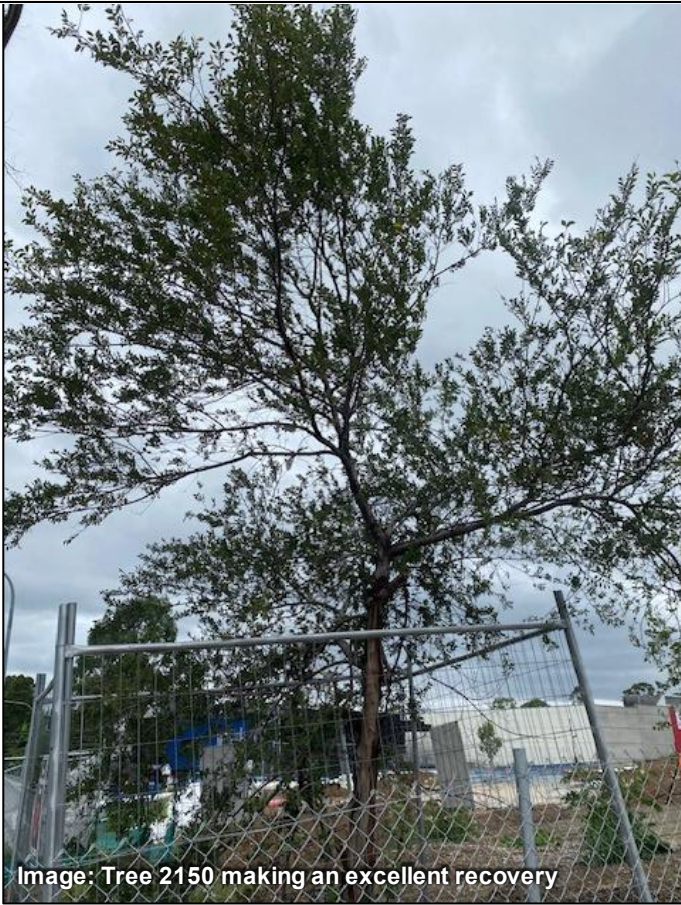
Image: Tree 2150 making an excellent recovery

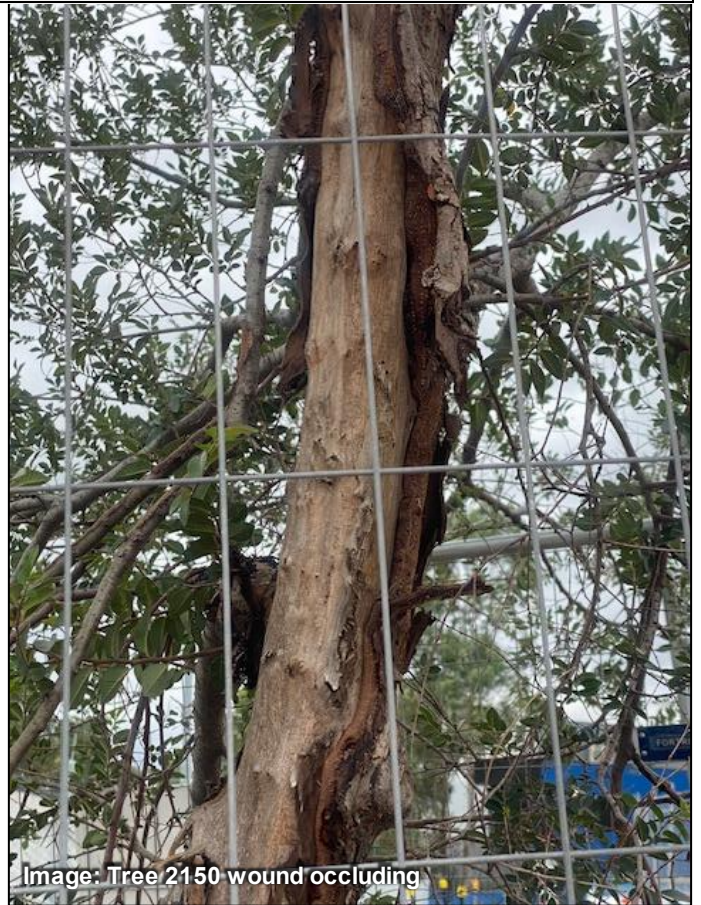
Image: Tree 2150 wound occluding

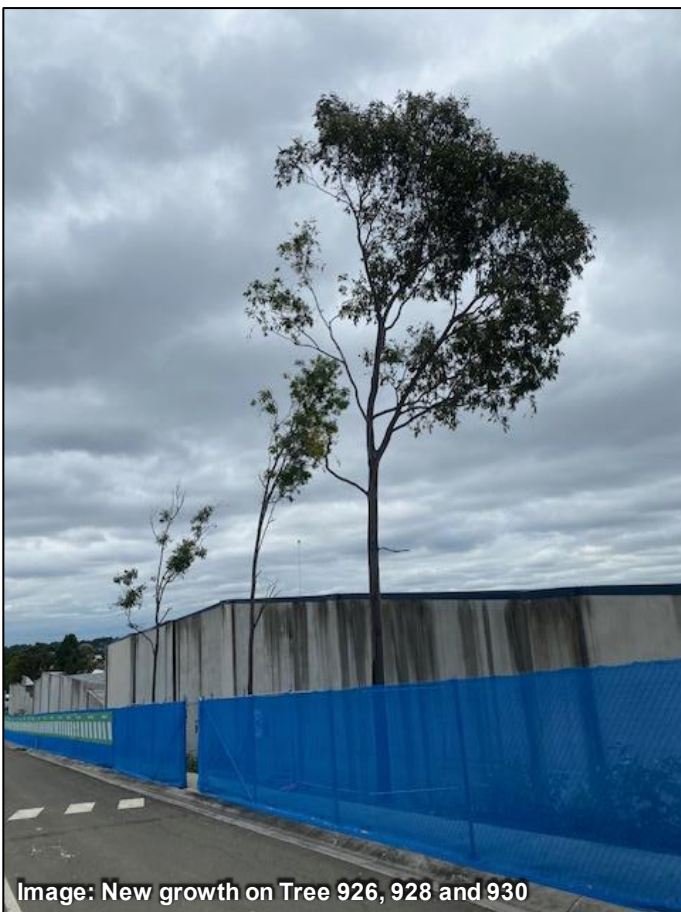
Image: New growth on Tree 926, 928 and 930

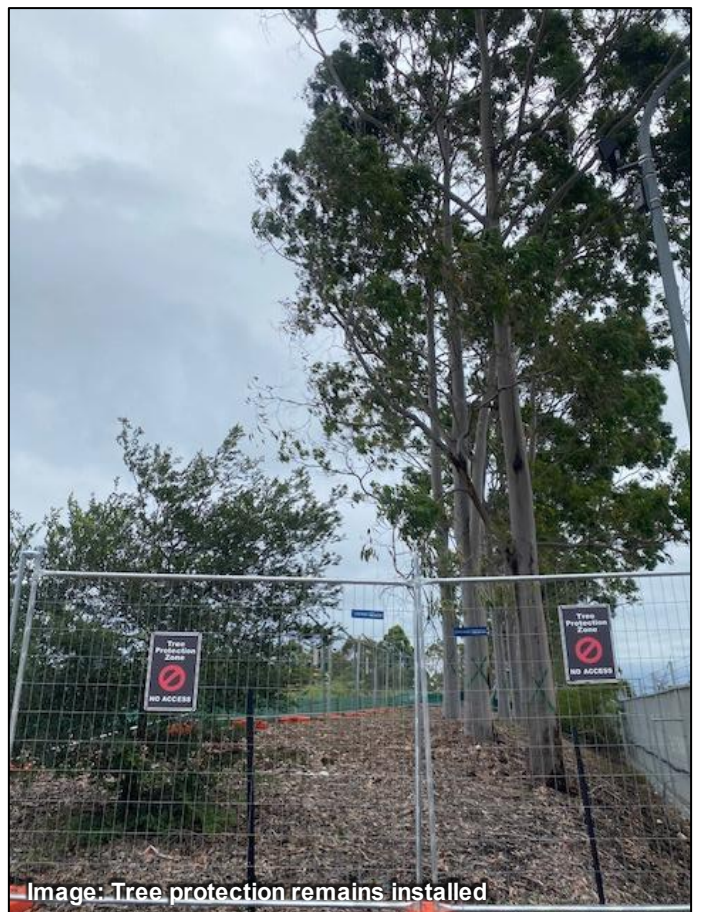
Image: Tree protection remains installed

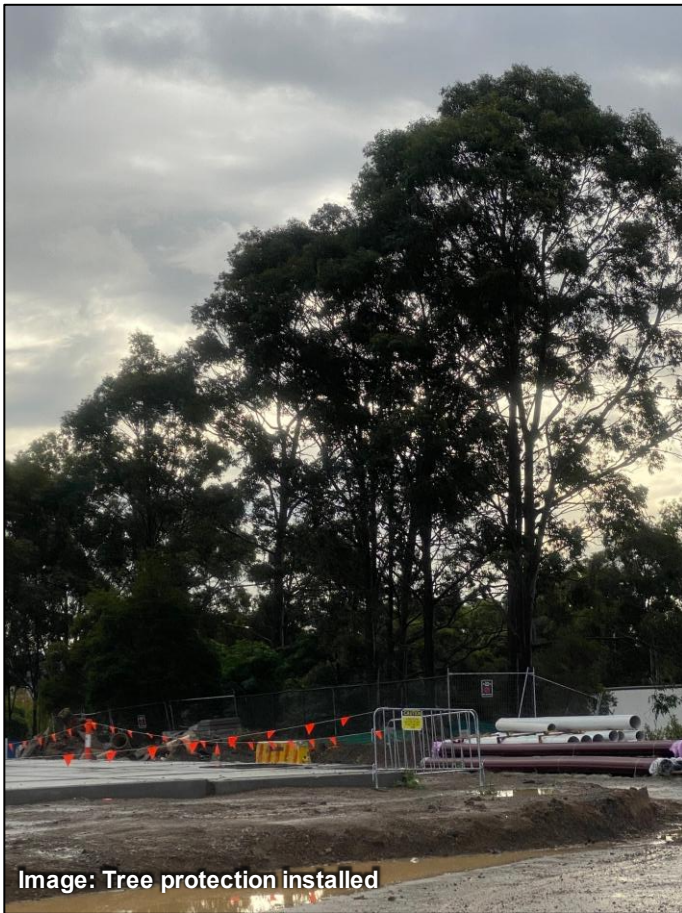
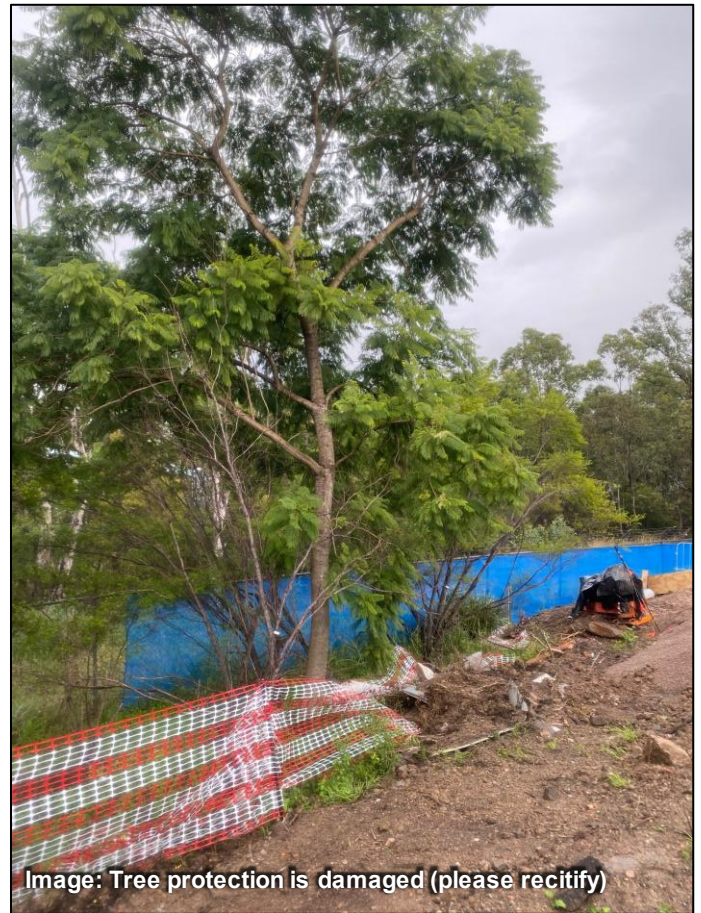
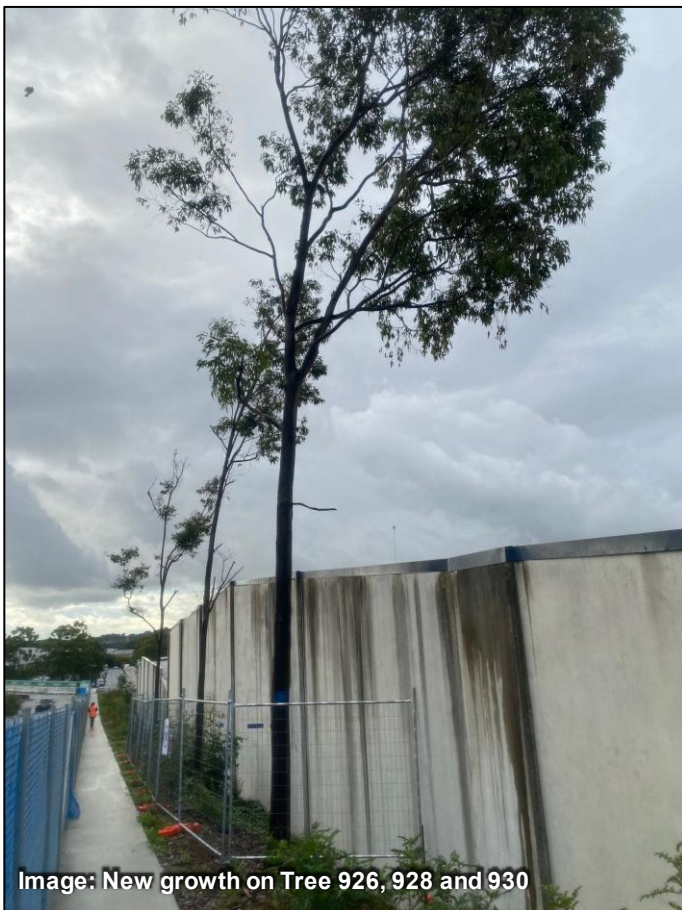
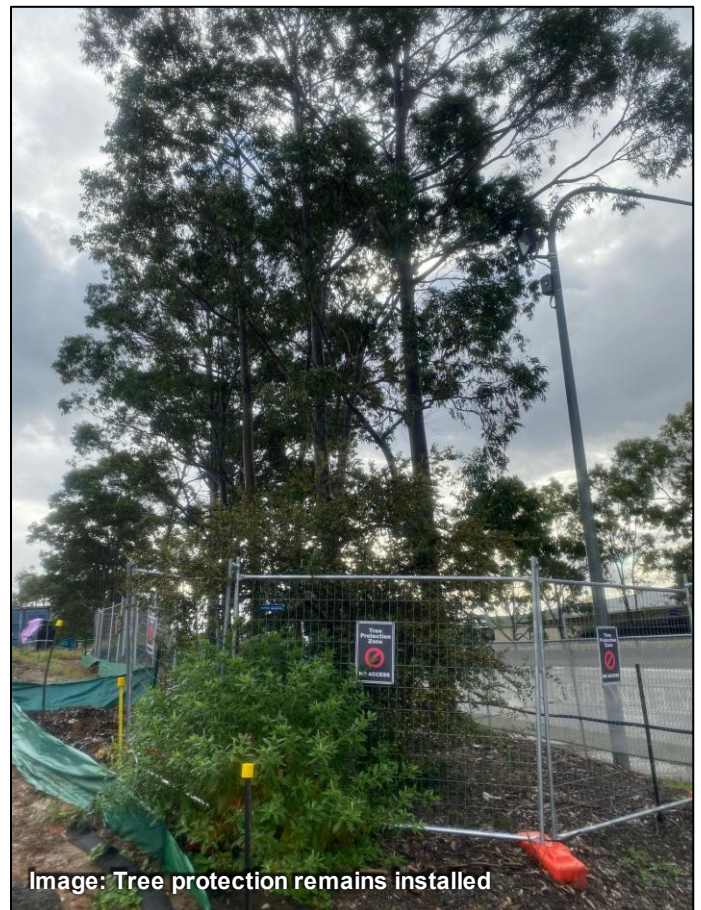
- All tree protection fencing has been installed in accordance with the approved tree protection plan.
- Some tree protection at the rear of the site has been damaged (photos attached). This part of the fence should be repaired.
- Tree 2150 was damaged by construction activities. This tree has been propped up in the ground and re-established. The health of this tree is still improving. Monitor tree.
- Trees 926, 928 and 930 were previously affected by the removal of larger adjacent shade trees. The increased sun exposure has caused canopy dieback and premature leaf drop. The health of these trees has continued to improve. New growth has appeared, and the trees are functioning well. Continuous monitoring is required.

- Monitor the health and condition of Tree 2150, Tree 926, 928, and 930 at the next inspection.
- Repair tree protection fence at the rear of the site.
- Inspection of all retained trees should be carried out within 12 weeks.

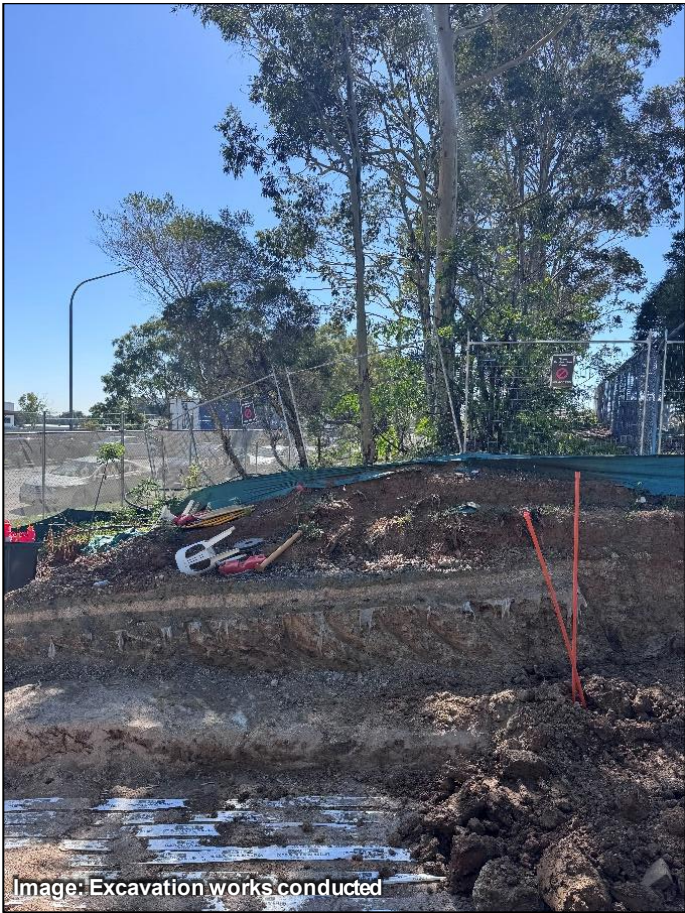
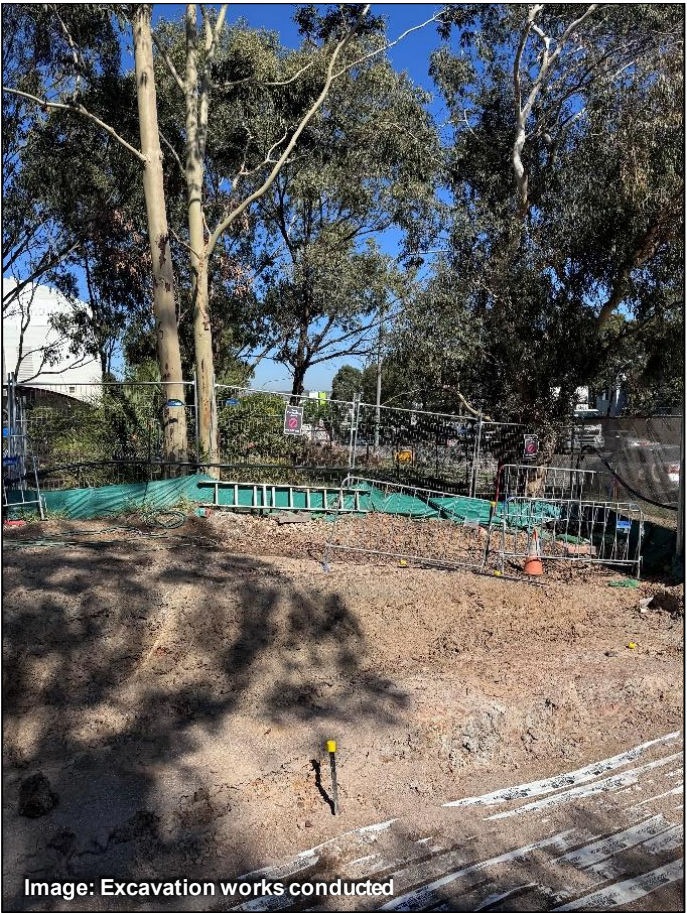
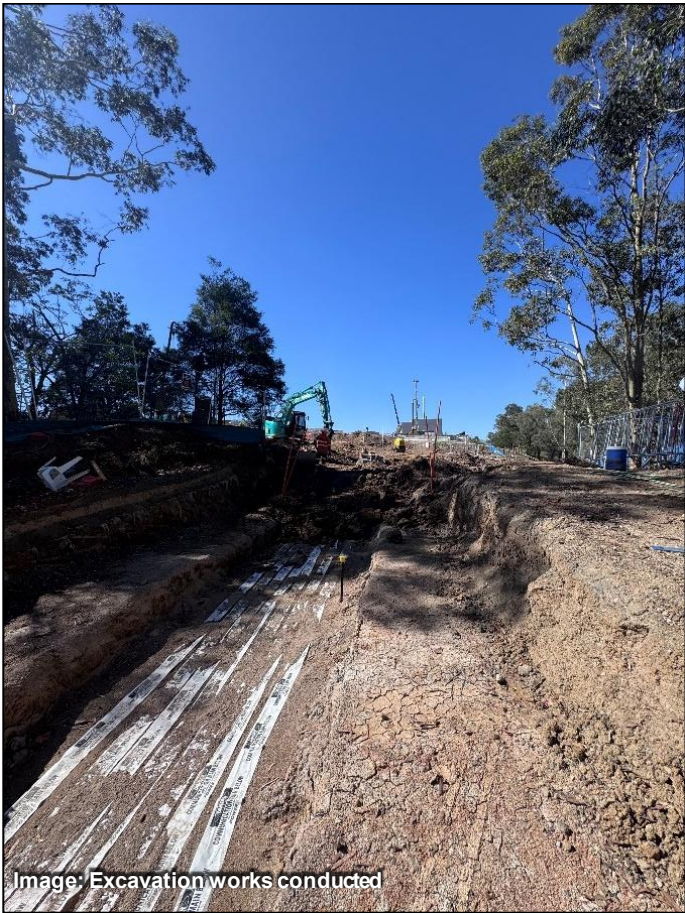
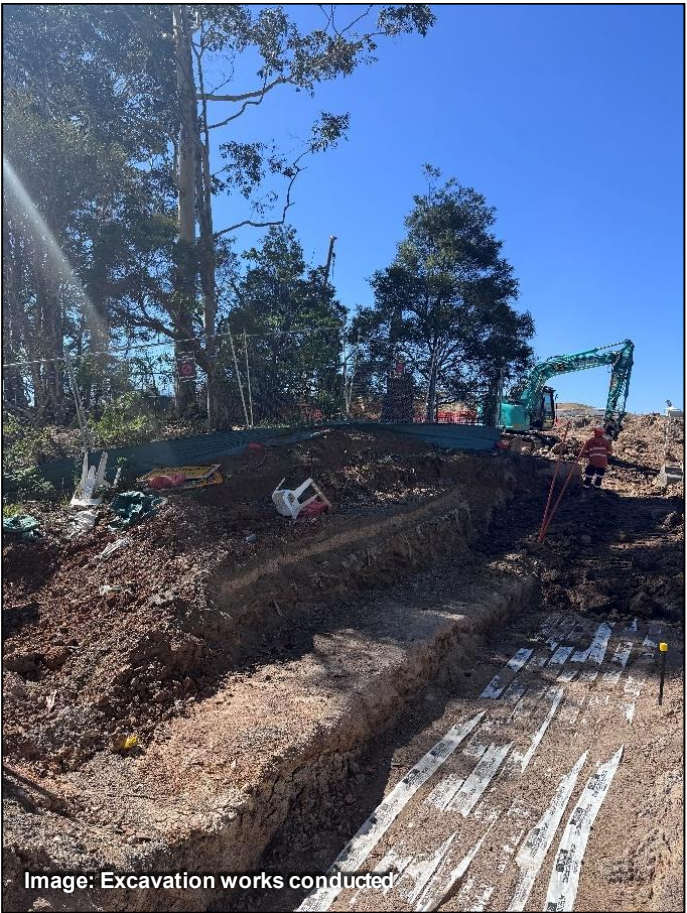
- Excavation was being conducted to build the entry point on the northern side of the site
- Further excavation will be required to construct the approved retaining walls
- Minor encroachments will occur in the TPZ of Trees 2180, 2181 2185 2249 and 1
- Advised contractors on site where excavation with machinery could occur

- Excavation as discussed onsite to be conducted with machinery to install retaining wall
- Minor roots will be affected on semi mature T2185 and T1
- Roots to be pruned with a sharp clean instrument if affected during excavation
- If further excavation is required excavation must be conducted by hand and project Arborist contacted for further assessment

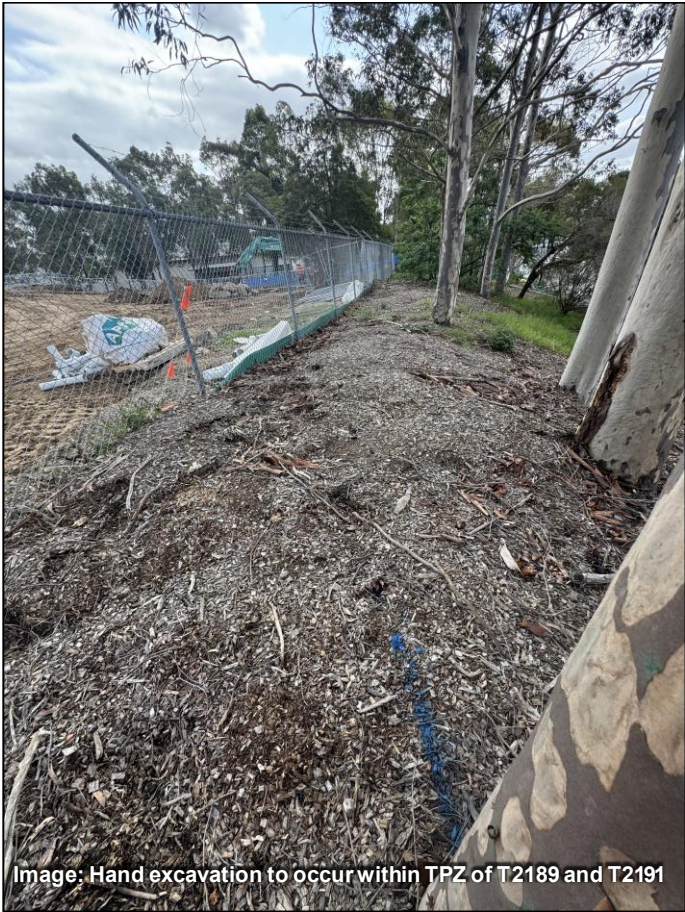
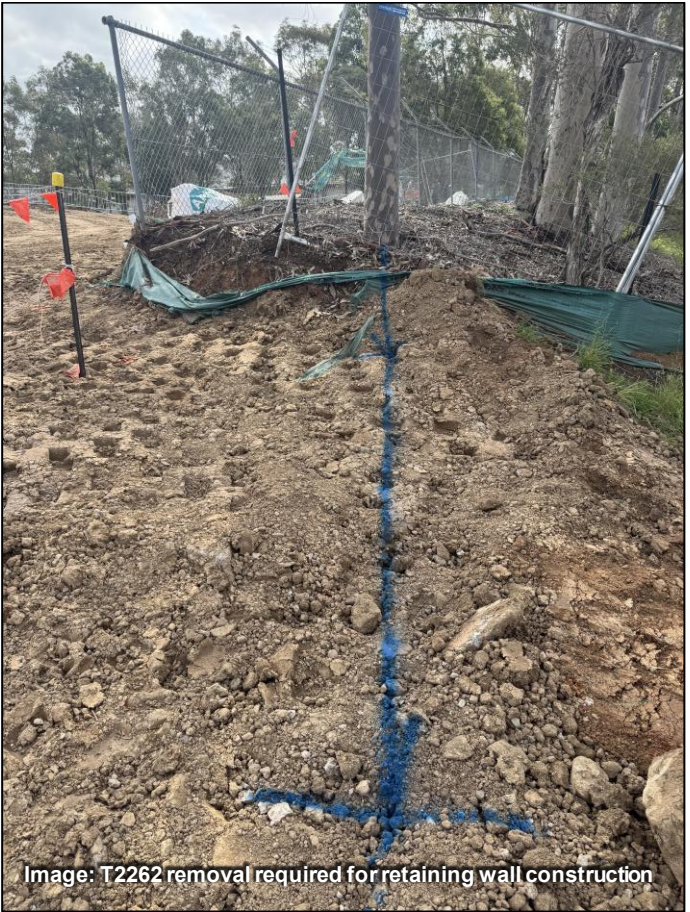
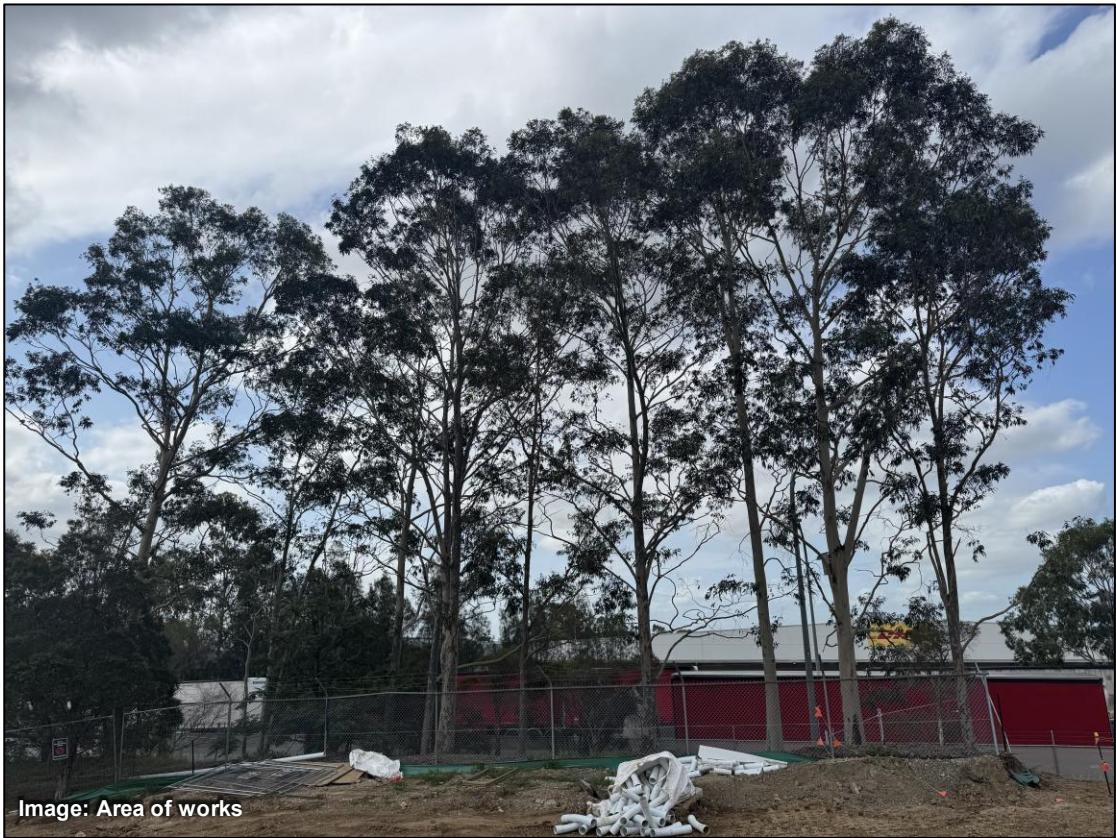
- Excavation for RW21 (Retaining Wall 21) was being conducted
- Minor encroachments in the TPZ of Trees 2180, 2181 2185 2249 and 1
- No structural roots have been affected
- Minor roots >30mm have been pruned with a clean reciprocator saw
- Excavation for RW20 (Retaining Wall 20) requires removal of T2262
- T2262 identified for removal in Arborist Report

- T2262 to be removed prior to excavation
- Hand excavation to occur in the TPZ of T2191 and T2189 for RW20
- Project Arborist to be contacted for further assessment once excavation has occurred

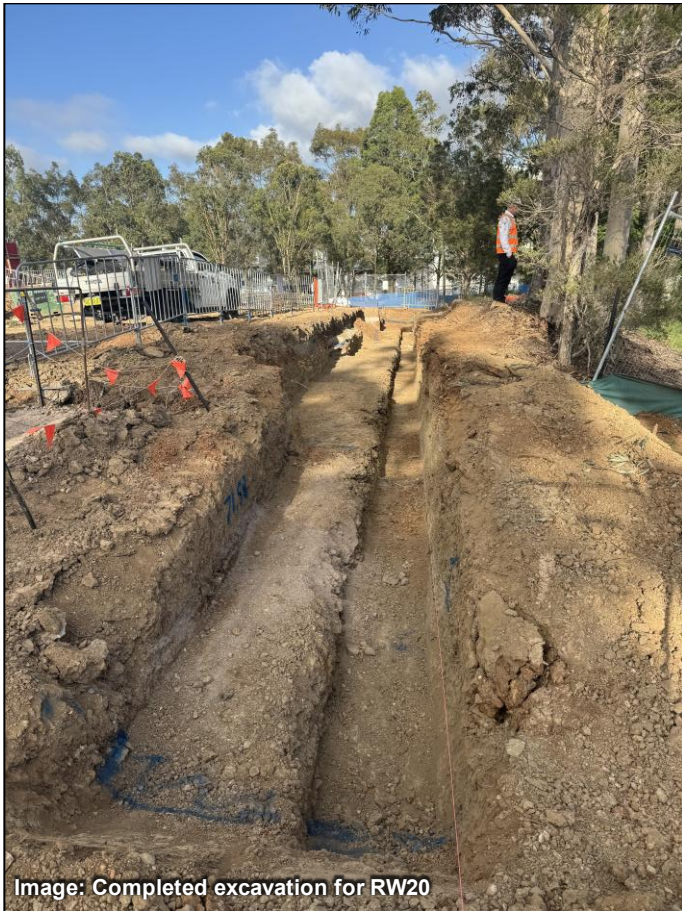
- T2262 has been removed
- Excavation for RW20 has been completed with machinery
- Excavation cut point measured approximately 500mm from T2
- One (1) large root approximately 80mm in diameter has been affected

Image: Completed excavation for RW20

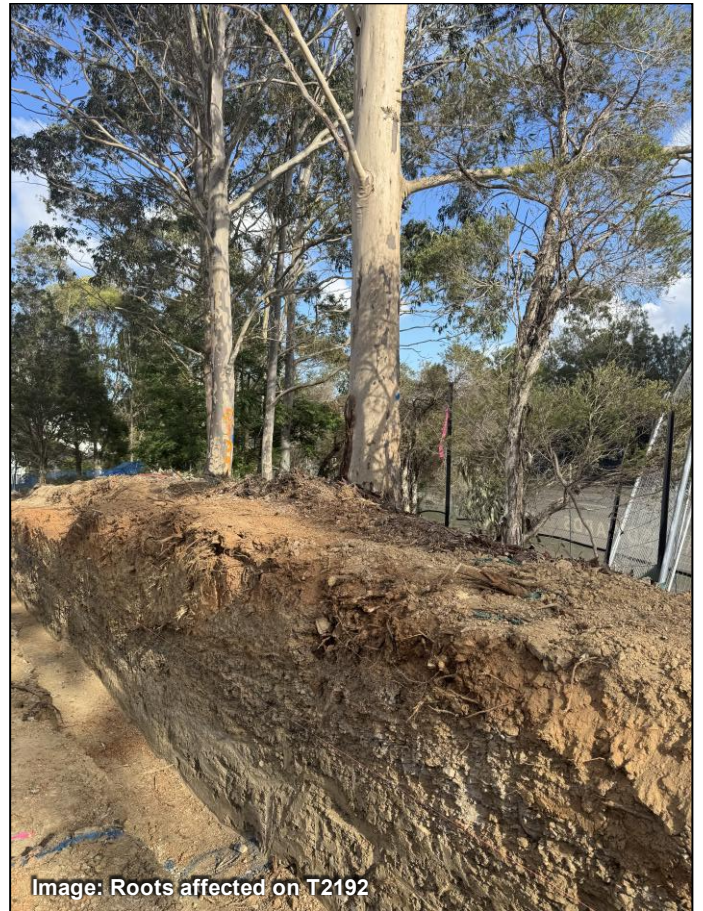
- Excavation cut point measured approximately 1.2m from T2192
- Damage to numerous roots approximately 50mm
- Three (3) roots approximately 100mm in diameter have also been affected. It was noted these have been cleanly cut with a sharp tool to rectify damage sustained during excavation

Image: Roots affected on T2192

- No further incursion in to SRZ to occur
- Roots affected from recent excavation to be cleanly cut with a clean, sharp tool to rectify damages
- T2, T2191 and T2192 to be pruned to rectify pruning works conducted for excavation
- Pruning must conform to AS4373 Pruning of Amenity Trees
- Pruning must be conducted by a minimum AQF Level III qualified Arborist
- If booster box is relocated then T2188, T2189, T2191, T2192, T2260, T2261 are recommended for removal
- Client to contact council and submit modification of consent for tree removal.

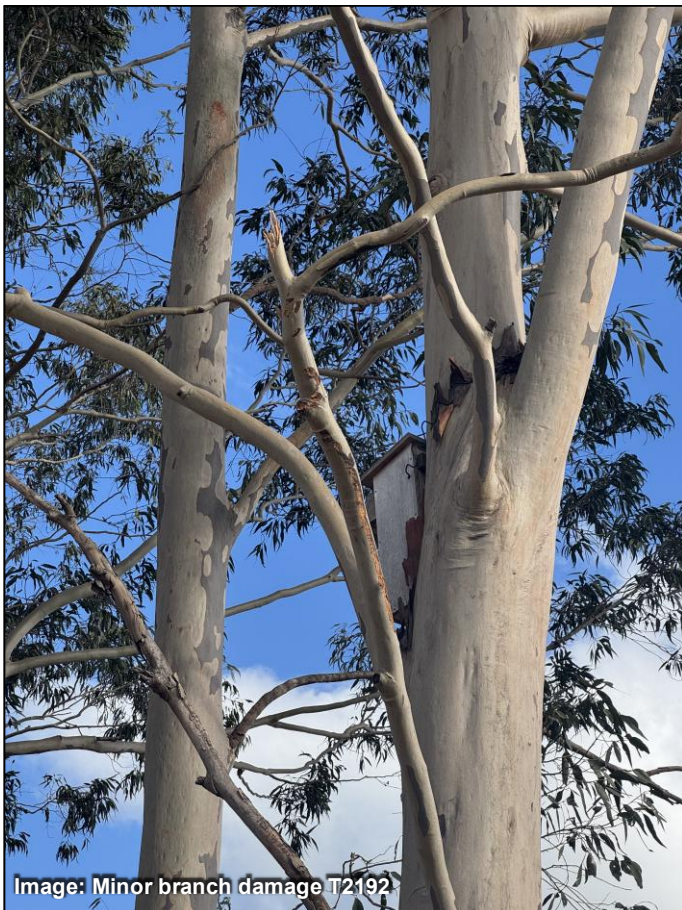
Image: Minor branch damage T2192

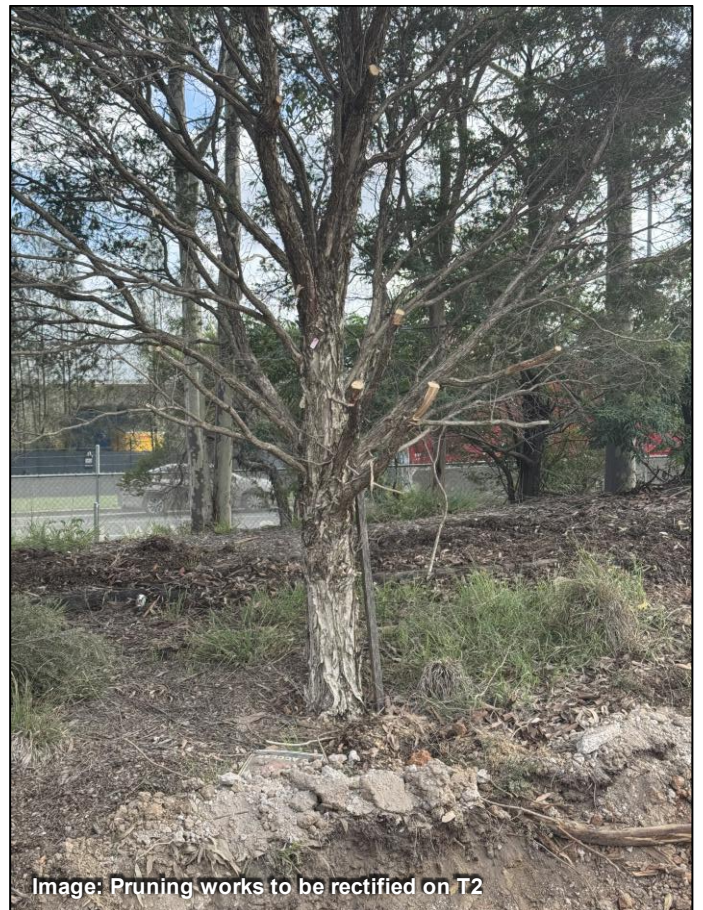
- T2 has been stub cut to allow for machinery excavation
- T2192 has sustained minor branch damage from excavation works
- If booster box is installed in location as per approved plans then excavation is unlikely to affect surrounding trees required for retention

Image: Pruning works to be rectified on T2

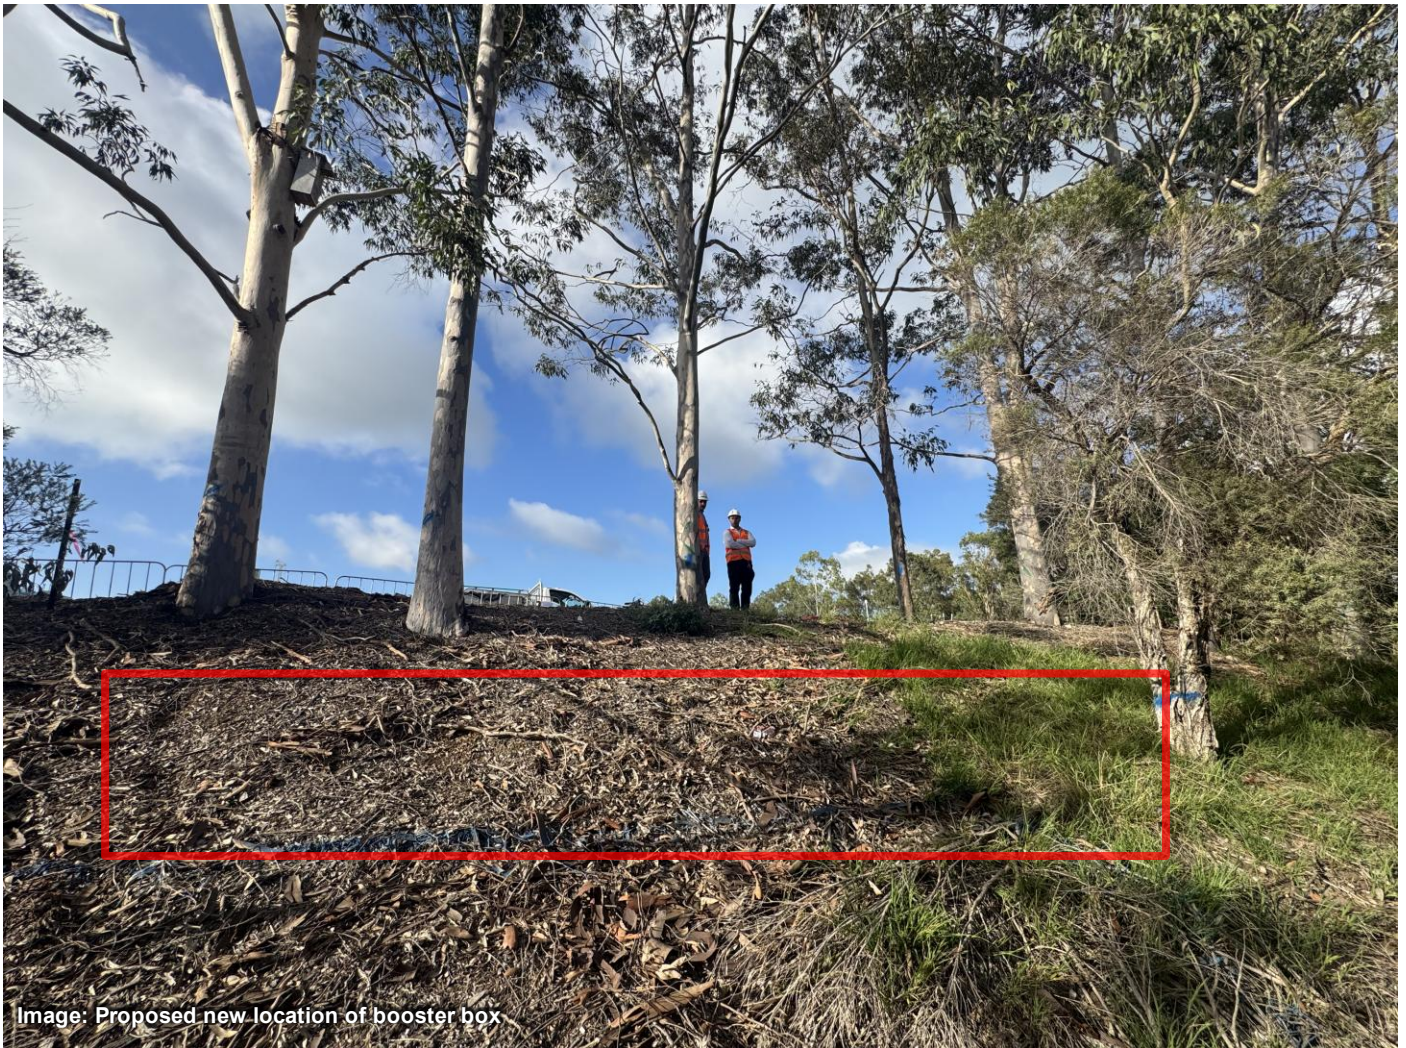
- If booster box is relocated, as discussed on site with Angelo Balassis, this will require the removal of T2188, T2189, T2191, T2192, T2260, T2261
- Excavation required for installation of booster box in new location will be in the SRZ of all trees

- Excavation for booster box is required to be 2.5m deep within SRZ of T2192
- T2191 and T2189 marked for removal in TPP

Image: Proposed new location of booster box

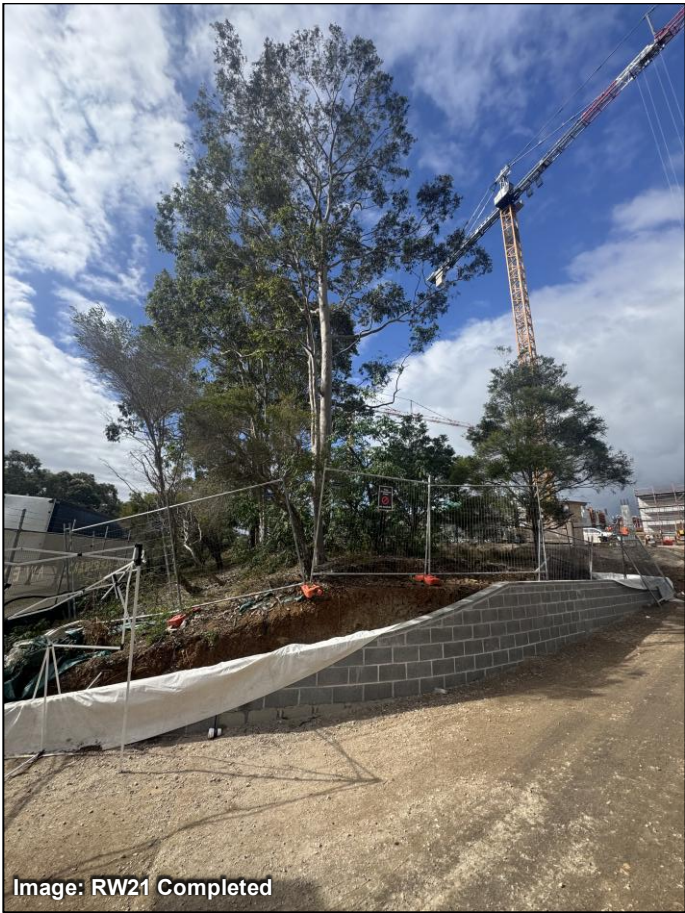
Image: RW21 Completed

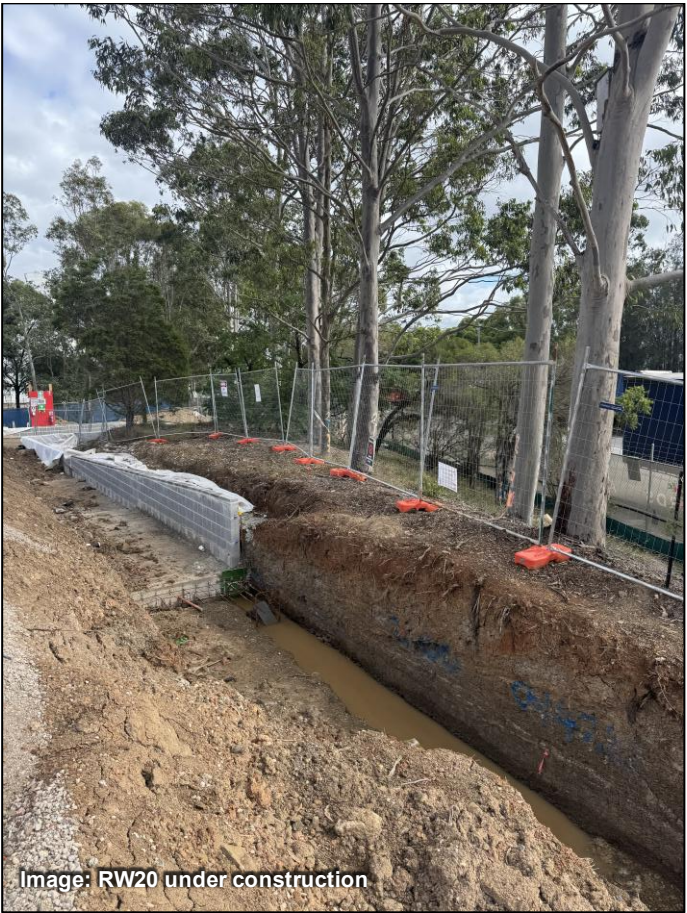
Image: RW20 under construction

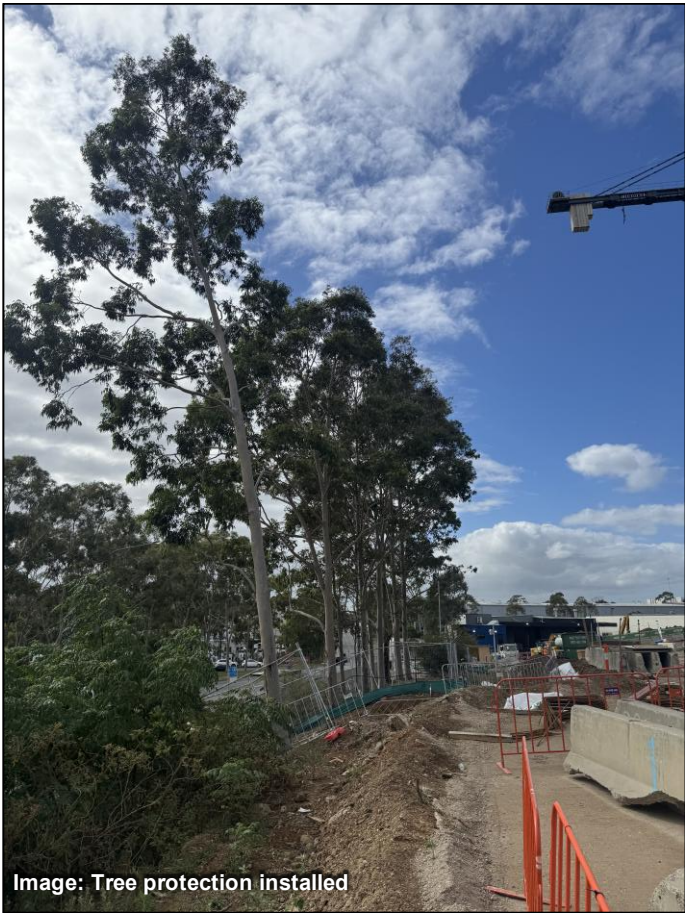
Image: Tree protection installed

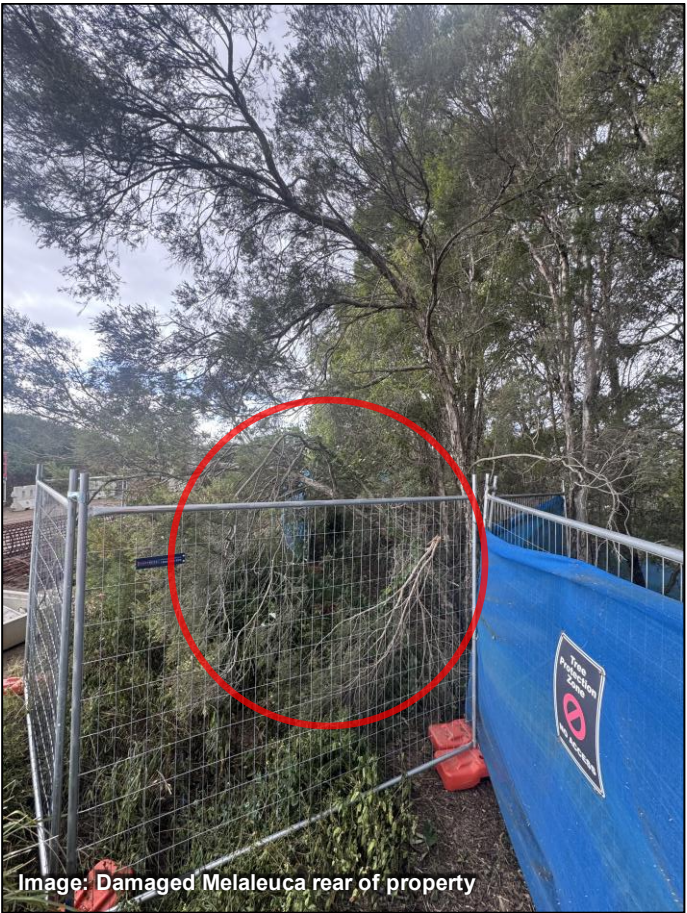
- Tree protection fencing installed as per TPP
- RW21 has been completed
- RW20 currently being constructed
- One (1) Melaleuca Tree rear of property has one (1) damaged limb requiring pruning

Image: Damaged Melaleuca rear of property

- All demolition and excavation within the TPZ must be supervised by the project Arborist
- T2, T2191 and T2192 to be pruned to rectify pruning works conducted for excavation
- Damaged Melaleuca tree rear of property to be pruned to rectify damaged limb
- All work must be conducted by a minimum AQF Level III qualified Arborist and conform to AS4373 Pruning of Amenity Trees
