# TREE SURVEY

## MONITORING & CERTIFICATION

**Airtrunk Data Centre**  
**51 Huntingwood Drive, Huntingwood**  
**Inspection 9**

**13 November 2025**

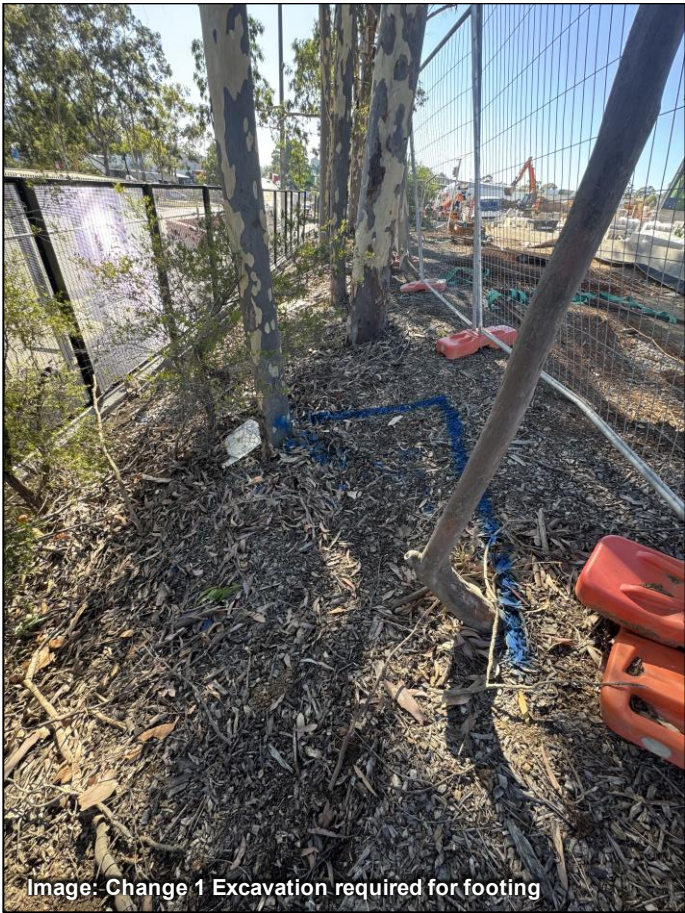
Image: Change 1 Excavation required for footing

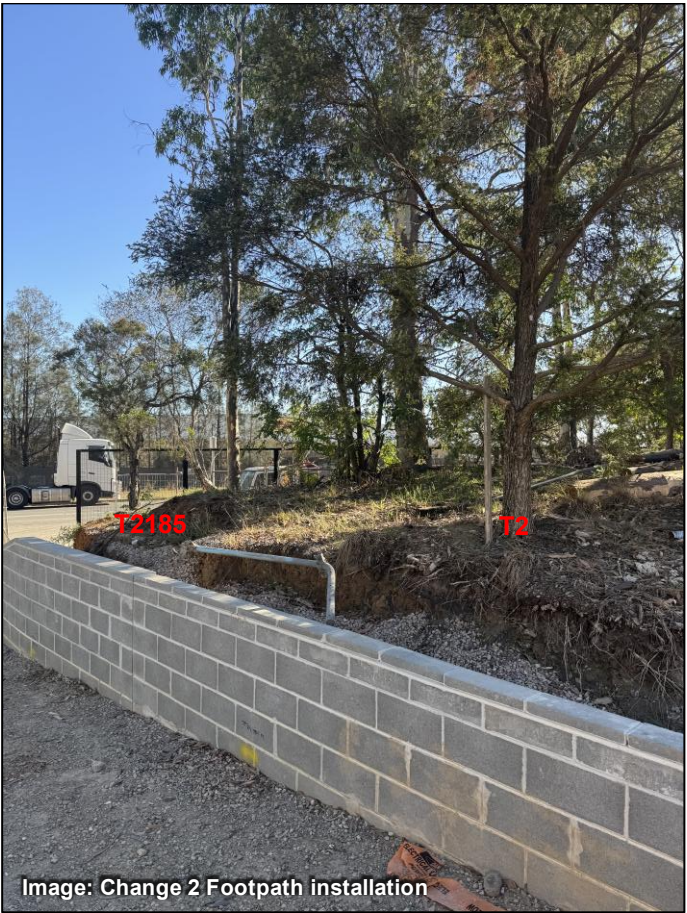
Image: Change 2 Footpath installation

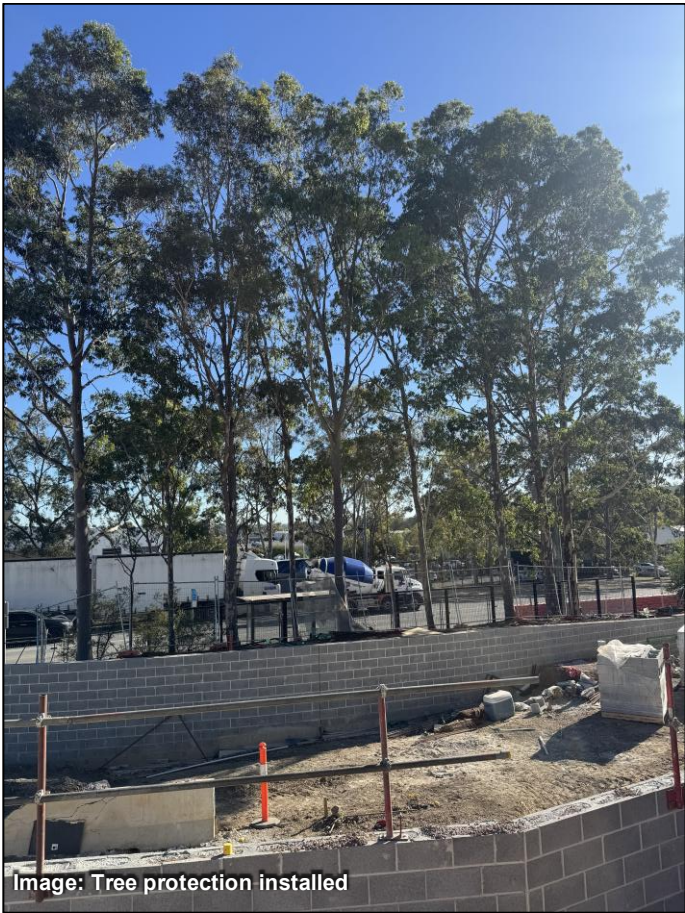
Image: Tree protection installed

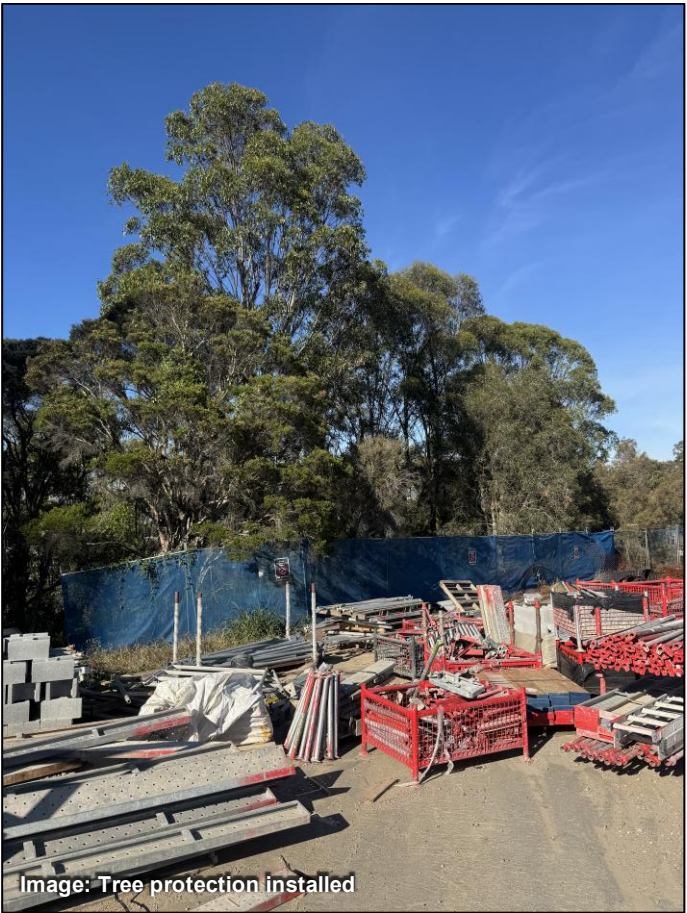
Image: Tree protection installed
